Pre-purchase Building Inspection

30 Granada Drive Highfields Qld 4352

Pre-Purchase Inspection - Residential Building Report (Except ACT)

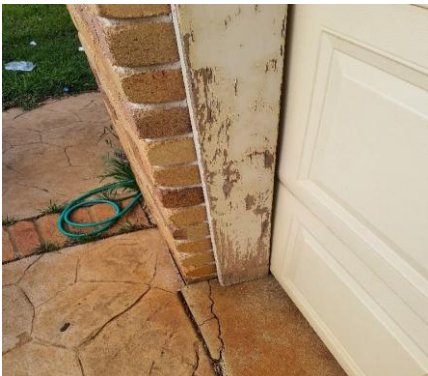
Weathering to the garage door frames

- *Weathering to the garage door frames. Engage a painting contractor for repainting.*
- *Cracking to the garage floor in various locations. Future maintenance may be required.*
- *The ceiling sheets are sagging, and timber has been installed to hold up ceiling lining. Rectification works are required – see a plastering contractor.*

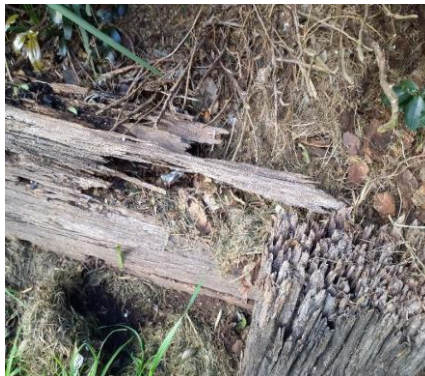
Wood decay and termite damage to retaining wall timbers

- *Wood decay and termite damage to retaining wall timbers. Engage a landscaper to quote for repairs.*

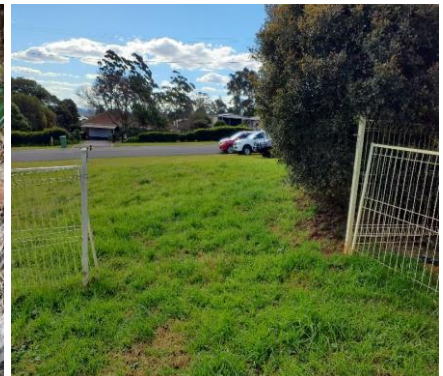
Fence gates are not attached

- *Side gates are not attached both side of the dwelling and wood decay to fence posts. Engage a fencing contractor for repairs where required.*

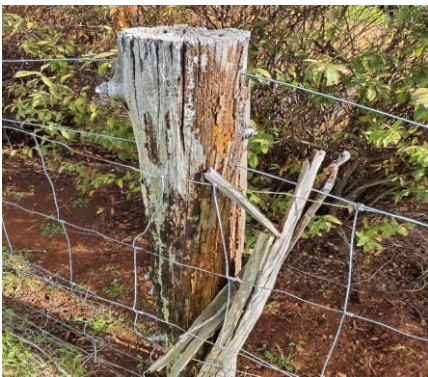
Wood decay to fence timbers

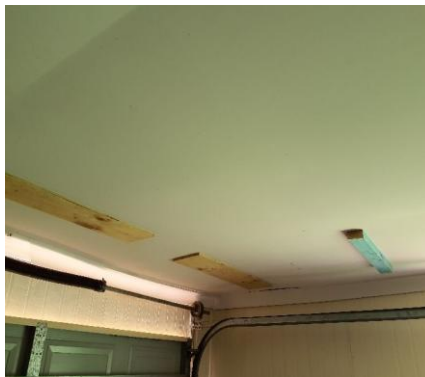
Timber has been attached to the garage ceiling

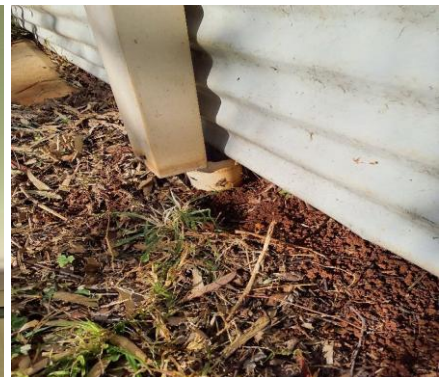
Shed downpipe is not connected

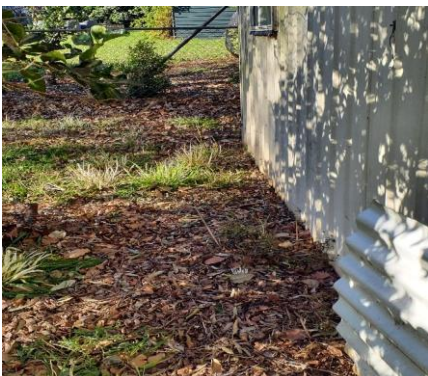
Landscaping is too high around the shed

- *Roof gutters need to be cleared of any debris. If left unattended, debris starts building up and gets trapped in the gutters creating acidic moisture that can lead to rust and water overflow. Clogged gutters also give trapped water time to soak through the structure causing damage. Maintenance - Required.*
- *Landscaping is too high which could cause moisture issues internally. Lower landscaping minimum of 75mm below the internal slab height.*

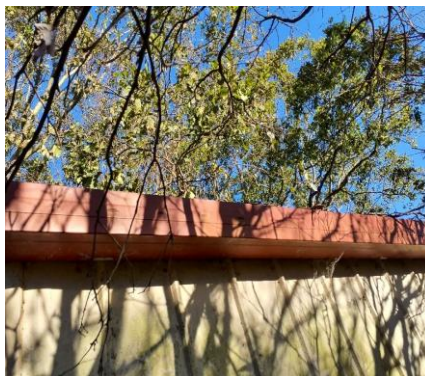
Debris to shed gutter

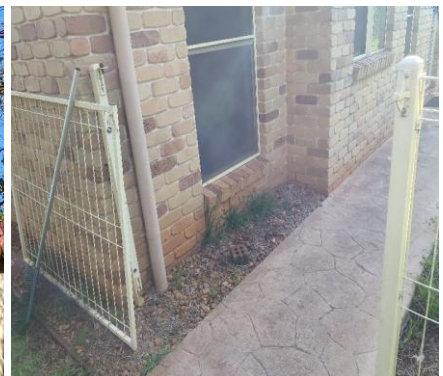
Side gate is not attached

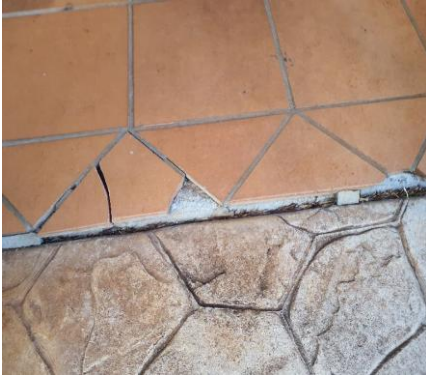
Damage floor tiles on the front porch

- *There are damaged floor tiles on the front porch. Engage a wall and floor tiler for repairs.*

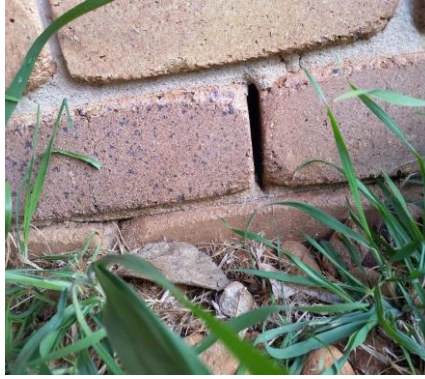
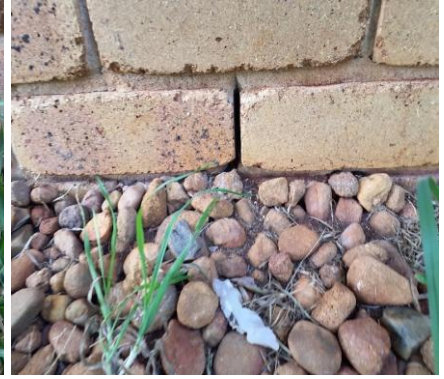
Landscaping is too high

- *Landscaping is too high in areas which could cause moisture issues internally. Lower landscaping minimum of 75mm below the weep holes.*

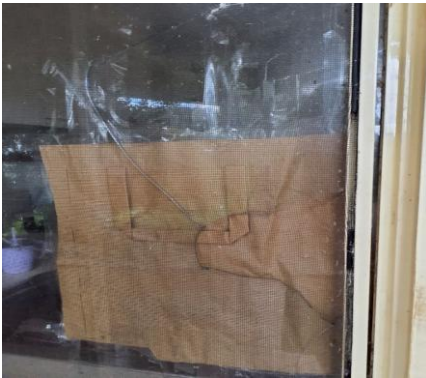
Kitchen window is broken

- *Kitchen window glass is broken possible safety hazard. Replacement - Required.*

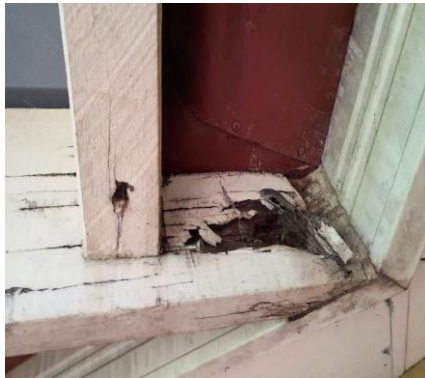
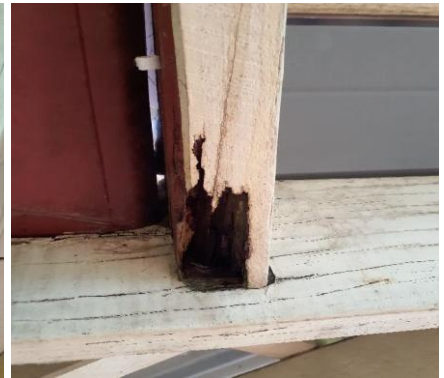
Wood decay to patio structure framework

- *Significant wood decay to rear patio area structure framework in isolated locations. Engage a carpenter for repairs where required.*

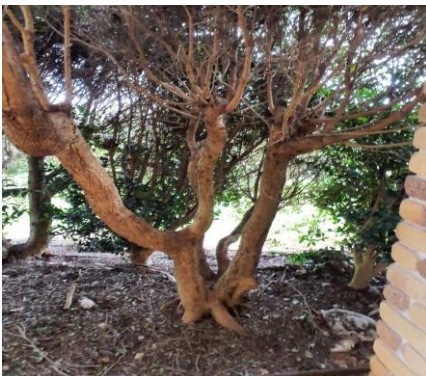
Vegetation is growing against the dwelling

- *Vegetation is growing against the wall of the dwelling in areas which could cause issues to the foundations. Removal of the vegetation is required.*

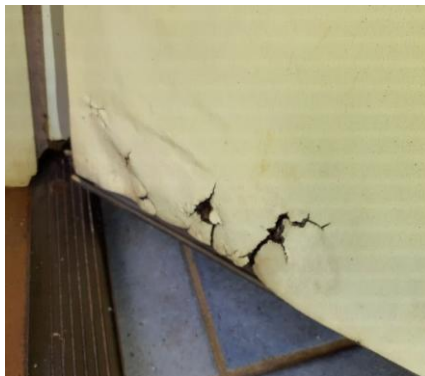
Water damage to the laundry external door

- *Water damage to the bottom of the laundry external door. Engage a carpenter for replacement.*

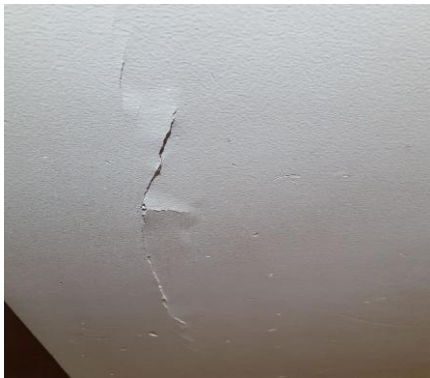
Damage to section of the lounge room wall lining

- *Damage to section of wall lining and cracking to the ceiling lining. Engage a plaster for repair.*

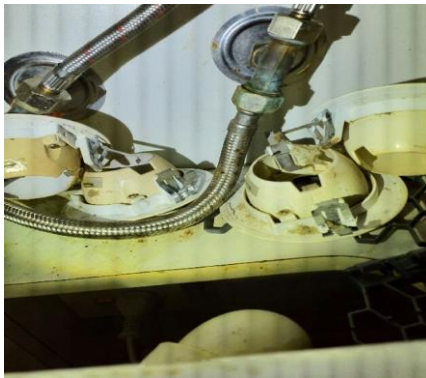
Rust to flexible hoses under the kitchen sink

- *There are signs of corrosion to the flexible hoses in the property. Rust spots on the exterior of the stainless steel braided flexible hoses are a good indication that the hose should be replaced. Engage a plumber to advise.*
- *Regular inspections are a key component in minimising the risk of a flooded house from a burst flexible hose and regardless our recommendation is to replace them every 3-5 years as part of a proactive preventative maintenance plan.*
- *Cracking to the join of the ceiling lining. Engage a plaster for repair.*

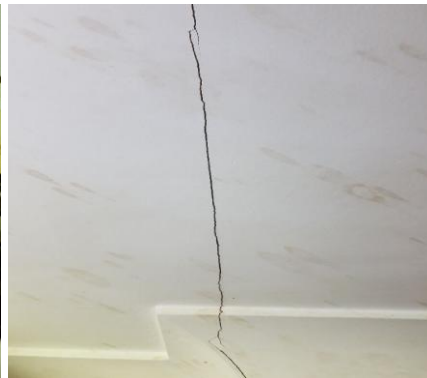
Cracking to the join of the dining / kitchen ceiling

- *Cracking to the join of the ceiling lining and damage to the wall lining. Engage a plaster for repairs.*

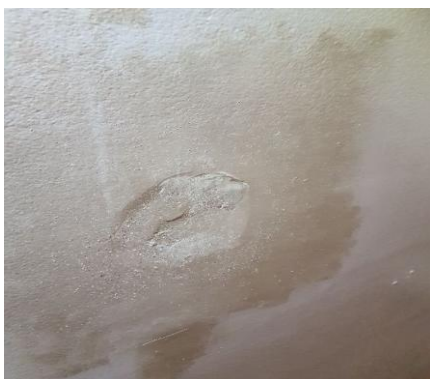
Damage to section of the dining room wall lining

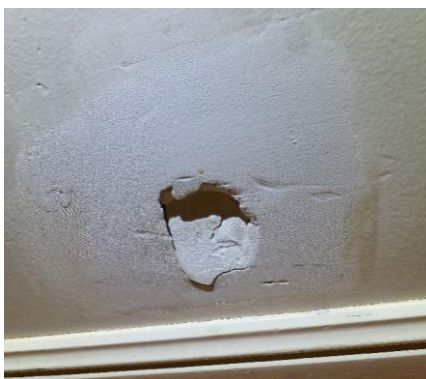
Damage to hallway wall lining

- *Damage to the hallway wall lining. Engage a plaster for repairs.*

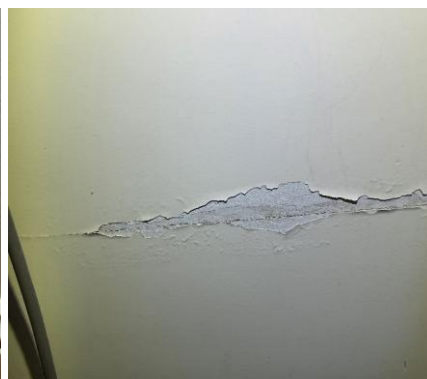
Cracking to join of the laundry wall sheeting and paint flaking

- *Cracking to the join of the wall sheeting. Engage a plaster for repair.*
- *Paint flaking from the wall sheeting. Engage a painting contractor for repairs.*

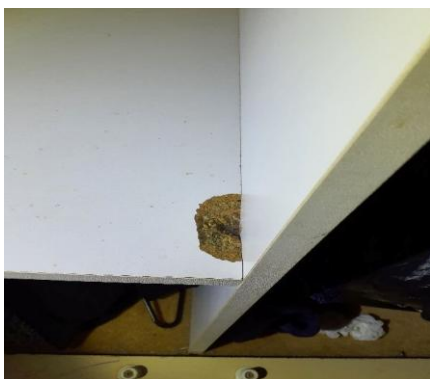
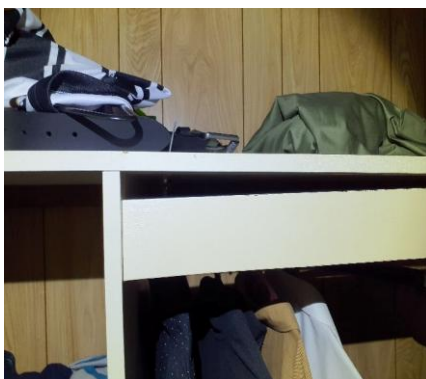
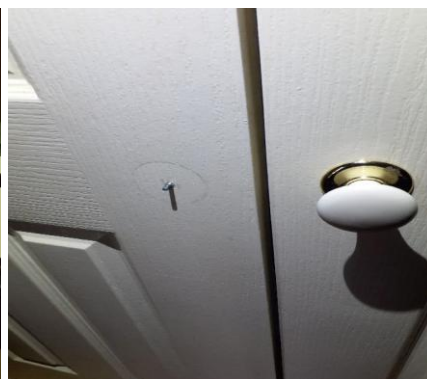
Damage to bedroom 2 robe shelf

Bedroom 2 robe shelf support has separated

Bedroom 2 robe doorknob is missing

- *Damage to robe shelf, section of robe shelf support has separated, and robe doorknob is missing. Engage a carpenter for repair.*
- *Damage to section of the bedroom ceiling. Engage a plaster for repair.*

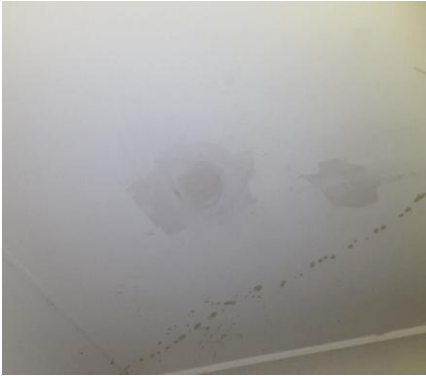
Damage to section of bedroom 2 ceiling

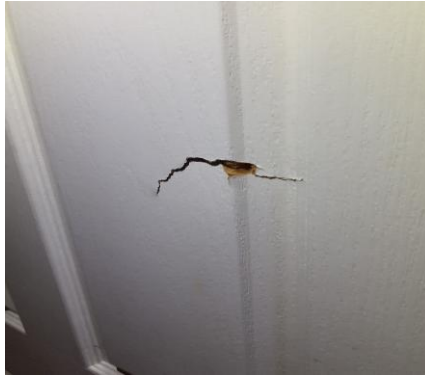
Damage to bedroom 1 doors

- *Damage to bedroom doors. Engage a painting contractor for repairs.*

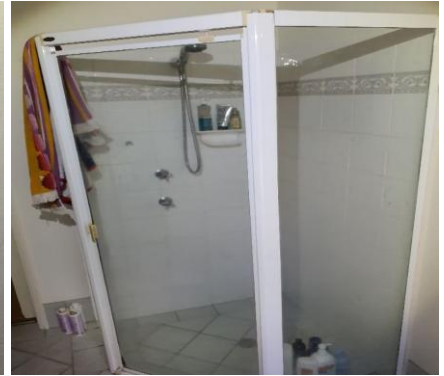
Ensuite shower screen is unsecure

- *Ensuite shower screen is unsecure. Engage a glazier for repair.*
- *Cracking to the join of the wall sheeting. Engage a plaster for repair.*
- *Ensuite wash basin tap is leaking. Plumber to advise.*
- *There are signs of corrosion to the toilet flexible hose. Rust spots on the exterior of the stainless steel braided flexible hoses are a good indication that the hose should be replaced. Engage a plumber to advise.*
- *Regular inspections are a key component in minimising the risk of a flooded house from a burst flexible hose and regardless our recommendation is to replace them every 3-5 years as part of a proactive preventative maintenance plan.*
- *The replacement of the internal shower recess sealants is recommended as a preventative measure.*

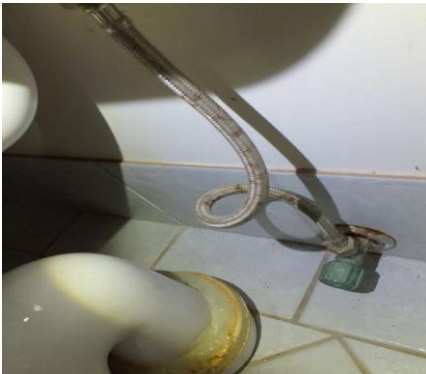
Rust to ensuite toilet flexible hose

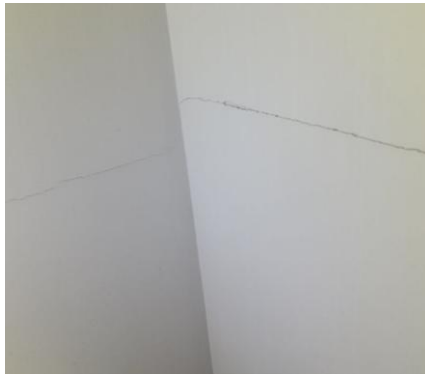
Minor cracking to the ensuite wall sheeting

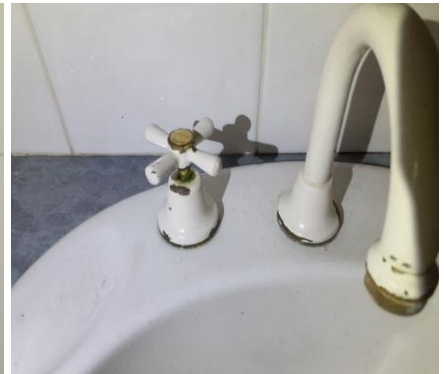
Ensuite wash basin tap is leaking

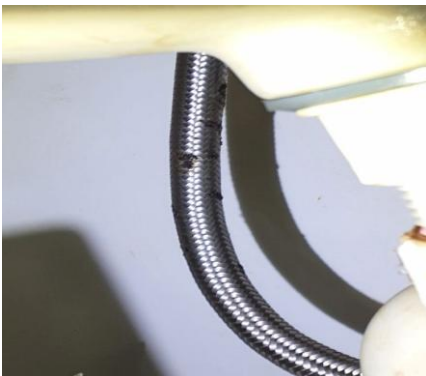
Rust to the flexible hoses under the wash basin

- *There is swelling to the vanity unit. Engage a cabinet maker to quote for repairs.*
- *The shower screen door does not close fully, and shower screen door is cracked. Engage a glazier for repair.*
- *There are signs of corrosion to the flexible hoses in the property. Rust spots on the exterior of the stainless steel braided flexible hoses are a good indication that the hose should be replaced. Engage a plumber to advise.*
- *Regular inspections are a key component in minimising the risk of a flooded house from a burst flexible hose and regardless our recommendation is to replace them every 3-5 years as part of a proactive preventative maintenance plan.*
- *The replacement of the internal shower recess sealants is recommended as a preventative measure.*

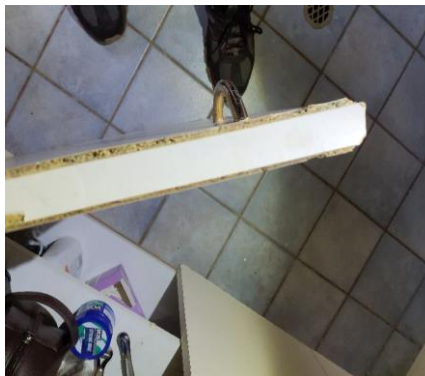
Swelling to the vanity unit

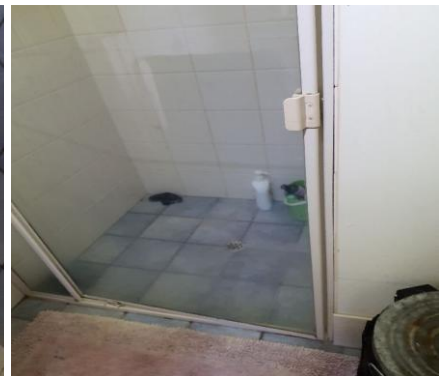
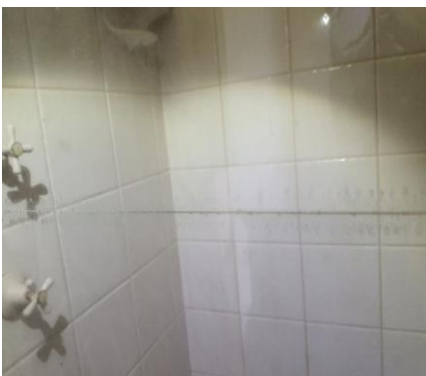
Shower screen door is not closing fully

Bathroom shower door glass is cracked

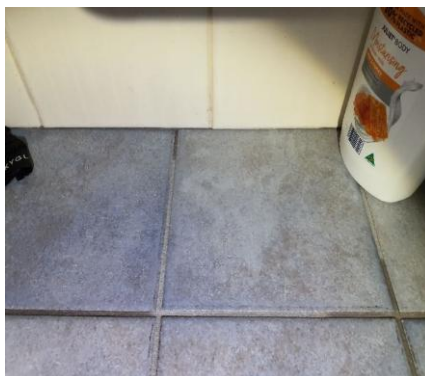
Sealant missing from around the bottom of the shower recess

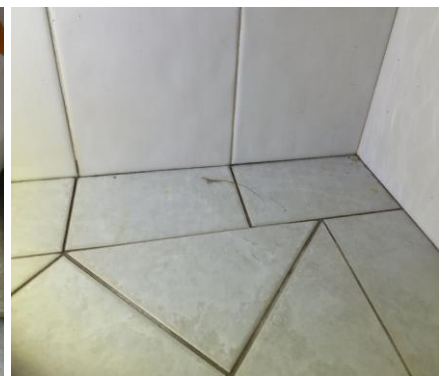
Sealant missing from around the bottom of the ensuite shower recess

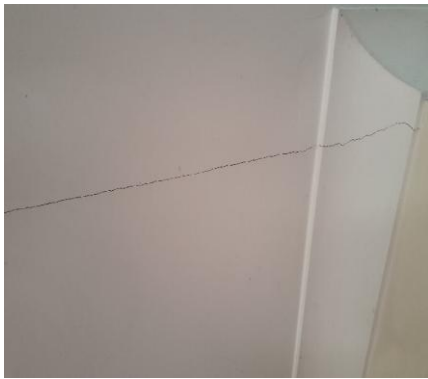
Cracking to the entry ceiling

- *There is cracking to the entry ceiling. The fitting of an expansion joint is recommended - see a plastering contractor.*

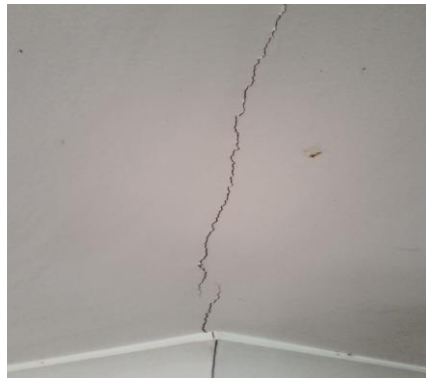
Cracking to the lounge room ceiling

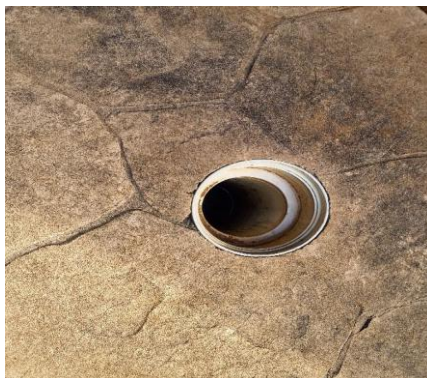
Grate is missing from drain

- *Grate is missing from drain in Northern path. Plumber to advise.*

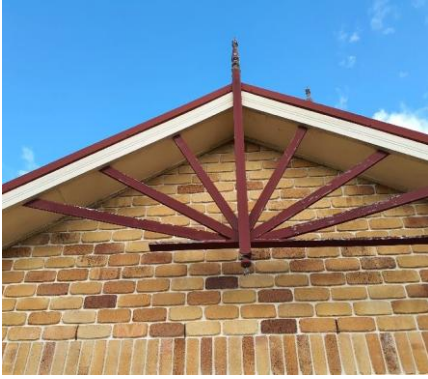
Wood decay to timber mouldings in the gable

- *Wood decay and weathering to the timber mouldings in the gable. Engage a carpenter for repairs.*

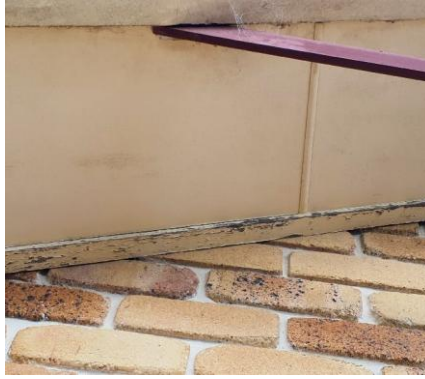
Weathering to the timber mouldings on eaves

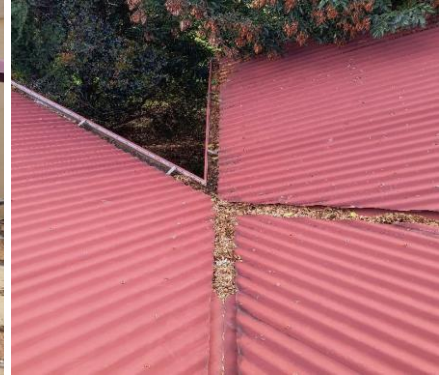
Debris to gutters

- *Roof gutters need to be cleared of any debris. If left unattended, debris starts building up and gets trapped in the gutters creating acidic moisture that can lead to rust and water overflow. Clogged gutters also give trapped water time to soak through the structure causing damage. Maintenance - Required.*

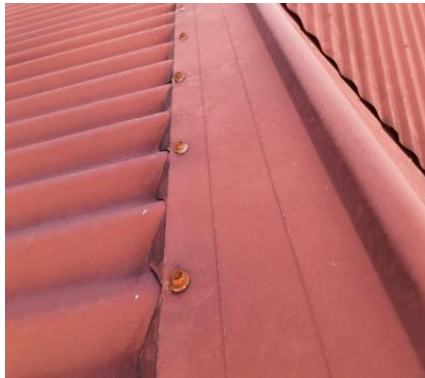
Rusty roof screws

- *There are some pop rivets missing from joins of ridge capping and rusty roof screws throughout. Engage a roofing contractor for repairs.*

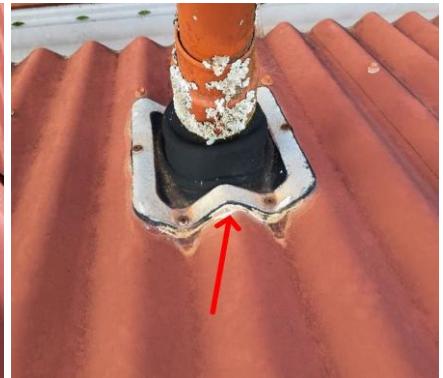
Sealant shows signs of deterioration around vent pipe boot

- *Rooftop vent pipe sealant shows signs of deterioration. Maintaining a leak-proof roof requires periodic checks to assure sealants such as caulk have not chipped, cracked, or pulled away from places they seal. These areas include roof vents. They require occasional reapplication of caulk around the base where the vent contacts the surrounding roof.*
- *Rooftop sealant has been applied prior to the inspection; such application is a temporary waterproofing measure and may last for some months before breaking down . Engage a roofing contractor to quote for repairs to rectify where required.*

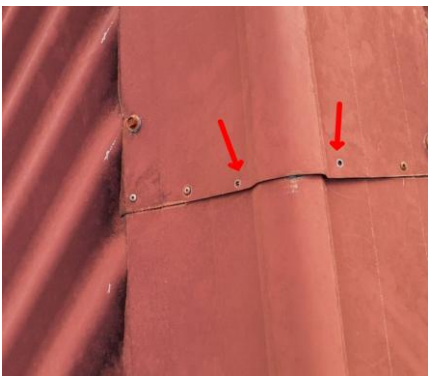
Pop rivets missing from join of ridge capping

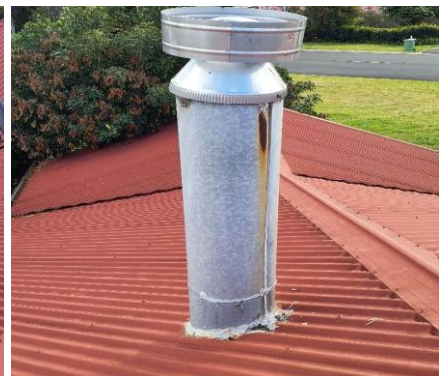
Minor rust and there is no boot around the flue

- *There is no boot around the flue. The installation of a heat-resistant boot is recommended.*
- *Minor rust is evident to the metal flue in isolated locations. This should be treated to prevent further deterioration.*

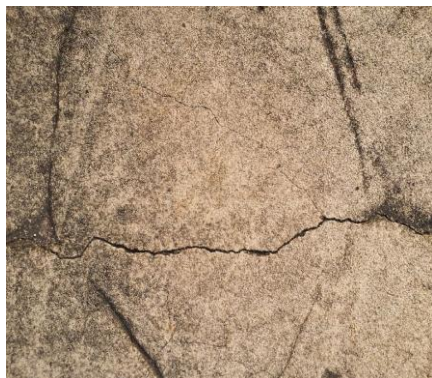
Minor cracking to the driveway

- *Minor cracking to the concrete driveway in various locations. Future maintenance may be required.*

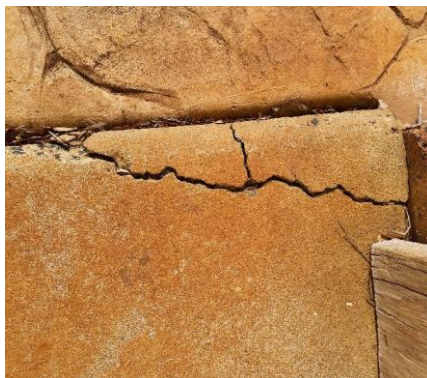
Cracking to the garage floor

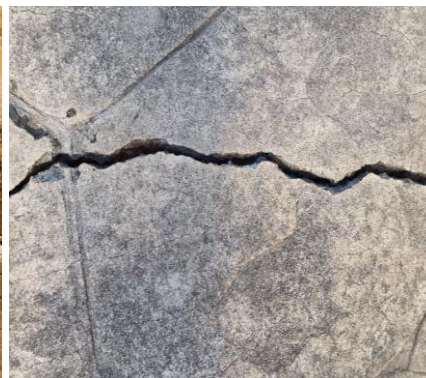
Cracking to the path

- *Cracking to the concrete paths in various locations. Future maintenance may be required.*
