Report No: 100454

**PRE-PURCHASE  
TIMBER PEST DETECTION REPORT**

ADDRESS OF PROPERTY INSPECTED: 30 GRANADA DRIVE HIGHFIELDS QLD 4352

DATE OF INSPECTION: 28/07/2025

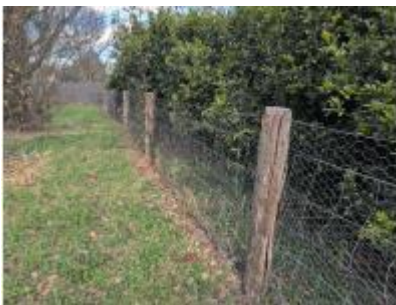
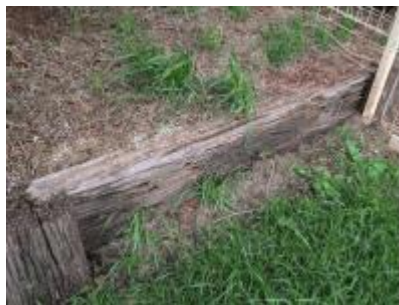
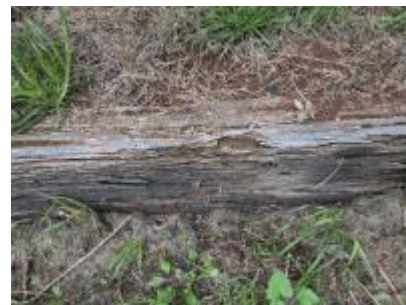
**Details - Old termite evidence found in fence posts and small garden retained walls.**

**RECOMMENDATION** Where evidence of damage to building timbers exists, competent advice (e.g. from a licensed and practicing building contractor) should be obtained to determine the extent of any structural damage and as to the need or otherwise for rectification or repair work. See also Item 3.1.5 ‘Frequency of Future Inspections’ recommendation.

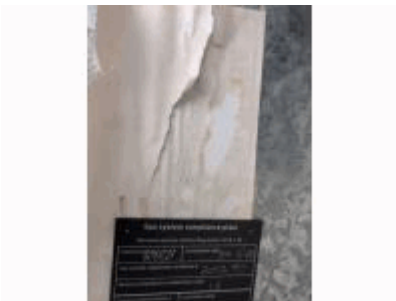
Was evidence of a possible previous termite management program found ? **Yes - see Notes and**

**Details below. - Details of the initial termite treatment at initial construction was not legible.**

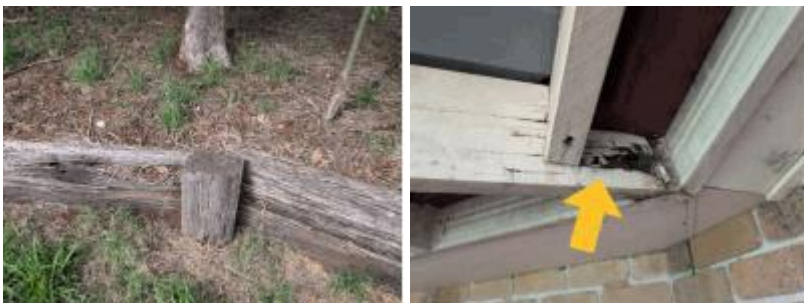
**Location - Decay in retained walls and rear pergola.**

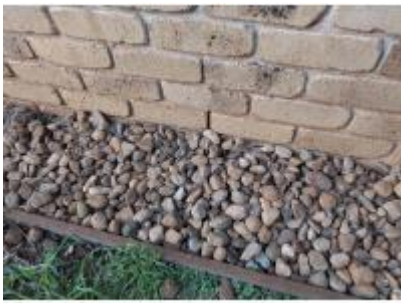
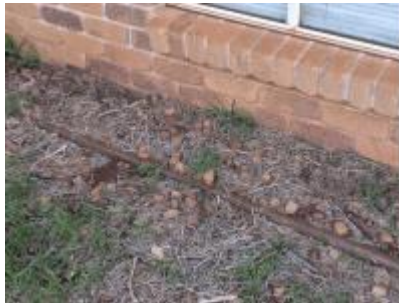
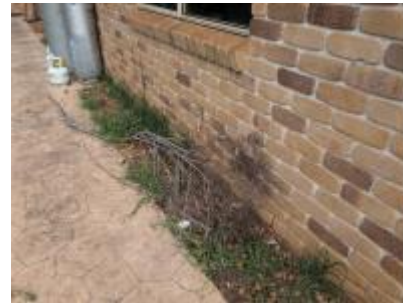
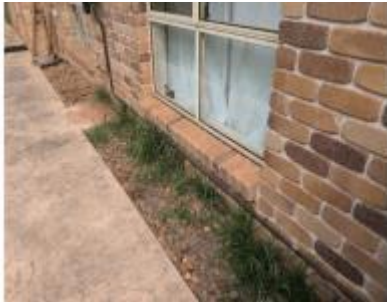
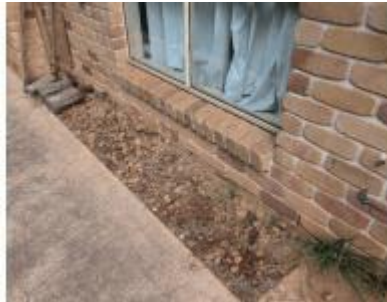
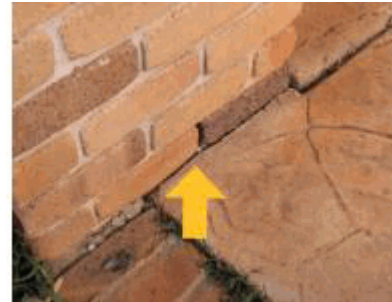
Include any visible evidence of bridging or breaching or slab edges obstructed by: **Earth - Lower ground levels one brick below the weep holes. Landscaping - Lower all soil, rocks, gardens 75mm below the weep holes. Driveway - Weep holes partly covered by driveway.**

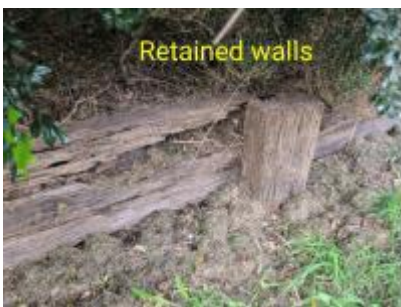
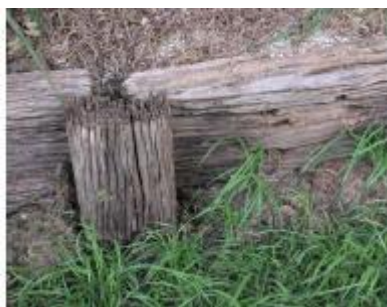
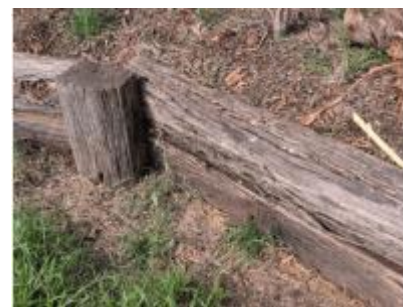
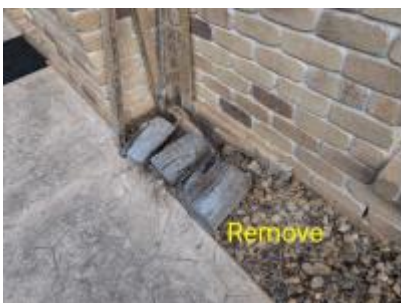
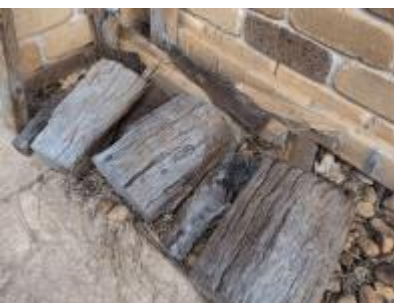
**Landscaping - Retained walls are termite susceptible. Other (explain) - Remove timber left against the home.**
