## **Pre-purchase Building Inspection**

**24 Helen Street Newtown Qld 4350**

## **Pre-Purchase Inspection - Residential Building Report (Except ACT)**

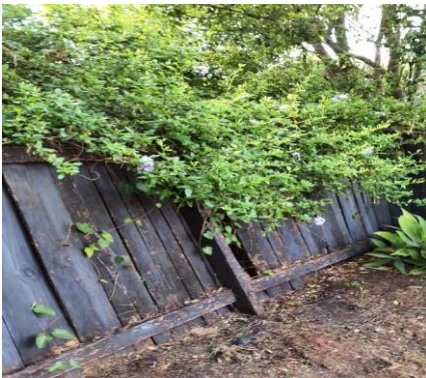
Wood decay, palings separated,  
and fence is leaning

- *Wood decay, palings separated, and fence is leaning on Eastern boundary. Engage a fencing contractor to quote for replacement.*

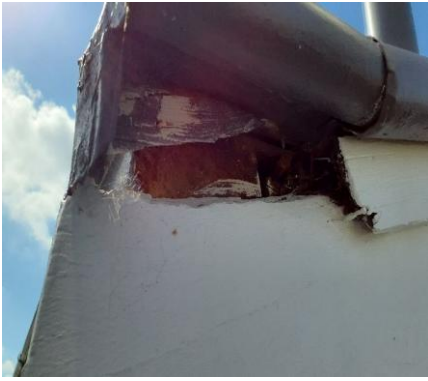
Section of timber barge is missing

- *Small section of timber barge is missing from the front of the dwelling. Engage a carpenter for repair.*

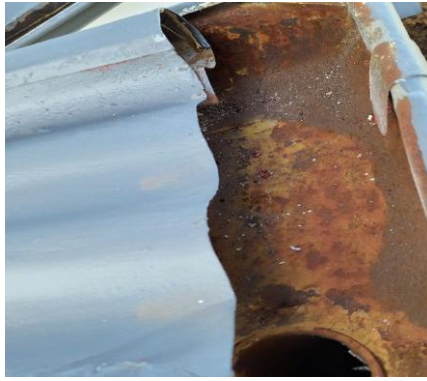
Rust to gutters

- *There is rust to the gutters sections in various locations will eventually require replacement.*

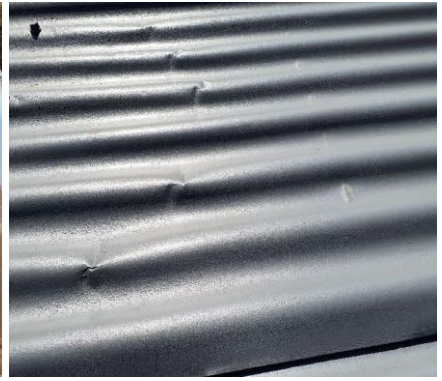
Roofing iron is dented

- *A piece of roofing iron is short and does not protrude into the gutter adequately, roofing iron dented also hail damage throughout and some heads of roofing nails are missing. Engage a roofing contractor to quote for repairs where required.*

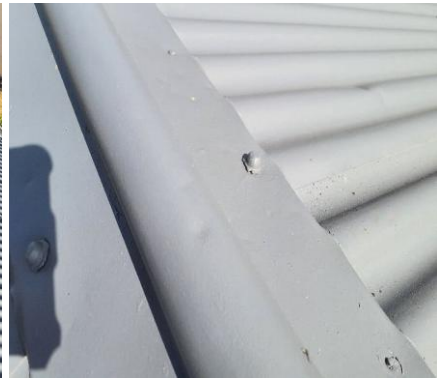
Hail damage to roof exterior

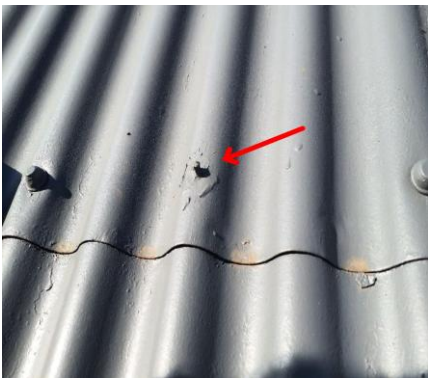
Heads of roofing nails missing

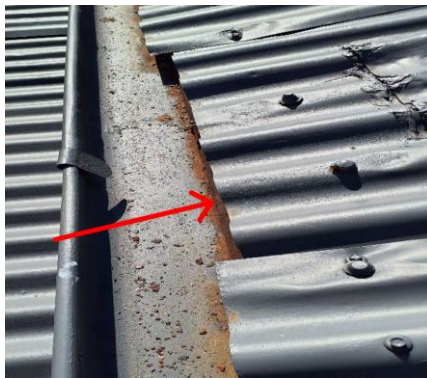
Roofing iron is short

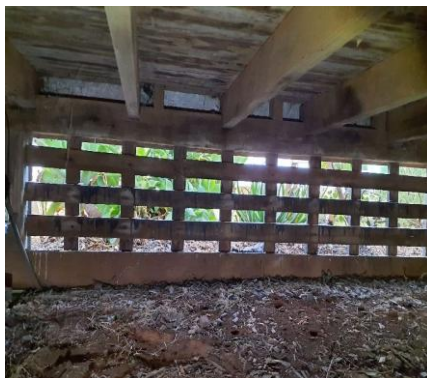
Timber slats in contact with the ground and floor framing

- *There are timber slats in direct contact with the ground and floor framing in areas. Refer to pest report.*

Recommend Timber Pest Inspection.

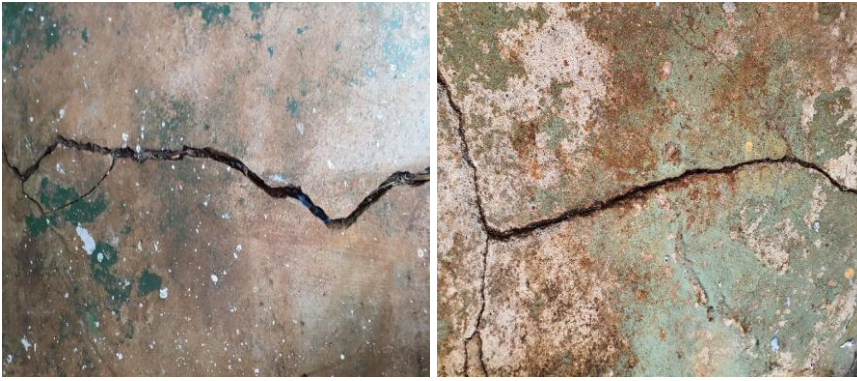
- *Significant cracking to the concrete paths in various locations. Engage a concreter to quote for repairs.*

- *Significant cracking to section of the rear building floor. Engage a concreter to quote for repairs.*

Significant cracking to section of detached building floor

Significant cracking to the path

| Areas Inspected | Location and Description of the Cracking Defect at the time of the Inspection. |
|---|---|
| Concrete Slabs | <i>Significant cracking to section of the detached building floor and concrete paths in various locations. Engage a concreter to quote for repairs.</i> |
