Report No: 103182

## PRE-PURCHASE TIMBER PEST DETECTION REPORT

ADDRESS OF PROPERTY INSPECTED: 24 HELEN STREET NEWTOWN QLD 4350

DATE OF INSPECTION: 30/10/2025

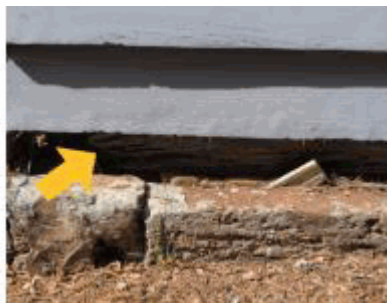
**Details - Old termite evidence found in tree stumps in yard. Subfloor - Old termite evidence found in timber foundations under the home. - Timber Piers have termite evidence noted. Out Buildings - Old pre existing termite evidence found in old outdoor toilet.**

**RECOMMENDATION** Where evidence of damage to building timbers exists, competent advice (e.g. from a licensed and practicing building contractor) should be obtained to determine the extent of any structural damage and as to the need or otherwise for rectification or repair work. See also Item 3.1.5 'Frequency of Future Inspections' recommendation.

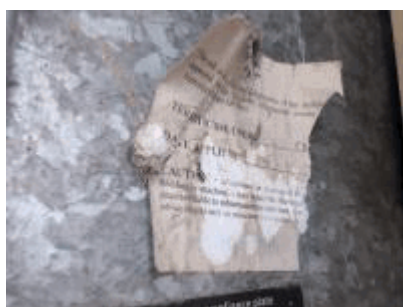
**Details below. - Last treatment undertaken on 08/12/1995 with Chlorpyrifos. Treatment notice in meter box.**

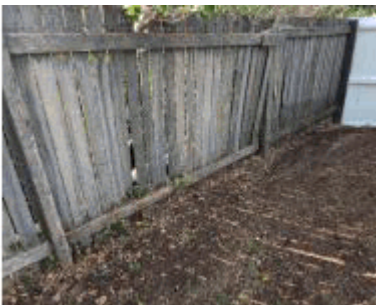
**Location - Decay in fencing.**

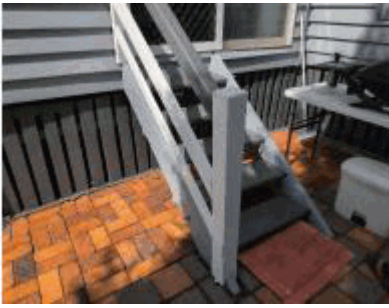
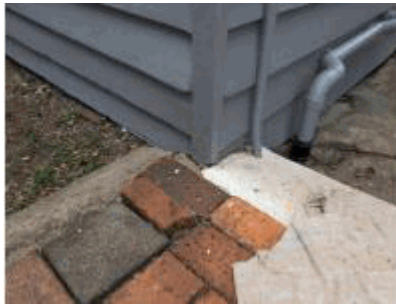
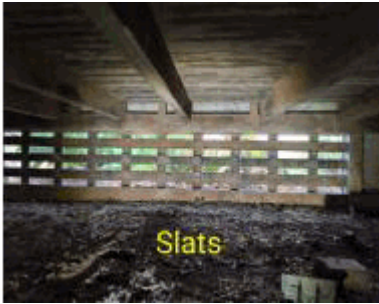
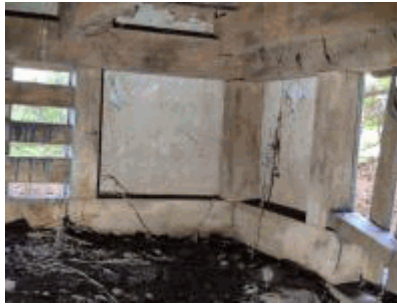
Include any visible evidence of bridging or breaching or slab edges obstructed by: **Steps/Ramps - Steps are in contact with the ground making them susceptible to termites and decay.**

**Paths/Paving - Paving and paths cover chamfers of laundry. Trellis/Fences - Side fence covers ant capping in areas. Other (explain below) - Slats contact ground and base of home in areas which can increase the risk of termite entry. These should be separated.**

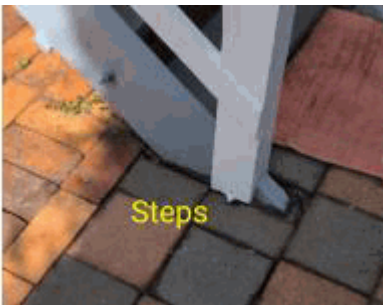
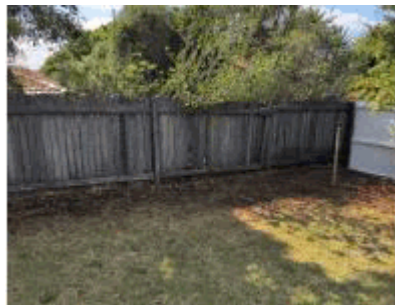
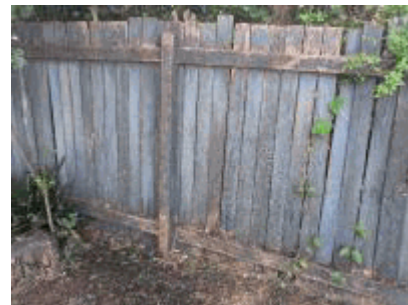
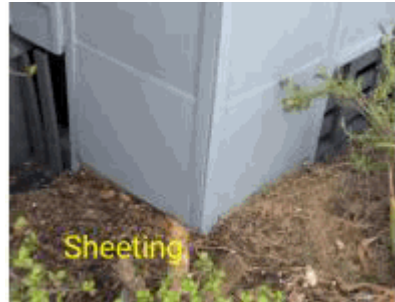
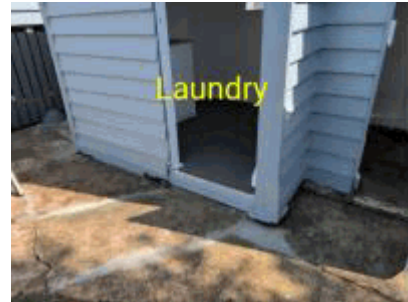
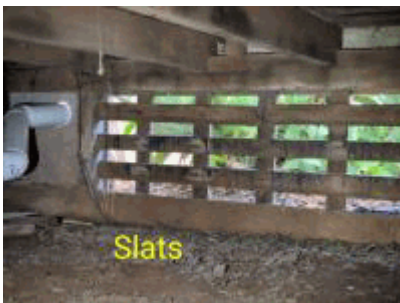
**Steps/Ramps - Steps bridge over ant capping. - Trellis/Fences are termite susceptible. - Older fencing is termite susceptible. Cladding - Sheeting at front contacts ground and base of home which can increase the risk of termite entry. Inspect annually and treat regularly. Other (explain) - Laundry has low clearance off the ground which can increase the risk of termite entry.**

**- Slats/battens under home contact ground. Avoid direct timber to earth contact wherever possible.**

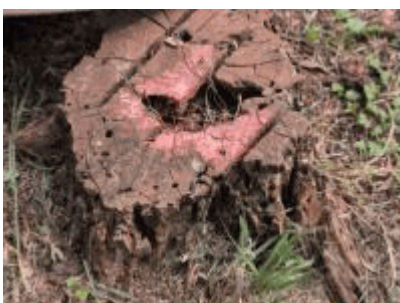
**Location - Tree stumps in yard will encourage and can conceal termites yet can be easily removed.**
