## **Pre-purchase Building Inspection**

**24 Helen Street Newtown Qld 4350**

## **Pre-Purchase Inspection - Residential Building Report (Except ACT)**

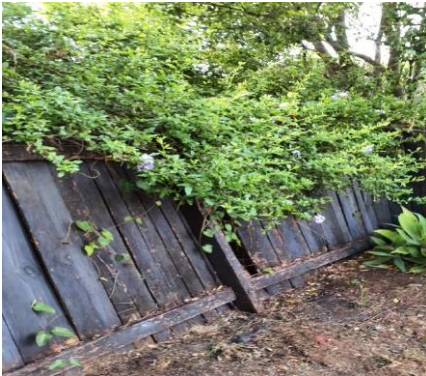
Wood decay, palings separated,  
and fence is leaning

- *Wood decay, palings separated, and fence is leaning on Eastern boundary. Engage a fencing contractor to quote for replacement.*

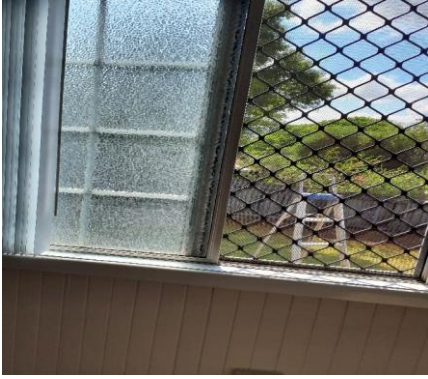
Windows require service

- *Aluminium sliding windows in general require maintenance (eg. Rollers)*

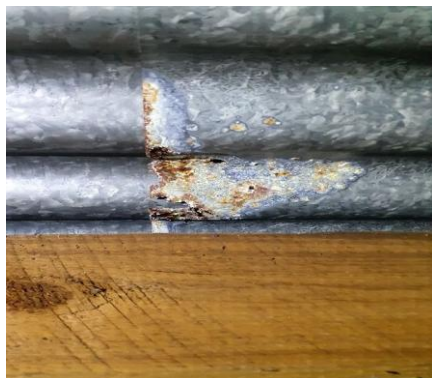
Rust to laps of roofing iron

- *There is rust / corrosion to laps of roofing iron in areas and maintenance will prolong the life of the sheeting but expert advice from a roofing contractor must be sought.*

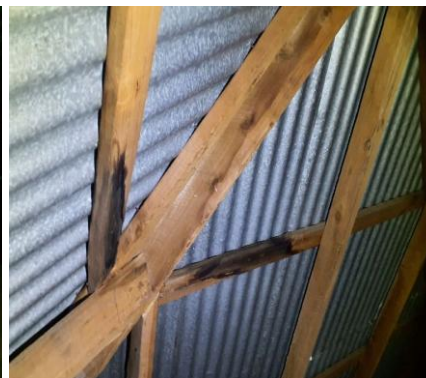
Water staining to roof framing

- *There is water staining to the roof battens typical of the dwelling age. Future maintenance may be required.*

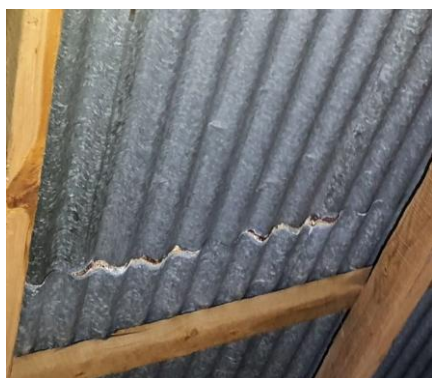
Rust / corrosion to laps of  
roofing iron

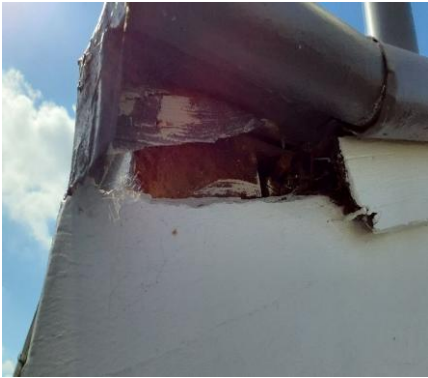
Section of timber barge is missing

- *Small section of timber barge is missing from the front of the dwelling. Engage a carpenter for repair.*

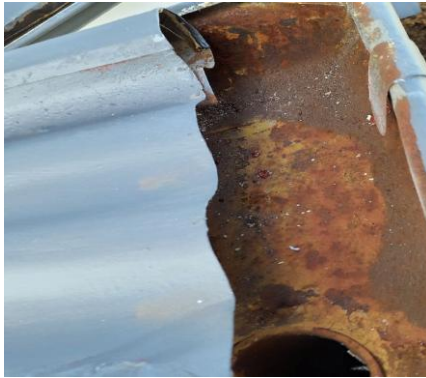
Rust to gutters

- *There is rust to the gutters sections in various locations will eventually require replacement.*

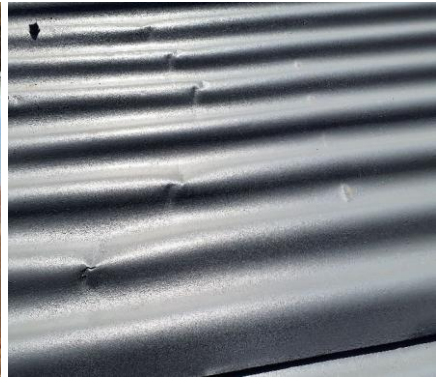
Roofing iron is dented

- *A piece of roofing iron is short and does not protrude into the gutter adequately, roofing iron dented also hail damage throughout and some heads of roofing nails are missing. Engage a roofing contractor to quote for repairs where required.*

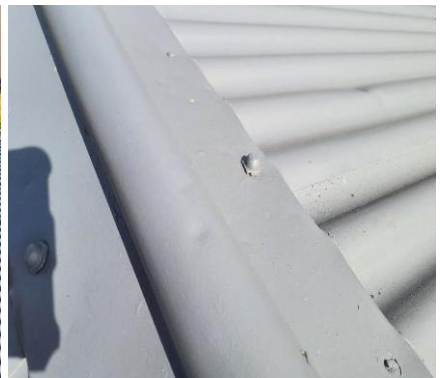
Hail damage to roof exterior

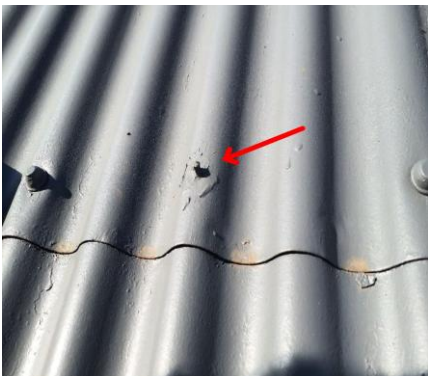
Heads of roofing nails missing

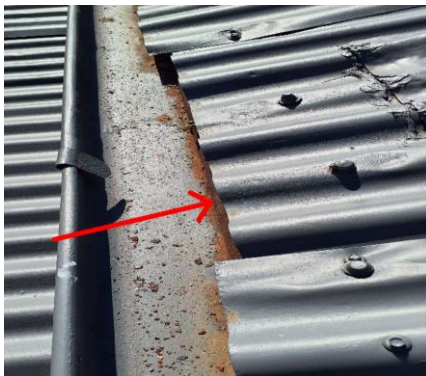
Roofing iron is short

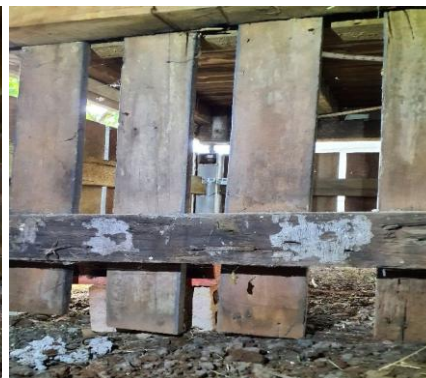
Timber slats in contact with the ground and floor framing

- *There are timber slats in direct contact with the ground and floor framing in areas. Refer to pest report.*

Recommend Timber Pest Inspection.
