Residential Pre-Sale Building & Pest Report

11 Edward St, North Toowoomba QLD 4350

PRE-PURCHASE INSPECTION RESIDENTIAL BUILDING REPORT

Property Address: 11 Edward St, North Toowoomba Qld 4350

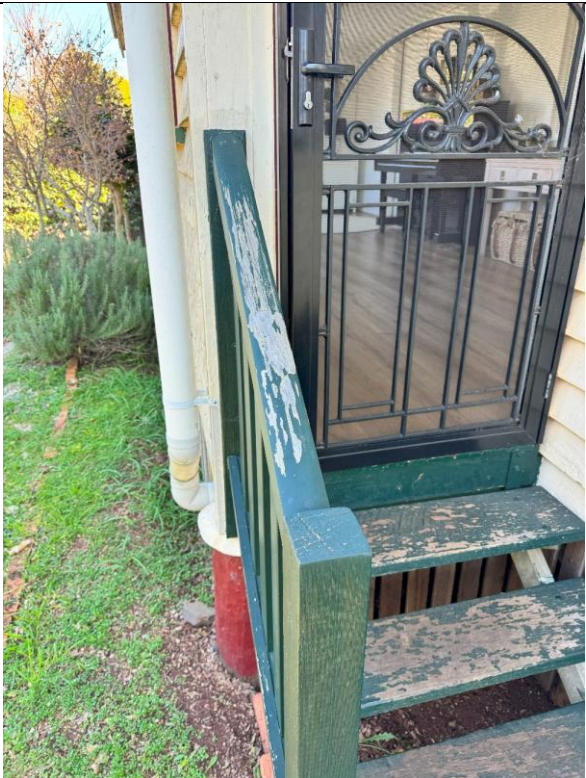
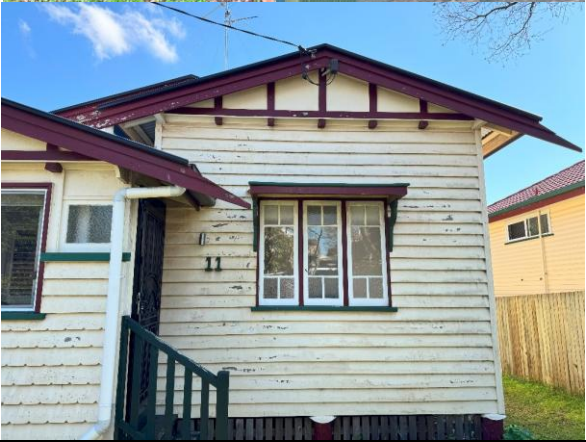
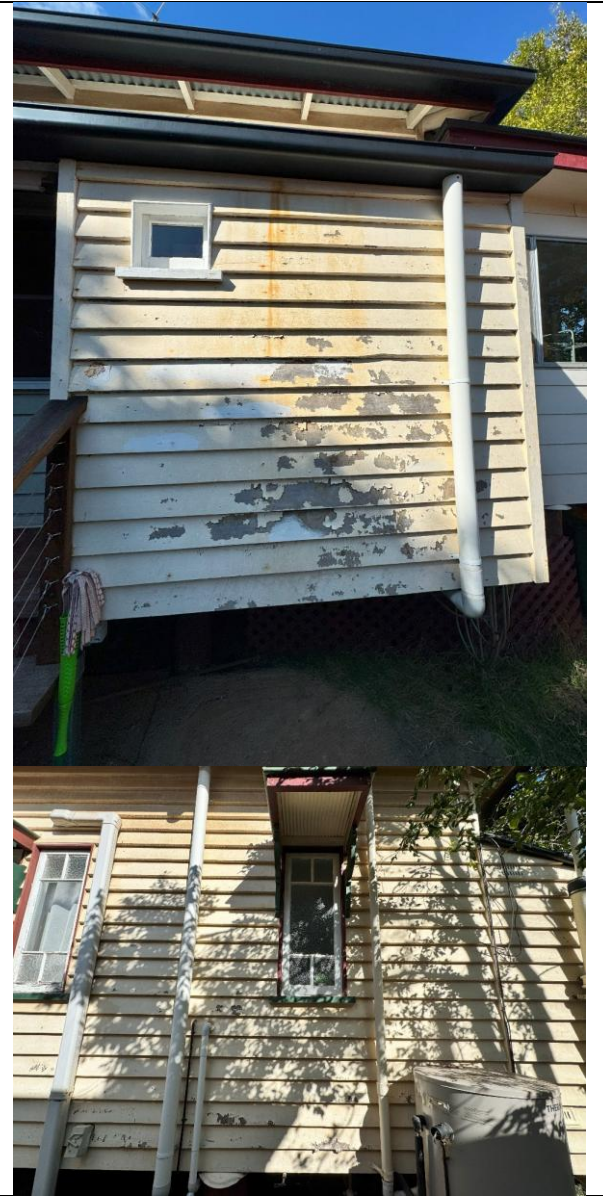
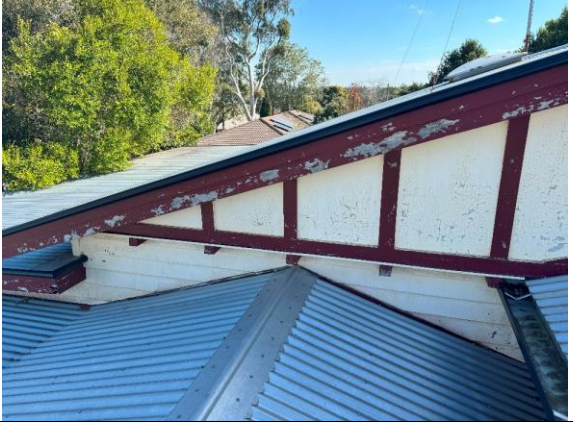
DEFECT NO:	1	Inspectors Comments:
Inspection Parts	Exterior	External paint generally degraded, no signs if significant wood rot. Recommendations: Recommend suitably qualified and licenced contractors be engaged to repaint
Location	Exterior in General	
Defect	Minor Defect	
Defect Description	Loss of Utility, Further Deterioration	
Defect Category	D – Material Deterioration	
Damage Category	NA	
Crack Category	NA

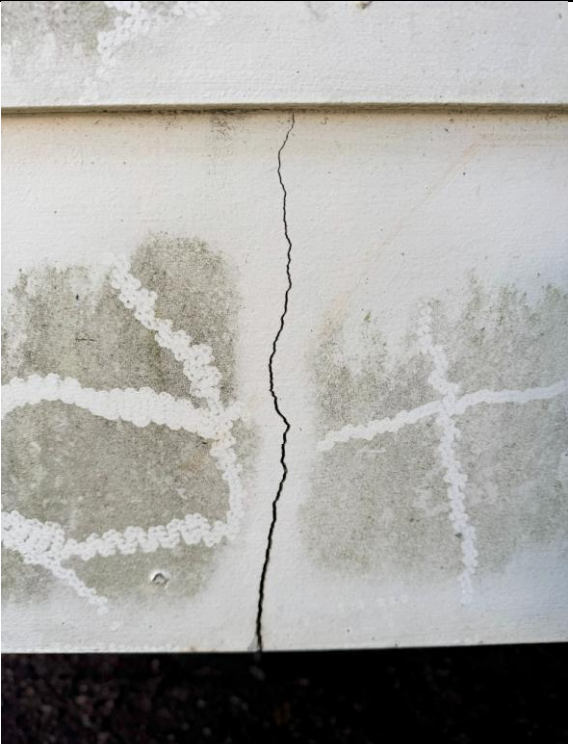
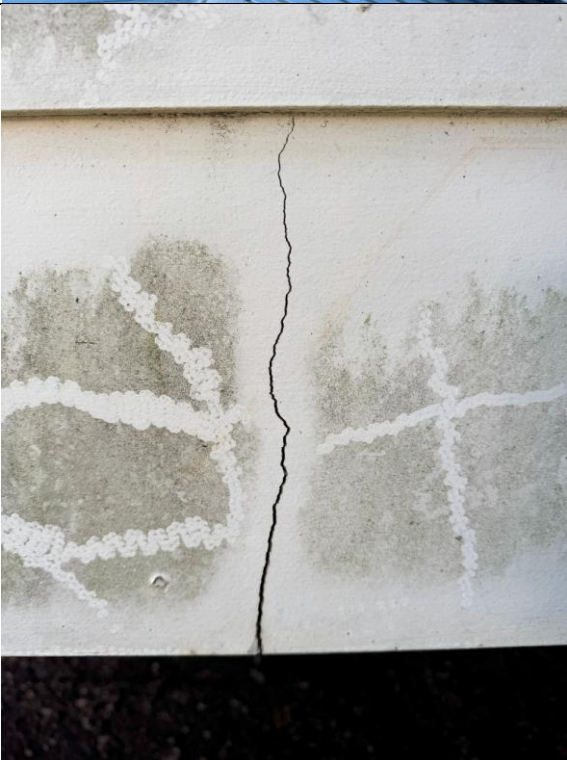
Inspection Parts	Exterior		
Location	Cladding	Cladding Board Cracked	
Defect	Minor Defect	Recommend suitably qualified and licenced contractors engaged to repair damage	
Defect Description	Loss of utility		
Defect Category	A - Damage		
Damage Category	NA

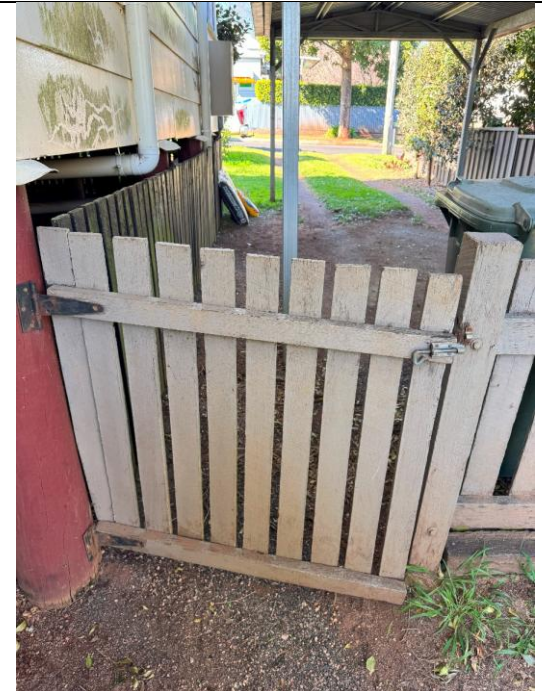
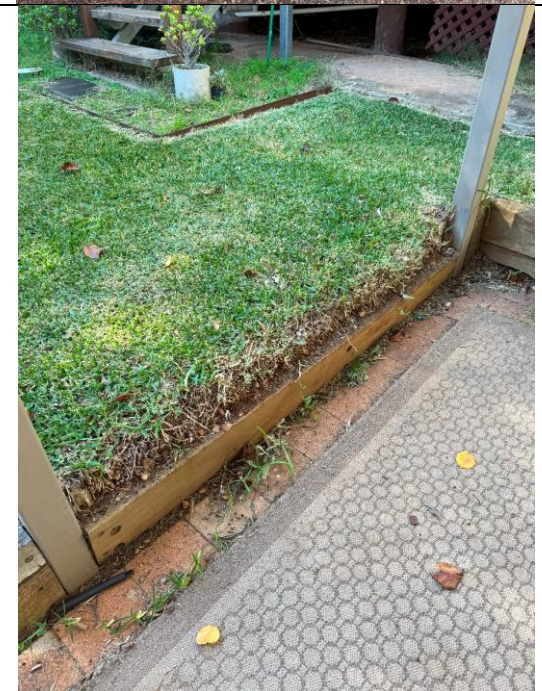
DEFECT NO:	3	Inspectors Comments:
Inspection Parts	Exterior	<p>Gate Sagging</p> <p>Recommend suitably qualified and licenced contractors engaged to repair</p>
Location	Gate	
Defect	Minor Defect	
Defect Description	Loss of utility	
Defect Category	E - Operational	
Damage Category	NA	
Crack Category	NA	
DEFECT NO:	4	Inspectors Comments:
Inspection Parts	Exterior	<p>Small retaining sleeper missing</p> <p>Recommend suitably qualified and licenced contractors engaged to repair</p>
Location	Yard	
Defect	Minor Defect	
Defect Description	Loss of utility	
Defect Category	E - Operational	
Damage Category	NA	
Crack Category	NA

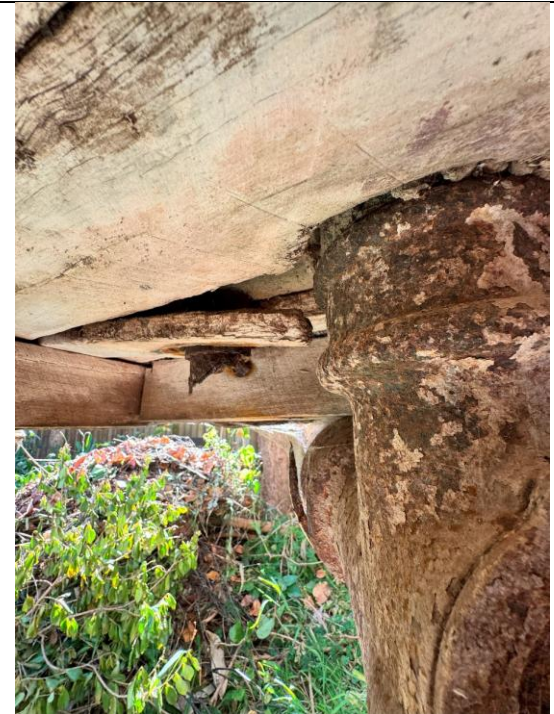
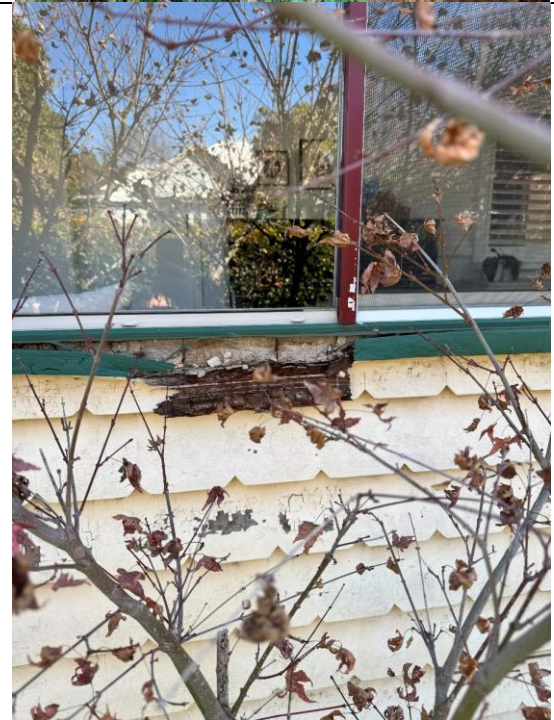
DEFECT NO:	5	Inspectors Comments:	
Inspection Parts	Exterior		
Location	Subfloor	Old floorboards damaged	
Defect	Major Defect	Recommend suitably qualified and licenced contractors engaged to repair	
Defect Description	Loss of utility, further deterioration		
Defect Category	A – Damage, D – Material Deterioration		
Damage Category	NA		
Crack Category	NA		
DEFECT NO:	6	Inspectors Comments:	
Inspection Parts	Exterior		
Location	Eastern Wall	Timber windowsills rotten	
Defect	Major Defect	Recommend suitably qualified and licenced contractors engaged to repair	
Defect Description	Loss of utility, further deterioration		
Defect Category	A – Damage, D – Material Deterioration		
Damage Category	NA		
Crack Category	NA

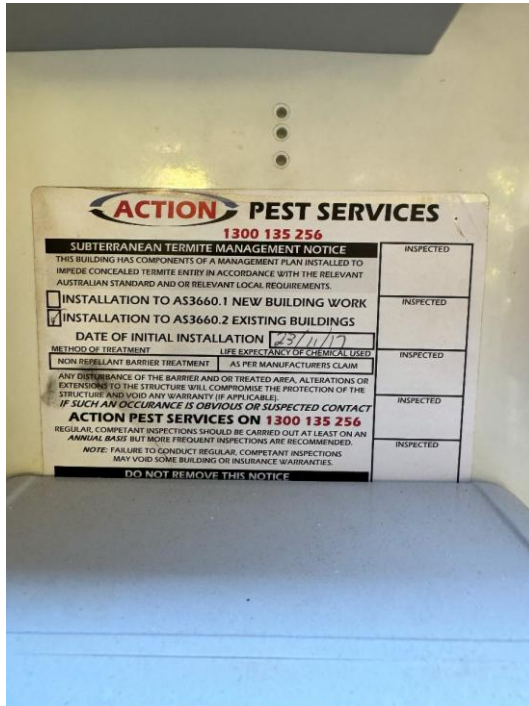
Was evidence of a possible previous termite management program found? Yes

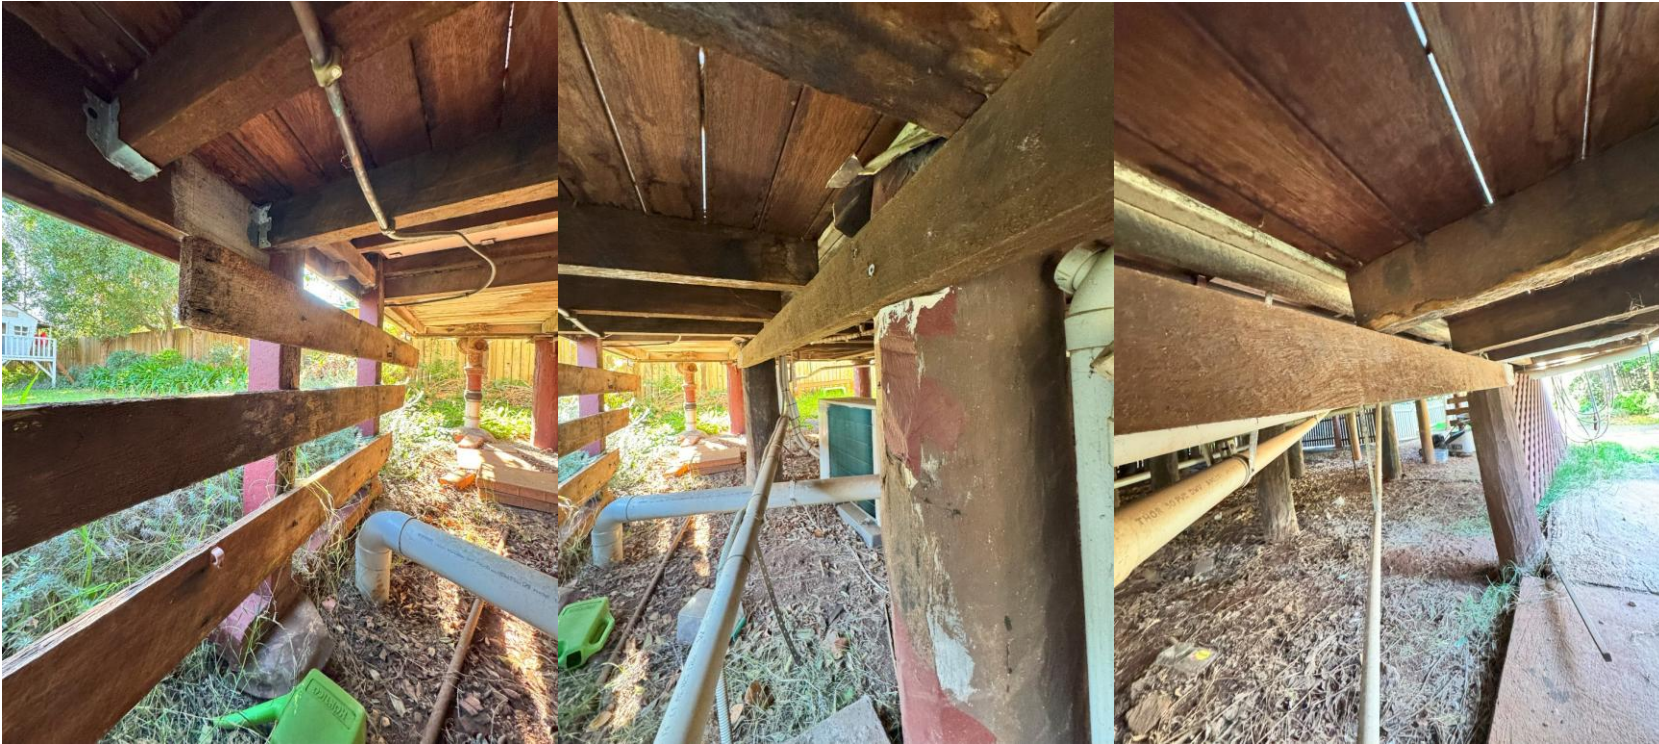
Was evidence of bridging or breaching found? Yes – Rear verandah area installed without barrier to existing house - see Details below, Clauses A.7 and A.8 - The subfloor structure of the rear deck is connected to the rear elevation of the house without appropriate termite barriers or treatment. Recommend chemical treatment of the deck stumps and/or physical barrier installed at possible bridging point:
