# Residential Pre-Sale Building & Pest Report

**106-108 Prince Henry Dr, Prince Henry Heights QLD 4350**

Report prepared: 25/09/2025

## PRE-PURCHASE INSPECTION RESIDENTIAL BUILDING REPORT

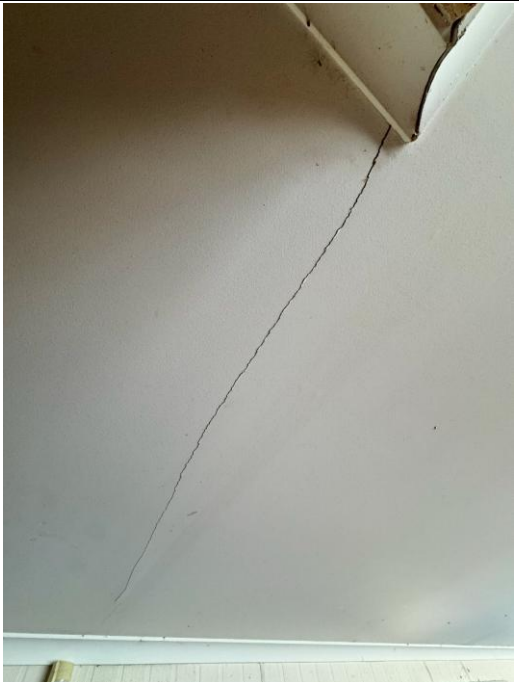
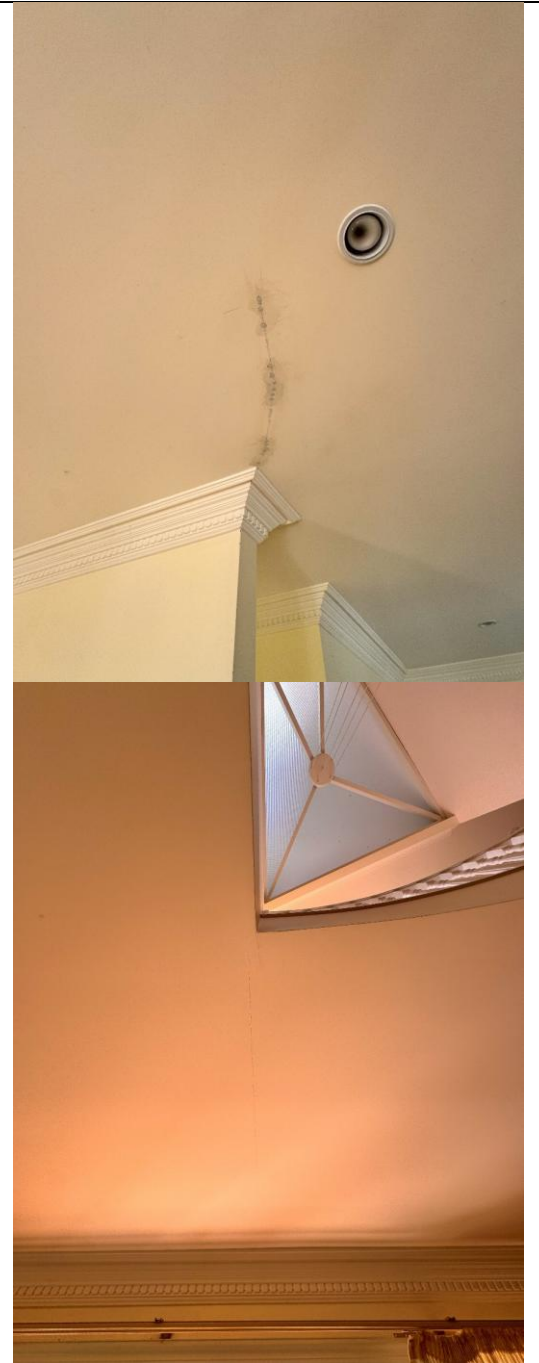
| DEFECT NO: | 1 | Inspectors Comments: | |

| DEFECT NO: | 1 | Inspectors Comments: | |
|---|---|---|---|
| Inspection Parts | Interior | Generally minor damage and appearance cracks throughout the house<br><br>Recommend suitably qualified and licenced contractors engaged to repair | |
| Defect | Minor Defect | | |
| Defect Category | A – Damage | | |

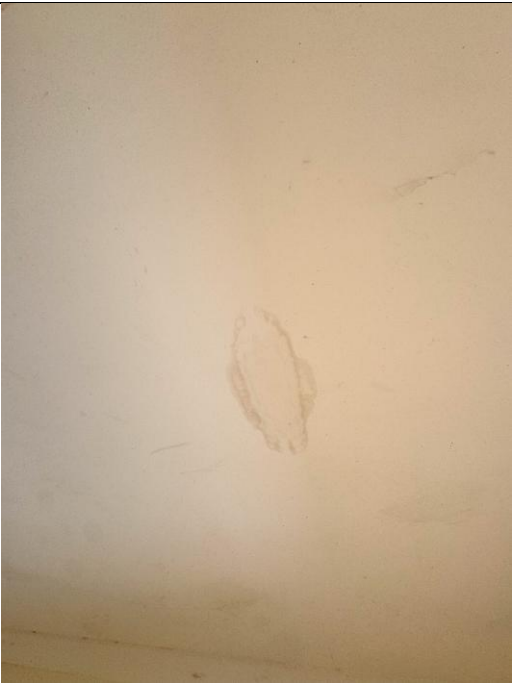
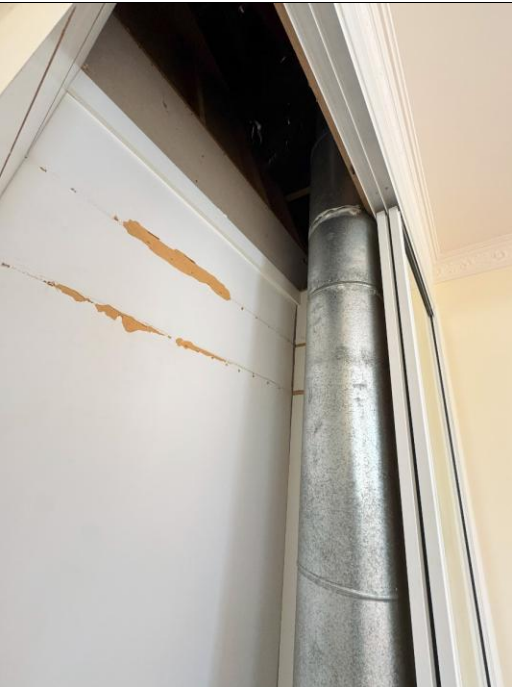
| <b>DEFECT NO:</b> | 2 | <b>Inspectors Comments:</b> | |

| Inspection Parts | Interior | Signs of water damage to cupboard from chimney<br>Recommend suitably qualified and licenced contractors engaged to replace | |
| Defect | Major Defect | | |
| Defect Description | Further Deterioration | | |
| Defect Category | C – Water Penetration, D – Material Deterioration | | |

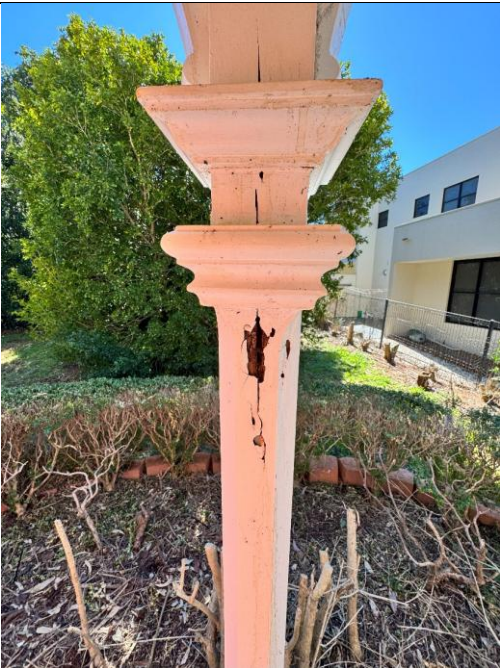
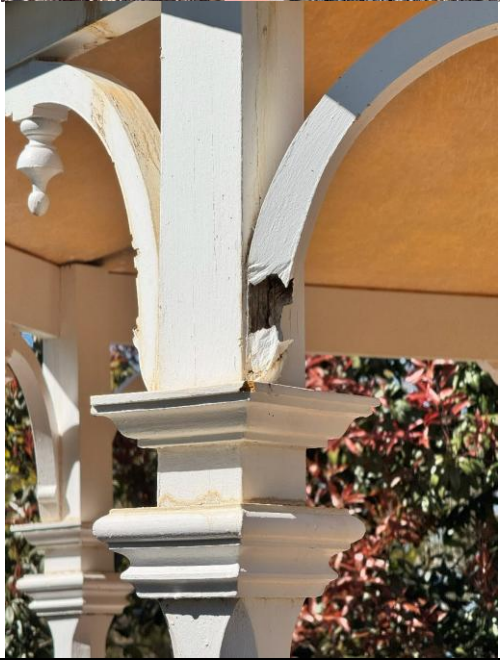
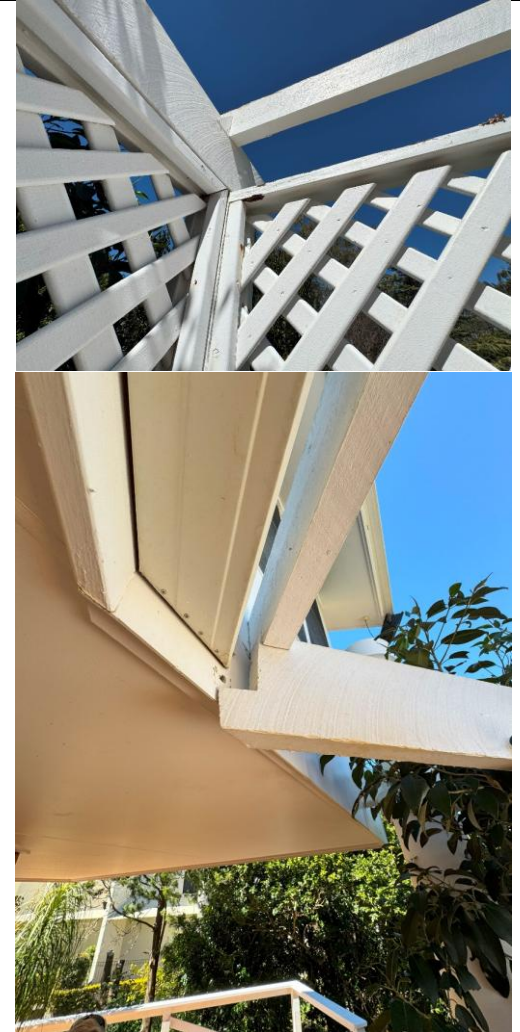
| DEFECT NO: | 3 | Inspectors Comments: |

| DEFECT NO: | 3 | Inspectors Comments: |
|---|---|---|
| Inspection Parts | Exterior | External timber structures display signs of water damage and rot<br><br>Recommend suitably qualified and licenced contractors be engaged to repair |
| Defect | Major Defect | |
| Defect Description | Loss of Utility, Further Deterioration | |
| Defect Category | A – Damage, C – Water Penetration, D – Material Deterioration | |

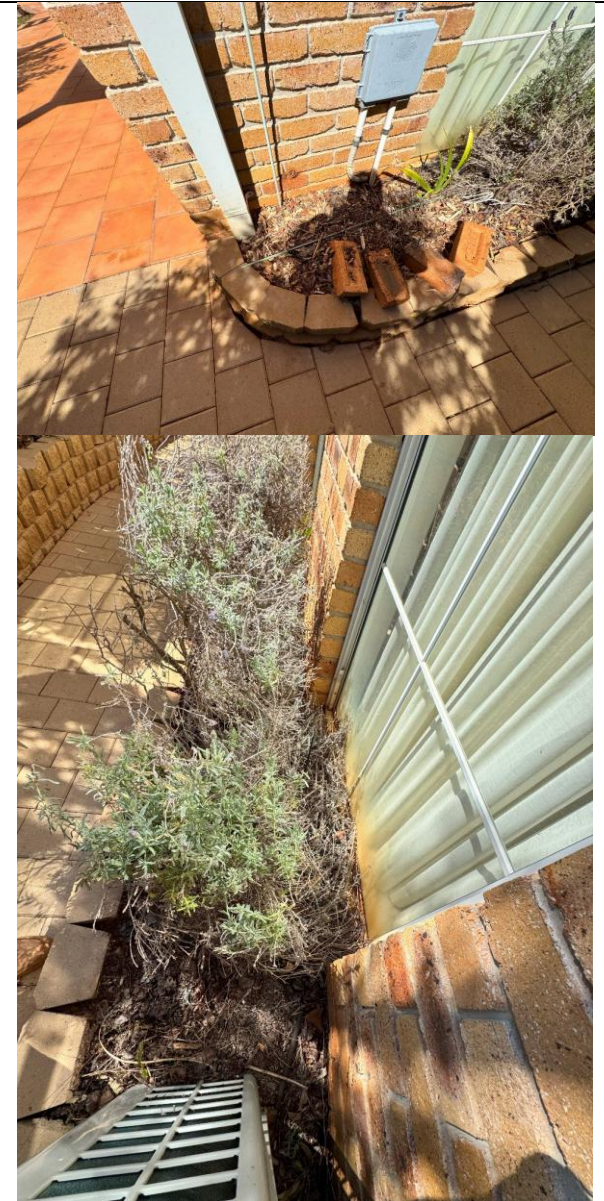
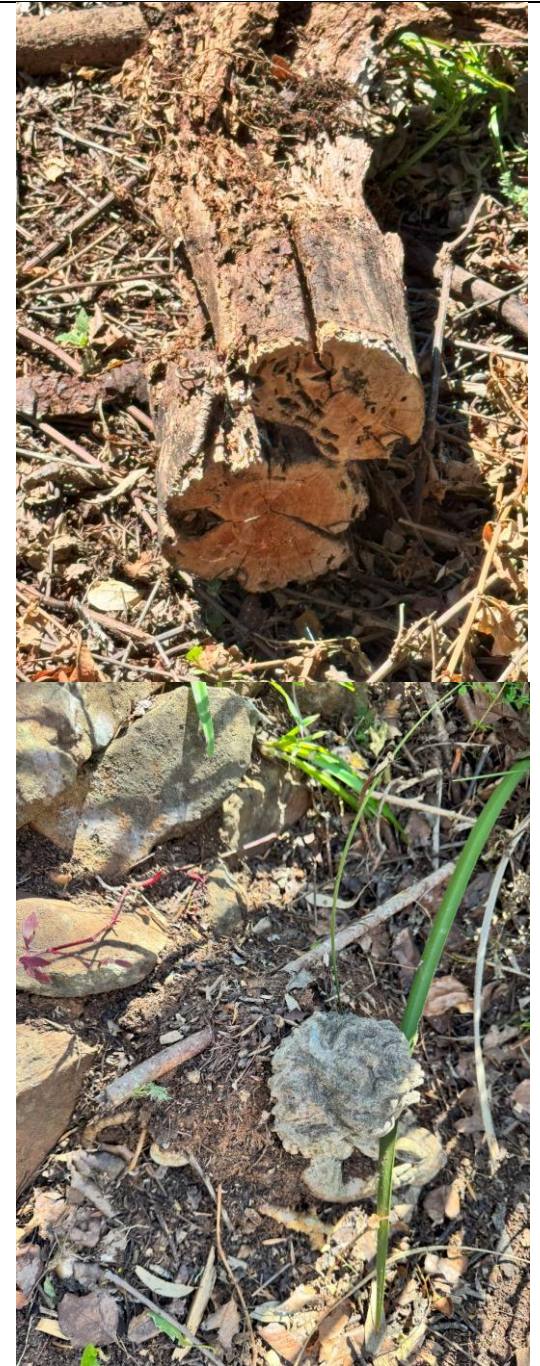
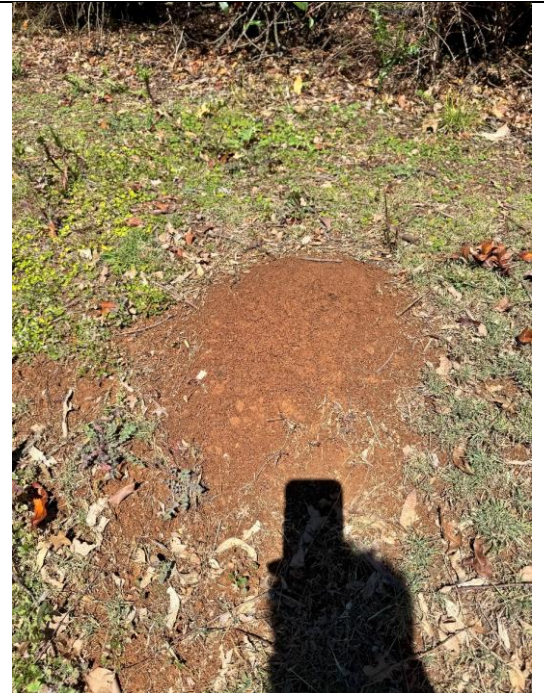
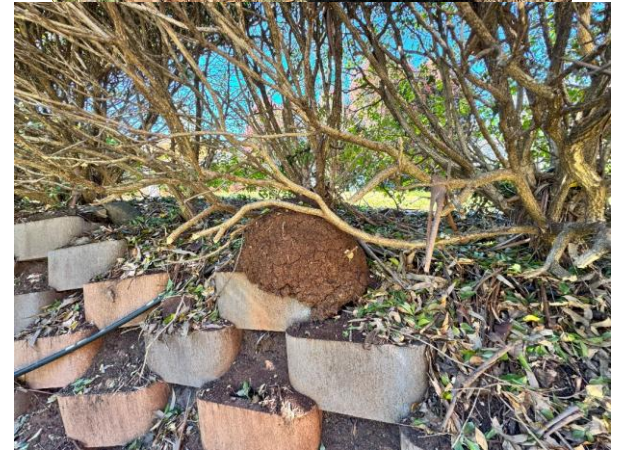
| DEFECT NO: | 4 | Inspectors Comments: |

| DEFECT NO: | 4 | Inspectors Comments: |
|---|---|---|
| Inspection Parts | Exterior | Gardens generally have the potential to generate timber pest activity with some creating bridging locations with the house |

**Was evidence of termite workings or damage found? Yes – in surrounding gardens and stumps not in dwelling**

| DEFECT NO: | 4 | Inspectors Comments: |
|---|---|---|
| Defect | Major Defect | Recommend suitably qualified and licenced contractors engaged to rectify |

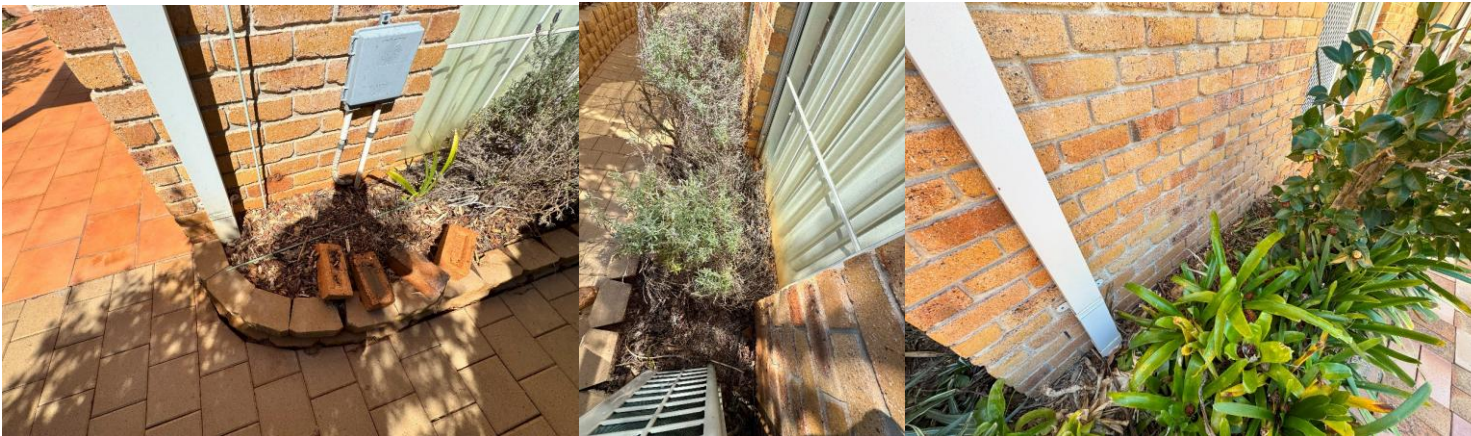
**Was evidence of bridging or breaching found? Yes – Garden beds against the house can allow bridging**

- see Details below, Clauses A.7 and A.8 - The subfloor structure of the rear deck is connected to the rear elevation of the house without appropriate termite barriers or treatment. Recommend chemical treatment of the deck stumps and/or physical barrier installed at possible bridging point:
