# Residential Pre-Sale Building & Pest Report

**149 Holberton St Newtown QLD 4350**

Report prepared: 25/08/2025

## PRE-PURCHASE INSPECTION RESIDENTIAL BUILDING REPORT

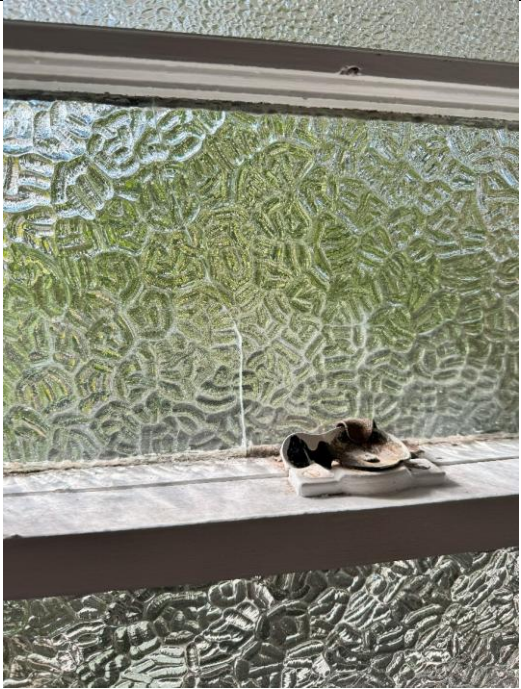
| DEFECT NO: | 1 | Inspectors Comments: |
| Inspection Parts | Interior | Cracked Windows<br><br>Recommend suitably qualified and licenced contractors engaged to repair |
| Defect | Minor Defect | |
| Defect Category | A - Damage | |

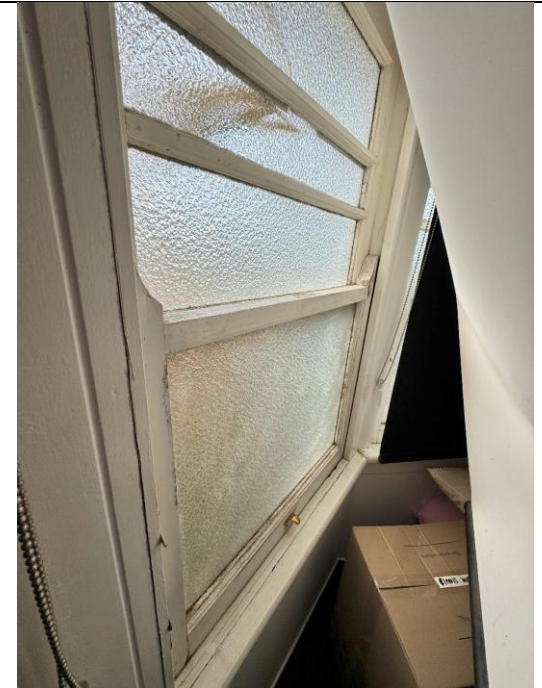
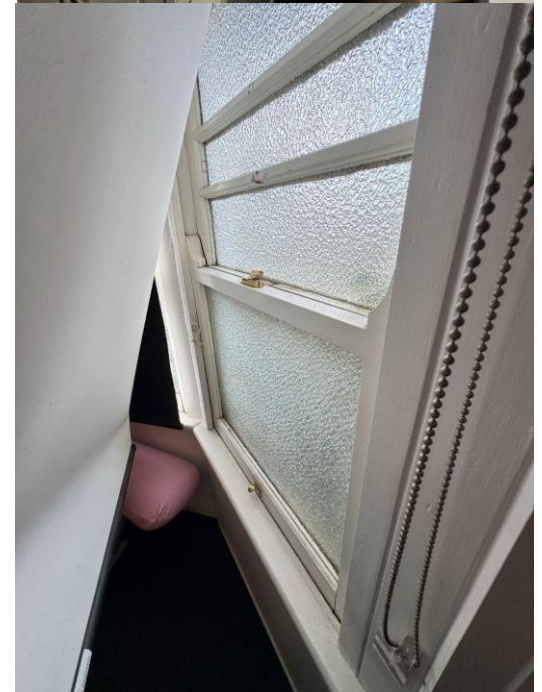
| DEFECT NO: | 2 | Inspectors Comments: |
| Inspection Parts | Interior | Window hardware missing from a number of fixtures<br>Recommend suitably qualified and licenced contractors engaged to repair |
| Defect | Minor Defect | |
| Defect Category | E – Operational | |

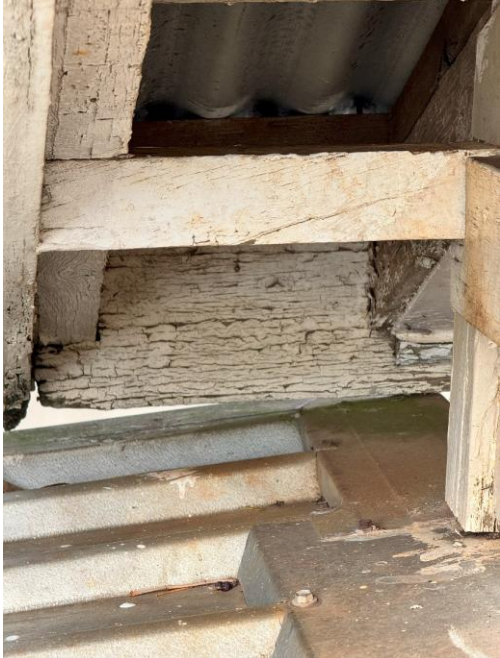
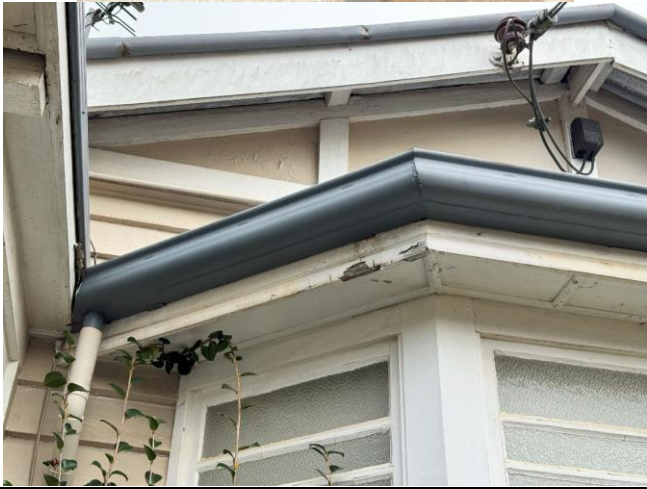
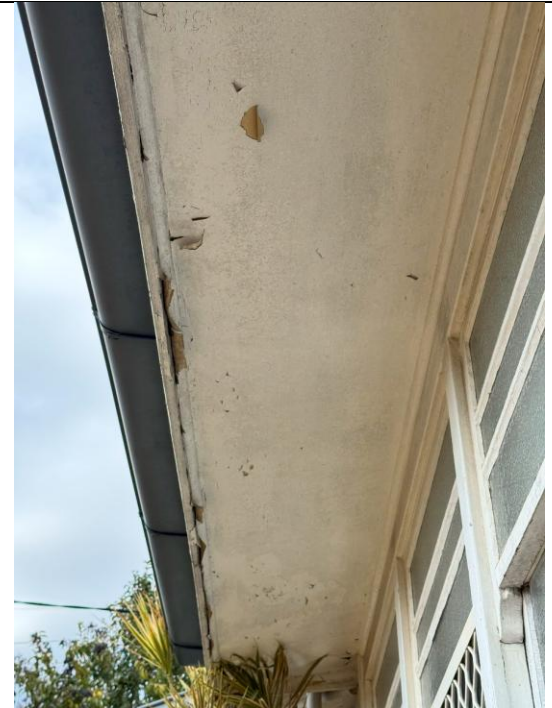
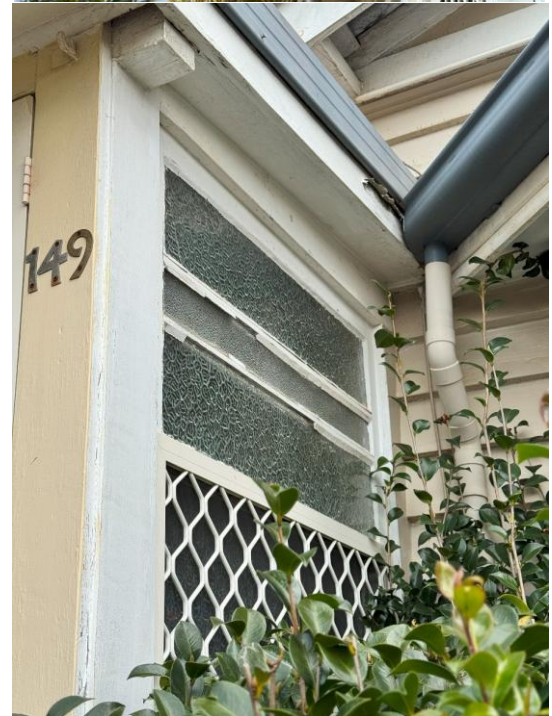
| DEFECT NO: | 6 | Inspectors Comments: |
| Inspection Parts | Exterior | Paint flaking and deteriorating in areas of high exposure<br><br>Recommend suitably qualified and licenced contractors engaged to repair |
| Defect | Minor Defect | |
| Defect Category | D – Material Deterioration | |

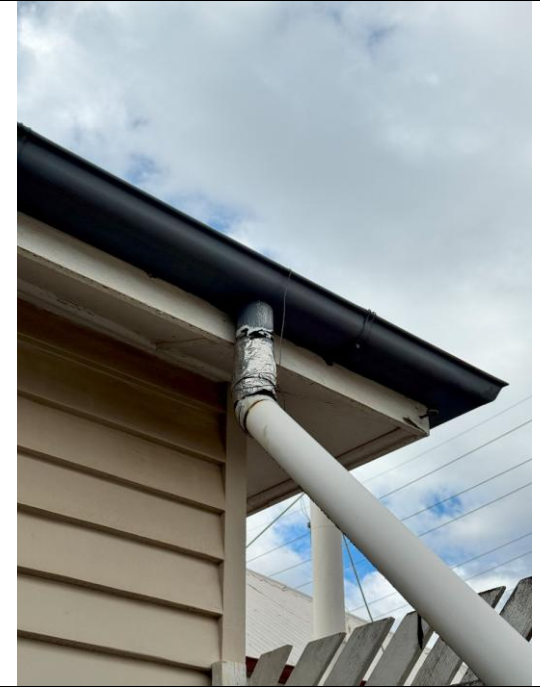
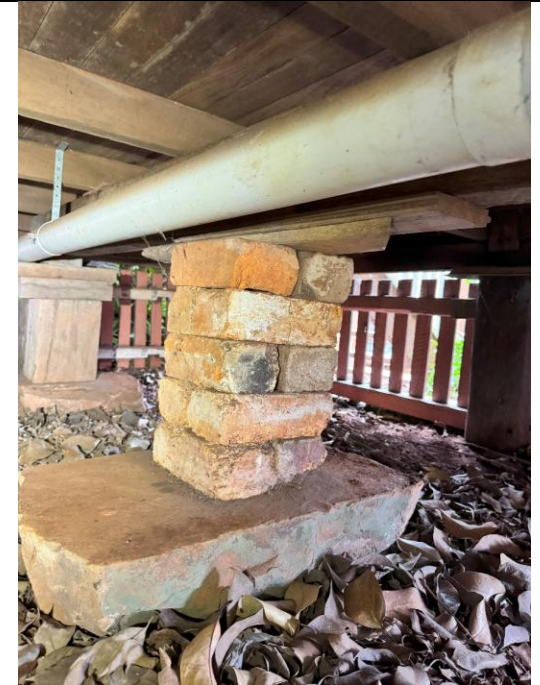
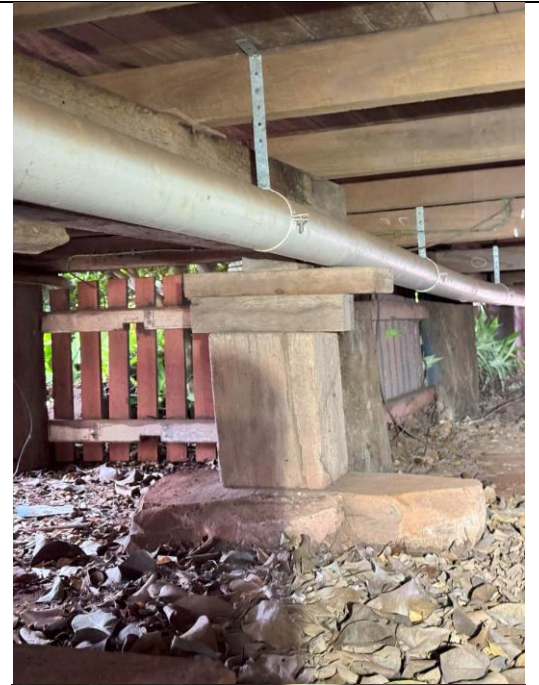
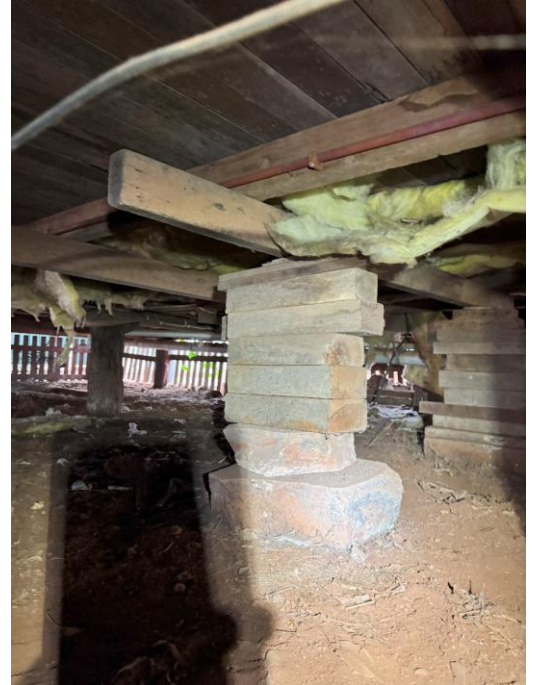
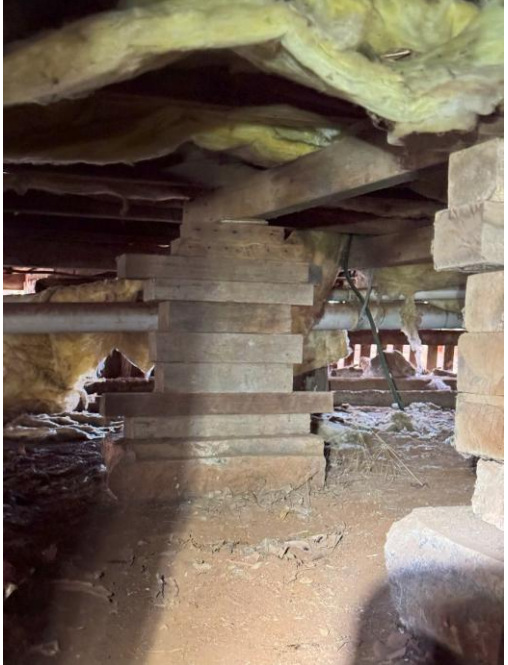
| <b>DEFECT NO:</b> | 8 | <b>Inspectors Comments:</b> | |
| Location | Subfloor | Stumps missing from locations under the house | |
| Defect | Major Defect | Recommend suitably qualified and licenced contractors engaged to repair | |
| Defect Description | Unsafe condition, Further Deterioration | | |
| Defect Category | F - Installation | | |

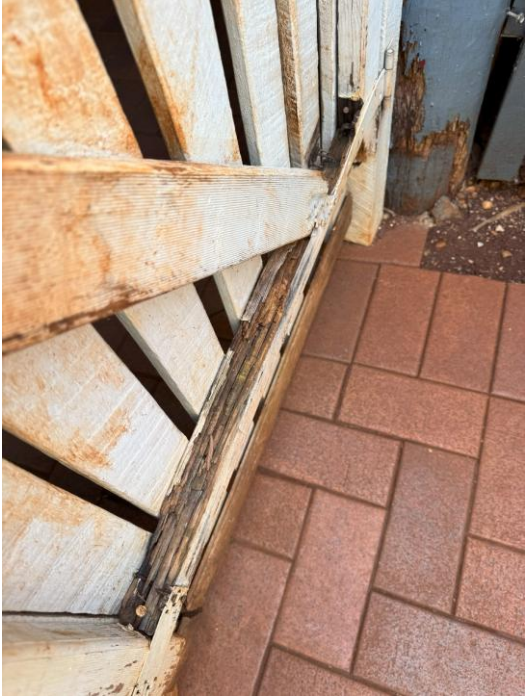
| Location | Side Gate | | |

| <b>DEFECT NO:</b> | 9 | <b>Inspectors Comments:</b> | |
| Inspection Parts | Exterior | Side gate timbers rotten<br><br>Recommend suitably qualified and licenced contractors engaged to repair | |
| Defect | Minor Defect | | |
| Defect Category | D – Material Deterioration | | |

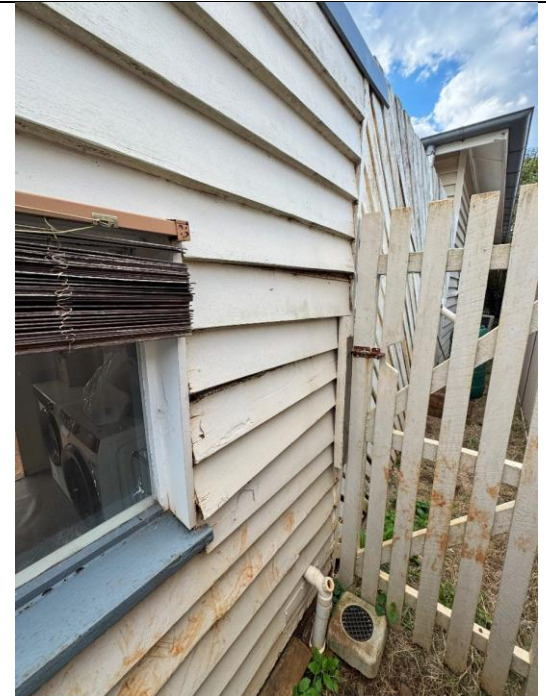
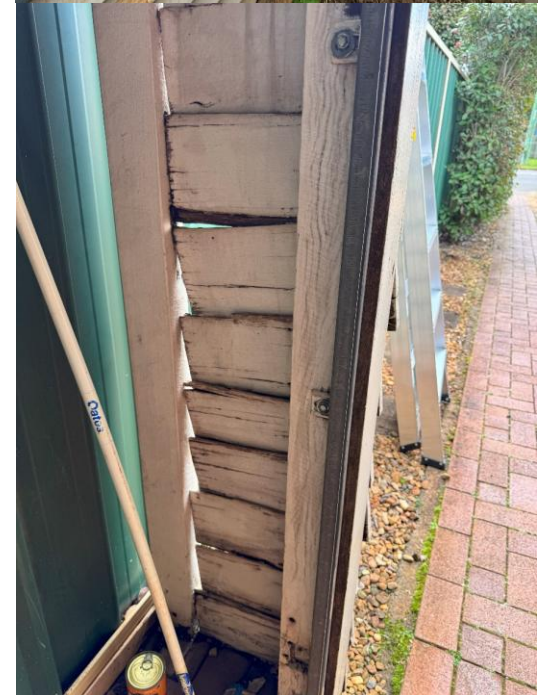
| DEFECT NO: | 10 | Inspectors Comments: |
| Inspection Parts | Exterior | <p>Areas of external cladding failing</p> <p>Recommend suitably qualified and licenced contractors engaged to repair</p> |
| Defect | Minor Defect | |
| Defect Category | A – Damage, D – Material Deterioration, F - Installation | |

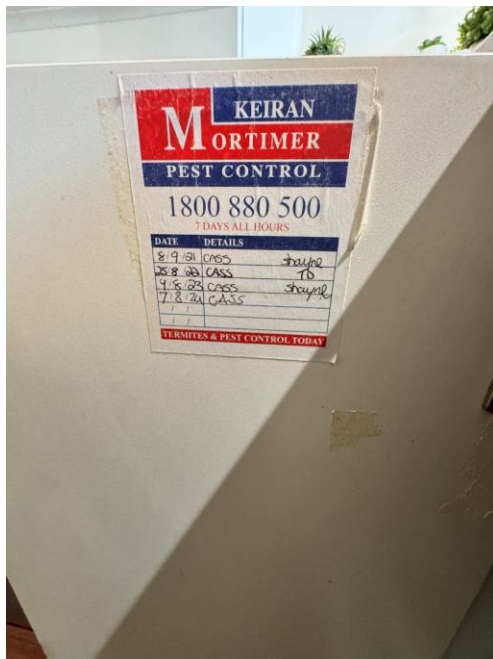
Was evidence of a possible previous termite management program found? Yes, annual chemical treatment has been observed

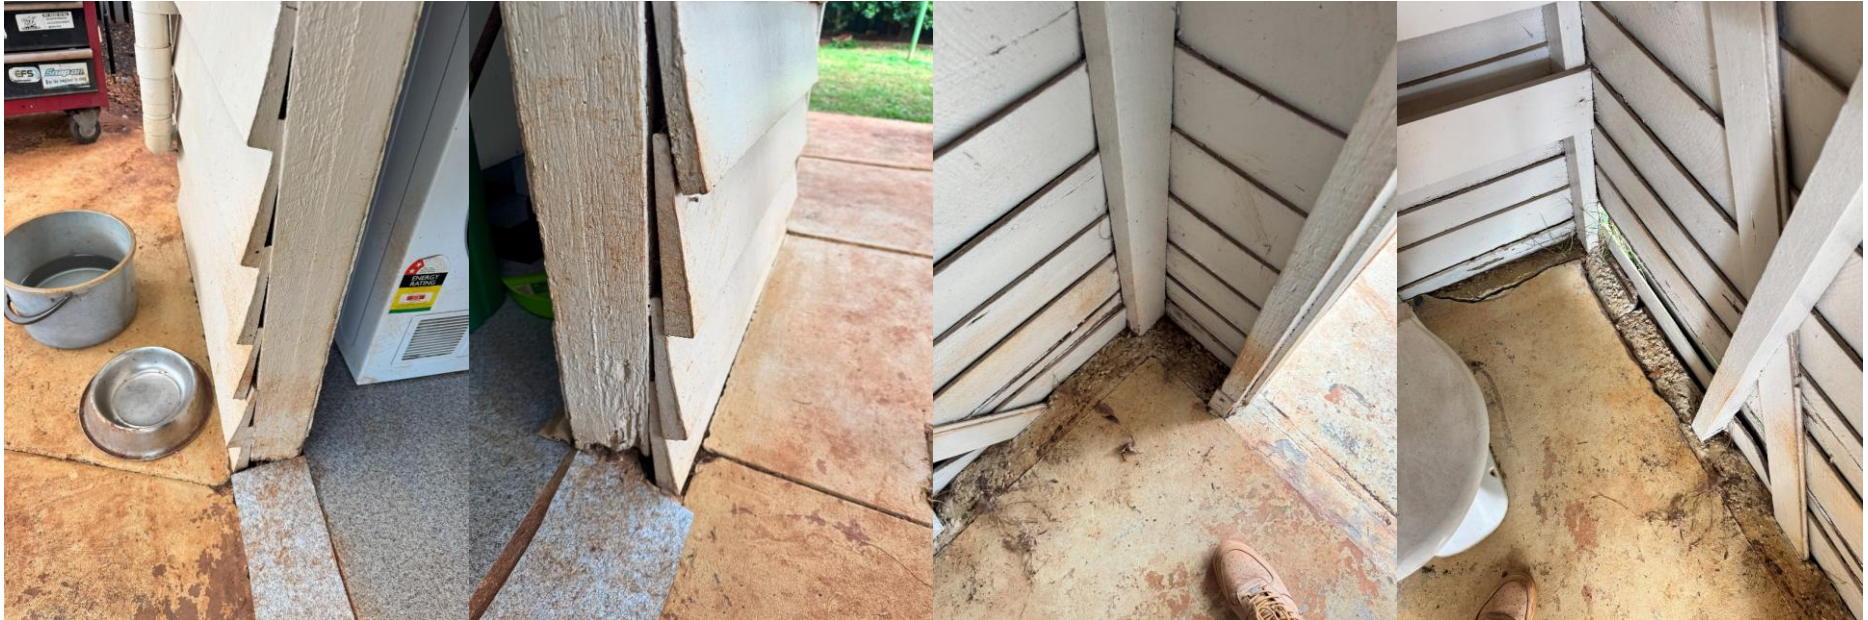
**Was evidence of bridging or breaching found? Yes, framing of the external laundry extended below the pavement level and is connected to the house by a roof structure**

- see Details below, Clauses A.7 and A.8 - The subfloor structure of the rear deck is connected to the rear elevation of the house without appropriate termite barriers or treatment. Recommend chemical treatment of the deck stumps and/or physical barrier installed at possible bridging point:
