# Residential Pre-Sale Building & Pest Report

**3 Benjamin St Mount Lofty QLD 4350**

Report prepared: 29/08/2025

## PRE-PURCHASE INSPECTION RESIDENTIAL BUILDING REPORT

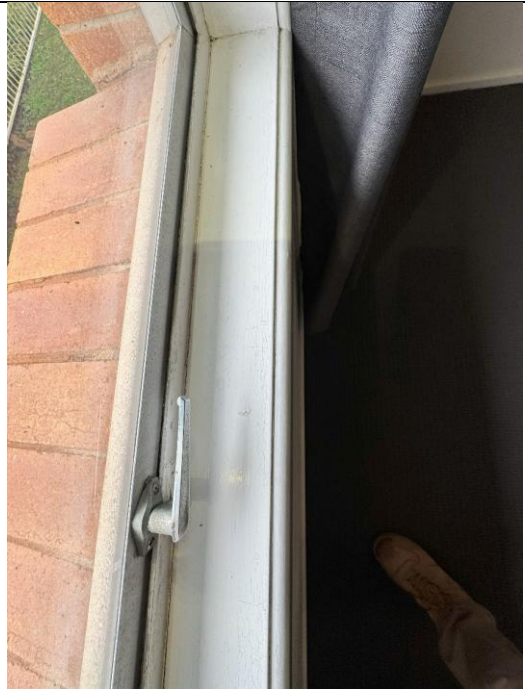
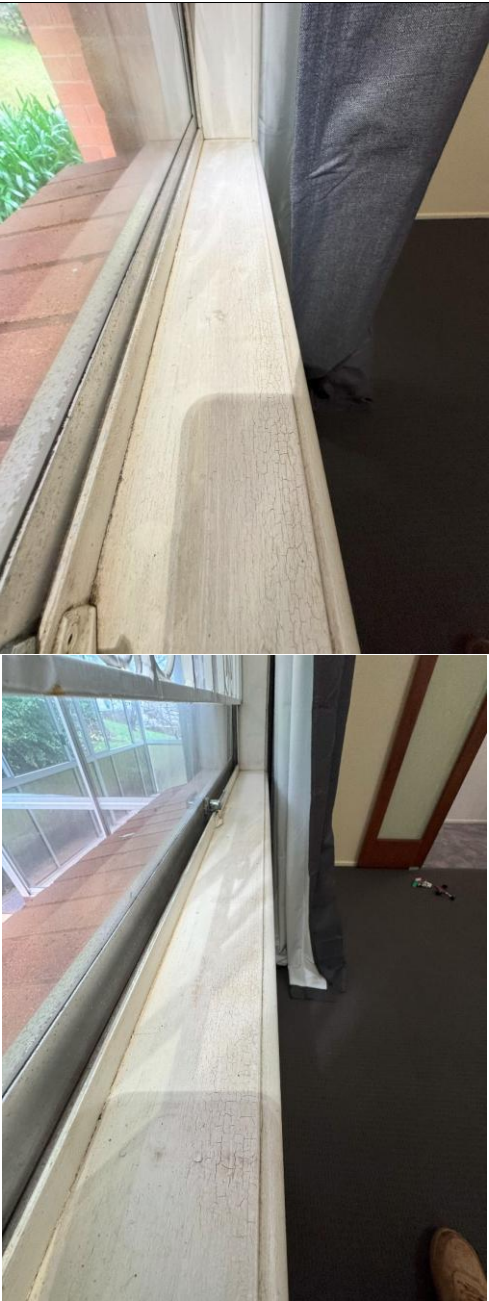
| DEFECT NO: | 1 | Inspectors Comments: |

| DEFECT NO: | 1 | Inspectors Comments: |
|---|---|---|
| Inspection Parts | Interior | Cracking Paint to Window Sils<br>Recommend suitably qualified and licenced contractors engaged to repair |
| Defect | Minor Defect | |
| Defect Description | Loss of utility | |
| Defect Category | A - Damage | |

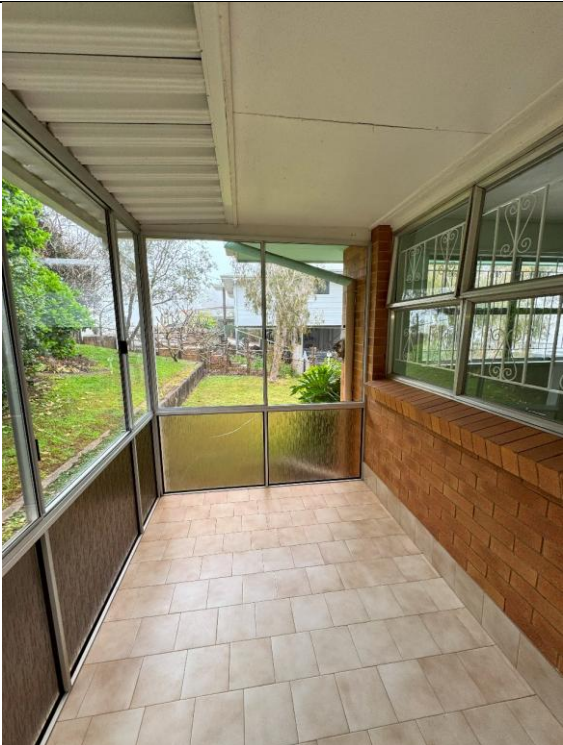
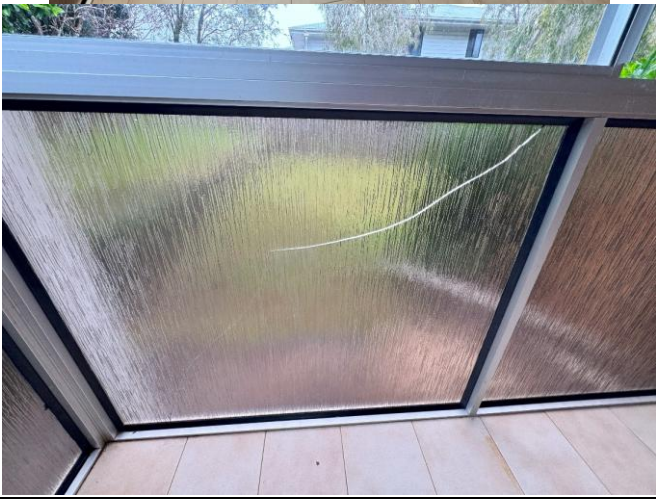
| DEFECT NO: | 2 | Inspectors Comments: |

| DEFECT NO: | 2 | Inspectors Comments: |
|---|---|---|
| Inspection Parts | Interior | Window Cracked<br><br>Recommend suitably qualified and licenced contractors engaged to repair |
| Defect | Minor Defect | |
| Defect Description | Loss of utility | |
| Defect Category | A – Damage | |

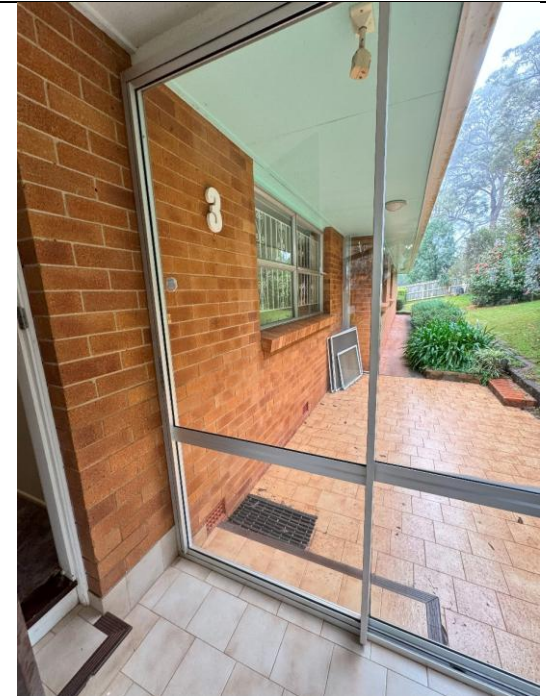
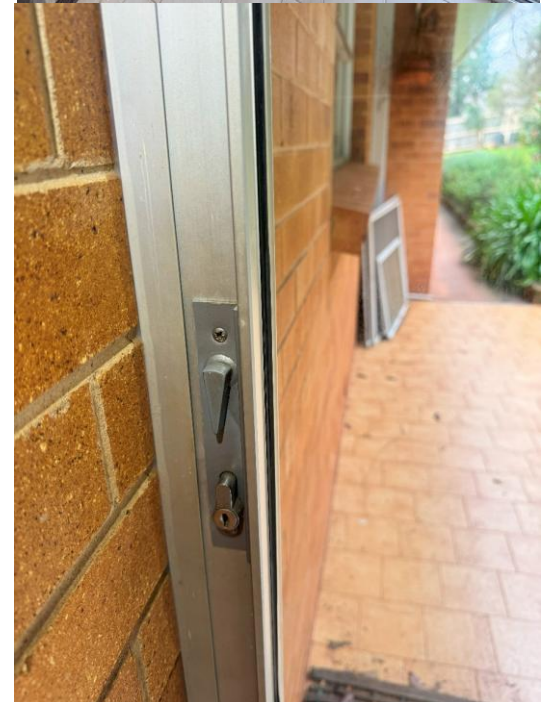
| DEFECT NO: | 3 | Inspectors Comments: |

| DEFECT NO: | 3 | Inspectors Comments: |
|---|---|---|
| Inspection Parts | Interior | Sliding Glass Door to Sunroom Unoperational and Locked<br><br>Recommend suitably qualified and licenced contractors engaged to repair |
| Defect | Major Defect | |
| Defect Description | Unsafe Condition, Loss of Utility | |
| Defect Category | A – Damage, E – Operational | |

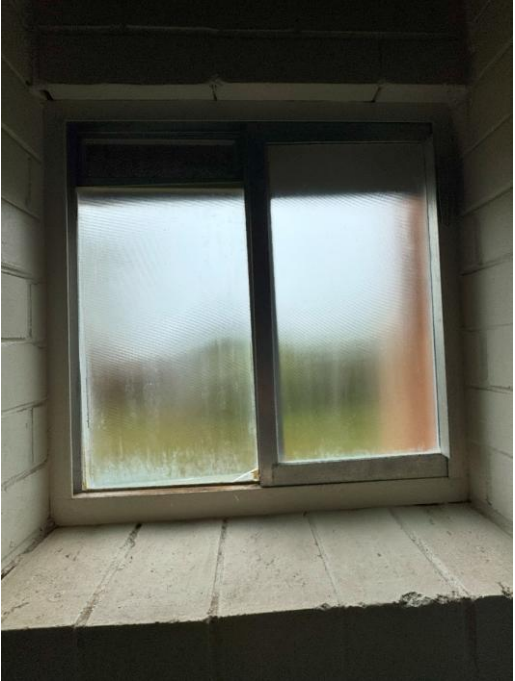
| <b>DEFECT NO:</b> | 4 | <b>Inspectors Comments:</b> | |

| Inspection Parts | Interior | Glazing to the WC window loose and moving<br>Recommend suitably qualified and licenced contractors engaged to repair | |
| Location | Lower Floor Toilet | | |
| Defect | Minor Defect | | |
| Defect Description | Loss of Utility, Further Deterioration | | |
| Defect Category | A – Damage, D – Material Deterioration | | |

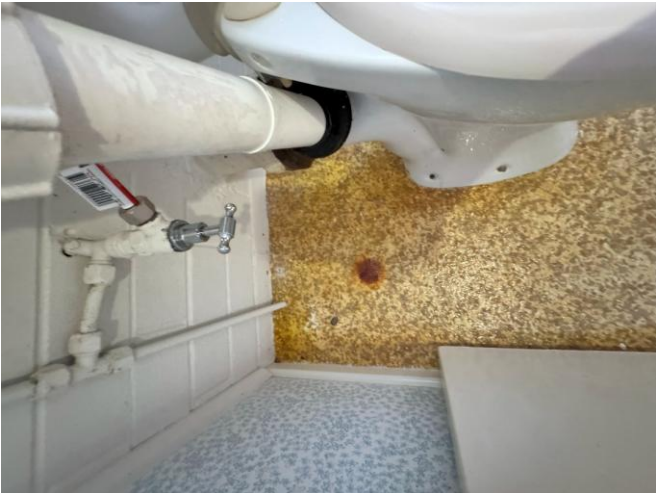
| <b>DEFECT NO:</b> | 5 | <b>Inspectors Comments:</b> | |

| Inspection Parts | Interior | Water pooling behind the toilet – Coming from vent pipe<br>Recommend suitably qualified and licenced contractors engaged to repair | |
| Location | Lower Floor Toilet | | |
| Defect | Major Defect | | |
| Defect Description | Loss of Utility, Further Deterioration | | |
| Defect Category | C – Water Penetration | | |

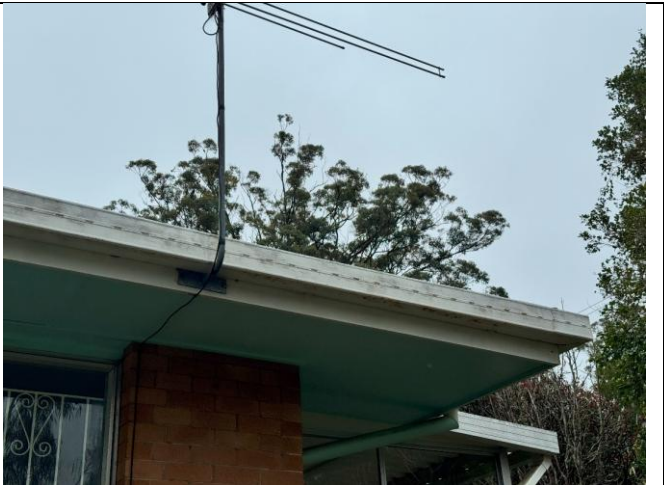
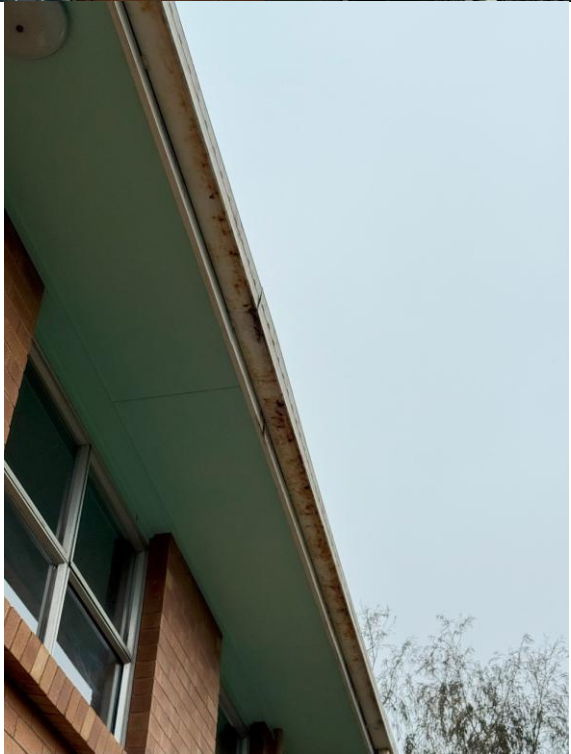
| DEFECT NO: | 6 | Inspectors Comments: |

| DEFECT NO: | 6 | Inspectors Comments: |
|---|---|---|
| Inspection Parts | Exterior | Rust appearing on the bottom of gutters<br>Recommend suitably qualified and licenced contractors engaged to repair |
| Defect | Minor Defect | |
| Defect Description | Further Deterioration | |
| Defect Category | D – Material Deterioration | |

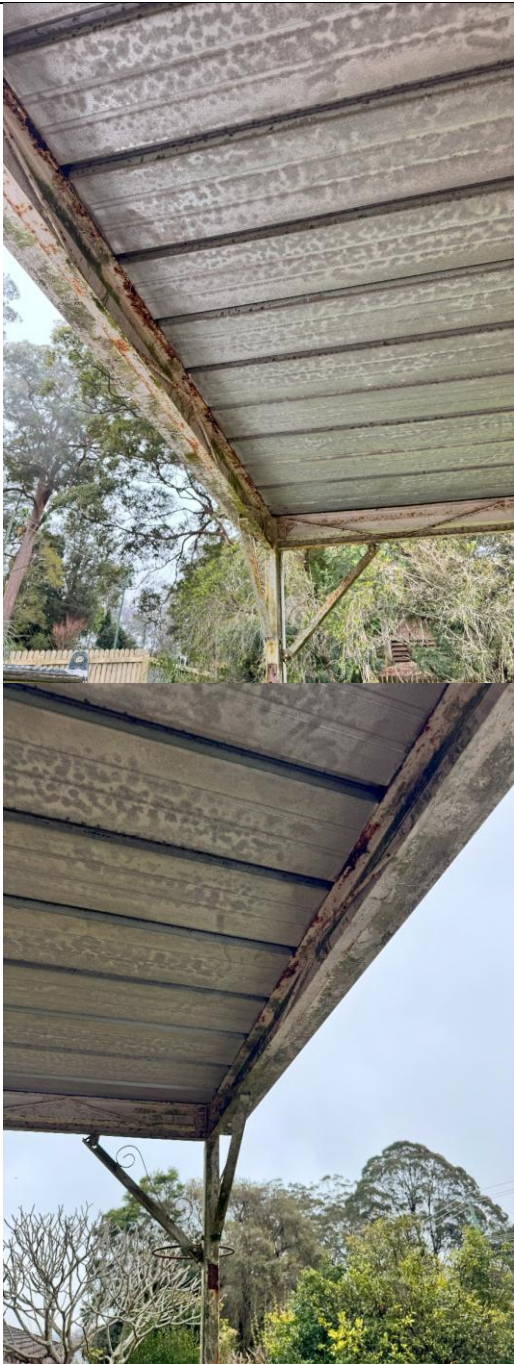
| DEFECT NO: | 7 | Inspectors Comments: | |

| DEFECT NO: | 7 | Inspectors Comments: | |
|---|---|---|---|
| Inspection Parts | Exterior | Carport structure rusting and deteriorated<br>Recommend suitably qualified and licenced contractors engaged to repair damage | |
| Location | Carport | | |
| Defect | Major Defect | | |
| Defect Description | Further Deterioration | | |
| Defect Category | A – Damage, D – Material Deterioration | | |

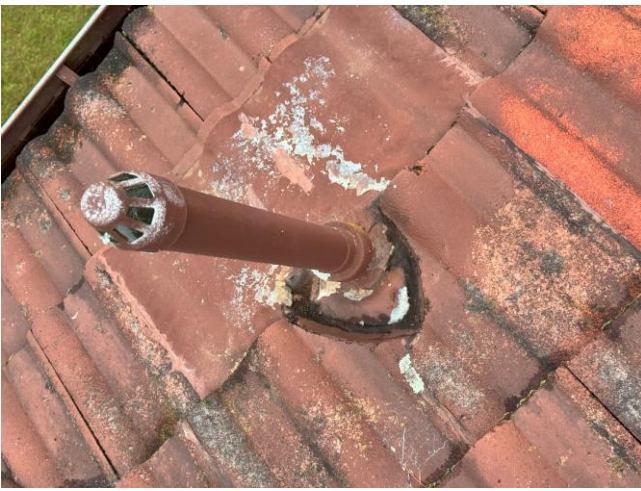
| DEFECT NO: | 8 | Inspectors Comments: | |

| DEFECT NO: | 8 | Inspectors Comments: | |
|---|---|---|---|
| Inspection Parts | Exterior | Flashings and pipework<br><br>Recommend suitably qualified and licenced contractors engaged to repair | |
| Location | Roof | | |
| Defect | Major Defect | | |
| Defect Description | Further Deterioration | | |
| Defect Category | C – Water Penetration, F - Installation | | |

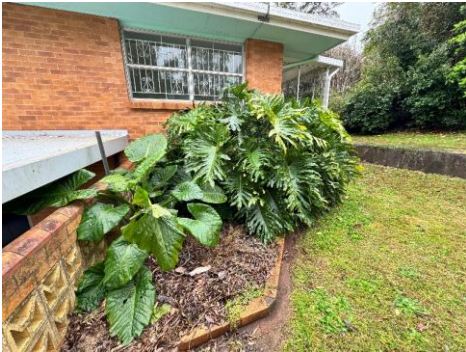
**Was evidence of bridging or breaching found? Yes, Dense gardens on the eastern elevation create a potentially even weaker.**

- see Details below, Clauses A.7 and A.8 - The subfloor structure of the rear deck is connected to the rear elevation of the house without appropriate termite barriers or treatment. Recommend chemical treatment of the deck stumps and/or physical barrier installed at possible bridging point:
