# Residential Pre-Sale Building & Pest Report

**4 Todwana Ct Glenvale QLD 4350**

Report prepared: 05/09/2025

## PRE-PURCHASE INSPECTION RESIDENTIAL BUILDING REPORT

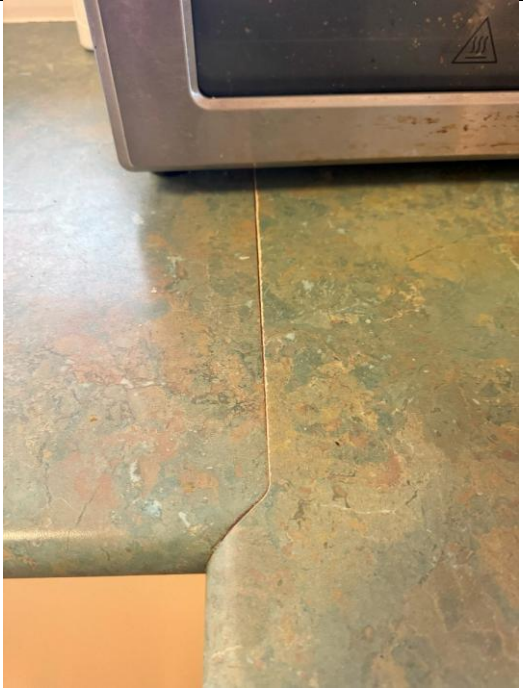
| DEFECT NO: | 1 | Inspectors Comments: | |

| DEFECT NO: | 1 | Inspectors Comments: | |
|---|---|---|---|
| Inspection Parts | Interior | Wear of the benchtop joint exposes material to further damage<br><br>Recommend suitably qualified and licenced contractors engaged to repair | |
| Location | Kicthen | | |

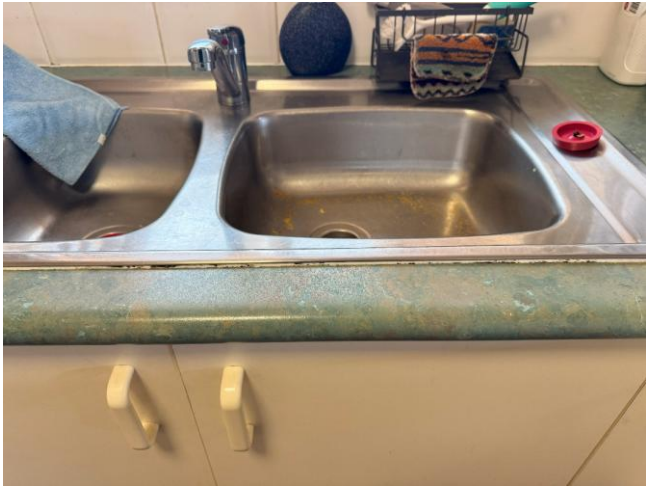
| DEFECT NO: | 2 | Inspectors Comments: | |

| DEFECT NO: | 2 | Inspectors Comments: | |
|---|---|---|---|
| Inspection Parts | Interior | Silicon bead to kitchen sink failing and mouldy<br>Recommend suitably qualified and licenced contractors engaged to repair | |
| Location | Kitchen | | |

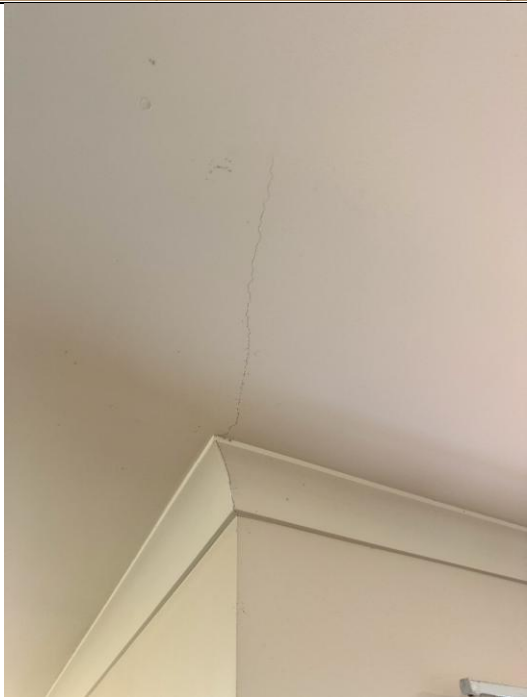
| DEFECT NO: | 2 | Inspectors Comments: | |
|---|---|---|---|
| DEFECT NO: | 3 | Inspectors Comments: | |

| DEFECT NO: | 2 | Inspectors Comments: | |
|---|---|---|---|
| Inspection Parts | Interior | Appearance crack in kitchen ceiling<br>Recommend suitably qualified and licenced contractors engaged to repair | |
| Location | Kitchen | | |

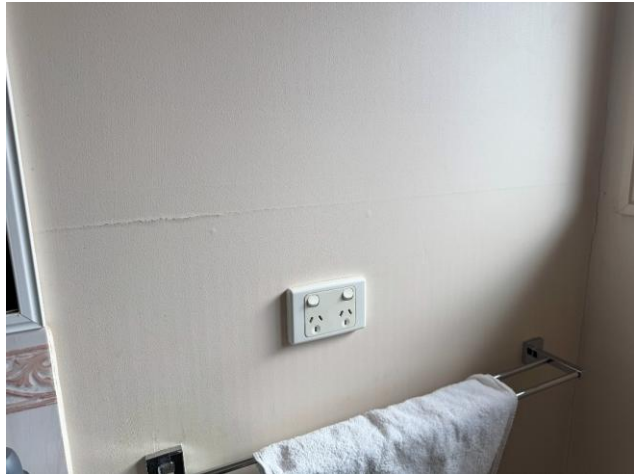
| DEFECT NO: | 4 | Inspectors Comments: | |

| DEFECT NO: | 4 | Inspectors Comments: | |
|---|---|---|---|
| Inspection Parts | Interior | <p>Appearance cracks to wall</p> <p>Recommend suitably qualified and licenced contractors engaged to repair</p> | |
| Location | Ensuite | | |

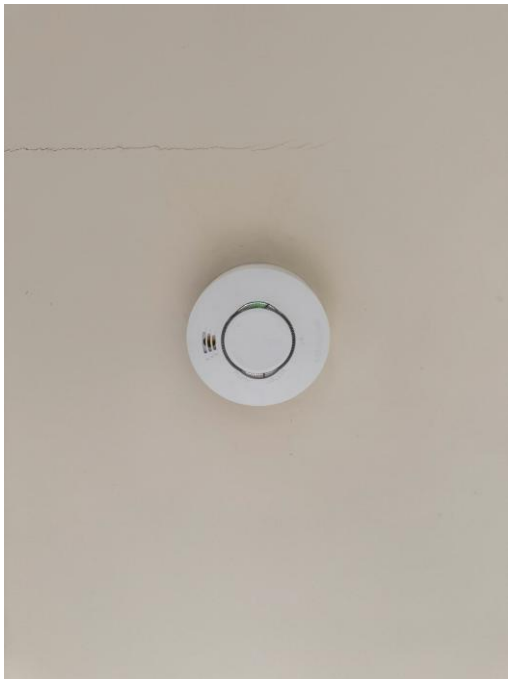
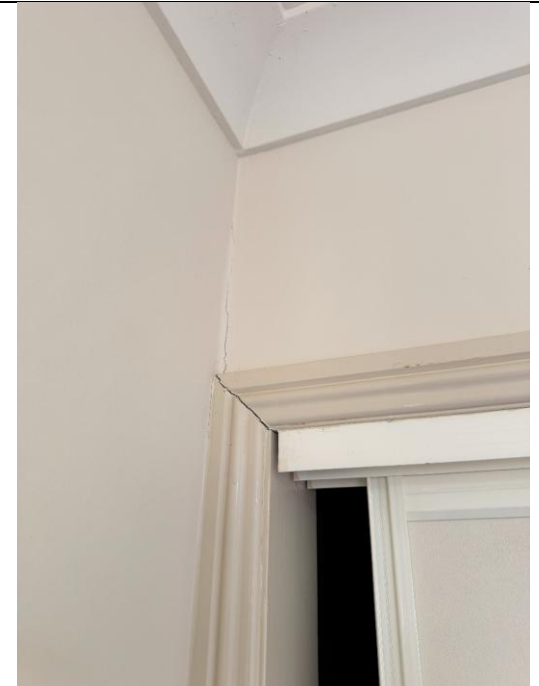
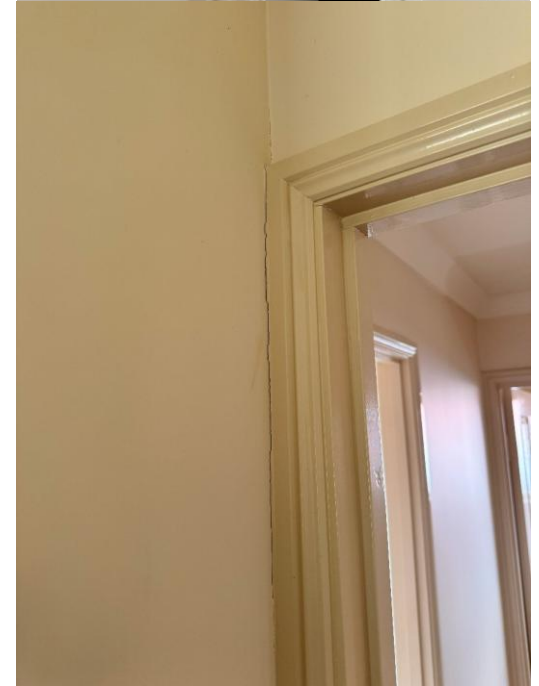
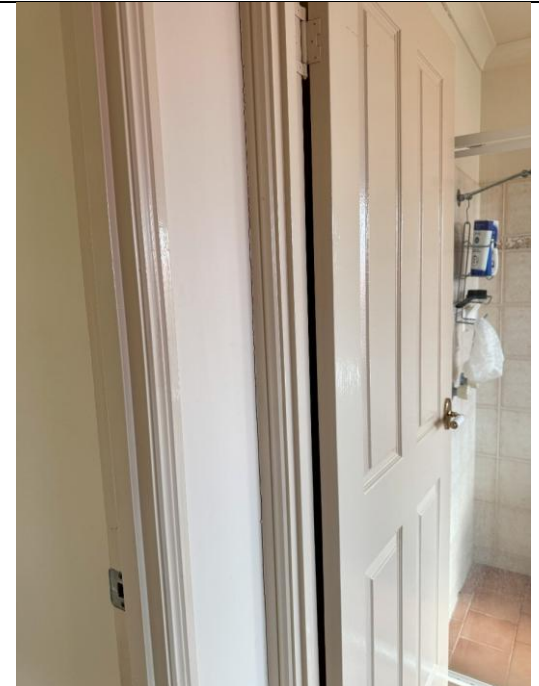
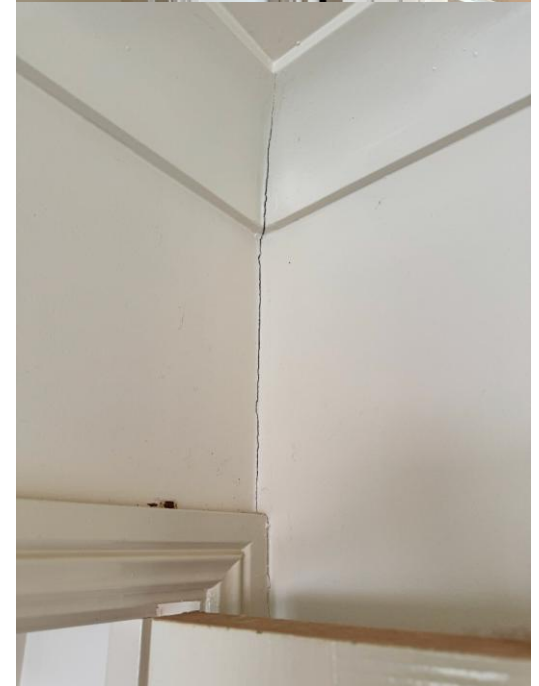
| DEFECT NO: | 4 | Inspectors Comments: | |
|---|---|---|---|
| DEFECT NO: | 5 | Inspectors Comments: | |

| DEFECT NO: | 4 | Inspectors Comments: | |
|---|---|---|---|
| Inspection Parts | Interior | <p>Appearance cracks to walls and ceilings</p> <p>Recommend suitably qualified and licenced contractors engaged to repair</p> | |
| Location | Generally | | |

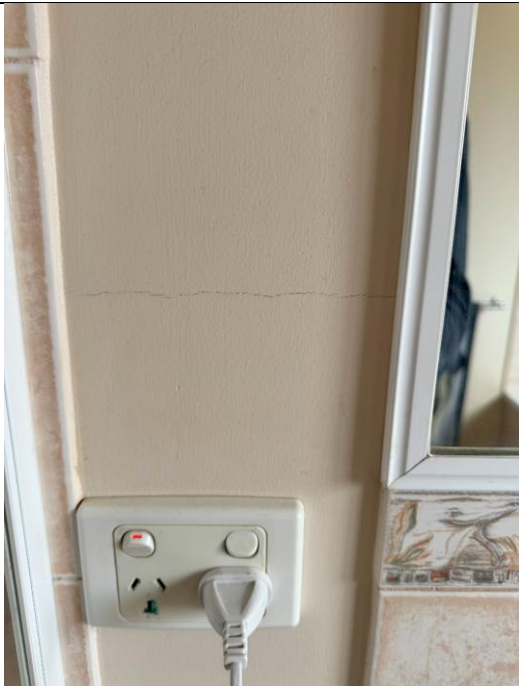
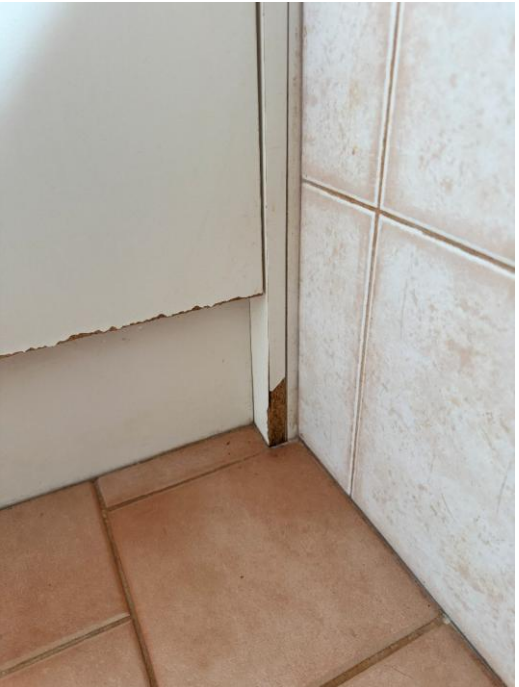
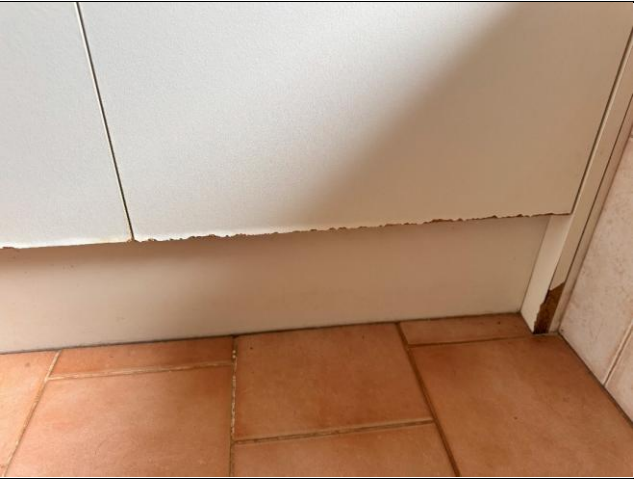
| <b>DEFECT NO:</b> | 6 | <b>Inspectors Comments:</b> | |

| Location | Bathroom | Damage to joinery and signs of moisture swelling to vanity doors | |

| Defect | Minor Defect | Recommend suitably qualified and licenced contractors engaged to repair | |

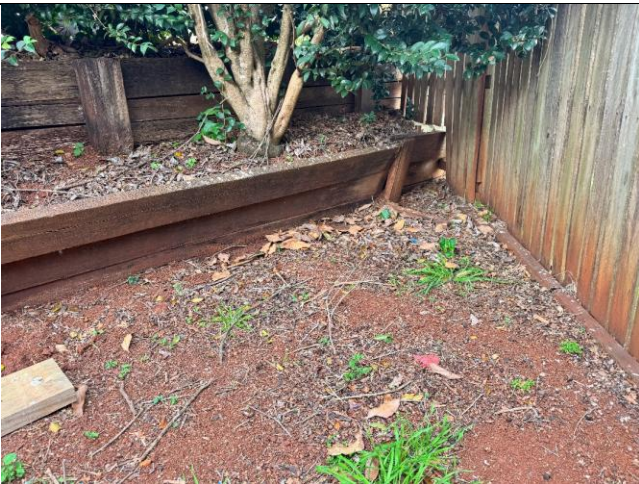
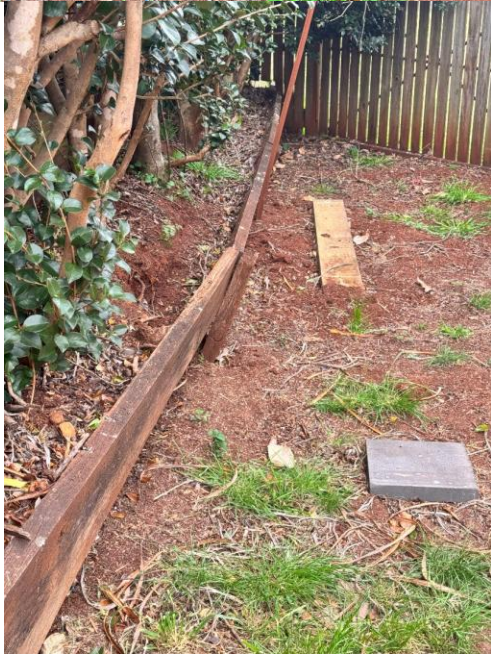
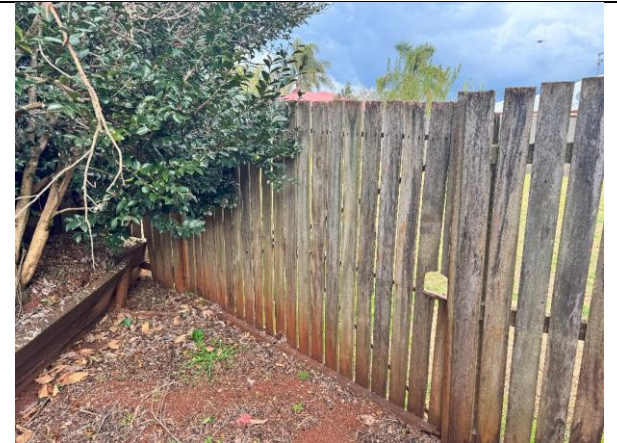
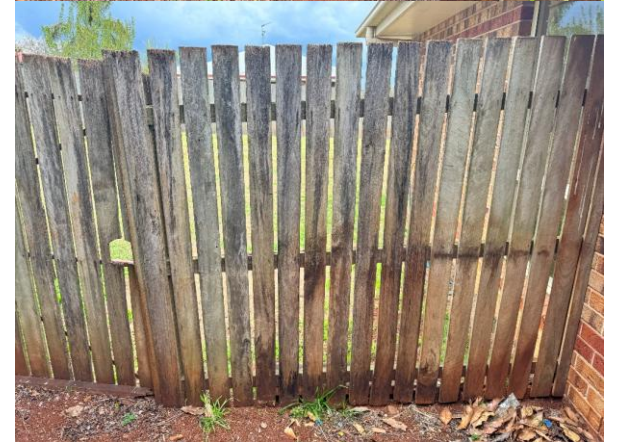
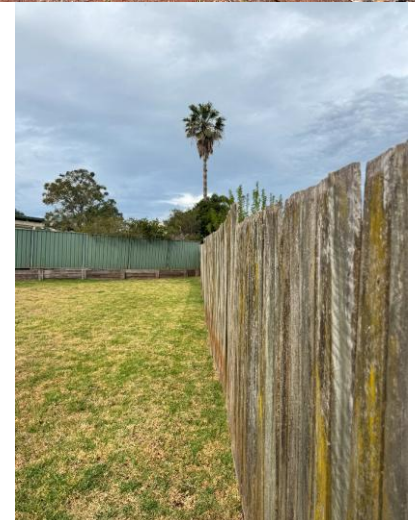
| DEFECT NO: | 7 | Inspectors Comments: |

| DEFECT NO: | 7 | Inspectors Comments: |
|---|---|---|
| Inspection Parts | Exterior | <div>Areas of fencing and retaining deteriorated beyond normal operation</div> <div>Recommend suitably qualified and licenced contractors engaged to repair</div> |

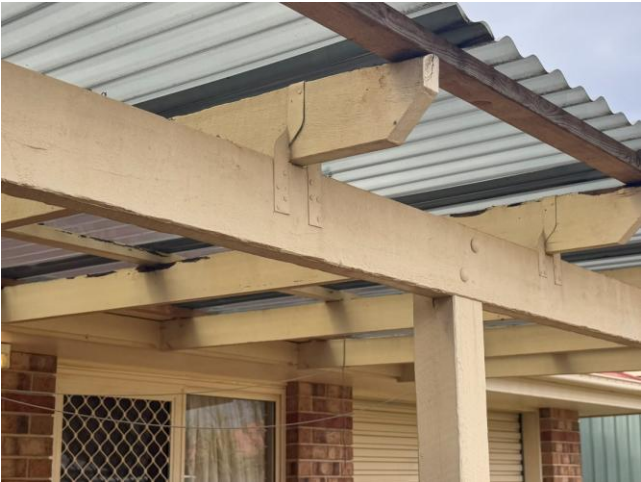
| DEFECT NO: | 8 | Inspectors Comments: | |

| DEFECT NO: | 8 | Inspectors Comments: | |
|---|---|---|---|
| Inspection Parts | Exterior | Pergola shows signs of water penetration and rot<br>Recommend suitably qualified and licenced contractors engaged to repair damage | |
| Location | Pergola | | |

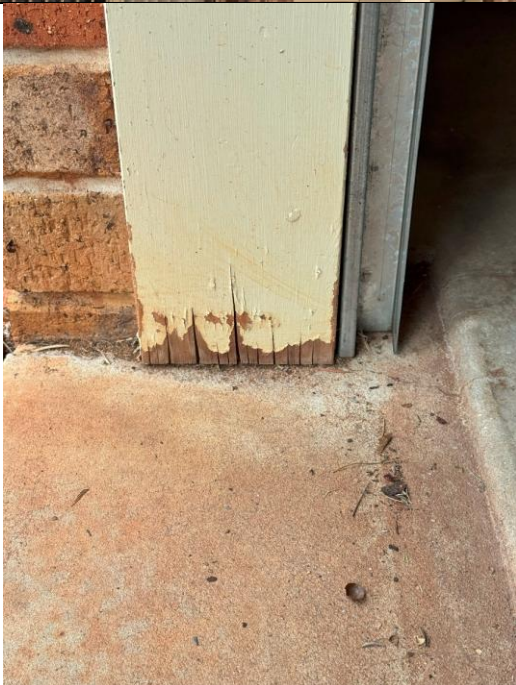
| DEFECT NO: | 8 | Inspectors Comments: | |
|---|---|---|---|
| DEFECT NO: | 9 | Inspectors Comments: | |

| DEFECT NO: | 8 | Inspectors Comments: | |
|---|---|---|---|
| Inspection Parts | Exterior | Garage door jambs show signs of water damage and rot<br>Recommend suitably qualified and licenced contractors engaged to repair damage | |
| Location | Garage Doors | | |

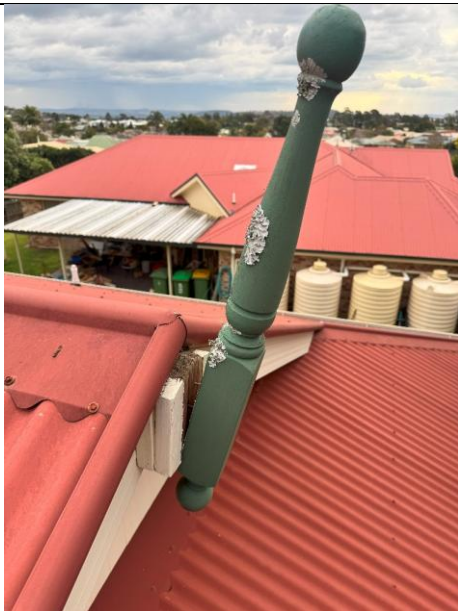
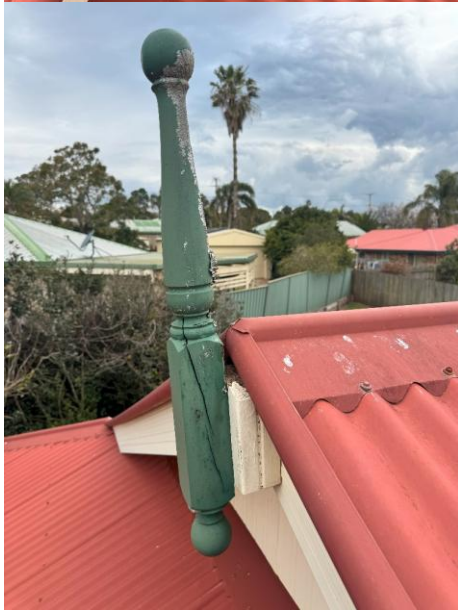
| DEFECT NO: | 10 | Inspectors Comments: |

| DEFECT NO: | 10 | Inspectors Comments: |
|---|---|---|
| Inspection Parts | Roof Exterior | Finials show signs of water damage and fixings failing<br><br>Recommend suitably qualified and licenced contractors engaged to repair damage |

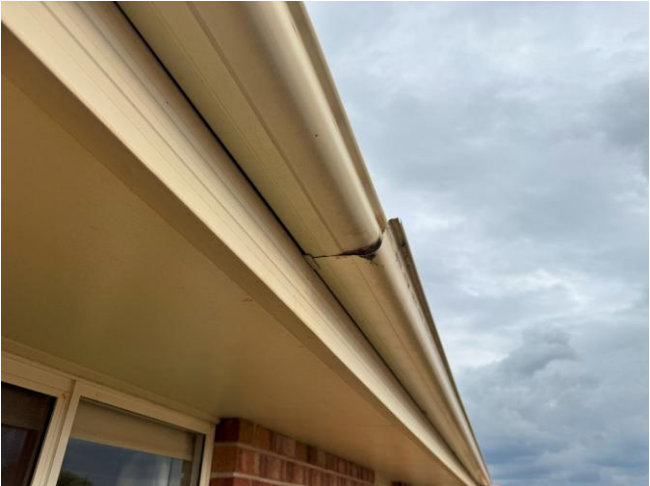
| DEFECT NO: | 11 | Inspectors Comments: | |

| DEFECT NO: | 11 | Inspectors Comments: | |
|---|---|---|---|
| Inspection Parts | Roof Exterior | Gutter rivet connections damaged<br>Recommend suitably qualified and licenced contractors engaged to repair damage | |

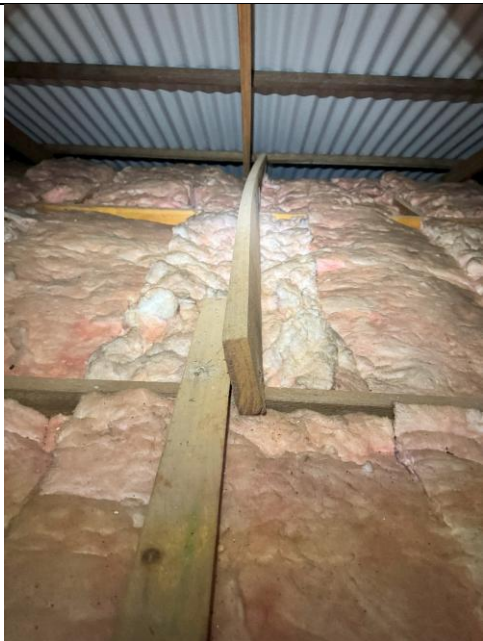
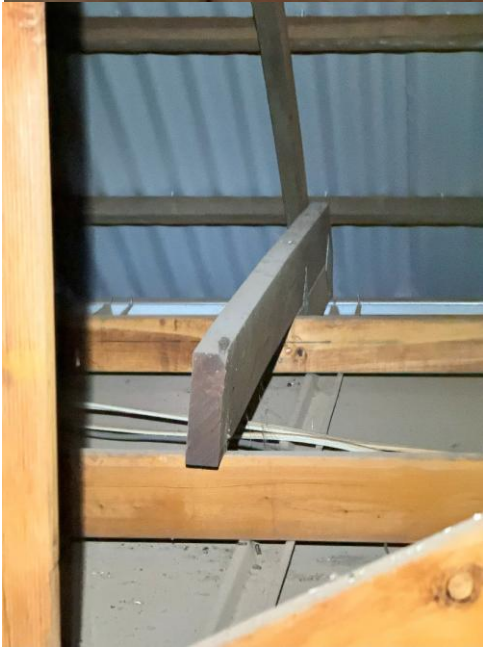
| DEFECT NO: | 12 | Inspectors Comments: |

| DEFECT NO: | 12 | Inspectors Comments: |
|---|---|---|
| Inspection Parts | Roof Interior | Timber hanging beams twisted and warped<br>Recommend suitably qualified and licenced contractors engaged to repair |

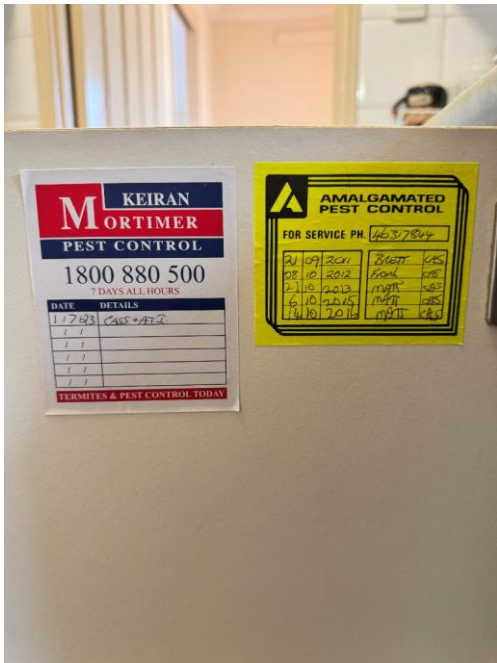
Was evidence of a possible previous termite management program found? Yes, annual chemical treatment has been observed last completed in 2023

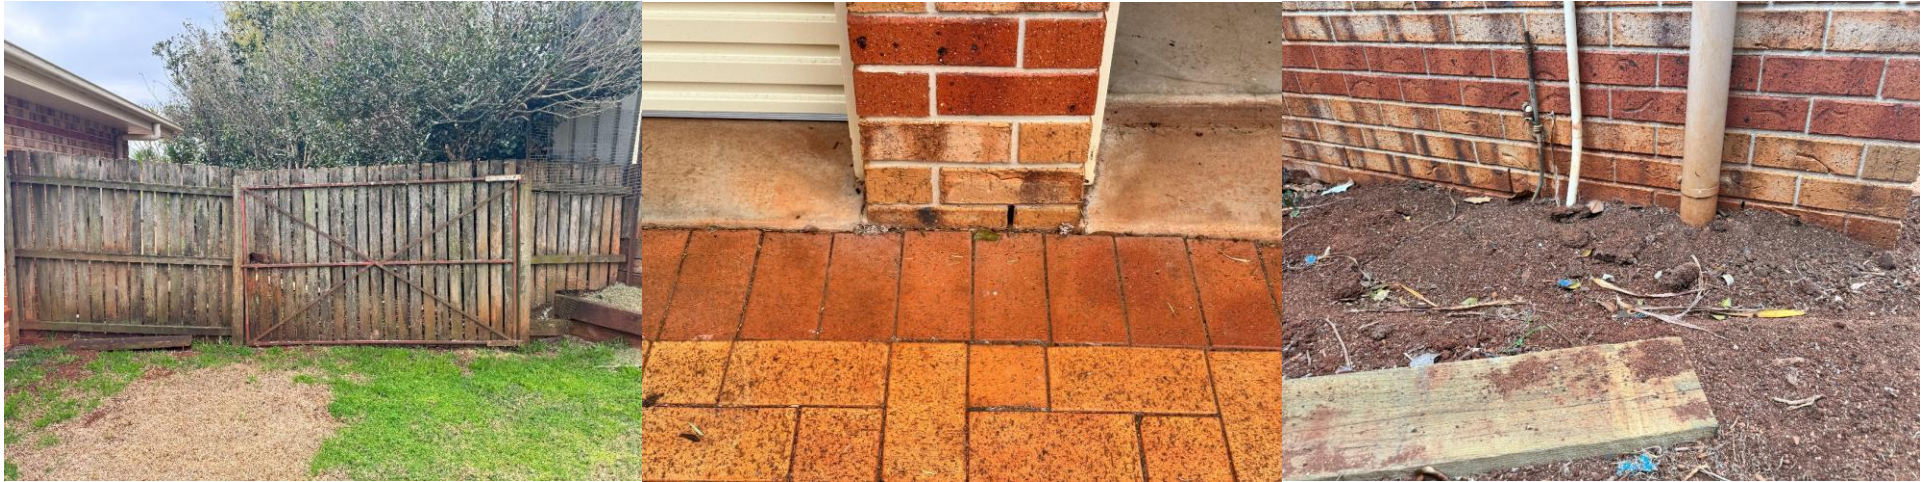
**Was evidence of bridging or breaching found? Yes, paving to driveway and side fences bridge the ground surface to the weep holes potentially allowing pest attack.**

- see Details below, Clauses A.7 and A.8 - The subfloor structure of the rear deck is connected to the rear elevation of the house without appropriate termite barriers or treatment. Recommend chemical treatment of the deck stumps and/or physical barrier installed at possible bridging point:
