# Residential Pre-Sale Building & Pest Report

**42 Bouganvillea Dr Middle Ridge QLD 4350**

Report prepared: 02/09/2025

## PRE-PURCHASE INSPECTION RESIDENTIAL BUILDING REPORT

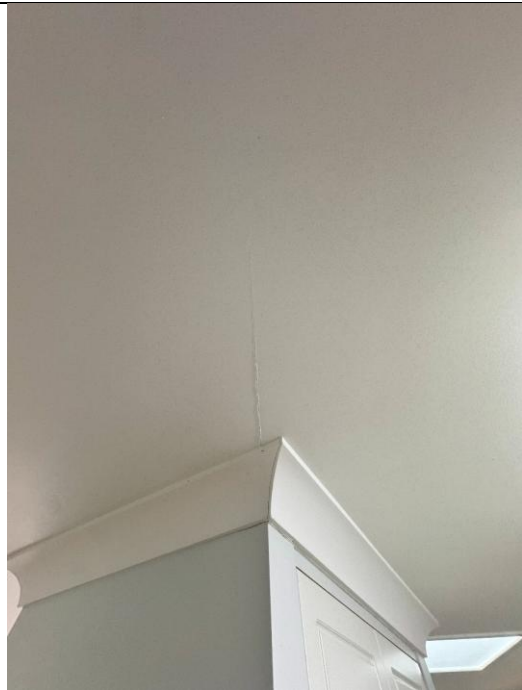
| DEFECT NO: | 1 | Inspectors Comments: |

| DEFECT NO: | 1 | Inspectors Comments: |
|---|---|---|
| Inspection Parts | Interior | Appearance cracks in ceiling<br>Recommend suitably qualified and licenced contractors engaged to repair |
| Defect | Minor Defect | |
| Defect Description | Loss of utility | |
| Defect Category | A - Damage | |

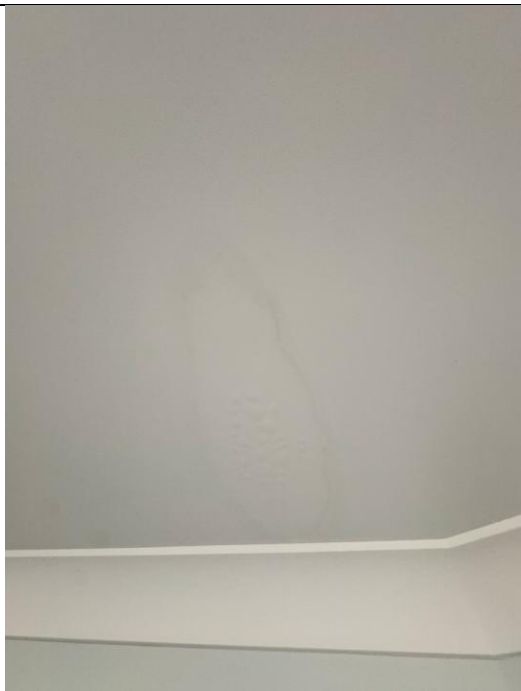
| DEFECT NO: | 2 | Inspectors Comments: | |

| DEFECT NO: | 2 | Inspectors Comments: | |
|---|---|---|---|
| Inspection Parts | Interior | Minor moisture stain to ceiling – no signs of water ingress in ceiling space | |
| Location | Dining | | |
| Defect Description | Loss of utility, Further Deterioration | | |
| Defect Category | C – Water Penetration, D – Material Deterioration | | |

| DEFECT NO: | 2 | Inspectors Comments: | |
|---|---|---|---|
| Defect | Minor Defect | Recommend suitably qualified and licenced contractors engaged to repair | |

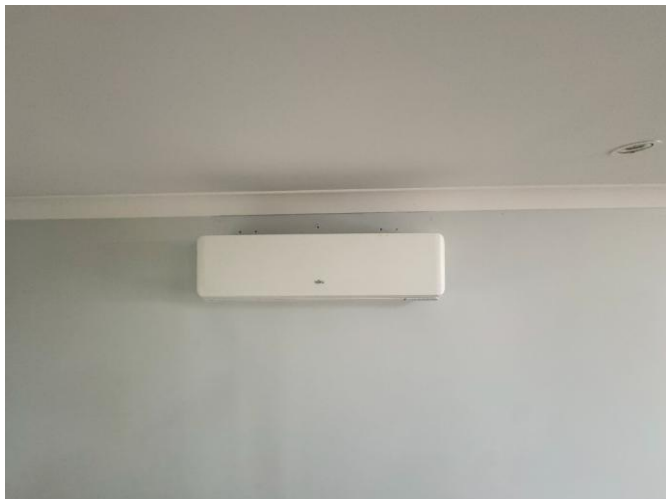
| DEFECT NO: | 2 | Inspectors Comments: | |
|---|---|---|---|
| DEFECT NO: | 3 | Inspectors Comments: | |

| DEFECT NO: | 2 | Inspectors Comments: | |
|---|---|---|---|
| Inspection Parts | Interior | Mounting holes visible from replaced AC head unit | |
| Location | Living | | |
| Defect Description | Loss of Utility | | |
| Defect Category | F - Installation | | |

| DEFECT NO: | 2 | Inspectors Comments: | |
|---|---|---|---|
| Defect | Minor Defect | Recommend suitably qualified and licenced contractors engaged to repair | |

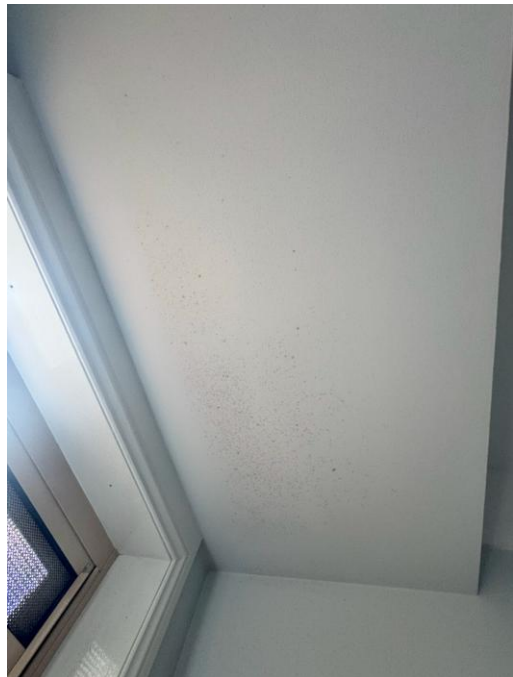
| DEFECT NO: | 4 | Inspectors Comments: | |

| Inspection Parts | Interior | Mould growth present in toilet – likely environmental | |
| Location | Toilet | | |
| Defect Description | Unsafe Condition | | |
| Defect Category | C – Water Penetration, D – Material Deterioration | | |

| Defect | Minor Defect | Recommend suitably qualified and licenced contractors engaged to address | |

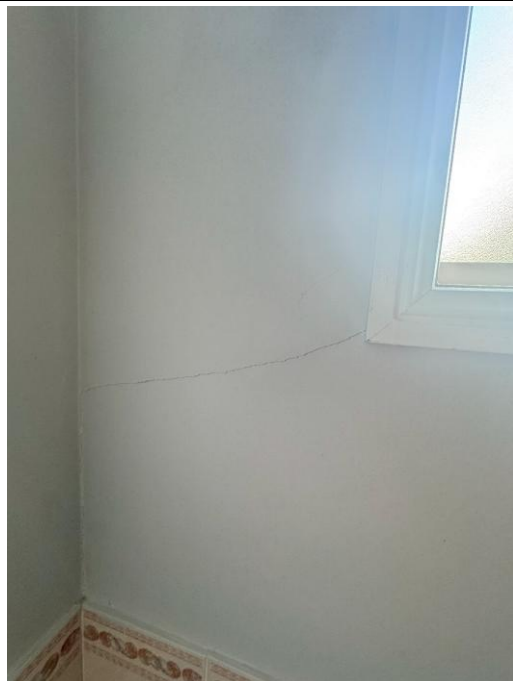
| DEFECT NO: | 5 | Inspectors Comments: | |

| Inspection Parts | Interior | Appearance crack on external wall | |
| Location | Bathroom | | |
| Defect Description | Loss of Utility | | |
| Defect Category | A - Damage | | |

| Defect | Minor Defect | Recommend suitably qualified and licenced contractors engaged to repair | |

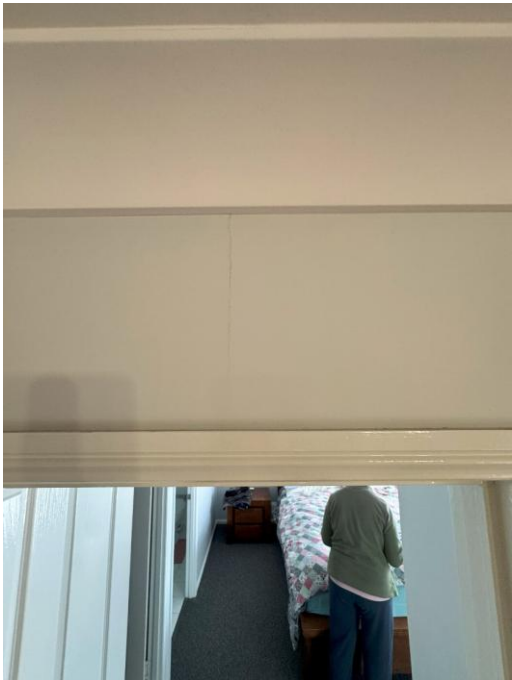
| DEFECT NO: | 6 | Inspectors Comments: | |

| DEFECT NO: | 6 | Inspectors Comments: | |
|---|---|---|---|
| Inspection Parts | Interior | <p>Appearance crack in walls</p> <p>Recommend suitably qualified and licenced contractors engaged to repair</p> | |
| Location | Master Bed | | |
| Defect | Minor Defect | | |
| Defect Category | A – Damage | | |

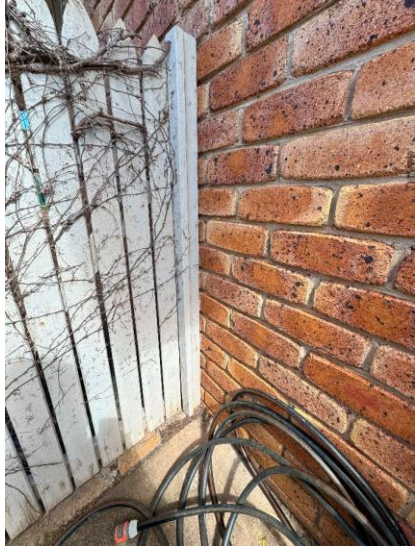
| DEFECT NO: | 7 | Inspectors Comments: | |
|---|---|---|---|
| Inspection Parts | Exterior | <p>Side gate installed with timber fixed to house extending below termite barrier</p> <p>Recommend suitably qualified and licenced contractors engaged to repair</p> | |
| Location | Side Gates x 2 | | |
| Defect | Major Defect | | |
| Defect Category | F - Installation | | |

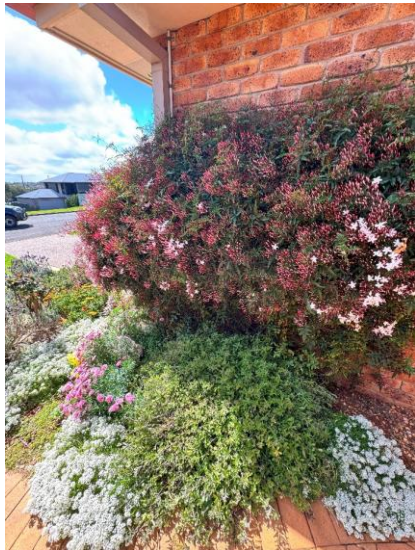
| DEFECT NO: | 7 | Inspectors Comments: | |
|---|---|---|---|
| Inspection Parts | Exterior | <p>Gardens installed hard to house with concealment of possible pest intrusion</p> <p>Recommend suitably qualified and licenced contractors engaged to repair damage</p> | |
| Location | Generally | | |
| Defect | Major Defect | | |
| Defect Category | F - Installation | | |

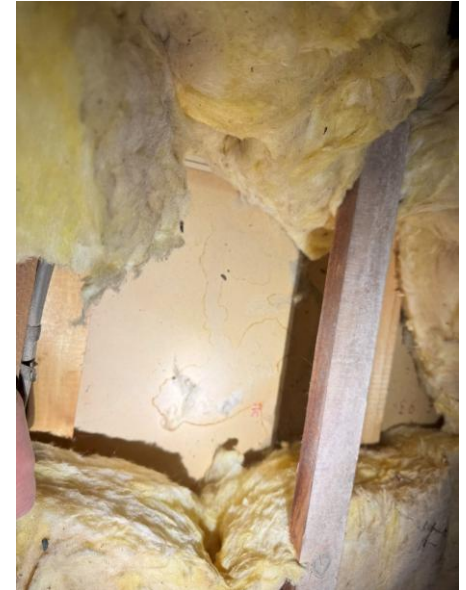
| <b>DEFECT NO:</b> | 9 | <b>Inspectors Comments:</b> | |

| Location | Roof | Water marks and signs of rodent activity – suspect water damage due to pest activity | |
| Defect Description | Further Deterioration | | |
| Defect Category | C – Water Penetration | | |

| Defect | Minor Defect | Recommend suitably qualified and licenced contractors engaged to address and repair | |

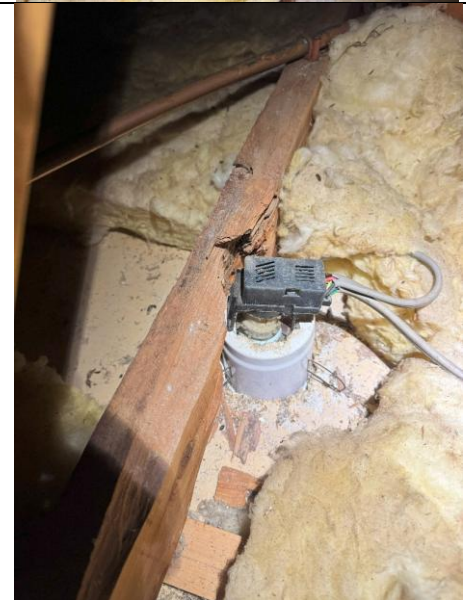
| <b>DEFECT NO:</b> | 10 | <b>Inspectors Comments:</b> | |

| Location | Roof | Downlight installation damaged bottom cord of truncated girder truss. | |
| Defect Description | Loss of Utility, Further Deterioration, Unsafe Condition | | |
| Defect Category | A – Damage, F - Installation | | |

| Defect | Major Defect | Recommend suitably qualified and licenced contractors engaged to repair | |

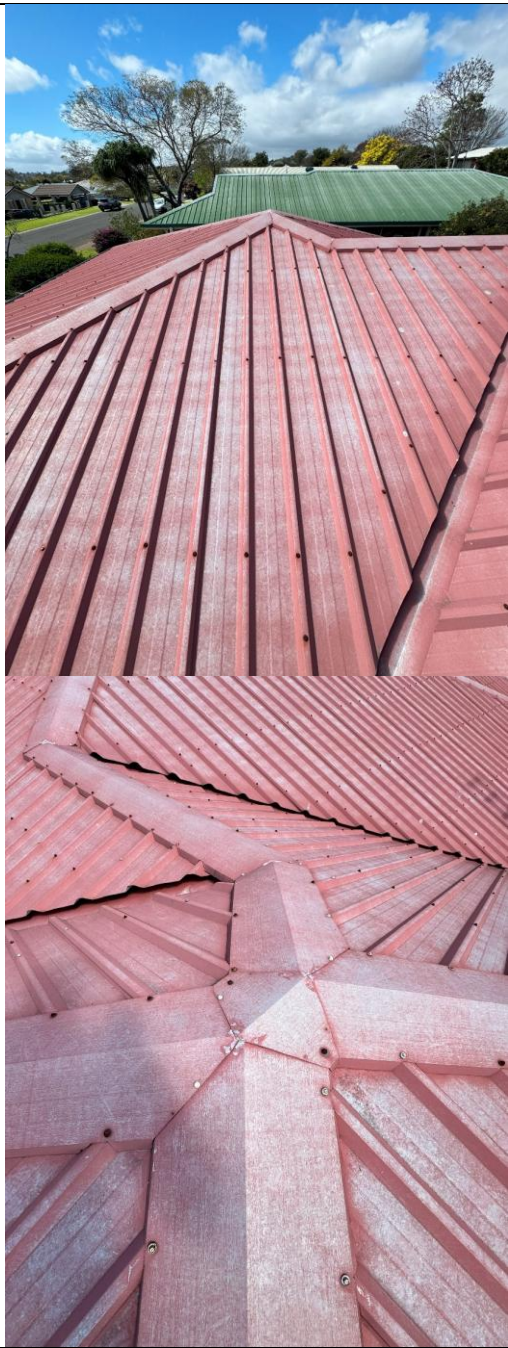
| DEFECT NO: | 11 | Inspectors Comments: |

| DEFECT NO: | 11 | Inspectors Comments: |
|---|---|---|
| Inspection Parts | Exterior | Roof surface corrosion present as expected in a house of this age<br><br>Recommend suitably qualified and licenced contractors engaged to replace in the next 10-15 yrs |
| Defect | Major Defect | |
| Defect Category | D – Material Deterioration | |

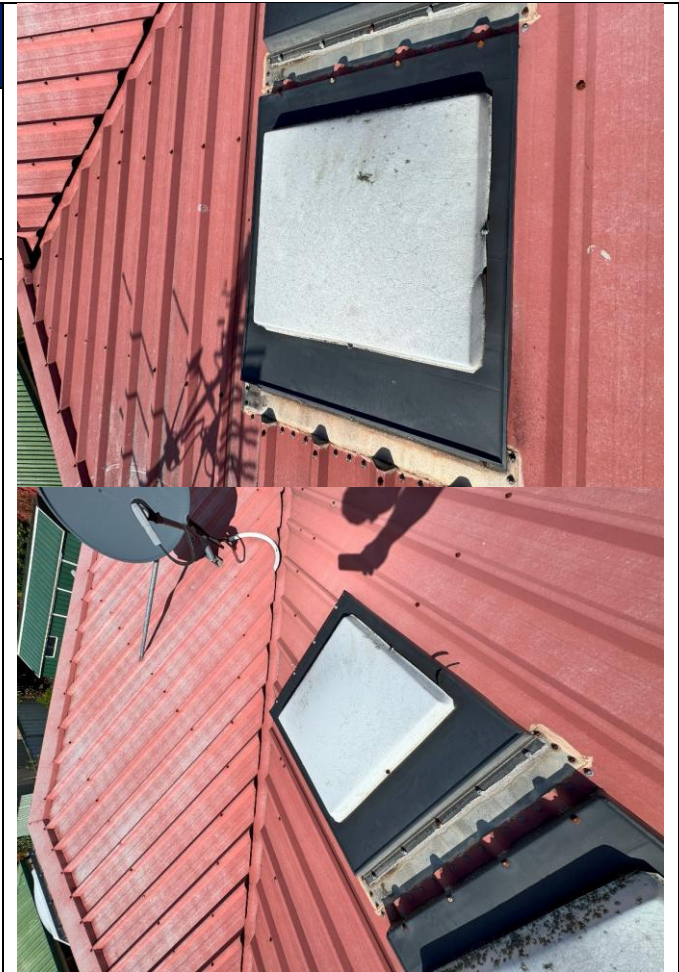
| DEFECT NO: | 12 | Inspectors Comments: |

| DEFECT NO: | 12 | Inspectors Comments: |
|---|---|---|
| Inspection Parts | Exterior | <p>Skylight covers UV damaged</p> <p>Recommend suitably qualified and licenced contractors engaged to repair</p> |
| Defect | Major Defect | |
| Defect Category | A – Damage, D – Material Deterioration | |

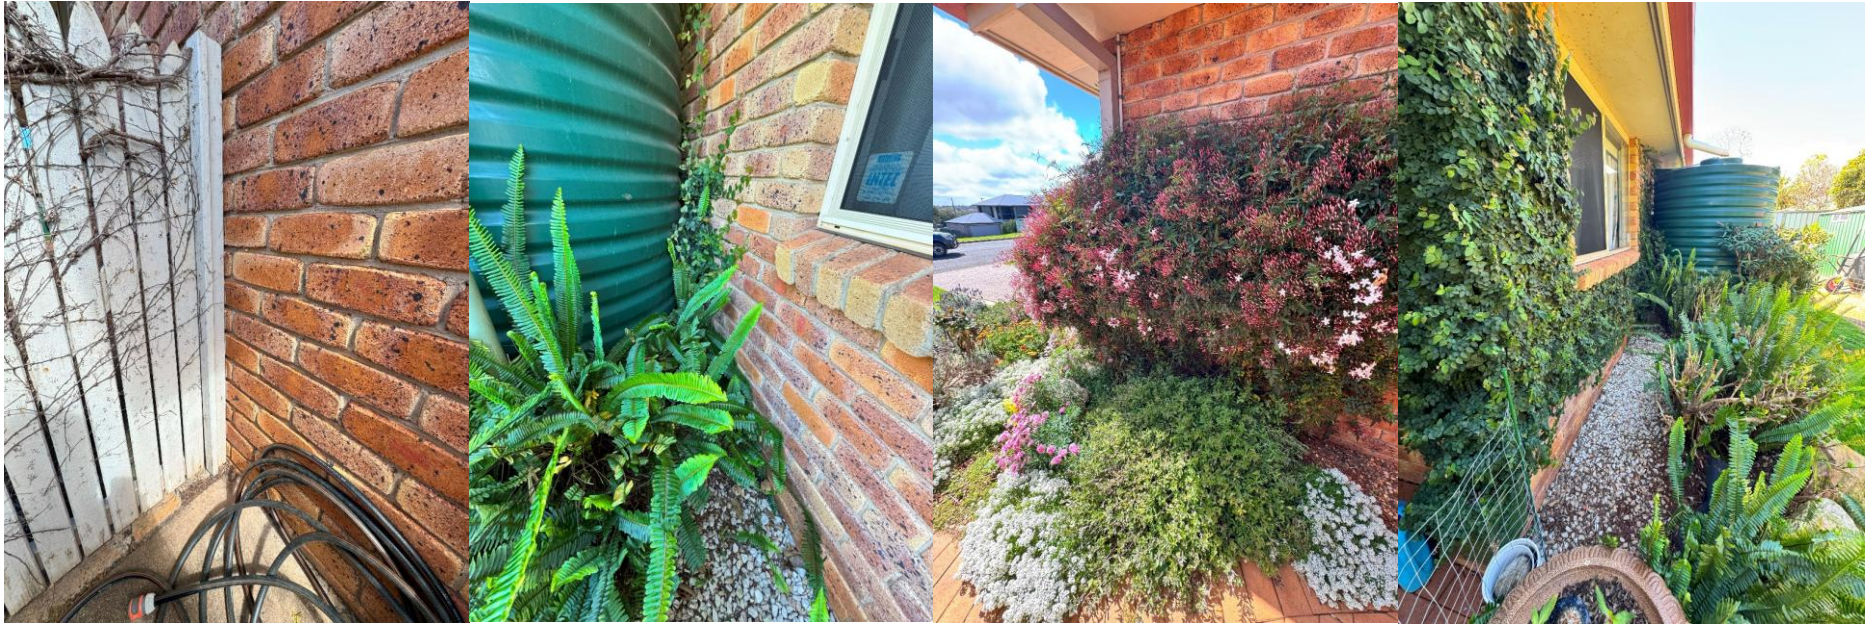
**Was evidence of bridging or breaching found? Yes, live garden plants and water tanks against house have created a bridging issue**

- see Details below, Clauses A.7 and A.8 - The subfloor structure of the rear deck is connected to the rear elevation of the house without appropriate termite barriers or treatment. Recommend chemical treatment of the deck stumps and/or physical barrier installed at possible bridging point:
