## **Pre-purchase Building Inspection**

**35 Blue Hills Drive Rangeville Qld 4350**

## **Pre-Purchase Inspection - Residential Building Report (Except ACT)**

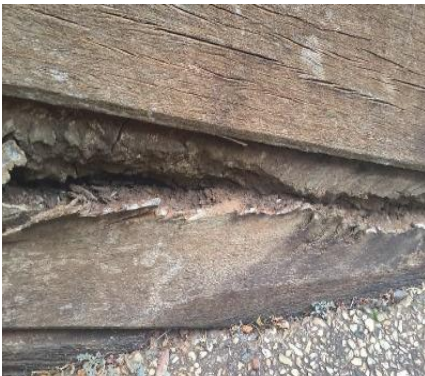
Wood decay to retaining wall timbers

- *Wood decay and termite damage to retaining wall timbers. Future maintenance will eventually be required.*

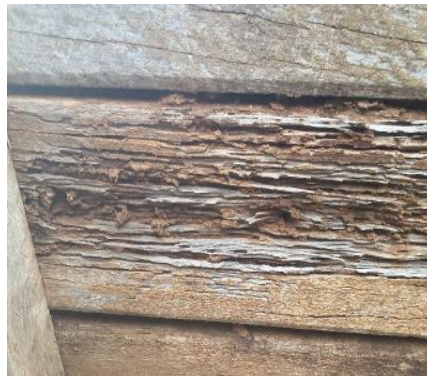
Termite damage to retaining wall timbers

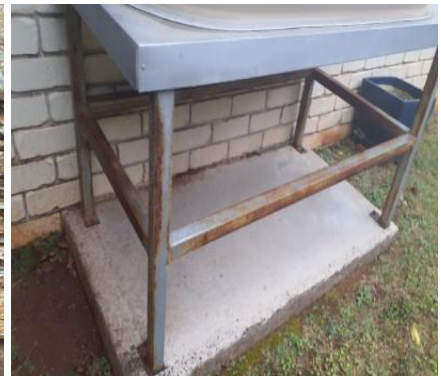
Rust to tank stand

- *Minor rust is evident to the metal tank stand. This should be treated to prevent further deterioration.*

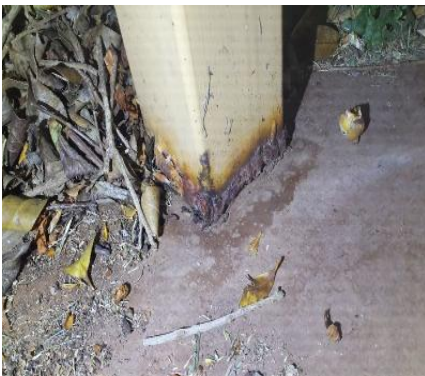
Rust to carport posts

- *Rust is evident to the steel carport posts. This should be treated to prevent further deterioration.*

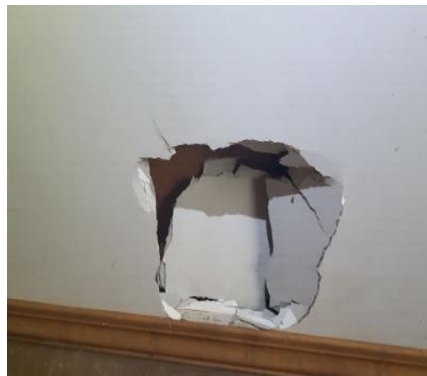
Damage to garage wall lining

- *Damage to sections of the panel lift door. Engage a garage door specialist for repairs.*
- *Minor cracking to the join of the ceiling lining and damage to section of the garage wall lining. Engage a plaster for repairs.*

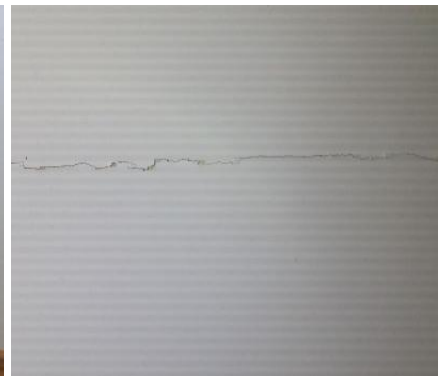
Cracking to the join of the garage ceiling lining

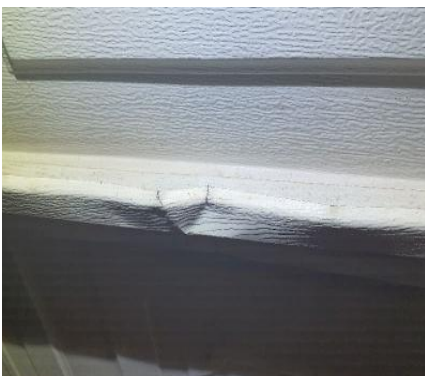
Damage to section of the panel lift door

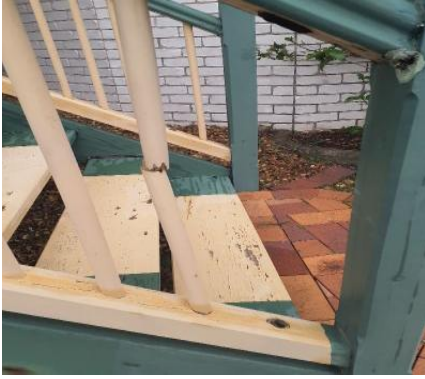
Wood decay, balustrade broken and missing

- *Wood decay, balustrade missing and broken balustrade at the front of the dwelling. Engage a carpenter to quote for repairs where required.*

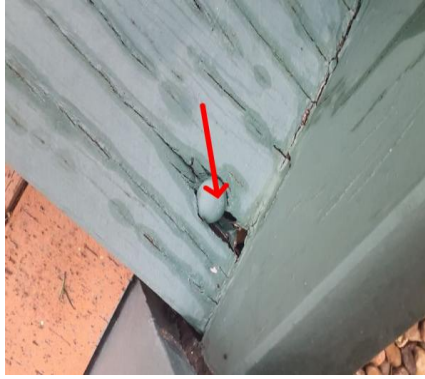
Wood decay to stairs

- *Wood decay to the front stairs. Engage a carpenter for repairs.*

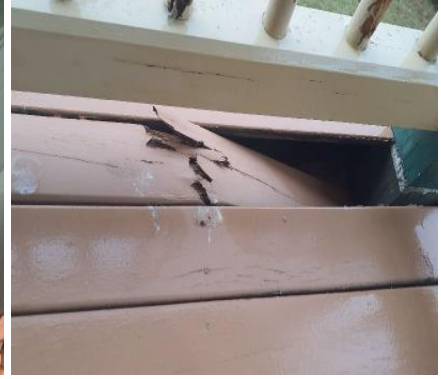
Damage to verandah decking boards

- *Wood decay and damaged decking boards. Engage a carpenter to quote for replacement where required.*

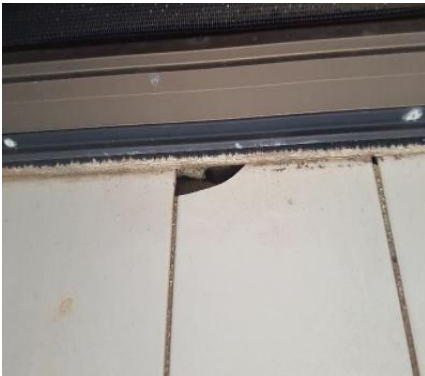
Damaged door sill tile

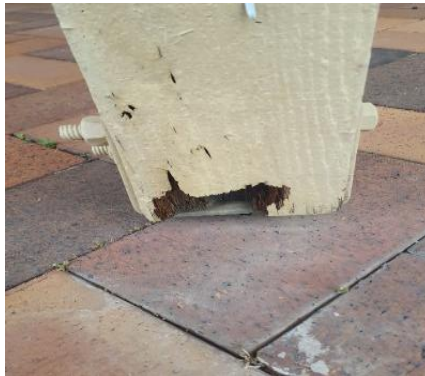
Wood decay to patio post

- *Wood decay to the patio post. Engage a carpenter for repairs.*

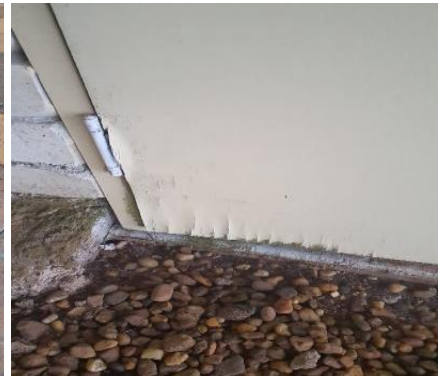
Door to subfloor area has delaminated

- *Door to subfloor area has delaminated. Engage a carpenter to quote for replacement.*

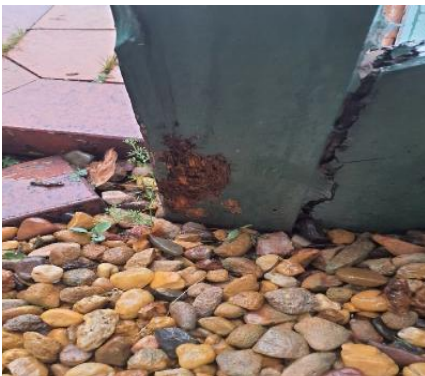
Wood decay to balustrade

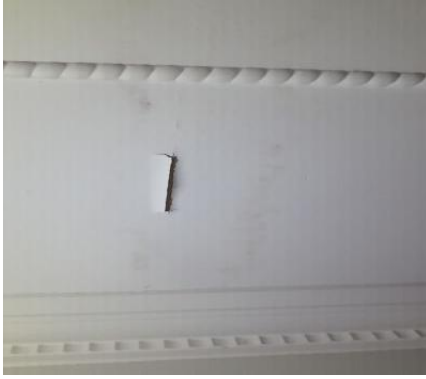
Water staining and paint flaking from section of the lounge room ceiling

- *There is old water staining and paint flaking from the lounge room ceiling. Engage a painting contractor for repair.*

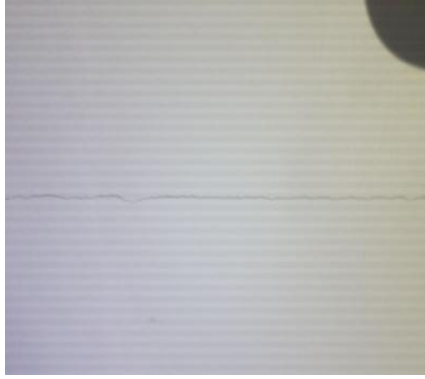
Minor cracking to the join of the ensuite wall sheeting

- *There is minor cracking to the join of the ensuite wall sheeting. Engage a painting contractor for repair.*

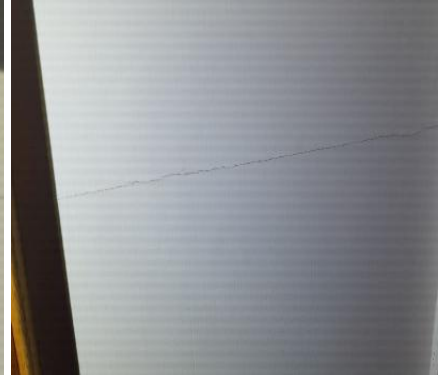
Minor cracking to the join of the bathroom wall sheeting

- *Minor cracking to the join of the wall sheeting and cracking above the doorway. Engage a painting contractor for repairs.*

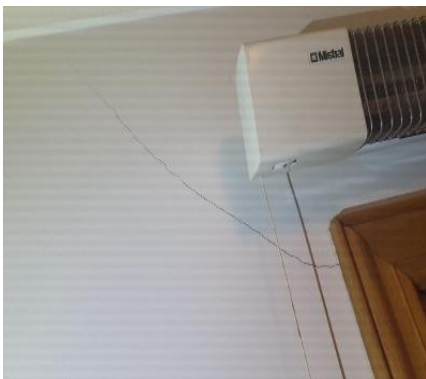
Minor cracking to the bathroom wall sheeting

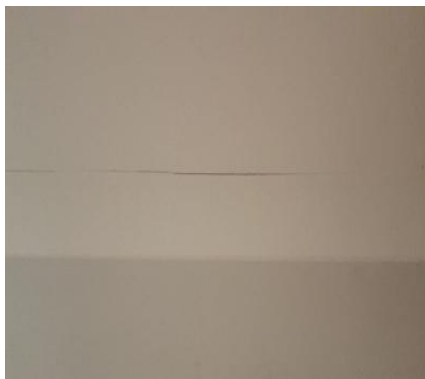
Plaster defects

- *There are some plaster & paint defects to the internal linings consistent with a house of this age. Patching and painting by tradesmen would improve the overall appearance.*

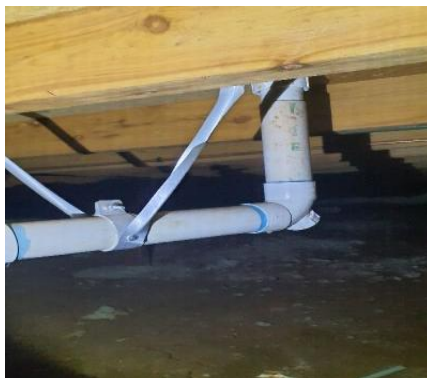
Ensuite waste pipe is leaking

- *Ensuite waste pipe is leaking in the sub floor area. Plumber to advise.*

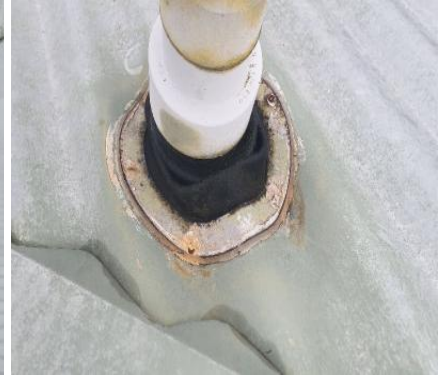
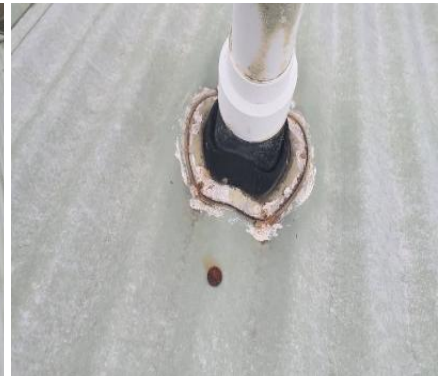
Sealant shows signs of deterioration around vent pipe boot

- *Rooftop vent pipe sealant shows signs of deterioration. Maintaining a leak-proof roof requires periodic checks to assure sealants such as caulk have not chipped, cracked, or pulled away from places they seal. These areas include roof vents. They require occasional reapplication of caulk around the base where the vent contacts the surrounding roof.*
- *Rooftop sealant has been applied prior to the inspection; such application is a temporary waterproofing measure and may last for some months before breaking down . Engage a roofing contractor to quote for repairs to rectify where required.*

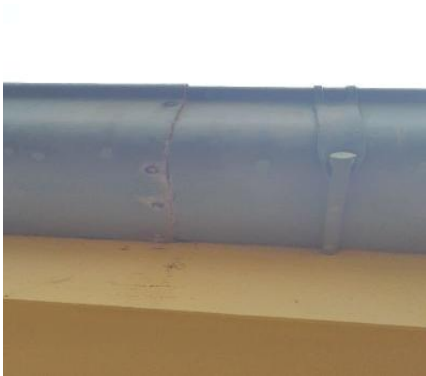
Gutter is leaking on join

- *Gutter sealant shows signs of deterioration and there is evidence of leaks to joins. Maintaining a leak-proof gutter requires periodic checks to assure sealants such as caulk have not chipped, cracked, or pulled away from places they seal. These areas include guttering. They require occasional reapplication of caulk where the guttering joins together.*
- *Gutter sealant has been applied prior to the inspection; such application is a temporary waterproofing measure and may last for some months before breaking down. Engage a roofing contractor to quote for repairs to rectify where required.*
- *Bottom of the rear downpipe is broken. Plumber to advise.*

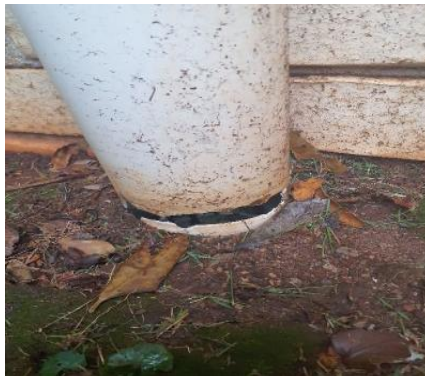
Bottom of the rear downpipe is broken

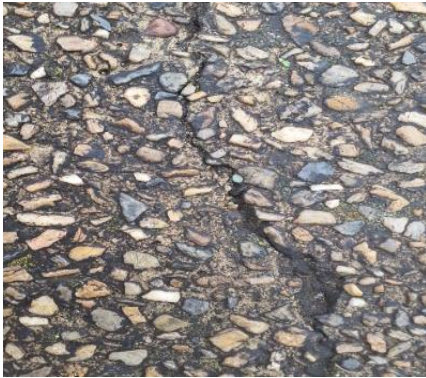
- *Cracking to the concrete driveway in various locations throughout. Future maintenance may be required.*

Cracking to the driveway

| Areas Inspected | Location and Description of the Cracking Defect at the time of the Inspection. |
|---|---|
| Concrete Slabs | <i>Cracking to the concrete driveway throughout. Future maintenance may be required.</i> |
