Report No: 103045

**PRE-PURCHASE  
TIMBER PEST DETECTION REPORT**

ADDRESS OF PROPERTY INSPECTED: 35 BLUE HILLS DRIVE RANGEVILLE QLD 4350

DATE OF INSPECTION: 28/10/2025

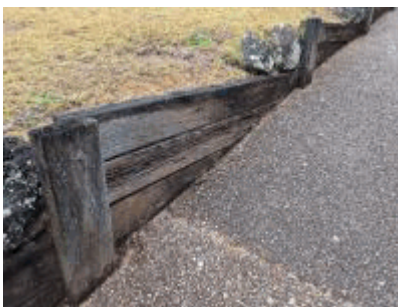
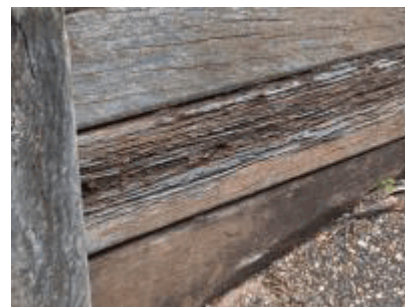
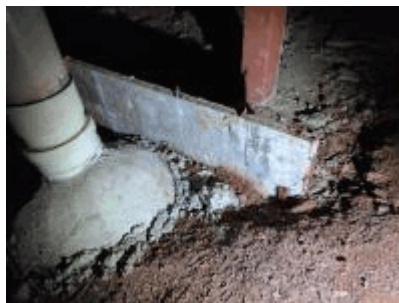
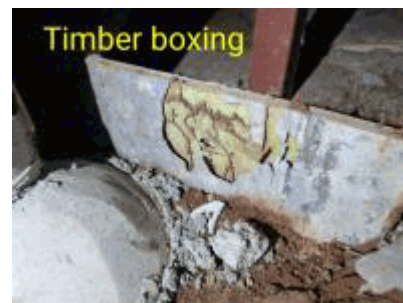
**Details - Termite evidence found in the retained wall of driveway. Subfloor - Old termite evidence found in timber boxing left in place under the home at initial construction. This can be removed.**

**RECOMMENDATION** Where evidence of damage to building timbers exists, competent advice (e.g. from a licensed and practicing building contractor) should be obtained to determine the extent of any structural damage and as to the need or otherwise for rectification or repair work. See also Item 3.1.5 'Frequency of Future Inspections' recommendation.

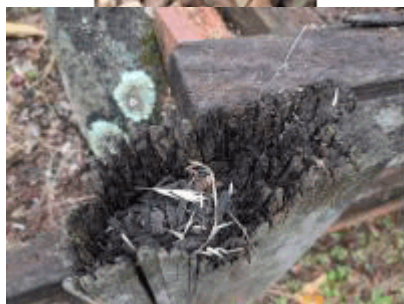
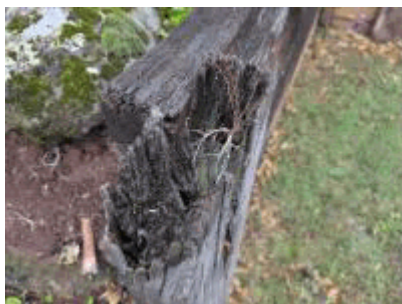
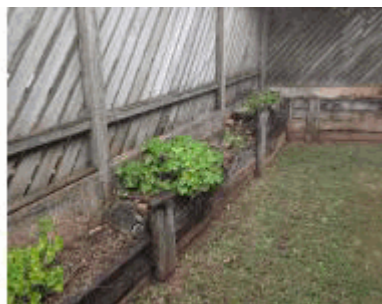
The extent of any visible damage appears: **Localised - see Details below - Decay in front deck and steps.**

**Location - Decay in areas of rear retained walls.**

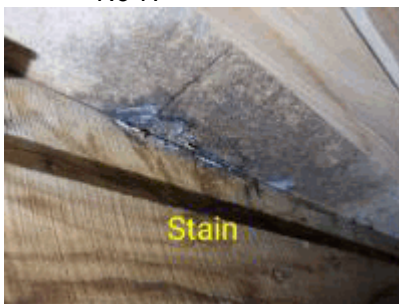
Was evidence of the presence of excessive moisture found? **Yes - see Details below, Clauses A.7 and A.8 - Slight stain in particleboard floor under deck, and leak at floor waste pipe under shower.**

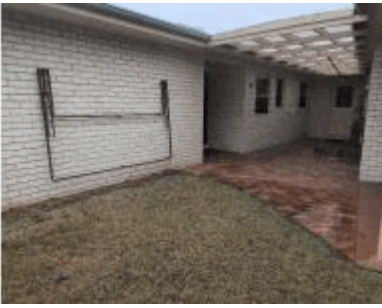
Include any visible evidence of bridging or breaching or slab edges obstructed by: **Paths/Paving - External ground levels at rear of home are higher than the adjacent termite shielding of these areas. Inspect annually and treat regularly. Landscaping - Lower rocks under stirrups of deck posts.**

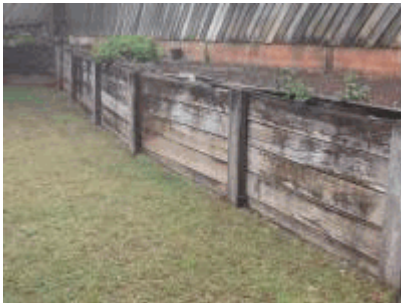
**Landscaping - Retained walls are termite susceptible and should be inspected annually and treated regularly.**
