# Property and Timber Pest Report

Inspection Date: 11 Sep 2025

Property Address: 129 Fuller Street Lutwyche 4030

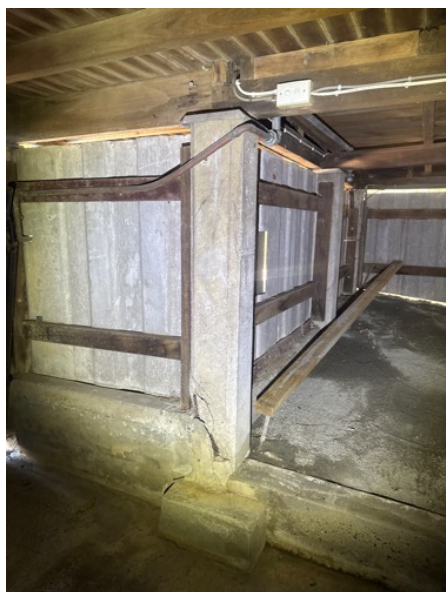
### Major Defect 1.01

**Location:** Subfloor

**Finding:** Concrete stump is significantly cracked and requires replacement.  
Replacement recommended.

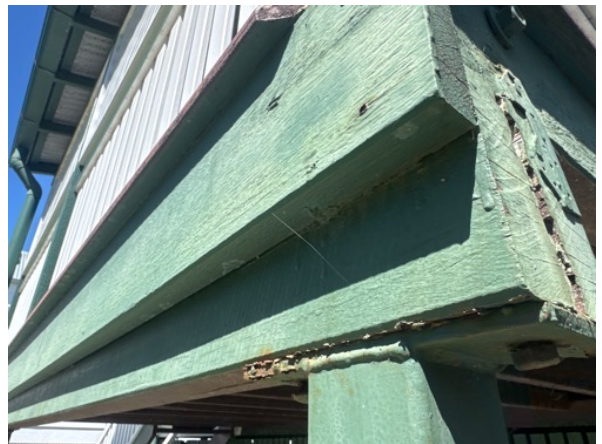
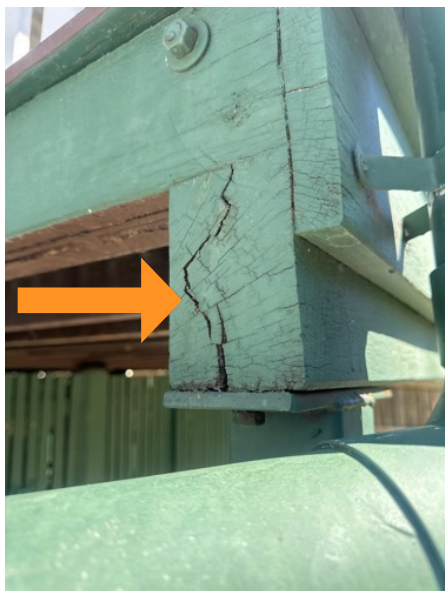
**Finding:** Ends of deck floor bearer are split.  
Timber is solid.

Recommend filling and painting ends to reduce risk of rot, seal and preserve timber.

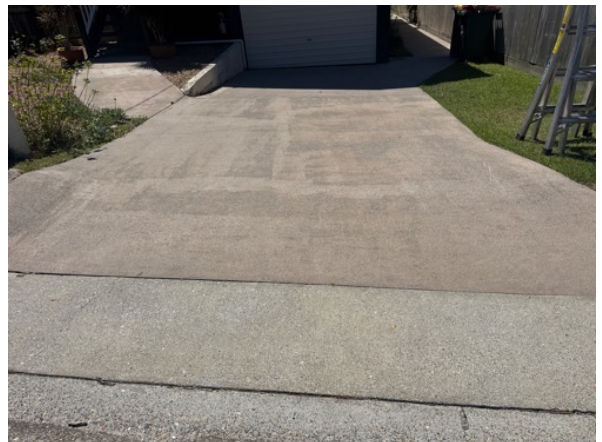
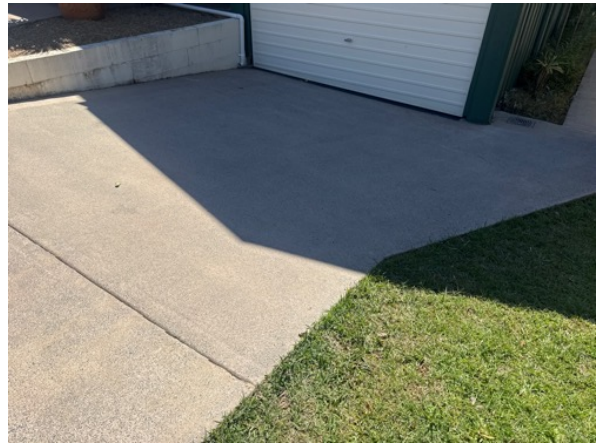
**Finding:** Concrete driveway is in good condition.

Some minor cracks noted- driveways and pavement are non-structural installations and minor cracking is common.

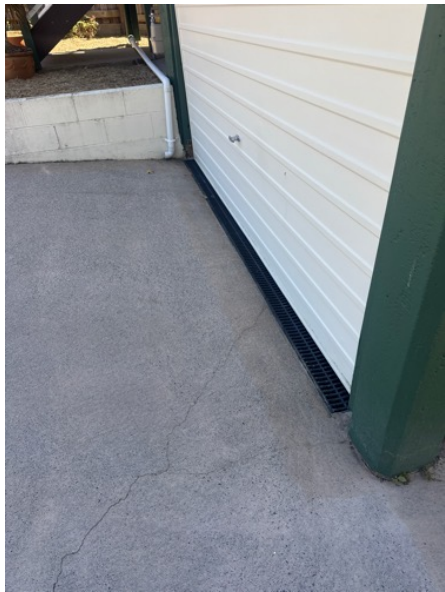
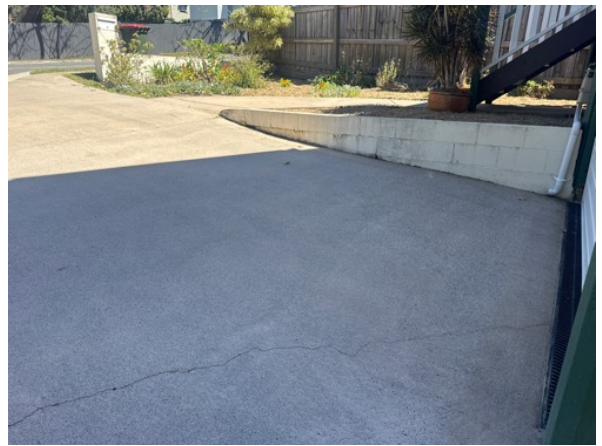
**Location:** Drainage- Grounds

Blocked grates can lead to pooling and possible ingress of water to property.

A degree of overland flow stormwater may enter garage area under heavy rain conditions.

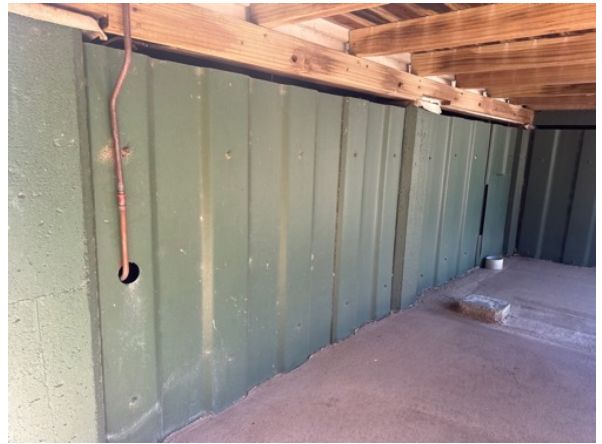
**Location:** External Walls

**Finding:** Fibre cement cladding appears in good condition and well sealed with paint.

Asbestos is likely present internally and externally due to vintage and visual indicators. A QBCC Licenced Asbestos professional should provide further advice prior to any building works or modifications are undertaken.  
No cracked or broken sheets observed.

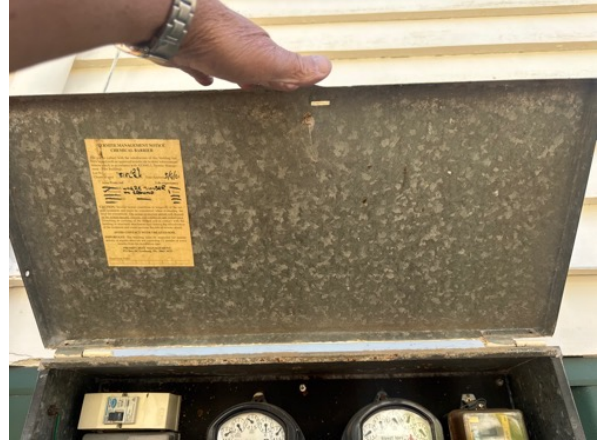
**Finding:** RCD (Electrical safety switch) installed to power circuits.

A Licenced Electrician is recommended to test all circuits to confirm compliance and safety as outside scope of Building Inspector.

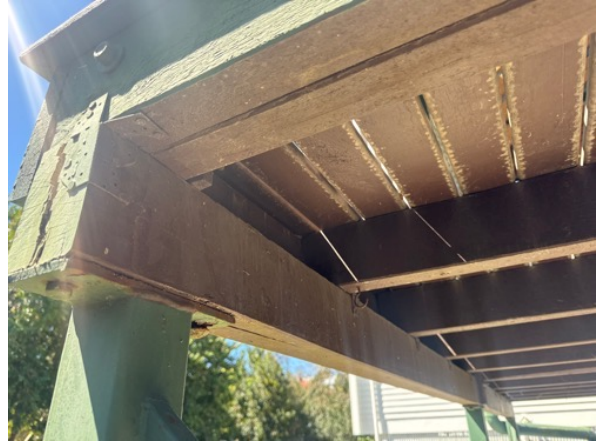
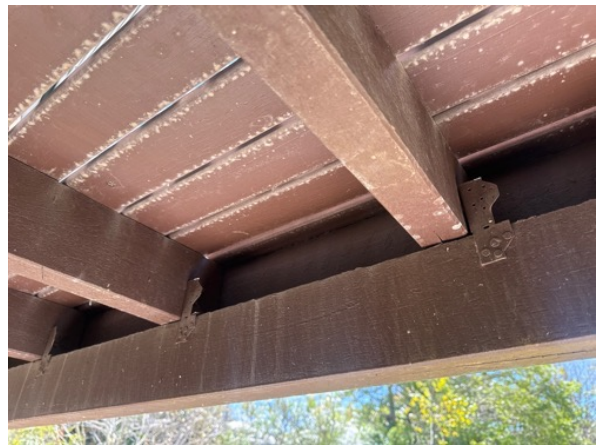
**Location:** Deck

**Finding:** Deck is timber structure with hardwood sub floor and decking.  
Presents in good condition.

Ensure external timber is well sealed to preserve timber.

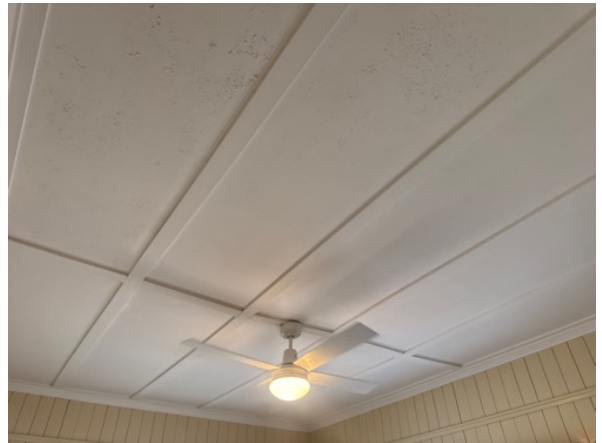
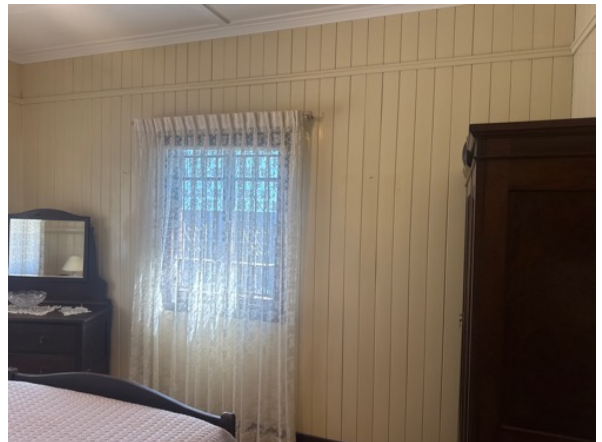
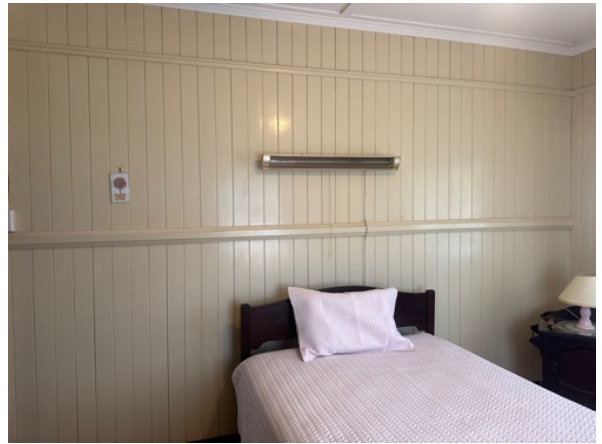
**Location:** Bedroom 1

**Finding:** Bedroom- presents in good condition and has been well maintained.  
Smoke detector NOT installed- Vendor to provide smoke detector compliance certification.

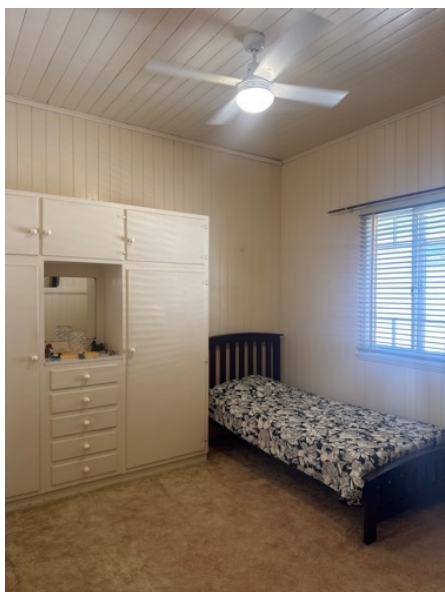
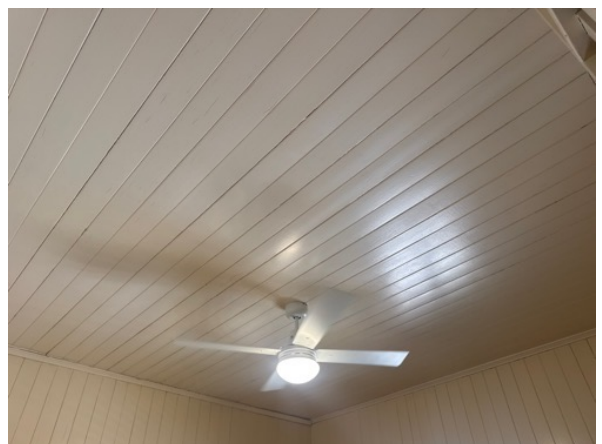
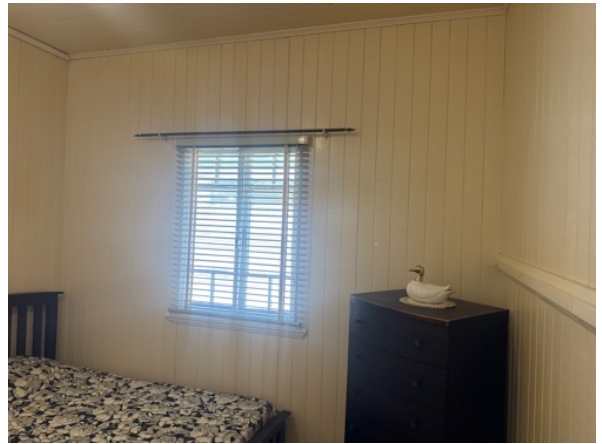
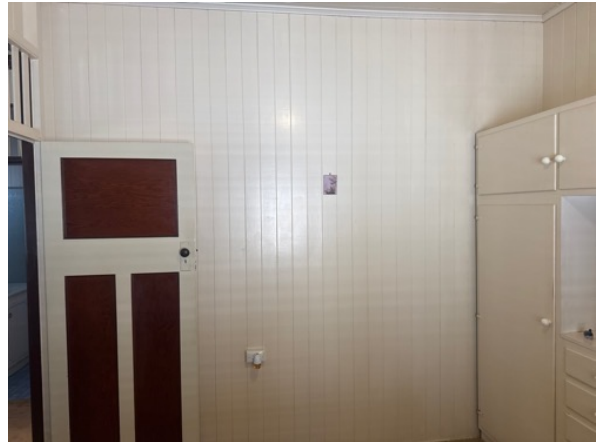
**Location:** Bedroom 2

**Finding:** Bedroom- presents in good condition and has been well maintained.  
Smoke detector NOT installed- Vendor to provide smoke detector compliance certification.

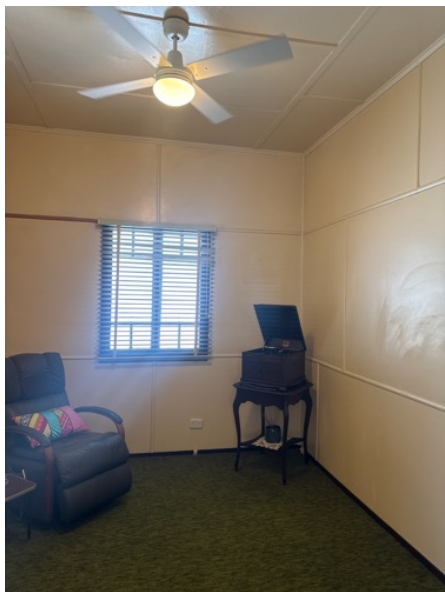
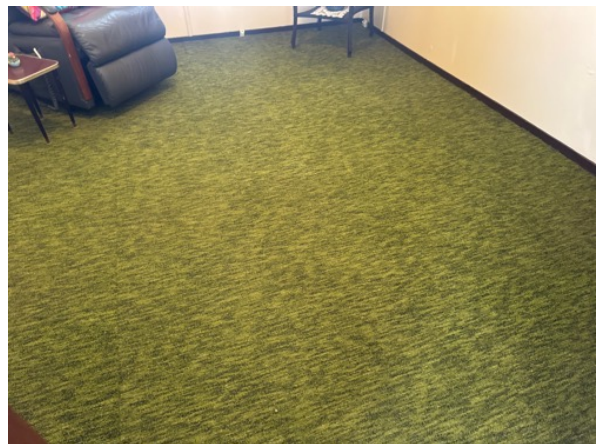
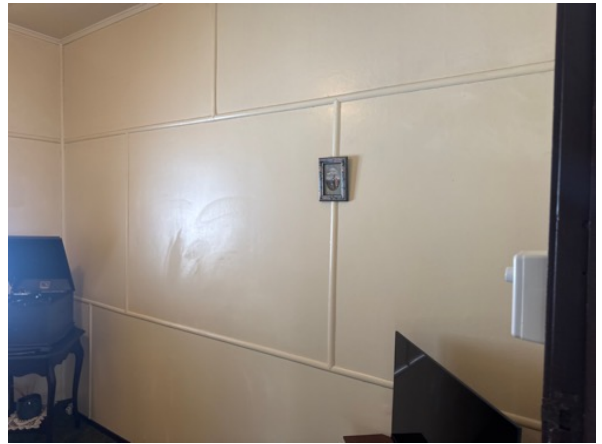
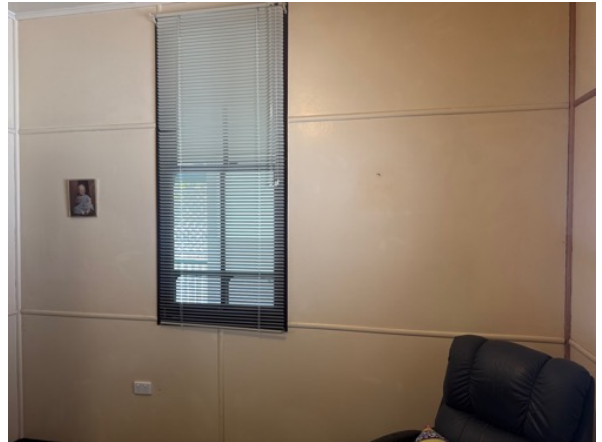
**Location:** Bedroom 3

**Finding:** Bedroom- presents in good condition and has been well maintained.  
Smoke detector NOT installed- Vendor to provide smoke detector compliance certification.

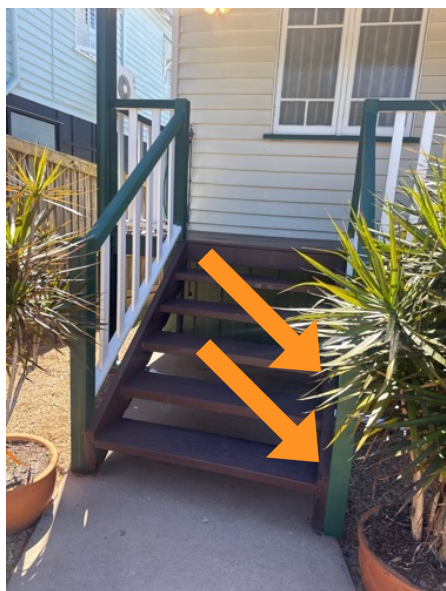
**Location:** External Stairs

**Finding:** Timber decay (rot) confirmed to sections of front stairs  
Replacement of affected members required.

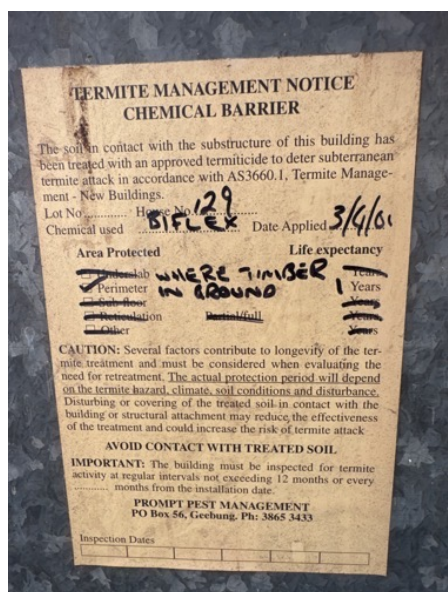
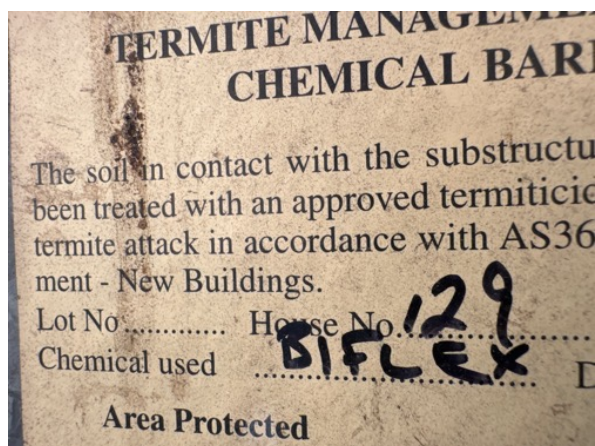
This system has expired- recommend a new chemical termite barrier be installed to reduce risk of concealed termite access.

Seek advice on termite management options from a QBCC Licensed Timber Pest Contractor.
