VENDORS IMPLIED WARRANTIES STATEMENT

In relation to the Contract for sale of lot(s) 5 in FOURTEEN Community Titles Scheme 43575

Community Titles Scheme 43575

**Initial Common Property Safety
Report
For
Fourteen
14 O'Connell Street, West End QLD 4101
Scheme Number: 43575**

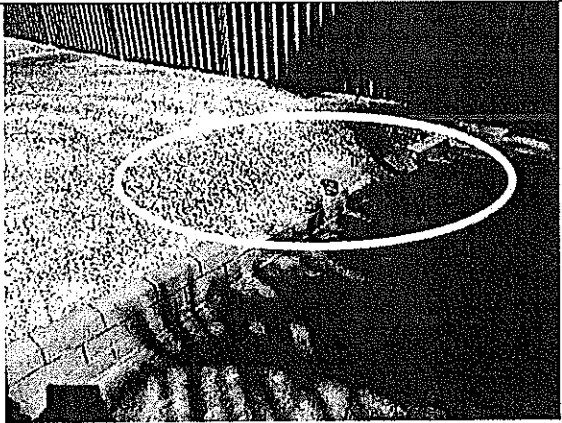
<p>Item 1: Please repair the boundary fencing small brick wall near entry as soon as possible as moderate deterioration is evident which represents a moderate impact/cutting hazard.</p>

Please repair the boundary fencing small brick wall near entry as soon as possible as moderate deterioration is evident which represents a moderate Impact/cutting hazard.

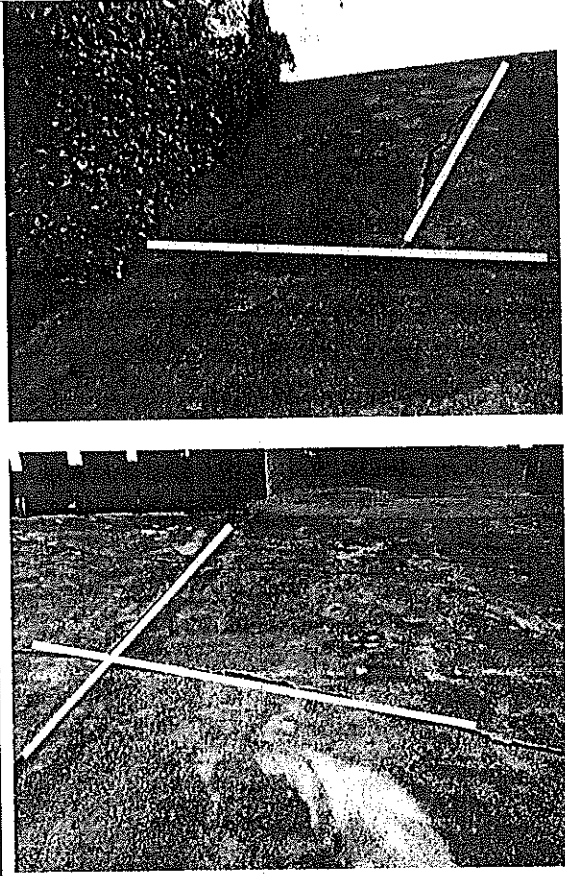
<p>Item 2: Please ensure that the upper edge of the lip/s in the driveway area front right hand corner of building are ground back at approx. 25 degrees as soon as possible as they currently represent a moderate tripping hazard.</p>

Please ensure that the upper edge of the lip/s in the driveway area front right hand corner of building are ground back at approx. 25 degrees as soon as possible as they currently represent a moderate tripping hazard.

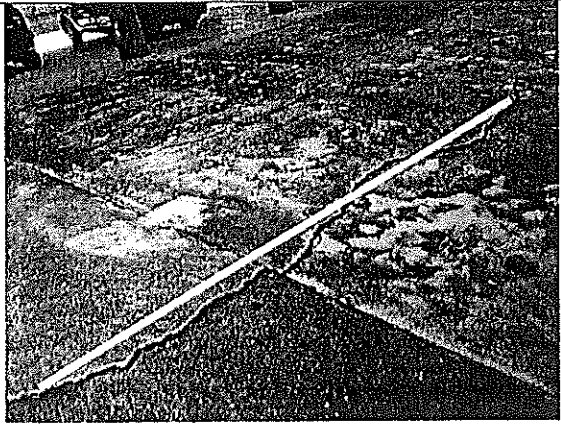
<p>Item 3: Please ensure that the upper edge of the lip/s in the driveway area opposite unit 2 & 3 garages are ground back at approx. 25 degrees as soon as possible as they currently represent a moderate tripping hazard.</p>

Please ensure that the upper edge of the lip/s in the driveway area opposite unit 2 & 3 garages are ground back at approx. 25 degrees as soon as possible as they currently represent a moderate tripping hazard.

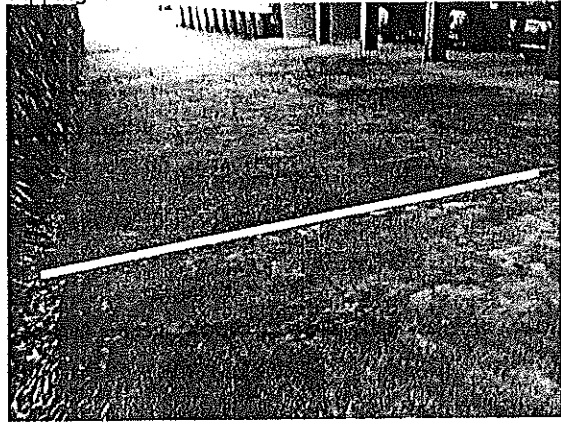
<p>Item 4: Please ensure that the upper edge of the lip/s in the driveway area opposite unit 5 & 6 garages are ground back at approx. 25 degrees as soon as possible as they currently represent a moderate tripping hazard.</p>
--	--	--	--

Please ensure that the upper edge of the lip/s in the driveway area opposite unit 5 & 6 garages are ground back at approx. 25 degrees as soon as possible as they currently represent a moderate tripping hazard.

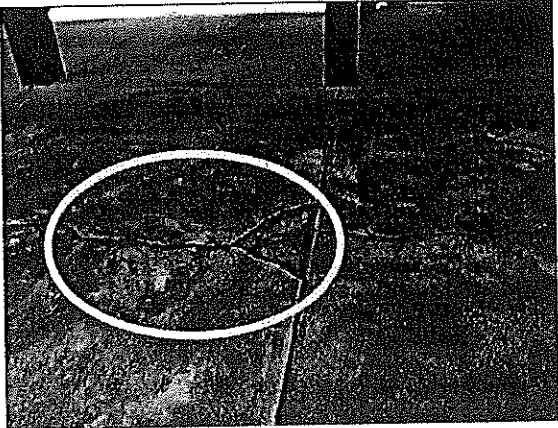
<p>Item 5: Please repair the driveway section opposite the 6th garage as soon as possible as the current situation represents a moderate tripping hazard.</p>
Surface Contamination	Yes		No hazards apparent at time of inspection. The driveway surfaces showed no signs of hazardous deterioration or contamination.
Obstructions	Yes		No hazards apparent. Vegetation is well trimmed and driveways were not obstructed.

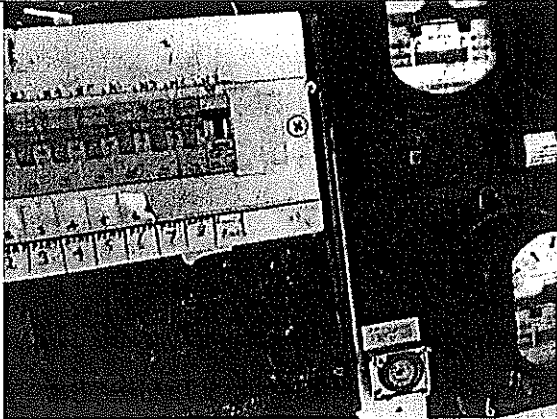
<p>Item 6: We recommend RCD/s (safety switches) are installed to protect all common property power points and lighting circuits as soon as possible and said RCD/s are subsequently inspected and tested in accordance with AS 3760 at least every 2 years by a suitably qualified electrical contractor and with inspection records maintained onsite.</p>
<p>RCD Testing</p>	<p>No</p>	<p>Moderate</p>

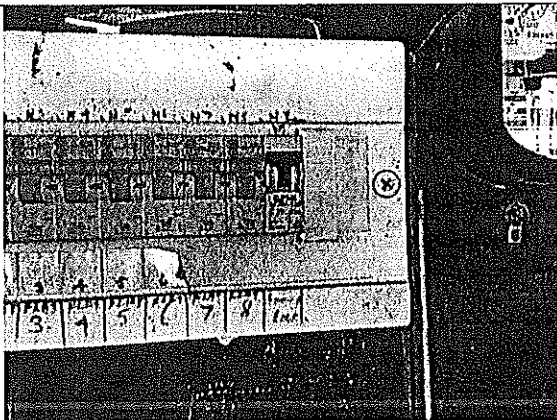
<p>Item 7: Once RCDs have been installed first garage, please ensure they are inspected and tested in accordance with AS 3760 at least every 2 years by a suitably qualified electrical contractor with inspection records maintained onsite.</p>

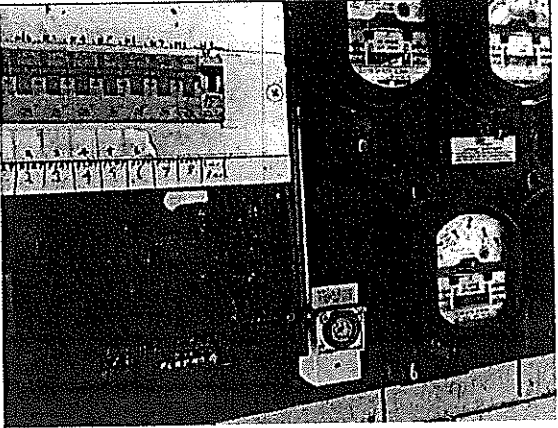
<p>Item 8: While not a legislative requirement we recommend that a suitably qualified electrical contractor carry out a thorough visual inspection of the Main Switchboard every 2 years and records are present onsite.</p>
<p>Overhead Powerlines</p>	<p>Yes</p>		<p>No hazards apparent at time of inspection. There were no tree branches within approximately 2 metres of the power lines that were overhanging them.</p>

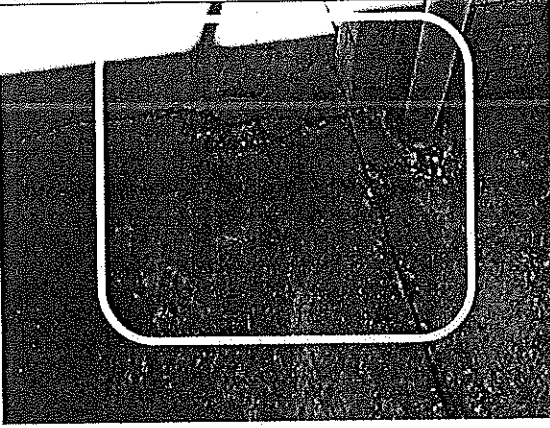
<p>Item 9: Please repair the pathway near the front steps as soon as possible as it currently represents a moderate tripping hazard.</p>

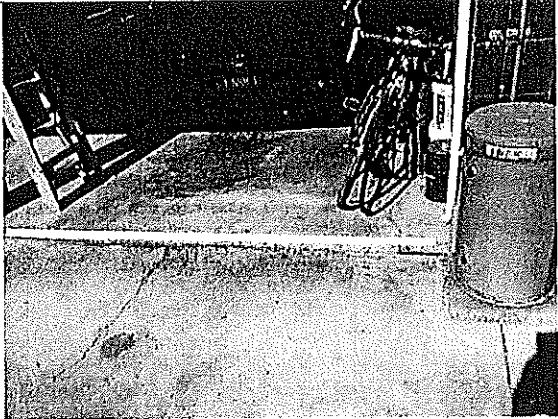
<p>Item 10: Please highlight with yellow non-slip road marking paint the leading edge of the lip/s in the concrete at the entry to the to the 3rd garage as soon as possible as the change in level is currently not readily discernible and may cause a person to trip and fall.</p>

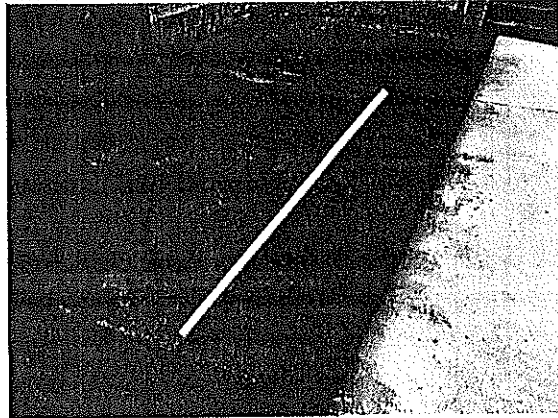
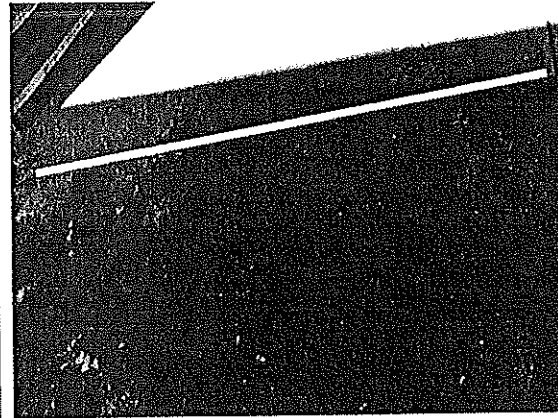
<p>Item 11: Please ensure that the upper edge of the lip/s in the pathway area in front of unit 6 & 7 garages are ground back at approx. 25 degrees as soon as possible as they currently represent a moderate tripping hazard.</p>
--	--	--	---

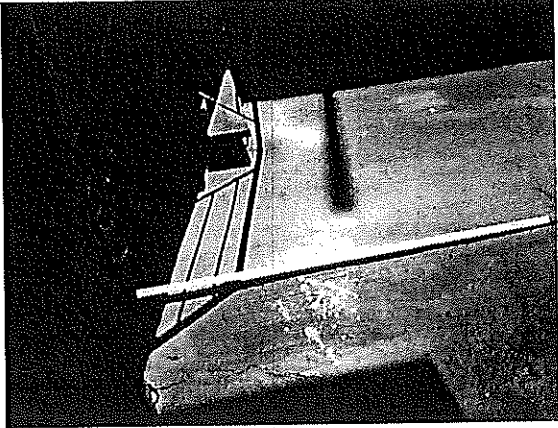
<p>Item 12: Please ensure that the upper edge of the lip/s in the pathway area at the 2nd garage leading to the front steps are ground back at approx. 25 degrees as soon as possible as they currently represent a moderate tripping hazard.</p>
Pathway Surface Variations (changes in level)	Yes		No hazards apparent at time of inspection. No hazardous changes in level such as unmarked steps were observed along the common property pathways.
Pathway Surface Contamination Levels	Yes		No hazards apparent at time of inspection. No hazardous contamination was evident at the time of inspection.
Access/Egress	Yes		No hazards apparent at time of inspection. Stairways were clear of any hazardous obstructions.
