OSTANES

Report Number

0429

13 Granada Drive Highfields QLD, Australia

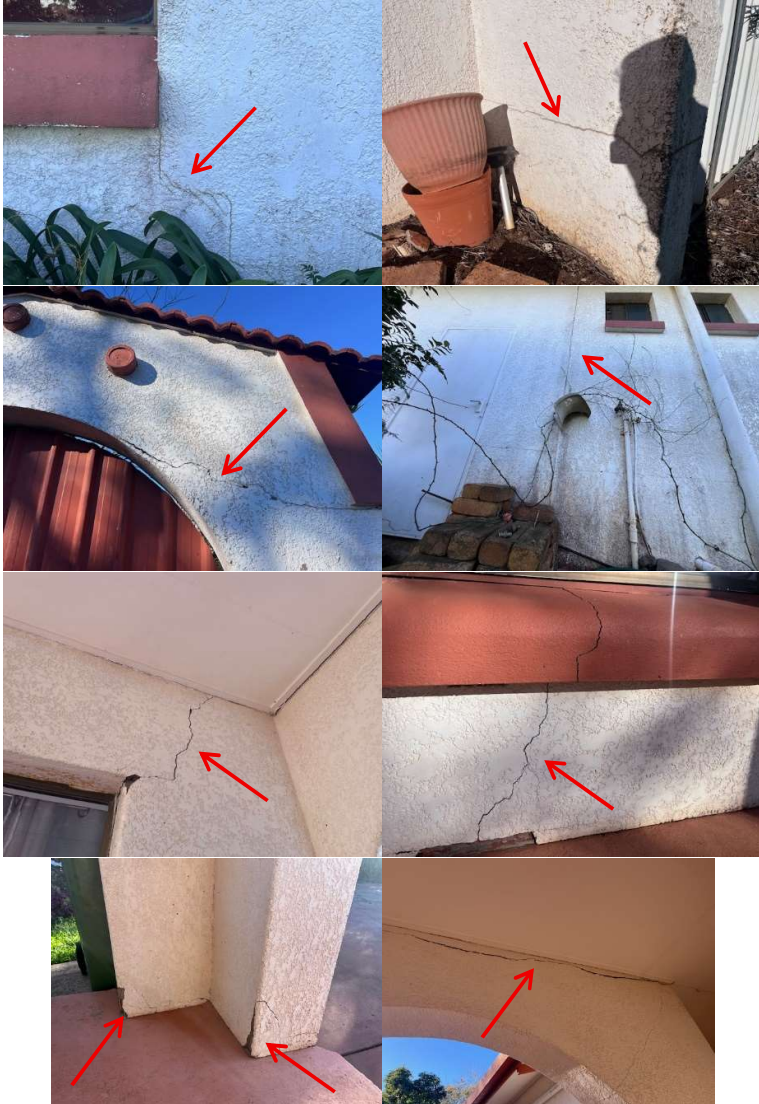
No.	Defect	Description	Recommendation
1

<p>Sign of foundation cracking due to ground movement is visible on the exterior block walls which has caused staggered cracking around the window sill, expansion joint and at corners. Additionally, clear sign of separation movement is noted in the front entrance.</p> <p>In the absence of soil report to understand the type of the soil the house is sitting on, there appears to be ground movement across the house.</p> <p>Ground naturally moves and settles and with variations in the moisture level (such as during raining seasons) as well as fluctuation in the ambient temperature, the amount of ground movement varies. Variation in the moisture level at ground causes slight movement for all houses (which is common), and usually cracking occurs at the locations where there is not enough flexibility for the material to move with the ground.</p>	<p>It is suggested to carry out soil testing to understand the ground condition at this site noting the presence of red clay during inspection. After which appropriate strengthening solutions can be implemented such as underpinning, resin injection and alike for the area of the house which is sitting on brick stump.</p> <p>It should be noted some cracking were less than 3mm wide and mainly appeared to be through the rendered parts of block walls. Such cracks can be repaired by removing the rendering, then applying high-strength low-shrinkage mortar in the affected areas to match the same rendering finish as existing wall.</p> <p>Blocks to be inspected after removal of rendering to confirm no evidence of defects on the blocks.</p> <p>All repair works in the future shall be completed by licensed tradesman experienced in similar repair.</p> <p>Once repair work is completed, repaired area shall be monitored for 6 to 12 months to check the effectiveness of repair and appearance of new cracks.</p>

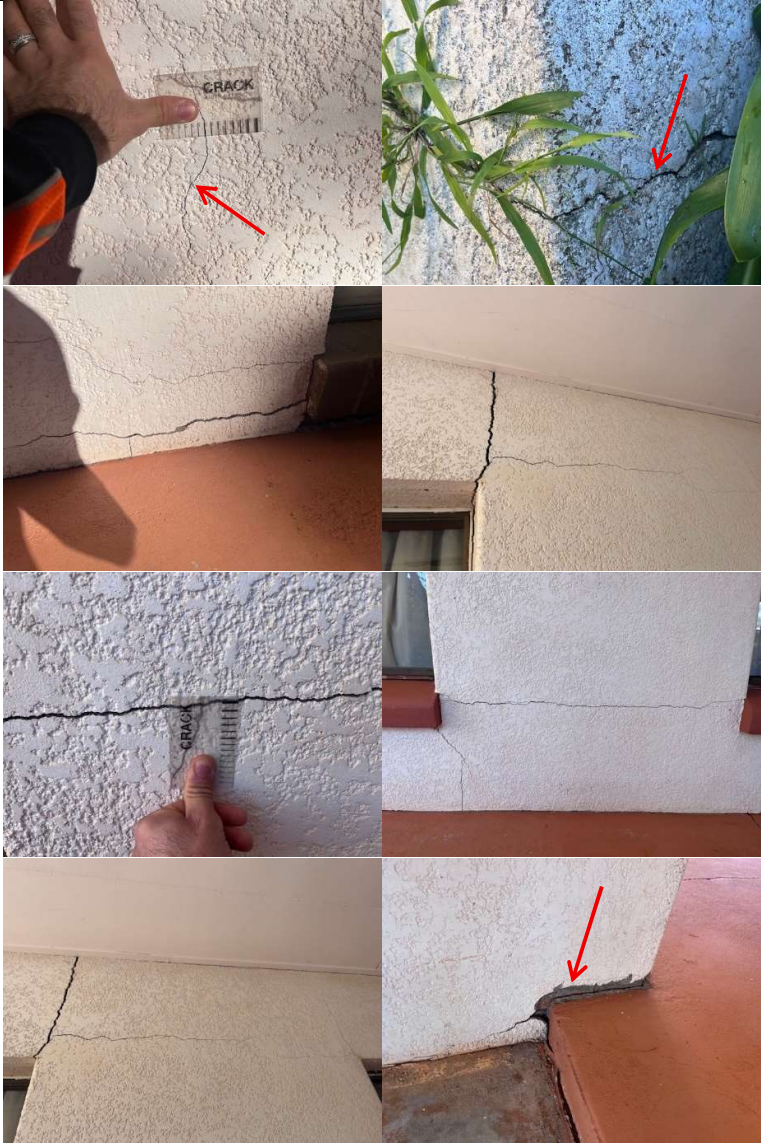
No.	Defect	Description	Recommendation
2

<p>On continuation from the previous page, additional cracking is shown on the exterior block walls.</p> <p>Given that the exterior face of walls is rendered, it is difficult to quantify if the cracking has also occurred through the blocks or not.</p> <p>Almost all of the cracks appears not to be recent and have occurred in the past over long period of time.</p>	Refer to page 4

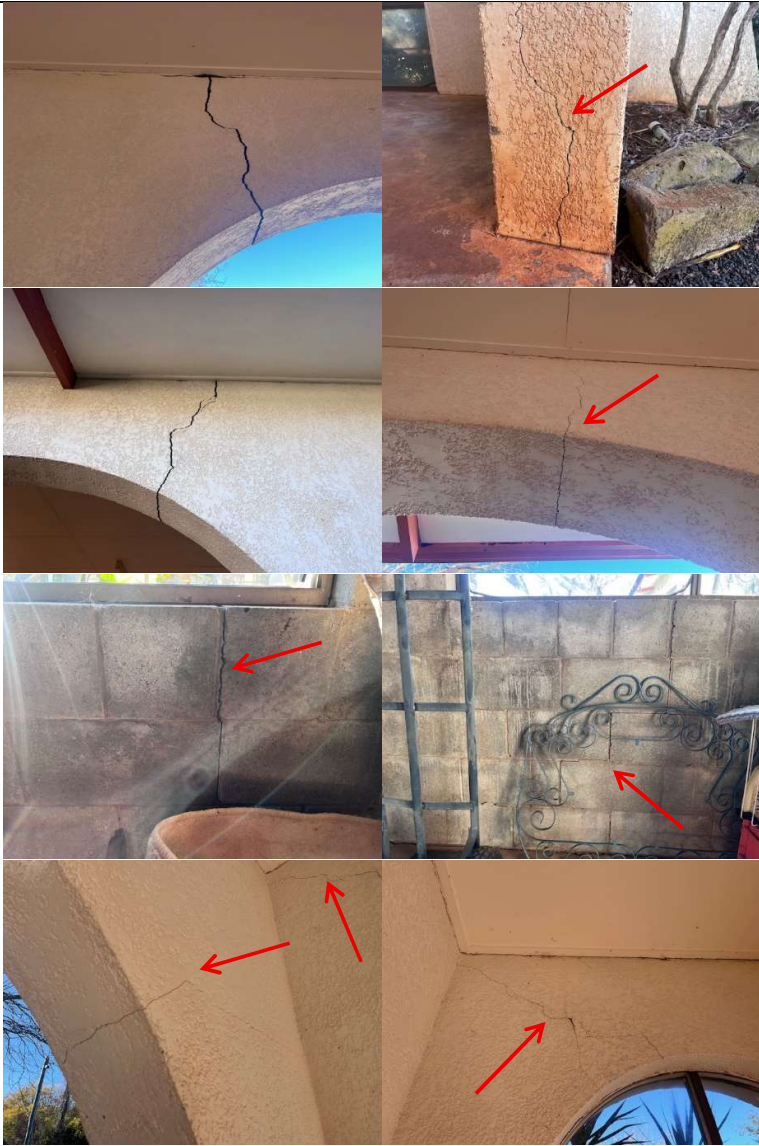
No.	Defect	Description	Recommendation
3

<p>On continuation from the previous page, additional cracking is shown on the exterior block walls.</p>	<p>Refer to page 4</p>

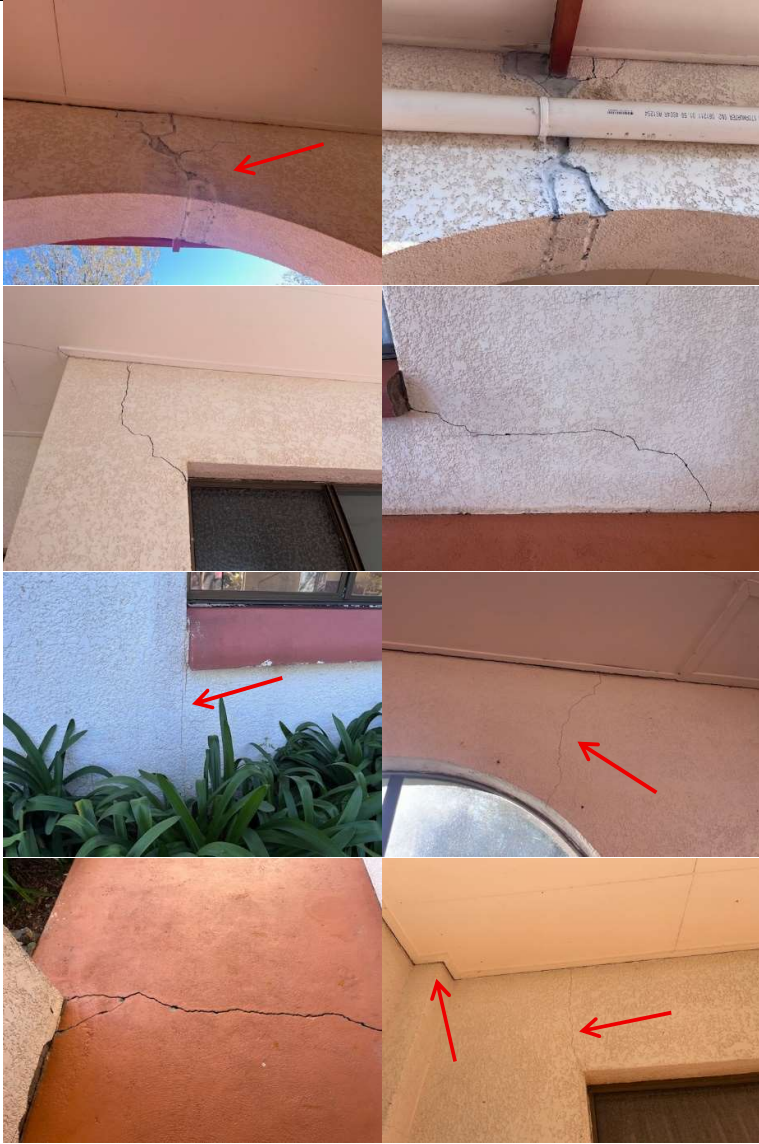
No.	Defect	Description	Recommendation
4

<p>On continuation from the previous page, additional cracking is shown on the exterior block walls.</p> <p>Also noted evidence of previous patch repair on some of the existing cracks.</p> <p>It should be noted the arched walls in the outside may crack again in the future given that these walls are connected via slab on ground, making them more prone to ground movement.</p> <p>Additionally, it is unclear if the arched walls and external block walls are reinforced or not.</p>	<p>Refer to page 4.</p> <p>Cracks on the arch walls can also be repaired using helical bar and high strength grout low shrinkage mortar. This method is also known as crack stitching, which involves inserting stainless steel helical bars at the affected locations that offers an effective and permanent solution.</p>

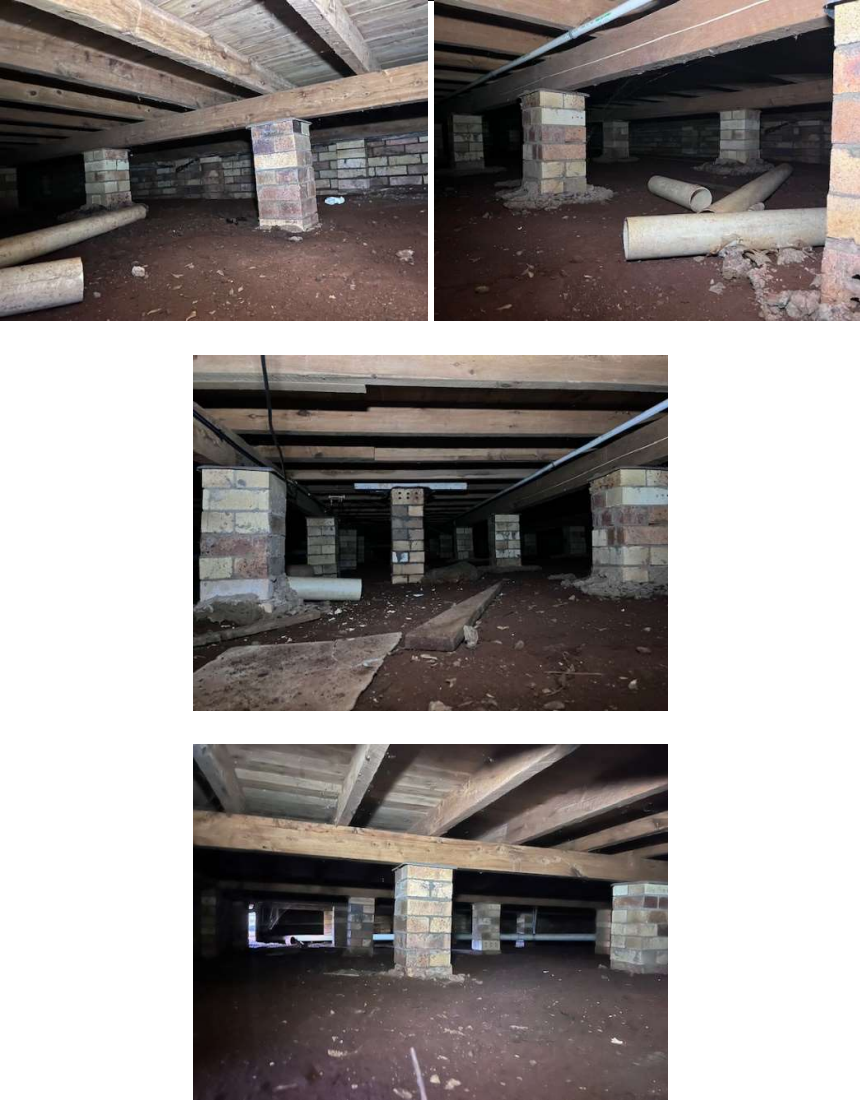
No.	Defect	Description	Recommendation
5

<p>Subfloor framing was visually inspected and no sign of structural defect was observed at the accessible areas on the floor joist and floor bearer.</p> <p>Note that no visual inspection was conducted inside the roof ceiling.</p>	N/A

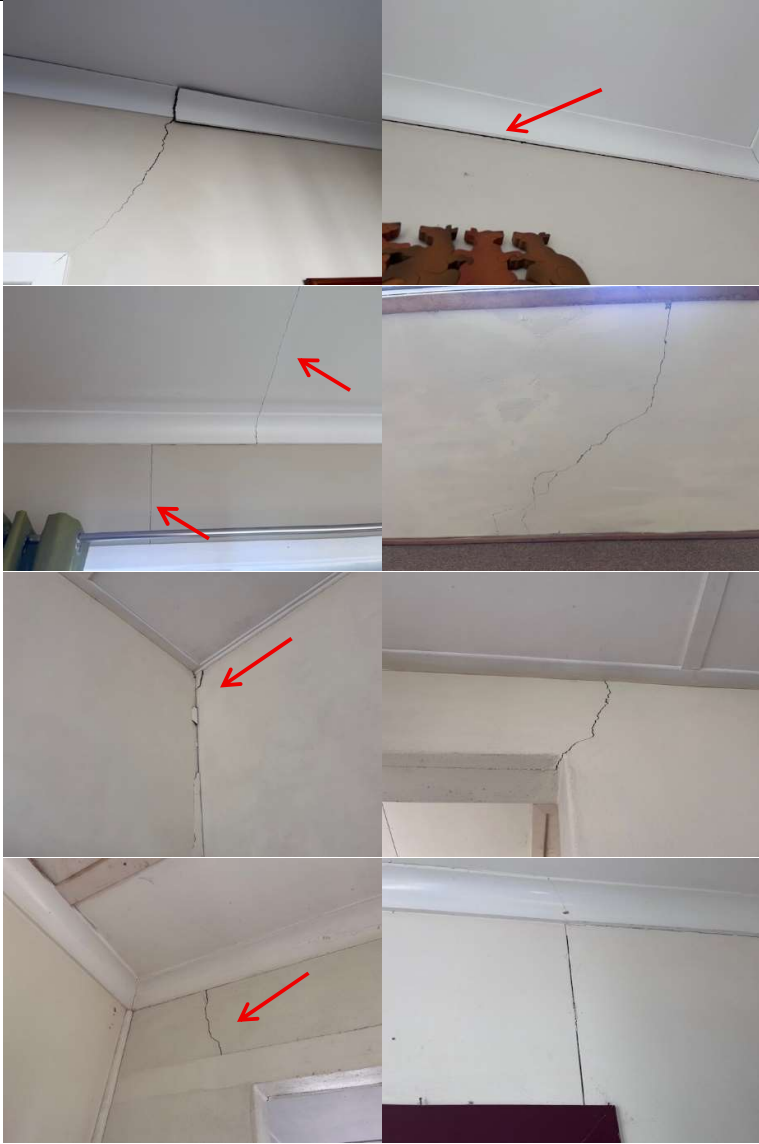
No.	Defect	Description	Recommendation
6

<p>Plastering defects observed on the internal lining walls and ceiling panels in terms of separation gaps at cornices, cracks at sharp corners and jointed panel locations.</p> <p>In addition to ground movement, natural thermal movement (expansion/contraction of materials during wet/dry cycles), such defects on plastering could be due to poor workmanship and insufficient use of adequate filler / patching materials during the plastering stages as all of the observed cracks appeared to be superficial.</p>	<p>It is recommended to have the cracks on the walls and ceilings to be repaired by a qualified plasterer using suitable patching / filler materials. Some of the defective panels may require full replacement if the panel is split up.</p> <p>During repair process, the timber framing and its connections behind the wall shall be checked for presence of any damage.</p> <p>Then, the repaired locations should be monitored to check the adequacy of the repair works and to monitor for appearance of any additional defect.</p>

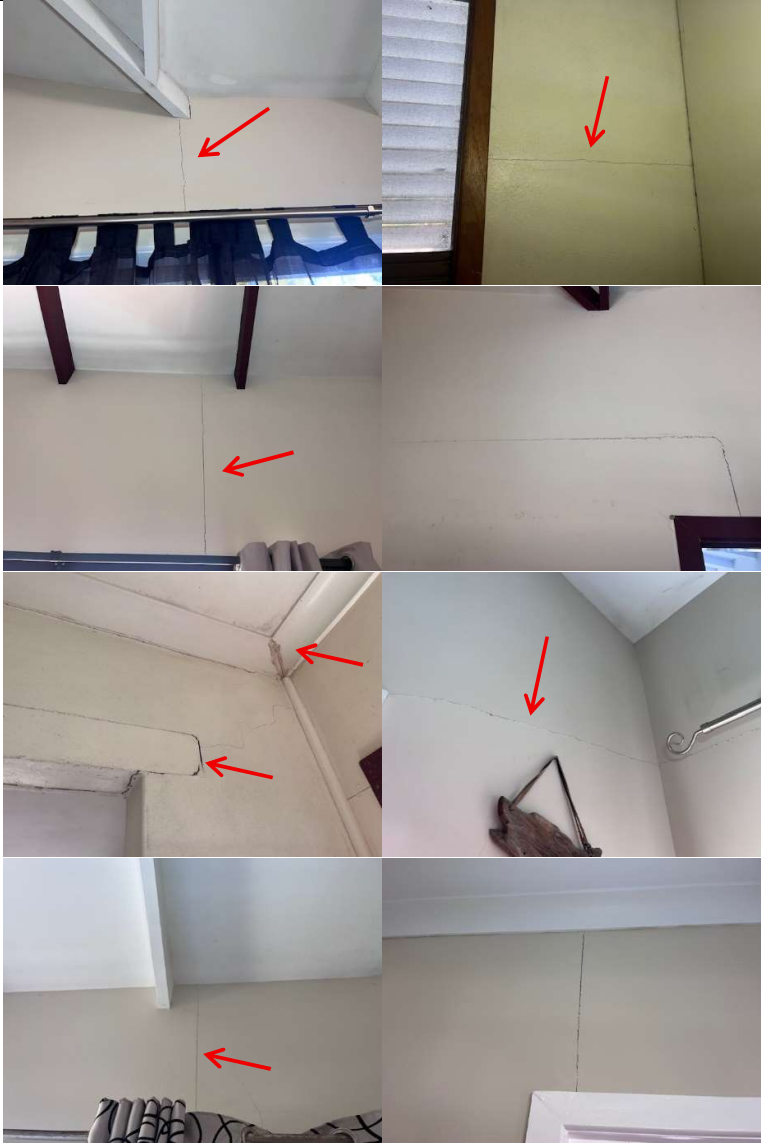
No.	Defect	Description	Recommendation
7

<p>On Continuation from the previous page. Additional, photos are showing the internal defects on wall and ceiling panels; which are made up of gyprock and FC sheets.</p>	<p>Refer to page 9</p>

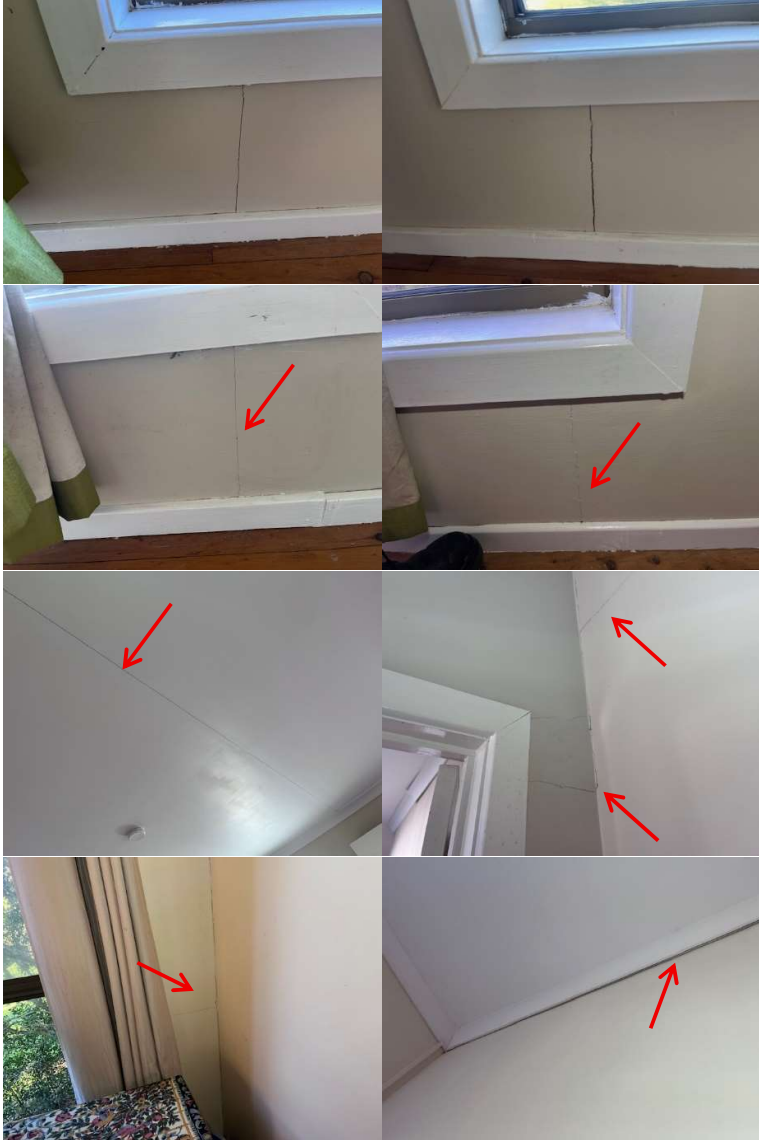
No.	Defect	Description	Recommendation
8

<p>On Continuation from the previous page. Additional, photos are showing the internal defects on wall and ceiling panels; which are made up of gyprock and FC sheets.</p>	<p>Refer to page 9</p>
