# Visual Pest Inspection Report

15 Glencarron St, Kenmore

# VISUAL TIMBER PEST INSPECTION REPORT as per AS4349.3-2010

Visual Pre Purchase Pest Inspection in accordance with AS4349.3.

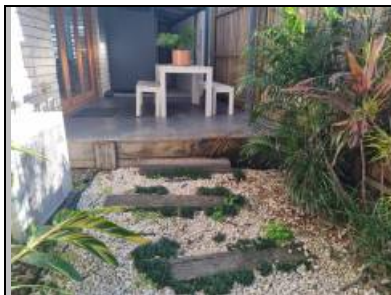
Yes - Fungal Decay (wood rot) was noted to the following timbers/areas.

Decking timbers: Steps/stair timbers: Sleepers or timber landscaping materials:

Visible timber damage appears minor to moderate. Refer to the definitions section of this report - Section 1.6 - Timber Damage.

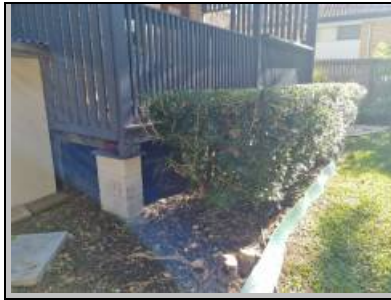
Garden beds have been built up against the external walls. These should be removed as they can allow concealed termite entry.

Some external timbers and cladding are in contact with soil. These should be modified so that timber to soil contact does not occur.

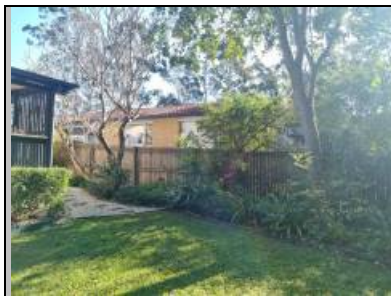
Yes - Wood decay damage was noted to the following timbers/areas.

Various fencing timbers:

Visible timber damage appears minor to moderate. Refer to the definitions section of this report - Section 1.6 - Timber Damage.

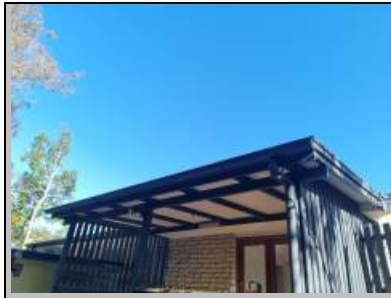
Appear to be in serviceable condition. Water staining was noted to sections of the gutter and fascia. Recommended to monitor when raining.

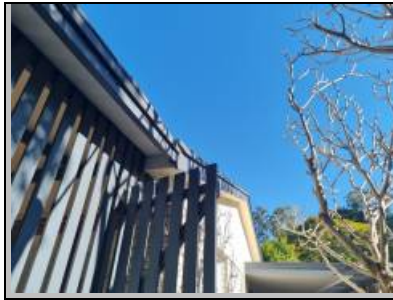
The eaves are lined with asbestos cement sheeting. The overall condition of the eaves lining is good. Minor decay to eave mouldings.

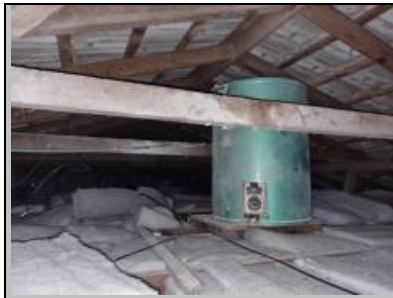
The cut and pitched roof timbers appear to provide adequate support. Timber deflection noted to some roof timbers. This is consistent with to settlement of timbers/ age and type of building.

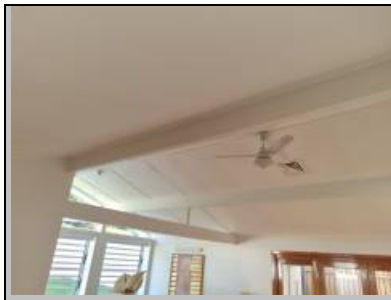
The condition of the ceilings is generally good. General wear and tear is noted. Minor settlement cracks were noted and these are typical of this type of material. Periodic maintenance may be required.

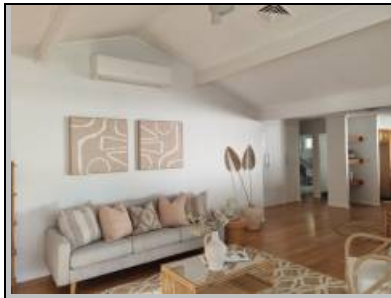
The condition of the walls is generally good. General wear and tear is noted. Minor cracking is evident to wall linings. Periodic maintenance may be required.

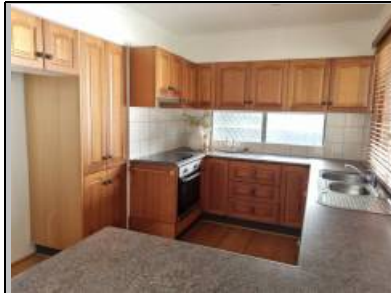
The condition of the tiles is generally good. Staining noted to grouting and silicone sealants, clean, regrout and replace sealants as required.

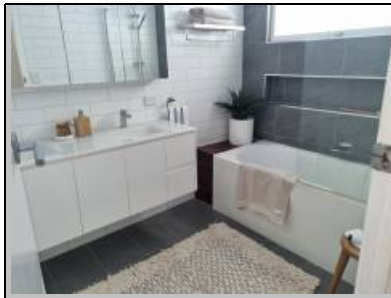
The shower is located over the bathtub. The area will need to be kept well sealed to prevent water penetration to surrounding areas. Staining noted to grouting and silicone sealants, clean, re-grout and replace sealants as required.

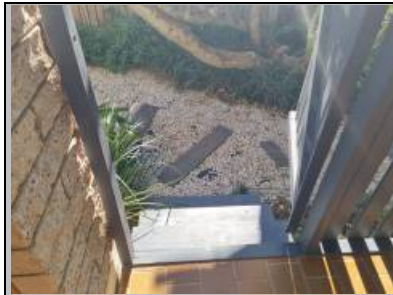
The stairs are constructed primarily from timber and steel. The overall condition of the stairs is good.

Minor wood decay damage was noted. Maintenance and repair is required.

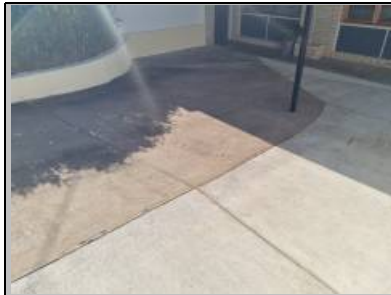
The concrete driveway stands in good condition. Minor concrete cracks are noted.

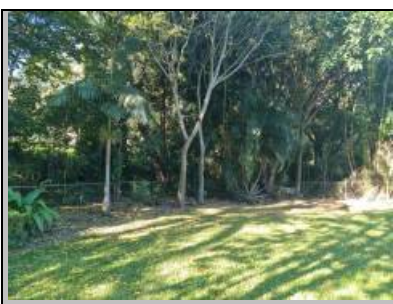
| Fences Type & Condition: | The fences are constructed from a combination of timber, brick and metal. The fences are generally in good condition. Minor wet rot or defects were noted to the wooden fences and minor repairs maybe needed. |

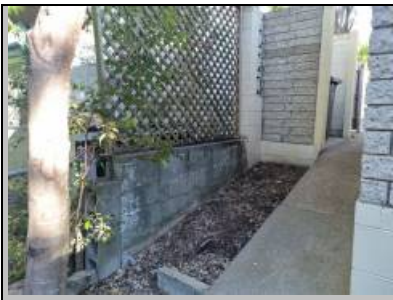
| The timber retaining walls show normal deterioration and should be monitored. The masonry retaining walls show normal deterioration, cracks etc, and should be monitored for any movement. |

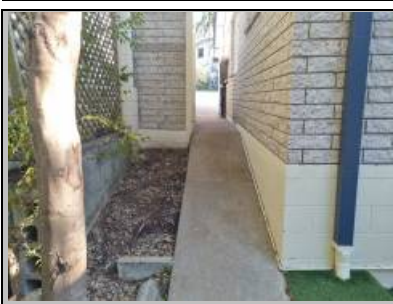
| Type & Condition: | The concrete paths/paved areas are in fair condition. Minor concrete cracks are noted. |
