## Building & Pest Inspection Reports

**43 Lizzie Street  
Bardon**

**Monday, 14 August 2023**

Re: Building & Timber Pest Inspection of Residence  
43 Lizzie Street, Bardon

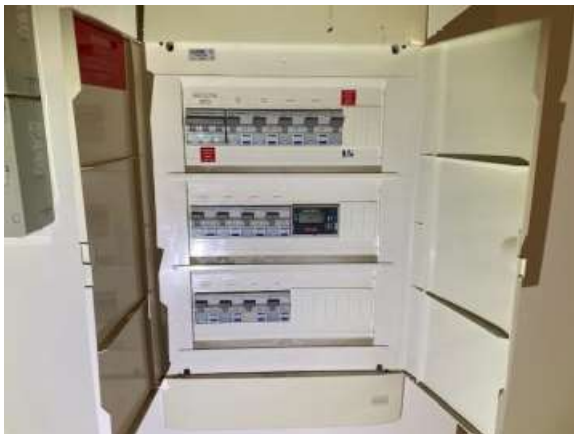
- Whilst not an electrician, an electrical safety switch / RCD (Residual Current Device) appears present to the building. We recommend an electrician be engaged test and check the switchboard and all electrical wiring / fittings to the property. A photo of the switchboard is shown in the below photo.

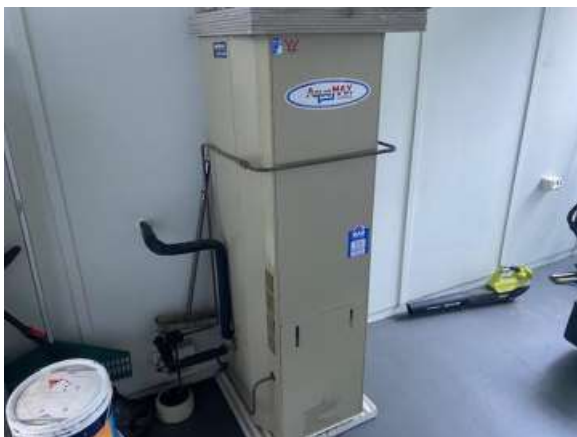
- Gas Hot Water Service is present. We recommend you have a licensed plumber further inspect and comment on operation / service. A photograph of the system is shown below.

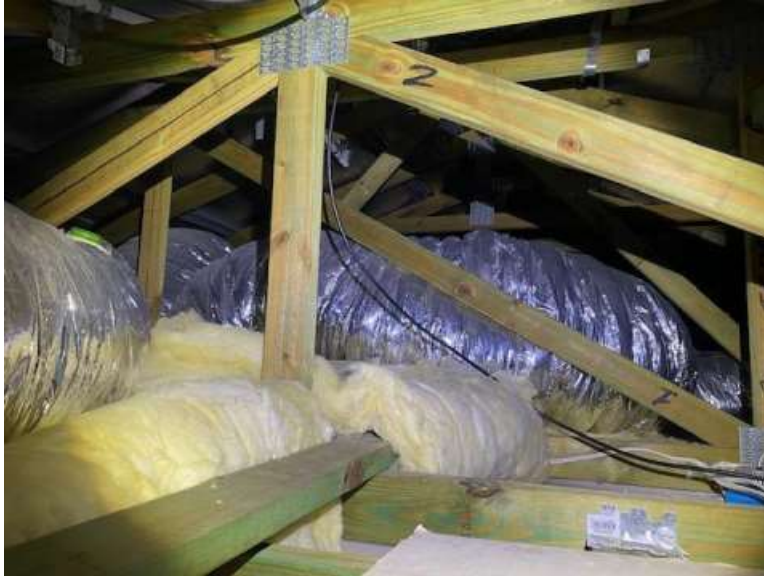
Truss - Pine. An example of the roof void is shown in the below photo.

The roof space is clean and dry and ventilation appears good. The roof framing also appears to be well constructed.

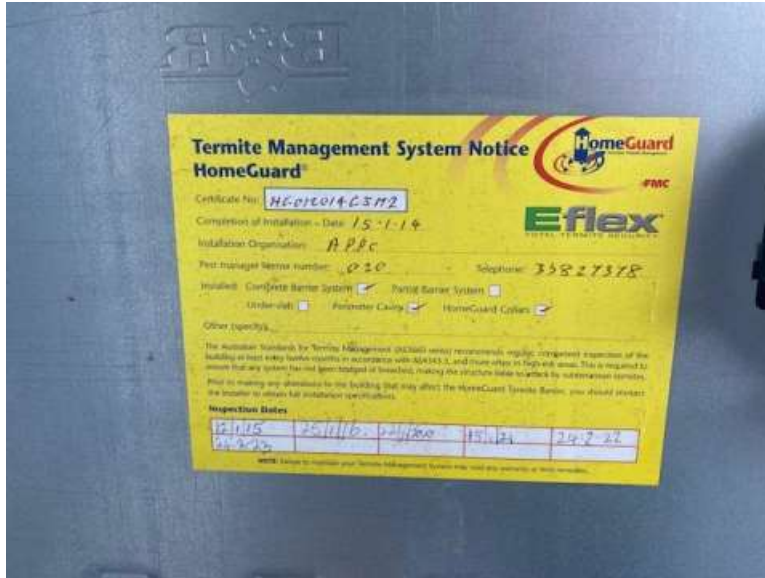
A termite treatment sticker in the meter box indicates that the slab penetrations and perimeters are protected from termite activity by Homeguard physical barriers. These barriers were installed in 2014. Evidence of this sticker is shown in the below photo.

We strongly recommend any prospective purchaser attempt to verify any treatment information and obtain copies of all relevant documentation.
