Property Inspection Report

7 View Street, Woody Point, 4019

Date of Inspection: 10/8/2023 Time: 1:00 Pm
Weather: Fine 23 C

Timber Pest Inspection Report

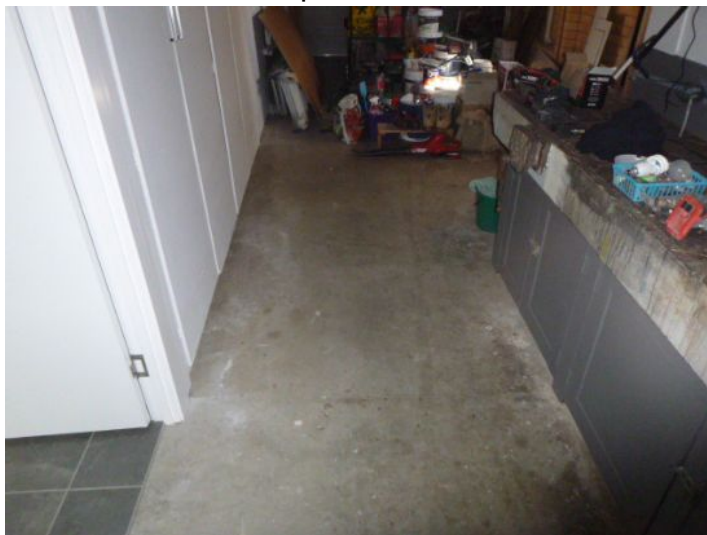
1. Slab Foundation

- As our inspection is a AS4349.1-2007 visual inspection, we cannot conclusively state the condition of the foundations. Foundations can be subject to various forms of movement such as wetting and drying causing shrinkage and expansion or earth movement. The inspection does not involve physical structural testing of any component of the building nor did it involve excavation of the site or removal and testing of any materials upon the site or components of the structure.
- Any significant tree within close proximity to the structure may have an influence upon the foundation material/footings and if applicable we would recommend that further advice be sought from an expert.
- There is an infill slab to the home, this slab may or may not be an integral part of the foundation. Joins along these slabs may be vulnerable to entry by moisture and or timber pests such as termites.

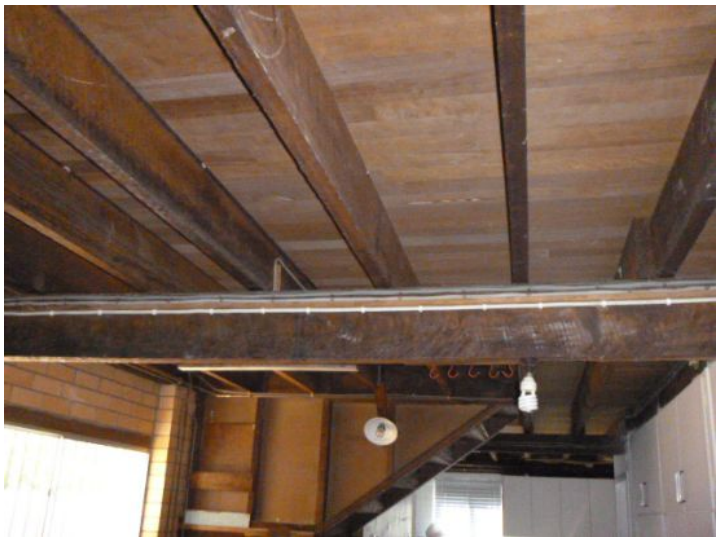
2. Raised Foundations

- Timber Beams noted.

- The foundations appear to be performing satisfactorily.

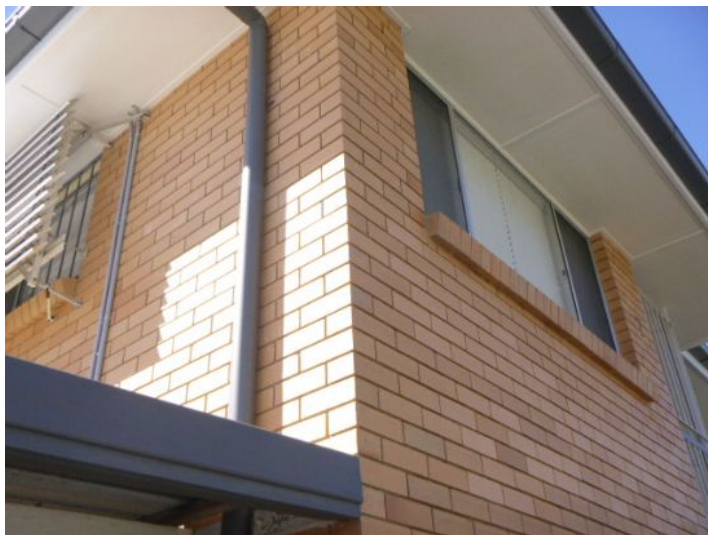
1. Wall Structure

- The wall structure components appeared functional.
- Externals walls are of a timber frame and brick veneer construction to the upper level.
- The external walls of the home are of a double brick construction, which contains an internal cavity.

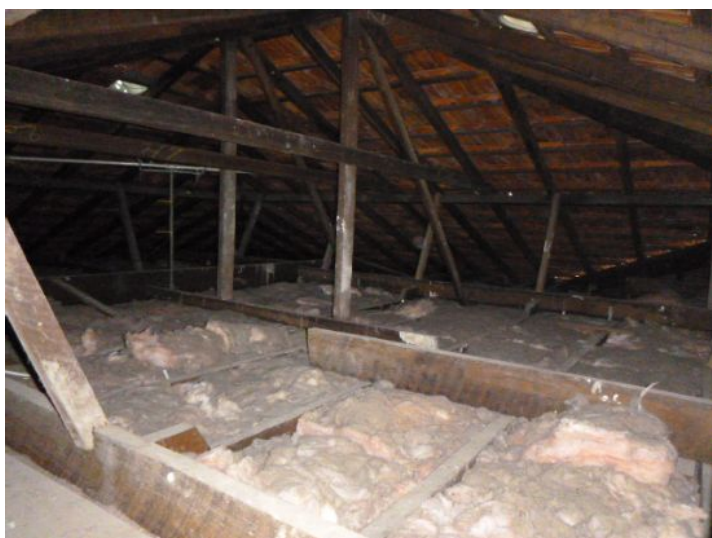
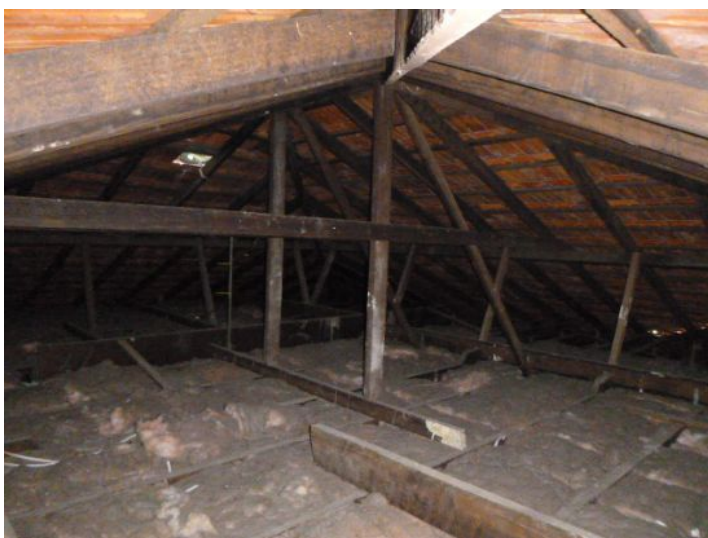
2. Ceiling Structure

- The ceiling structure appeared functional.
- Due to the placement of insulation on the top of the ceilings it is not possible to fully inspect the condition of the ceiling structure and supports. Inspection was limited and based on what was visually accessible at the time of the inspection.

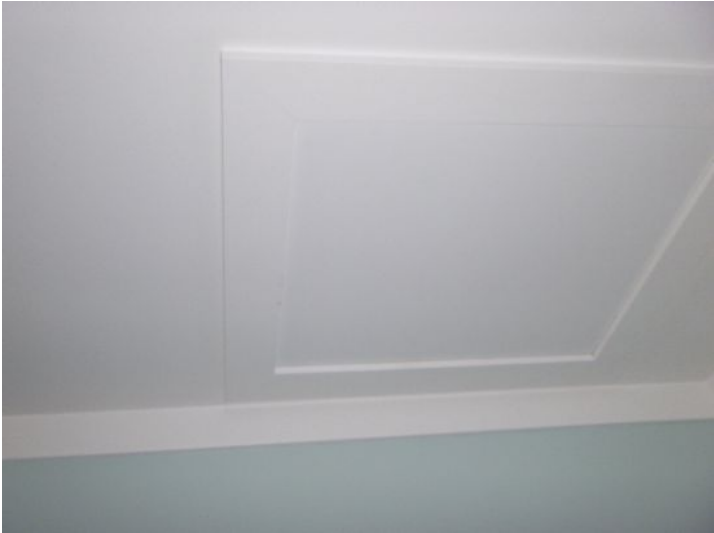
1. Access

- Access was available through a manhole in the bathroom.

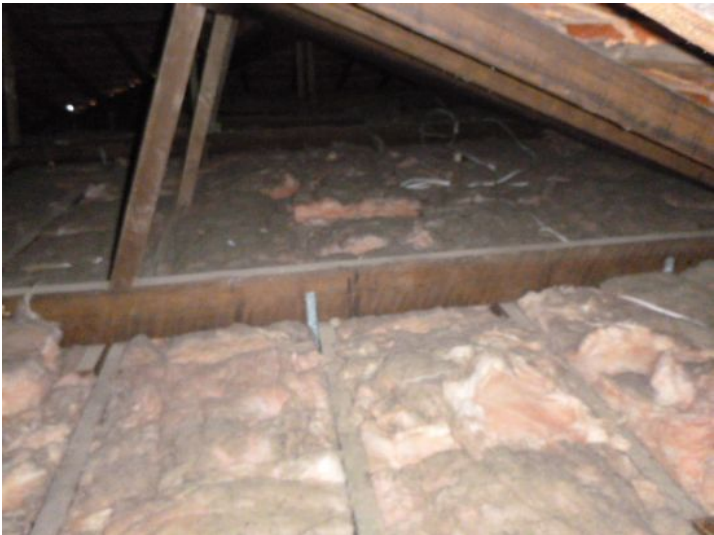
2. Insulation

- Fibreglass batts insulation noted in the accessible ceiling space.

- Insulation averages about 75mm to 100mm in depth.

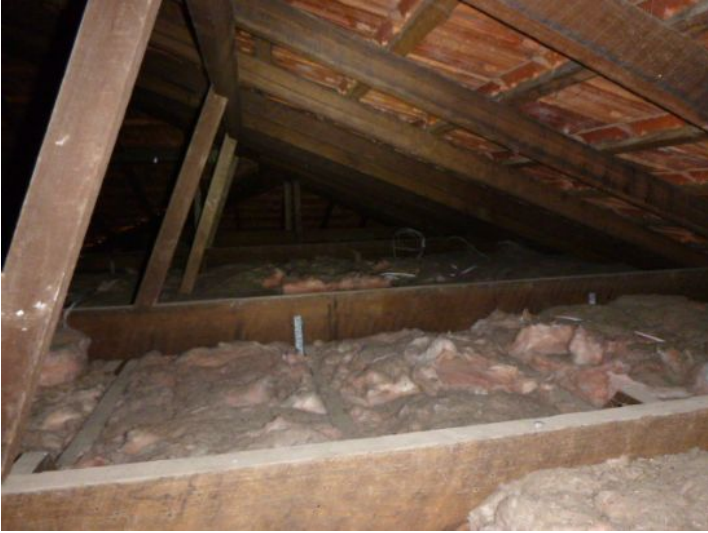
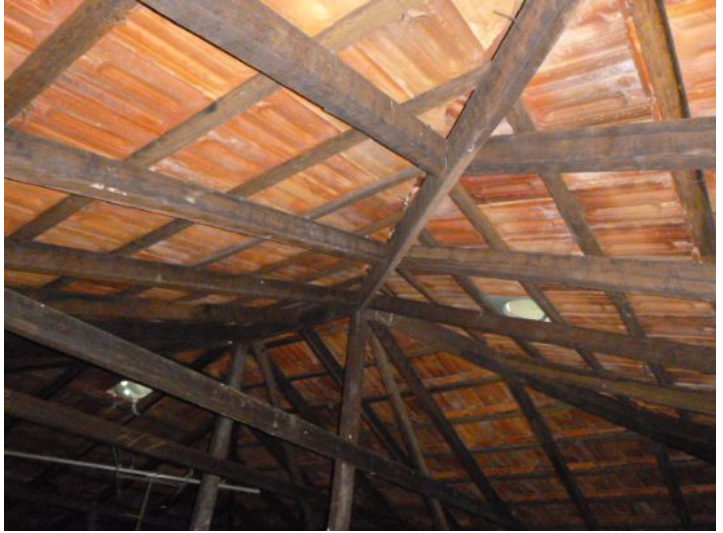
1. Roof Structure

- The timber roof structure appears sound.

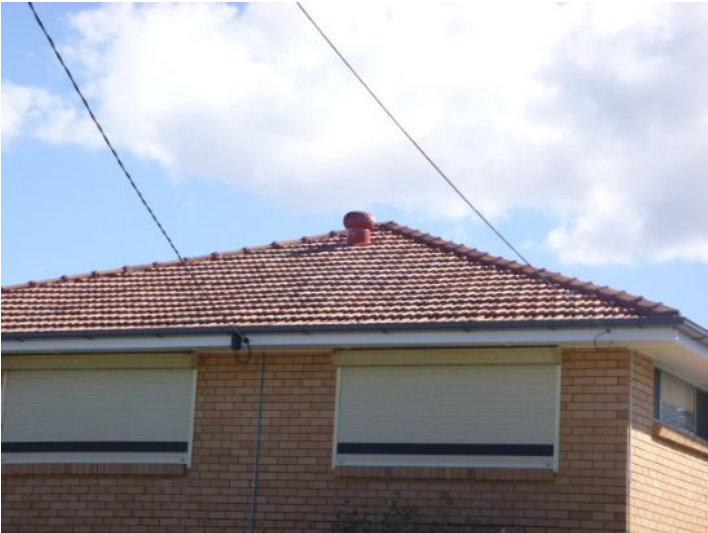
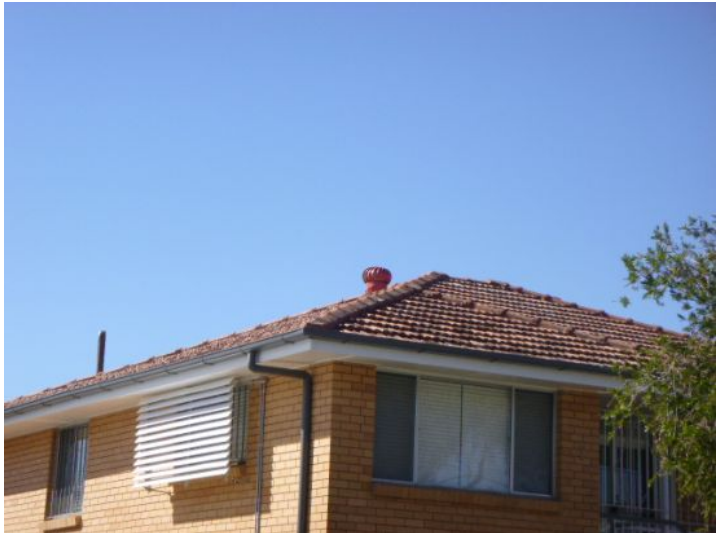
2. Roof Covering

- The clay tile roof covering appears to be in satisfactory condition other than noted.

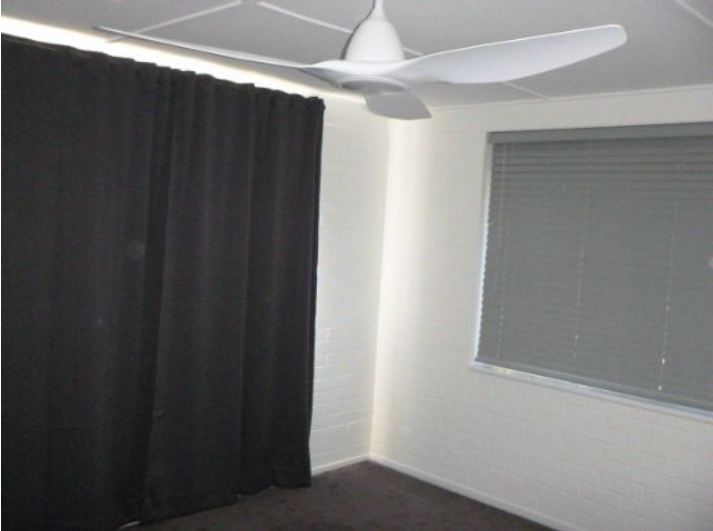
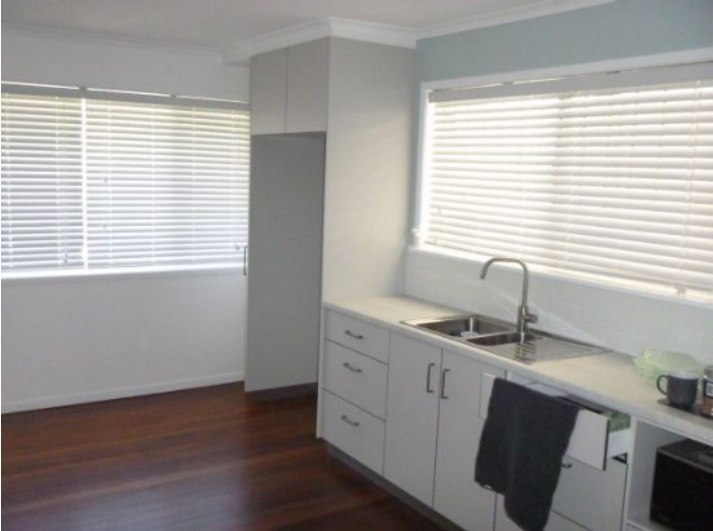
1. Wall Condition

- Plasterboard and what appears to be asbestos clad walls which appear to be functional.

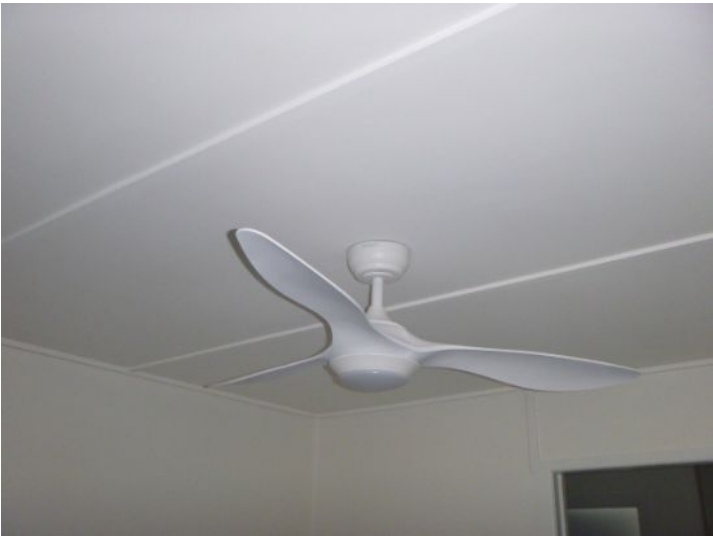
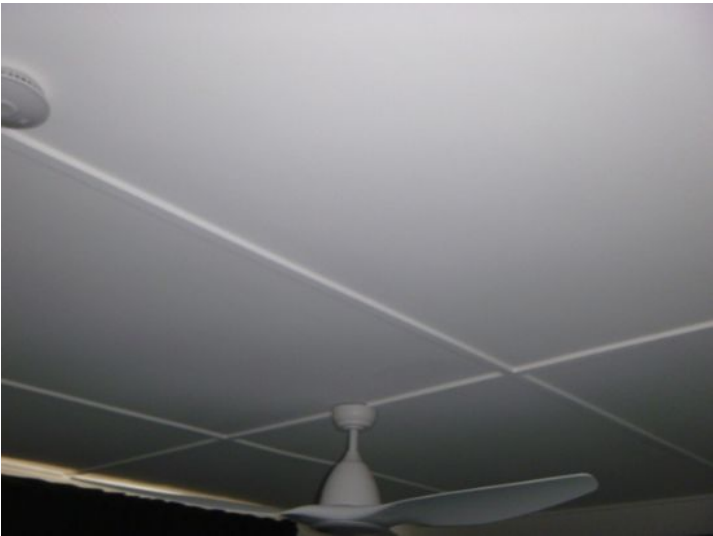
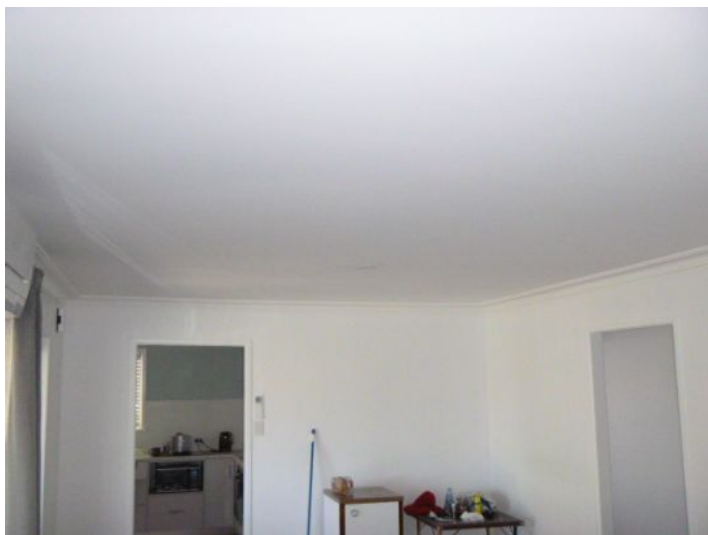
2. Ceiling Condition

- There are plasterboard/gyprock ceilings in the home which appear functional.

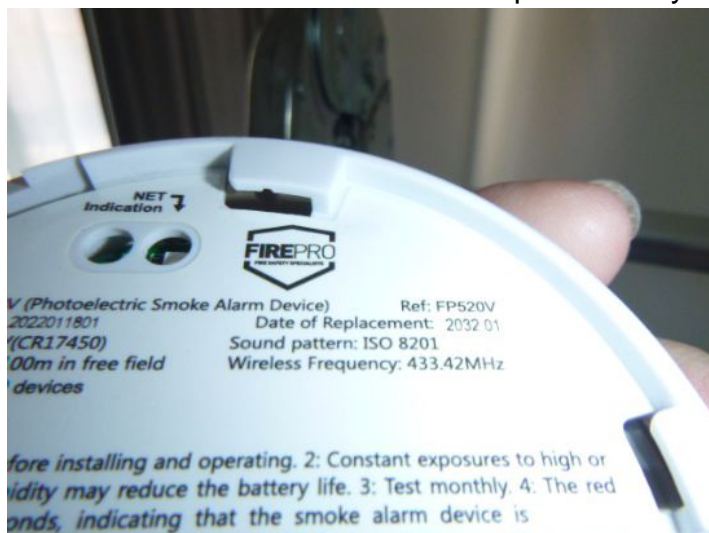
3. Smoke Alarms

- There appears to be interconnected smoke alarms installed in the living and bedrooms of the home. The service replacement year is noted as 2032.

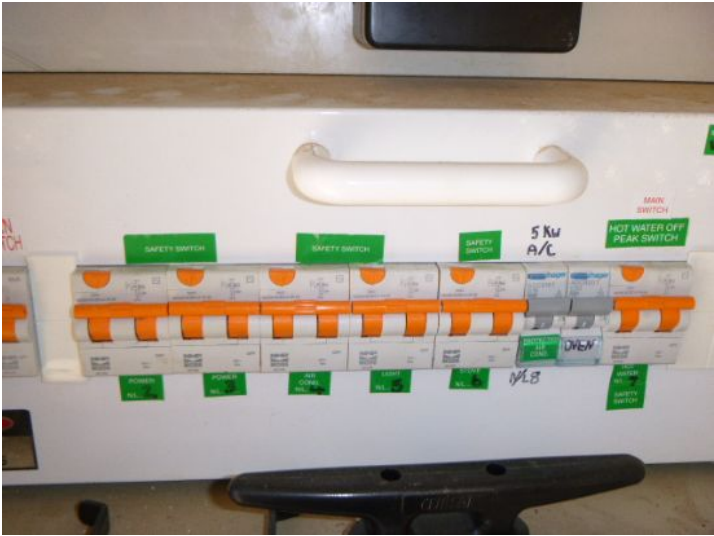
1. Electrical Panel

- Main Panel Location:
- Exterior of structure.

Observations: There are at least 2 RCD's installed which appear to protect both the power point and light circuits.

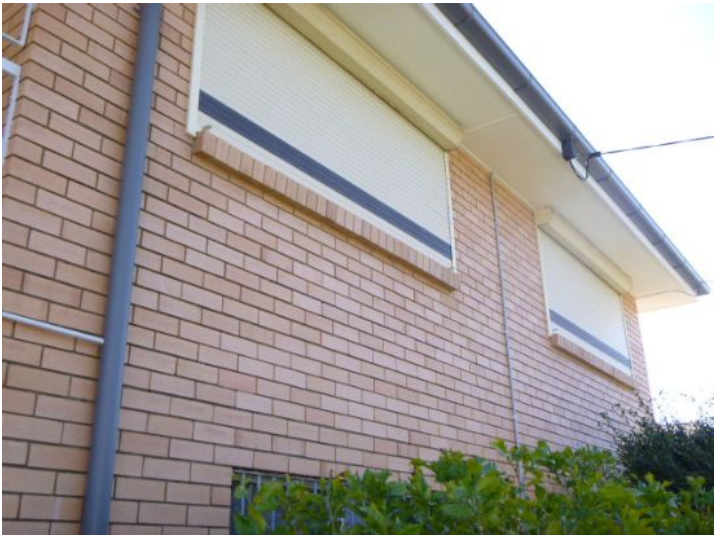
Materials:
• The brick wall covering is in a satisfactory condition.

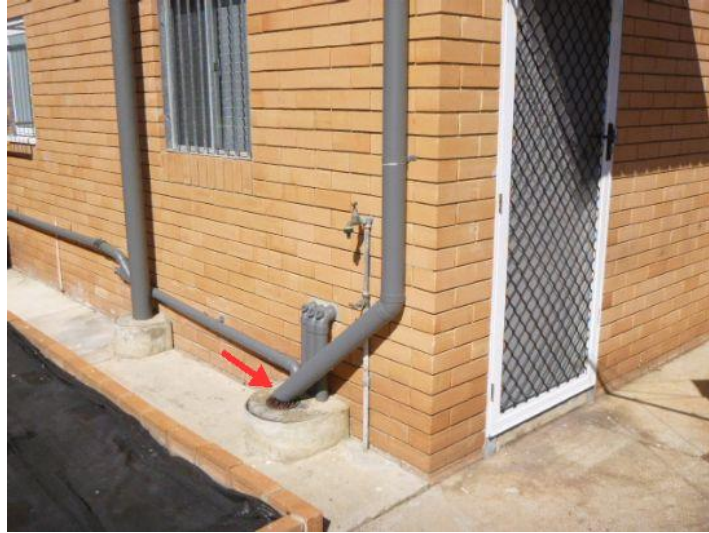
1. Grading and Drainage

- The rear downpipe discharges into the sewer, this should be relocated to the stormwater system.

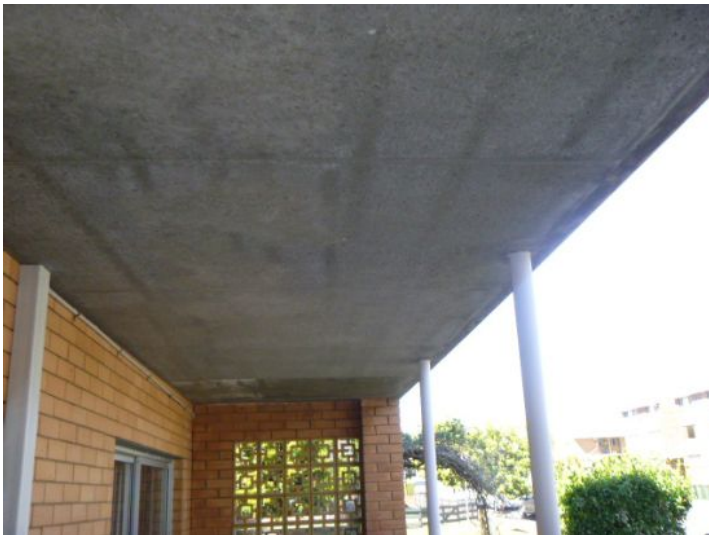
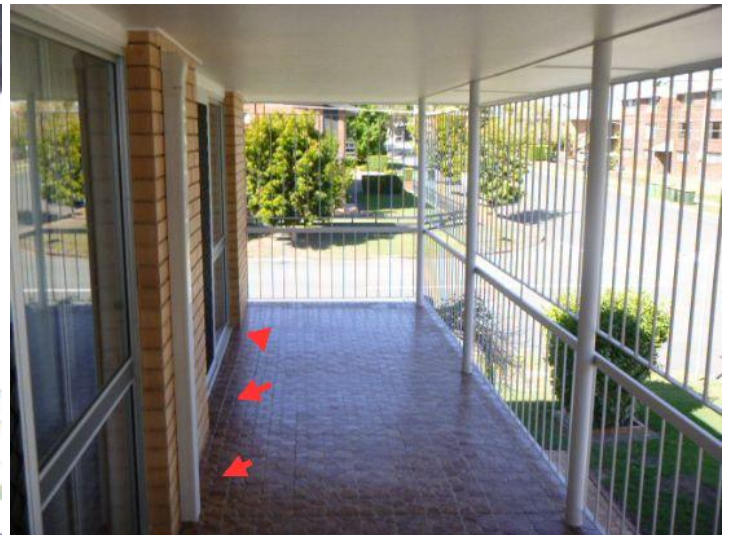
2. Balcony Structure

- Balcony appears in satisfactory and functional condition with normal wear for its age. Appears to be structurally sound.
- Some drummy tiles noted.

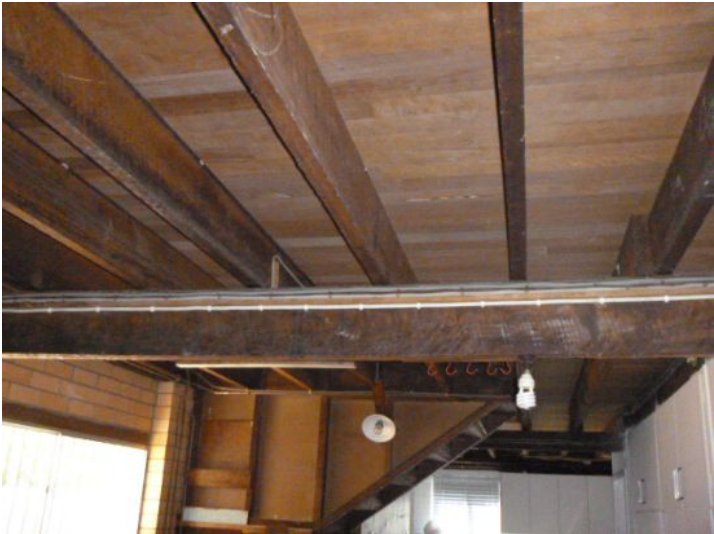
- Comments:
- Subfloor ventilation is a critical component of any good Timber Pest Management Program as moisture can lead to attack from termites, fungal decay and borers.
- Observations:
- Subfloor ventilation appeared satisfactory.

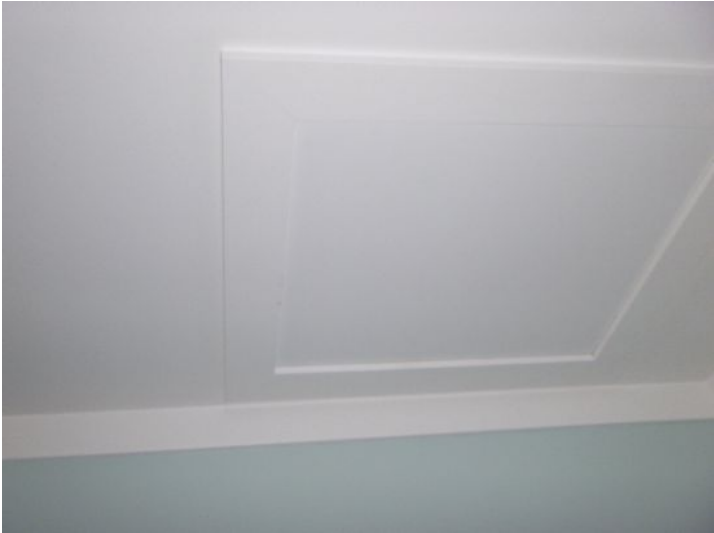
1. Roof Observations

- Access was available through a manhole in the bathroom.

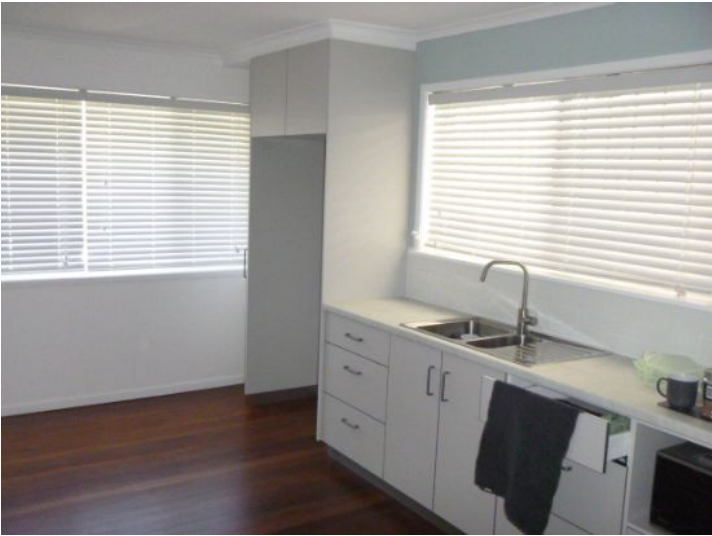
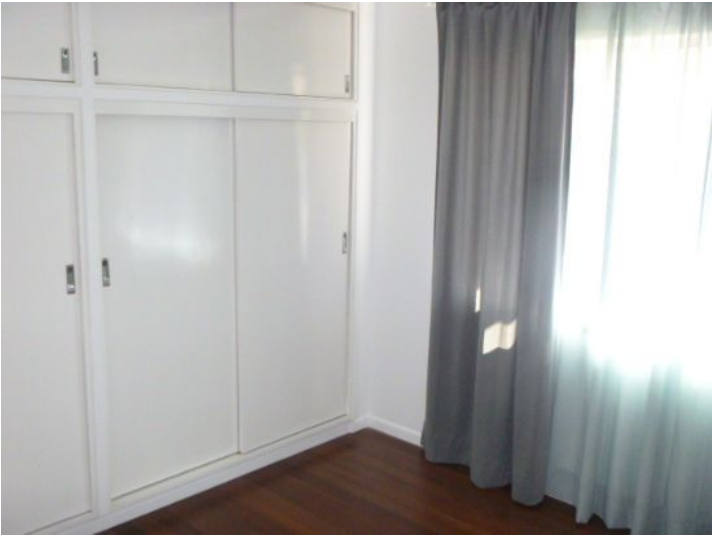
1. Wall Condition

- Materials:
- Plasterboard and what appears to be asbestos clad walls noted which appear functional.
- Observations:
- Timber skirting and door frames appear functional.

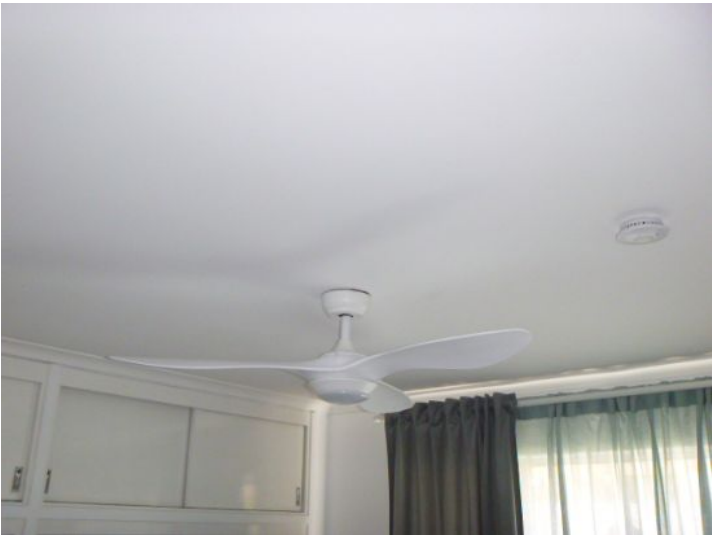
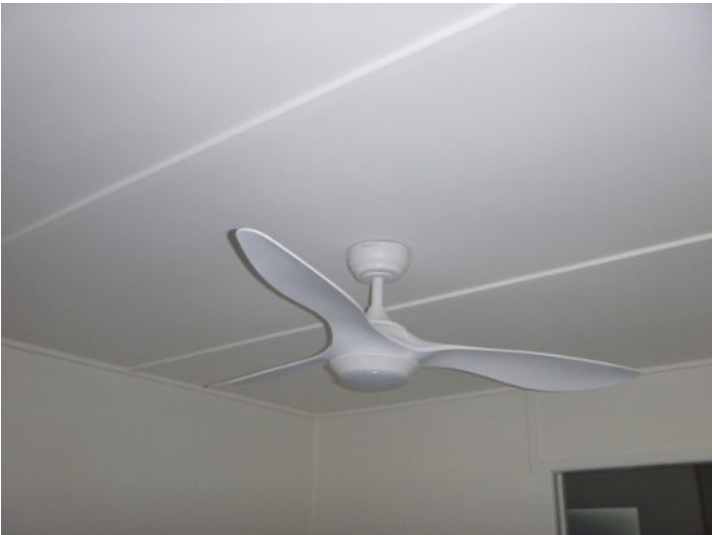
2. Ceiling Condition

- Materials:
- Plasterboard and what appears to be asbestos clad ceilings noted which appear functional.

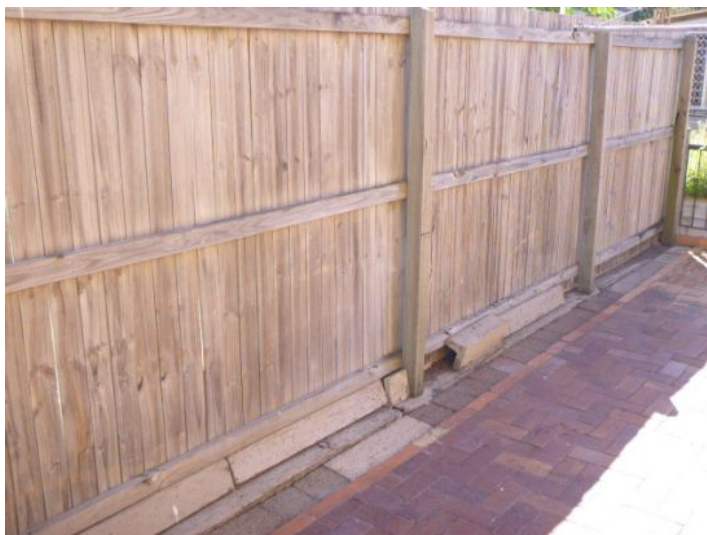
- Timber fences are in functional condition.

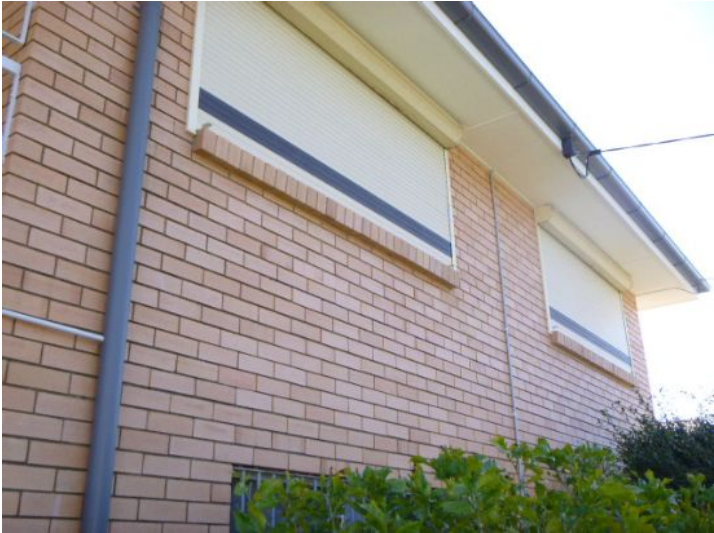
1. Wall Observations

Materials:
• Brick noted.
