# Inspection Report

## Abode Building and Pest

4 Pelion Street, Bardon

### Pest And Building Inspection

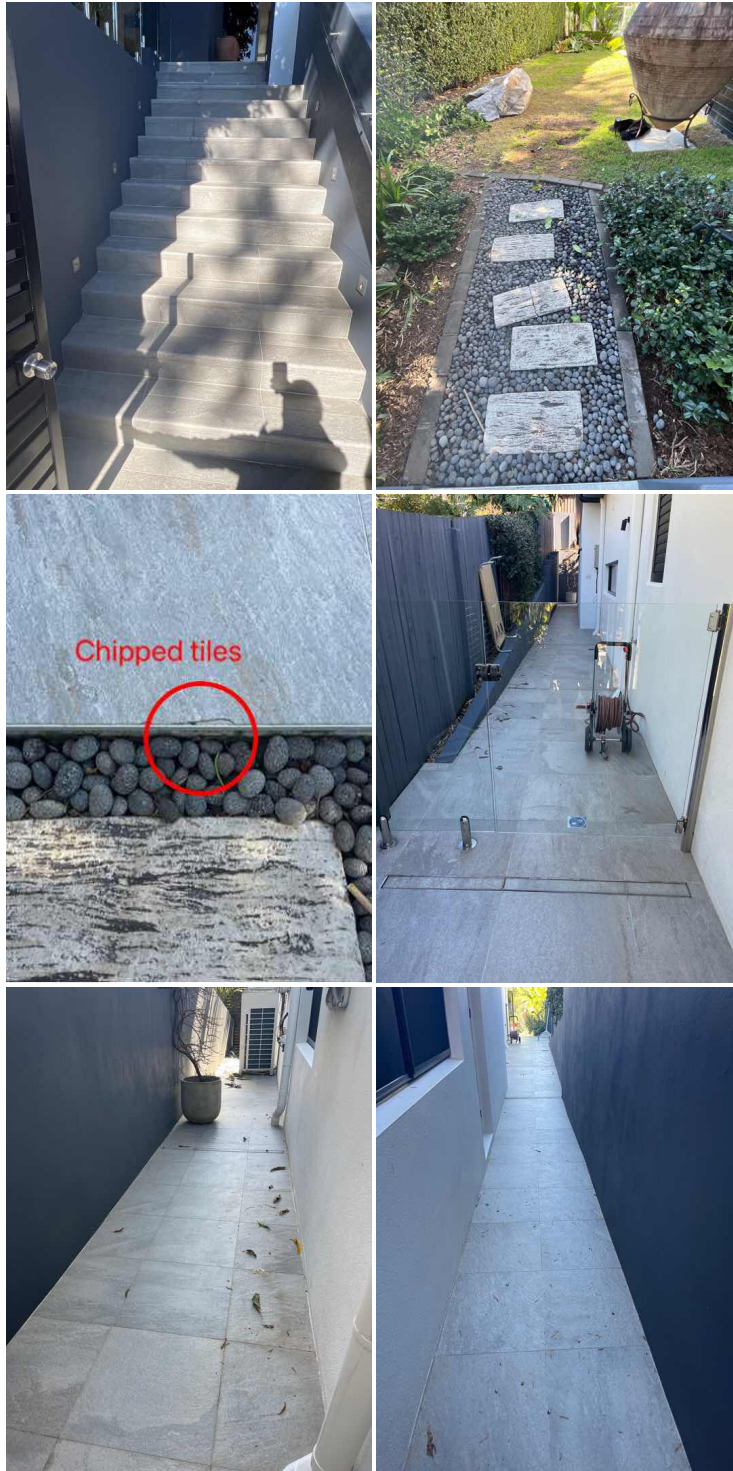
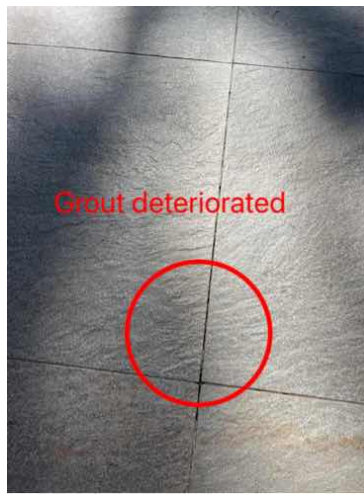
Chipped tiles observed. Please contact tiler to repair.

Grout deterioration to tiled areas. Re-grout these areas to preserve same.

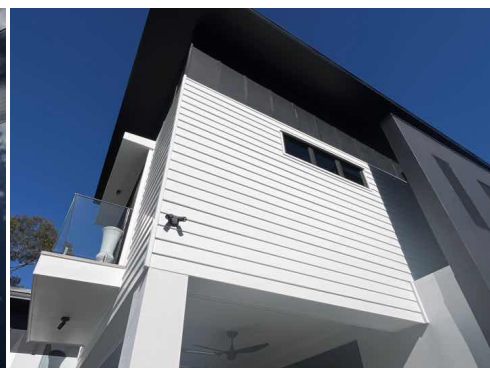
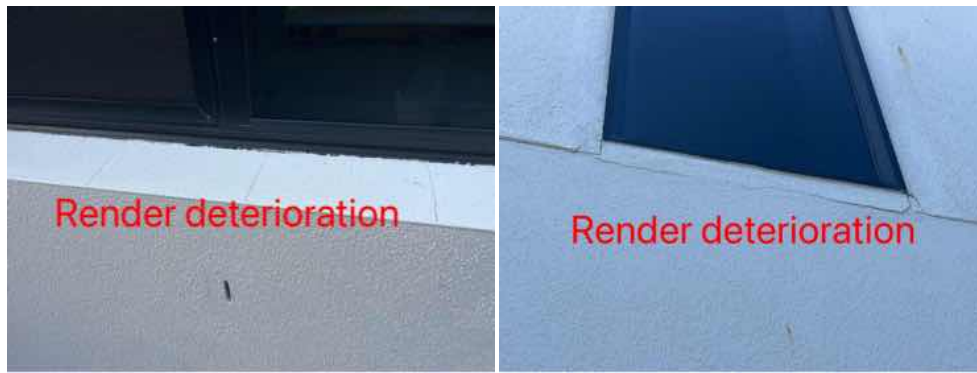
Render crack deterioration (minor) on wall visible - Recommendations: Engage a renderer for advice and repair.

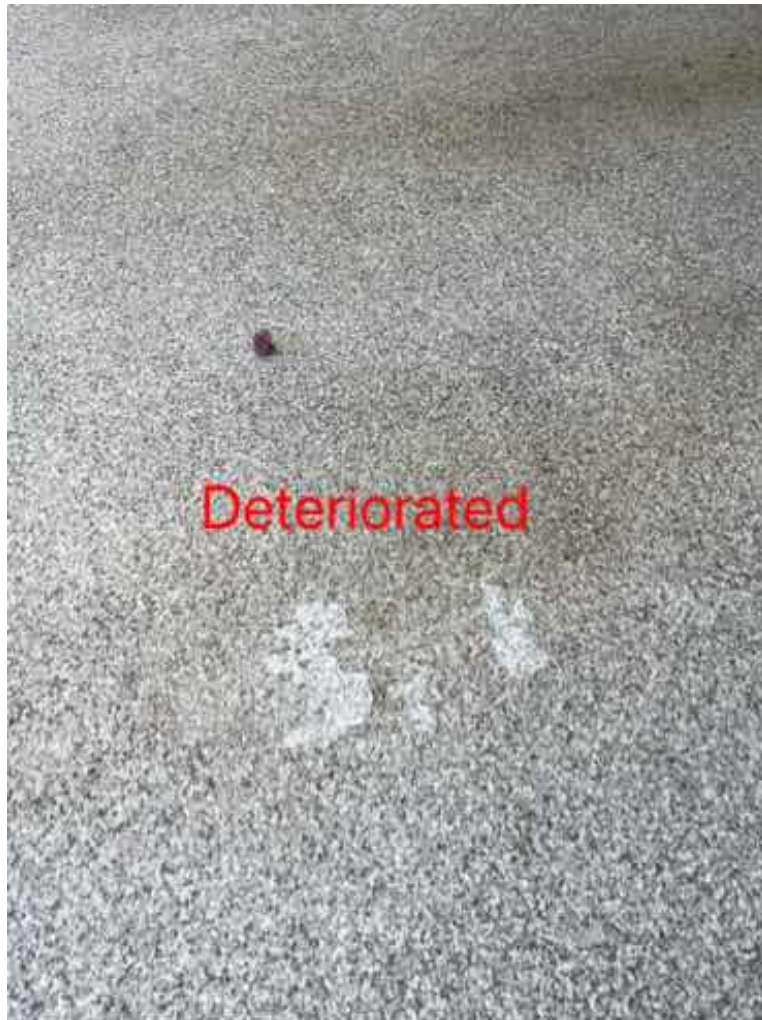
Minor deteriorated on surface- Note. contact a qualified tradesman for further advice.

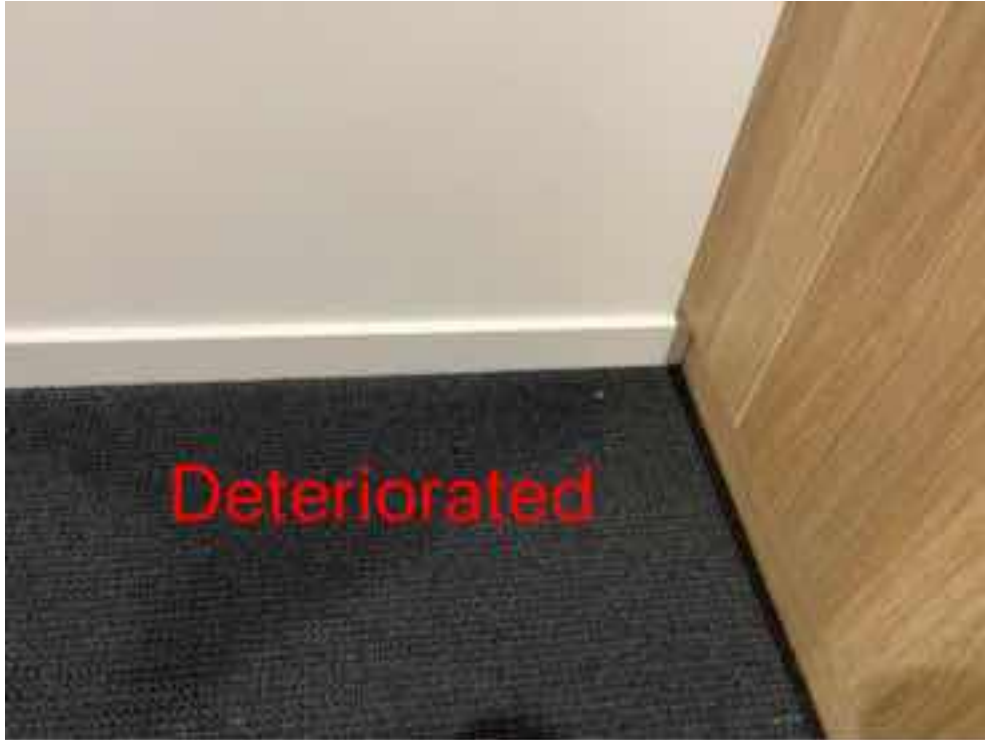
General carpet deterioration. Replacement may be required A qualified carpet layer should be engaged.

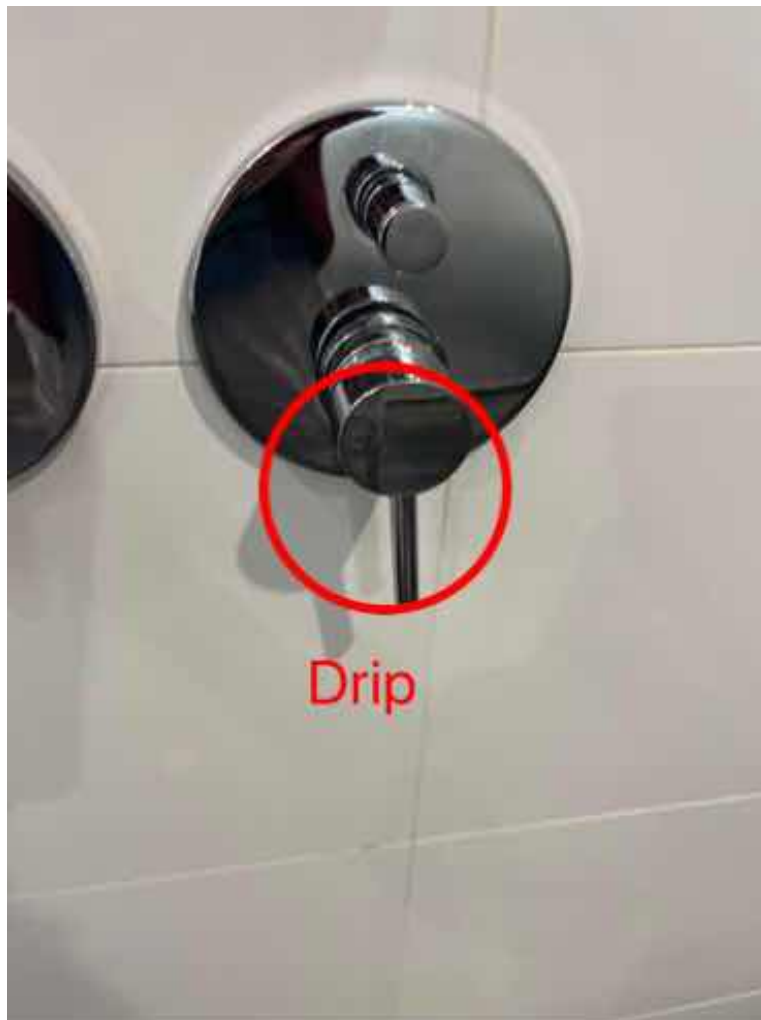
The shower mixer is dripping in the open position. Please contact plumber to repair.

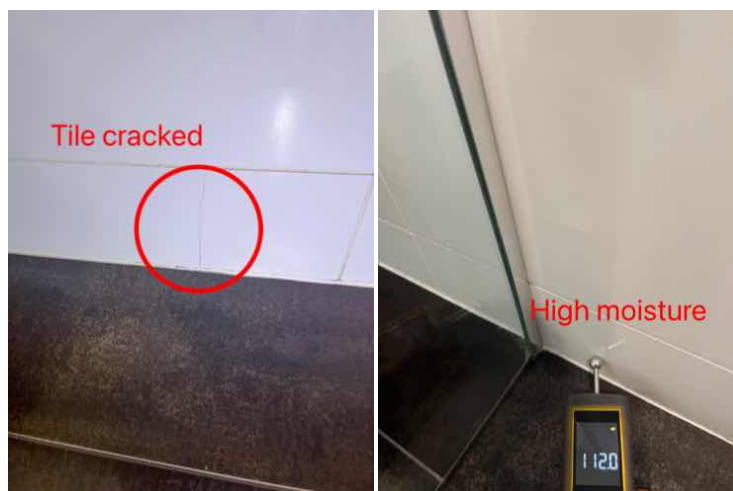
Cracked tile/s noted. High moisture readings close to cracked tile. No moisture detected to adjacent wall and ceiling under. Waterproofing should be working properly. A qualified tiler should be engaged for advice and recommendations.

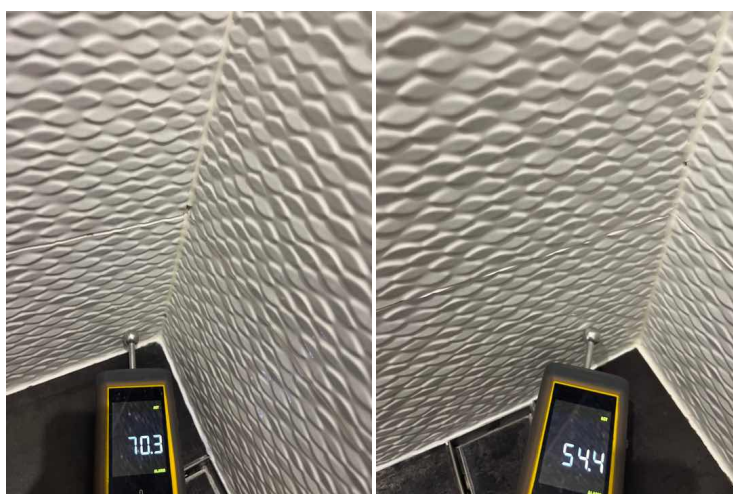
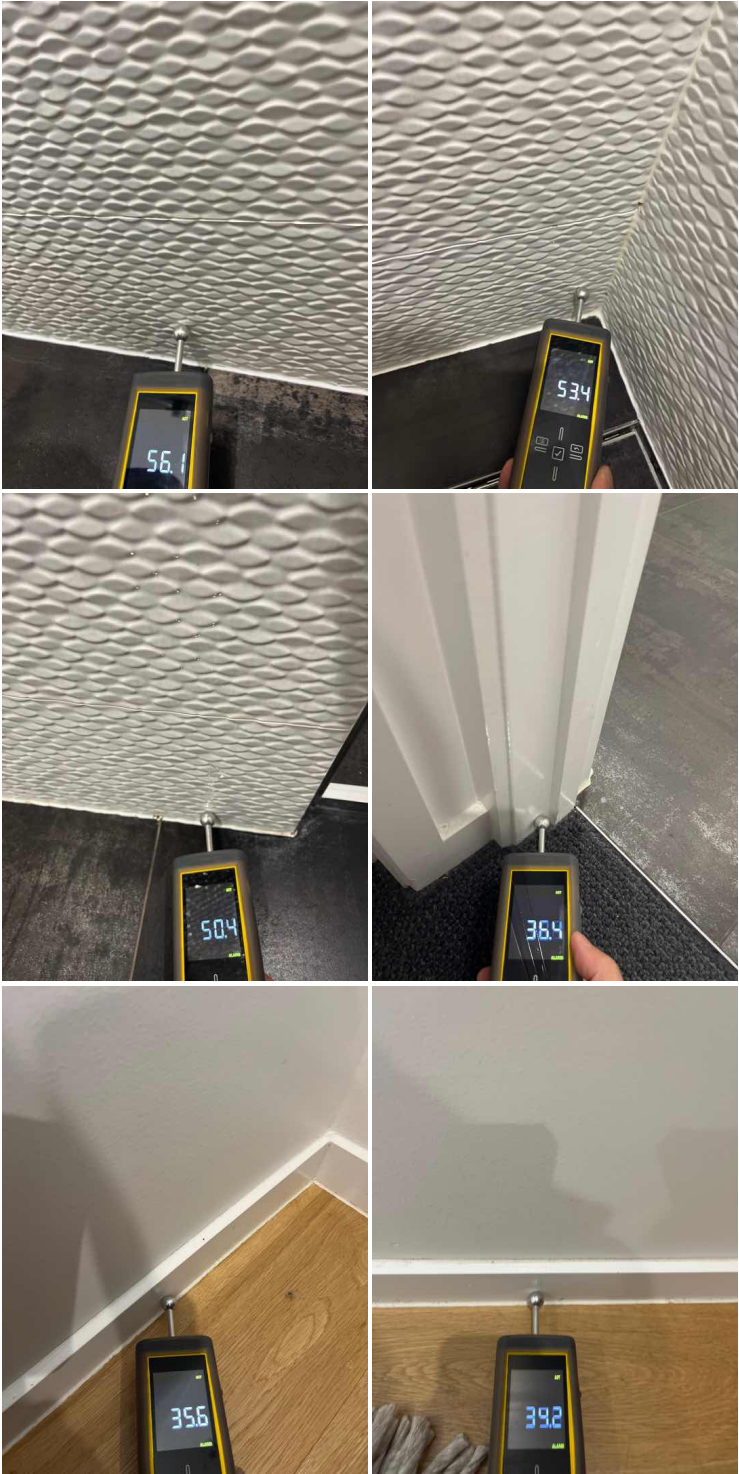
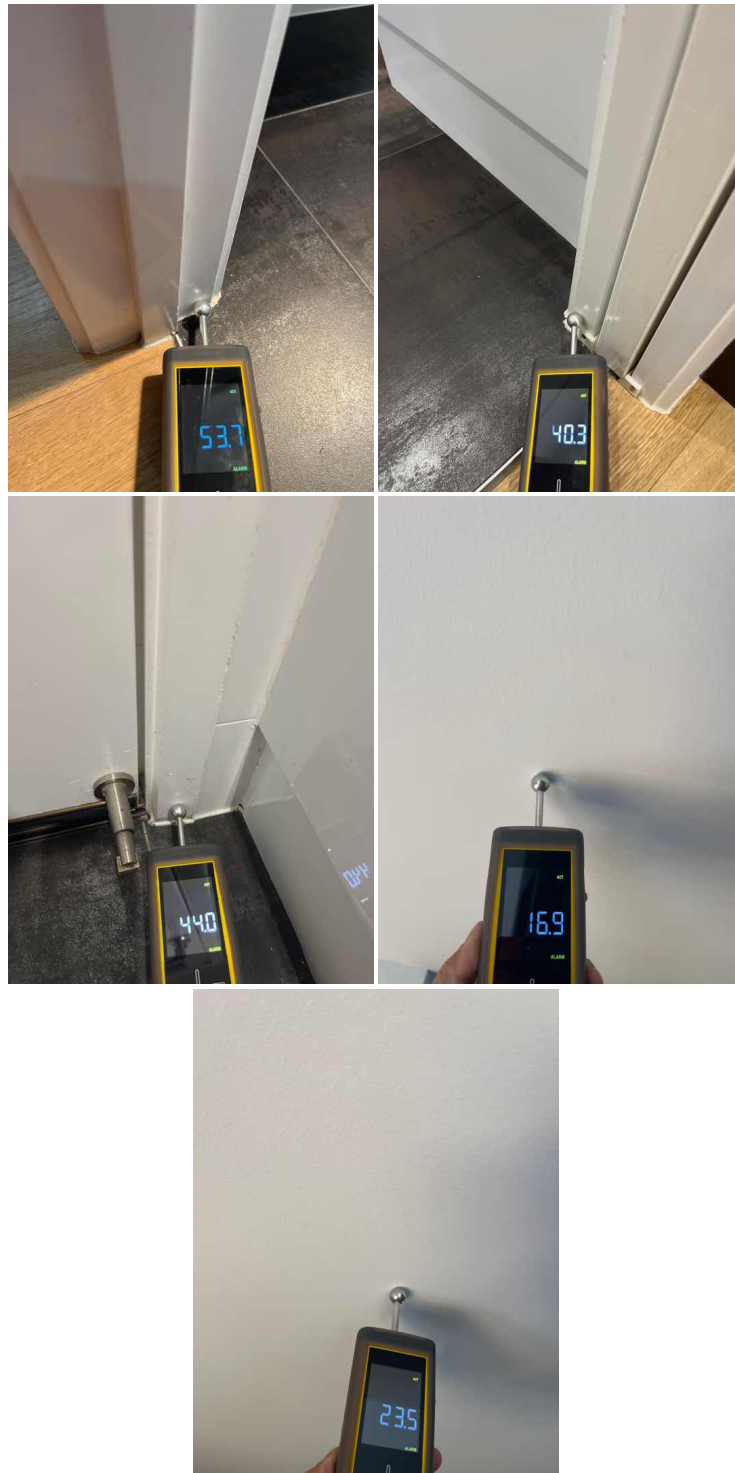
At the time of the inspection moisture readings were high to en-suite shower (please see under ensuite 1). Others are normal. NOTE: We recommend a leak detection test for the wet areas to ensure there are no water leaks to the concealed areas.
