Visual Termite Inspection & Report in Accordance with AS 3660.2-2000

Client	Murrumba Park
Address	info@bcsystems.com.au
Structure Address	Unit 41/113 Castle Hill Dr Murrumba Downs 4503
Phone/Email Manager	murrumbapark@outlook.com Ayu Katie Mao
Date of Inspection	24/03/2025

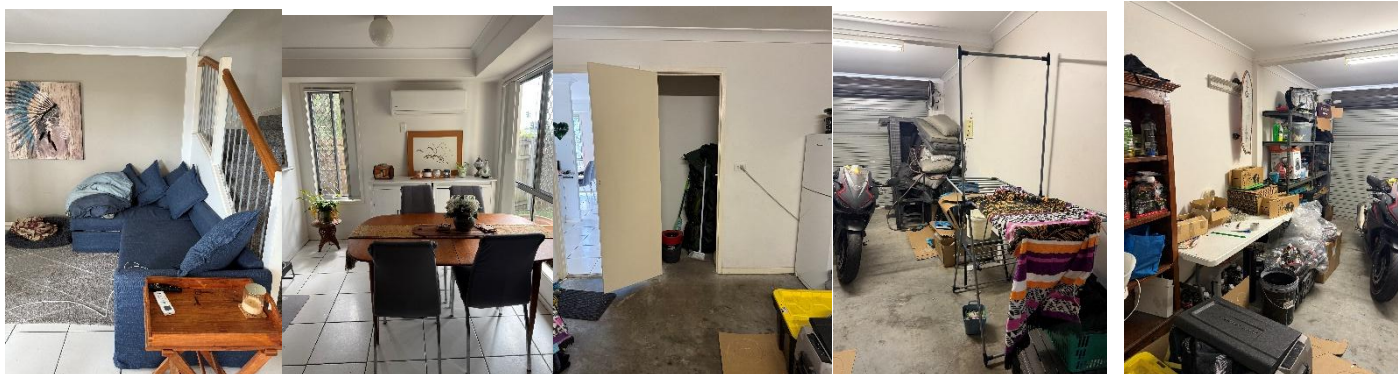
OBSTRUCTION PHOTOS

Interior		Roof Void	
Due to:		Due to:	
Furniture	<input checked="" type="checkbox"/>	Thermal insulation	<input checked="" type="checkbox"/>
Fixtures	<input checked="" type="checkbox"/>	Ducting	<input type="checkbox"/>
Floor coverings	<input checked="" type="checkbox"/>	Sarking	<input type="checkbox"/>
Stored articles	<input checked="" type="checkbox"/>	Stored articles	<input type="checkbox"/>
Clothing	<input checked="" type="checkbox"/>	Low clearance	<input type="checkbox"/>
Wall linings	<input checked="" type="checkbox"/>	No access to manhole	<input type="checkbox"/>
Locked door	<input type="checkbox"/>	N/A	<input type="checkbox"/>
Other:	<input type="checkbox"/>	Other:	<input type="checkbox"/>

- Any area, where there is no access to inspect a wall/skirting board/window frame/area under the stairs, due to furniture/stored goods, is high risk.
- It is possible for termites to gain undetected entry into the dwelling via cracks and/or construction joins in the slab and/or unprotected plumbing penetrations through the slab.
- Where one or more units within a block of attached units is not inspected, it is not considered to be a full inspection of the building. It is possible that termites have gained access to the building through uninspected attached units.

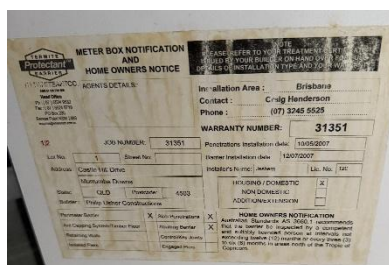
DURABLE SIGN PHOTO:

Was evidence of a possible previous treatment found?	Was a durable sign located?
Yes <input type="checkbox"/>	Yes <input checked="" type="checkbox"/>
No <input type="checkbox"/>	No <input type="checkbox"/>
Details:	Details: installation 12/05/2007 Thewhiteantco Banora Point

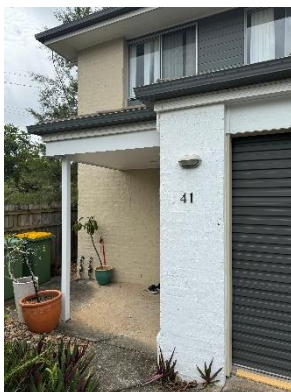
CONDUCTIVE CONDITION PHOTOS and COMMENTS:

- Where external concrete slab edges are not exposed there is a high risk of concealed termite entry.
