BIR_1820. Pre-Sale Building Inspection

Property Address: 30/20 Bognor Street Tingalpa 4173

Inspection Date: 24 Jun 2025

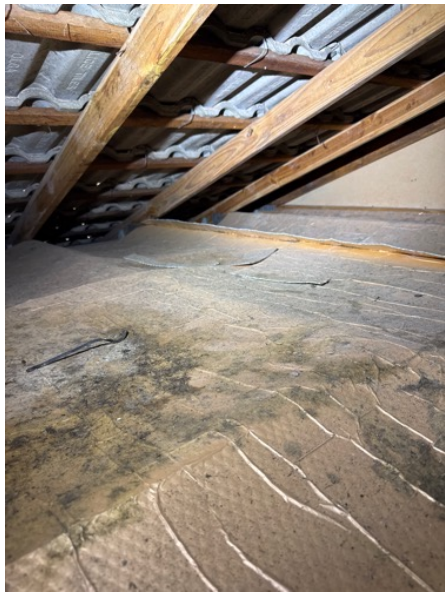
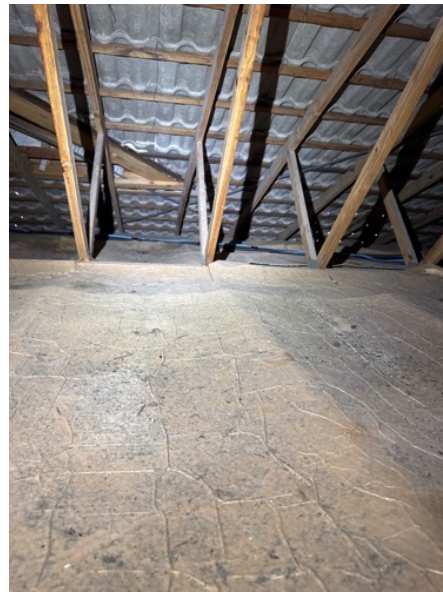
Safety Hazard 1.01

It is noted that no moisture stains on the upper floor ceiling were detected at the time of inspection using a thermal image camera.

However, there was evidence of ponding and stains on the foil insulation in the ceiling space. Therefore it is recommended to have the exterior roof inspected by a qualified roofing professional.

Furthermore, foil insulation is a potential safety hazard- staples may have been used to fix the foil to the ceiling which could be piercing electrical wires.

In addition, due to the safety issue, the roof structure could only be viewed from the access opening as it is a WPH&S risk to enter the space due to possible electrocution.

Recommend seeking advice from a qualified insulation company or Certifier for available options. It is recommended to remove the foil, it is important to engage an electrician to remove power from the home prior to entering the roof space.

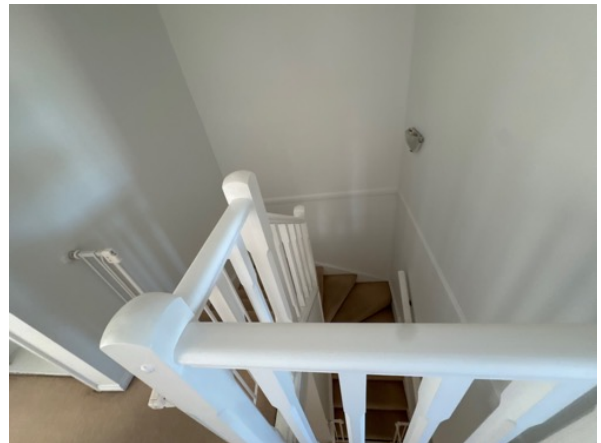
Safety Hazard 1.02

Location: Stairwell

The provision for handrails to stairs and ramps are required in Class 10a as well as a Class 1 building where a stairway or ramp is providing change in elevation of 1m or more (ie greater than 5 risers) a handrail will be required.

As a minimum requirement, handrails to a stairway flight or ramp must be provided on at least one side of the stairway or ramp and for the full length of the stairway flight or ramp. It must be continuous and have no obstruction that will tend to break a handhold except for a newel post or ball type stanchion.

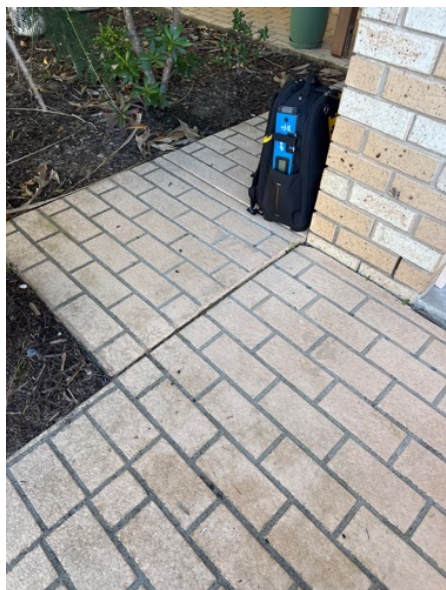
Safety Hazard 1.03

Location: Paths

The pathways have experienced some movement over time. There is a small amount of lippage that could pose a trip hazard. Repairing the paths to eliminate this hazard would

lippage that could pose a trip hazard. Repairing the paths to eliminate this hazard would ensure the safety of individuals using the area.

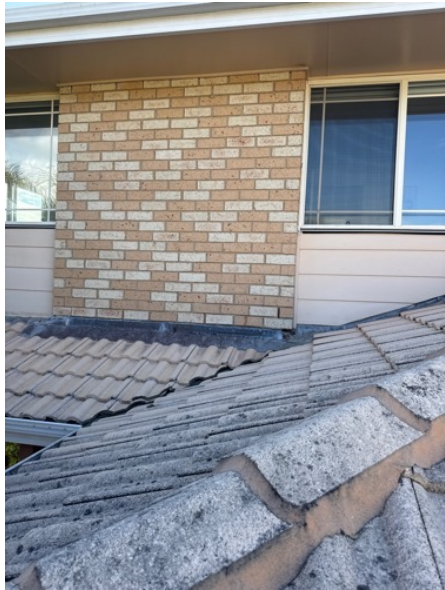
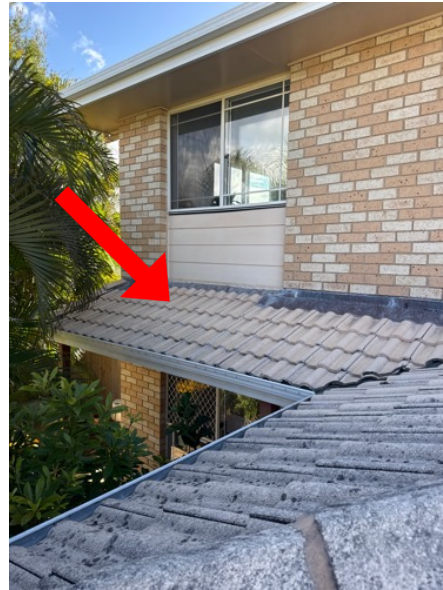
Minor Defect 2.01

Finding: Evidence of silicone repairs on the roof tiles.

There was evidence of silicone repairs on the porch roof, which indicates a history of leaks. It is recommended to have the roof inspected by a qualified roofing professional for advice.

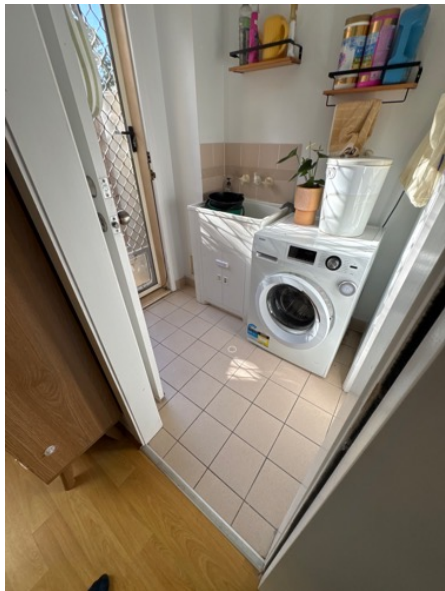
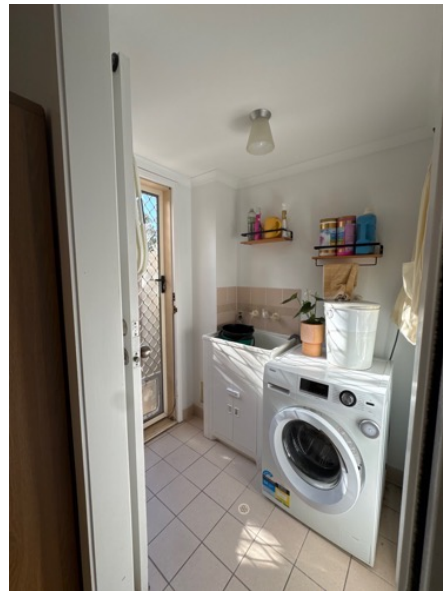
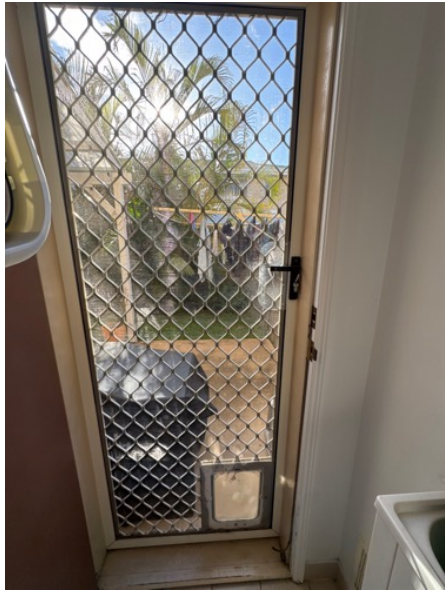
Minor Defect 2.02

Location: Laundry

Finding: Screen and timber door is binding with the jamb.

The doors are binding along the hinge-side of the door jamb. Therefore, it is recommended to engage a qualified, licensed and experienced carpenter and joiner to repair as required.

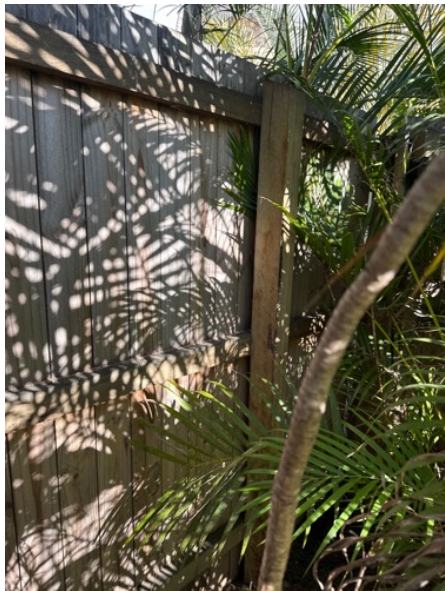
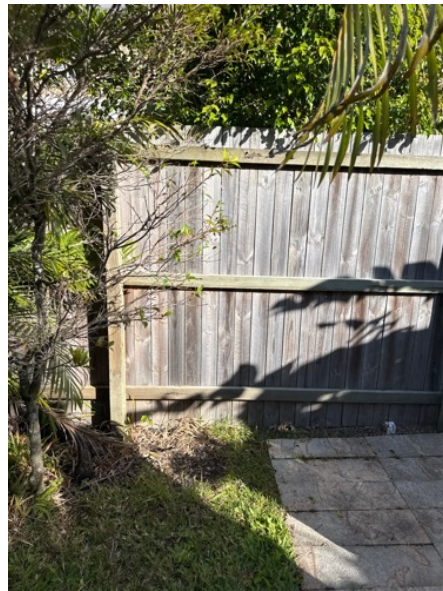
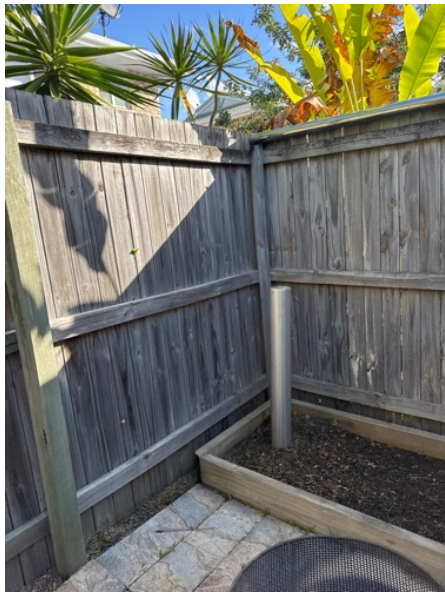
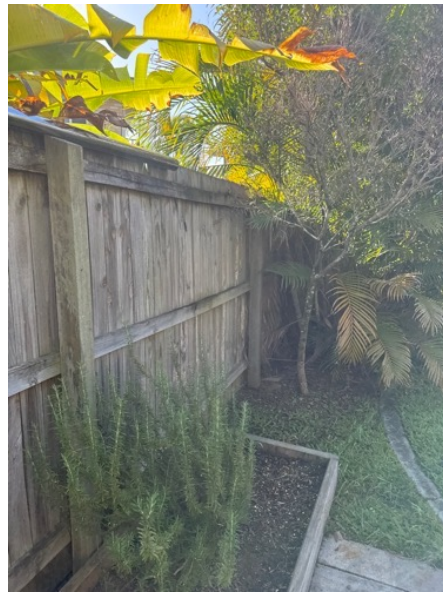
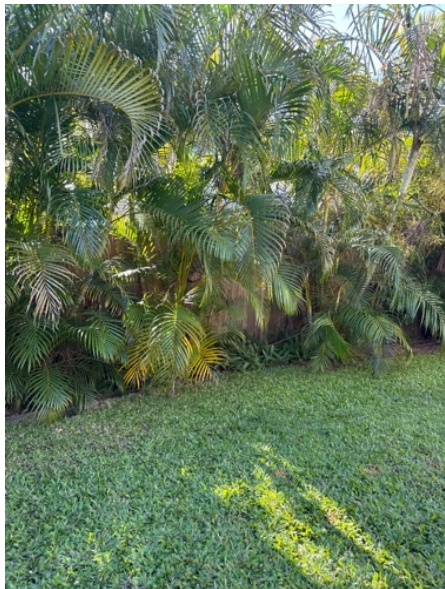
Minor Defect 2.03

Location: Fence & Retaining Walls

Finding: Fence- Obstruction vegetation

The fence was heavily obstructed with vegetation. From the areas that could be viewed, it appeared to be in fair condition for its age.

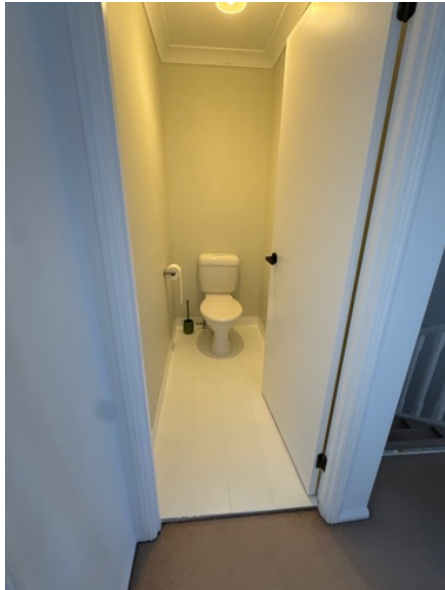
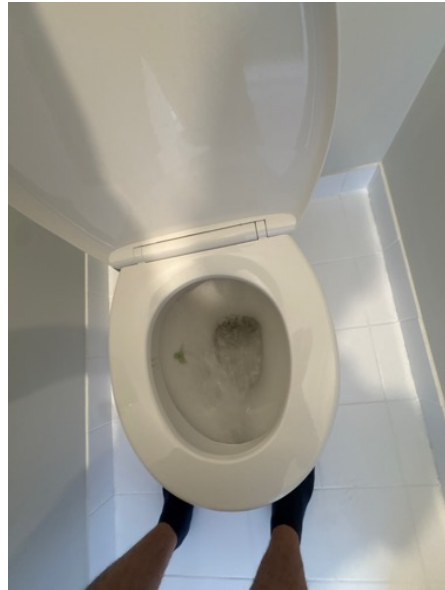
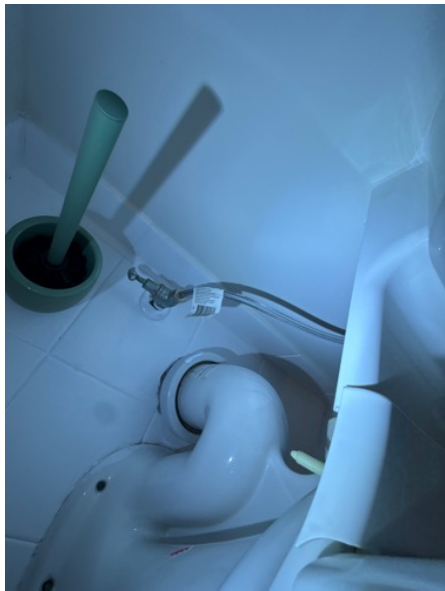
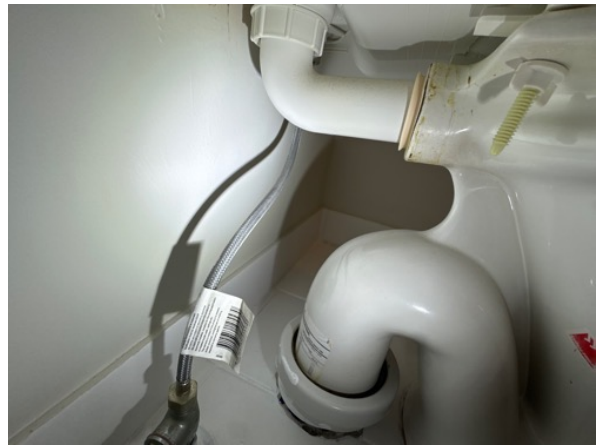
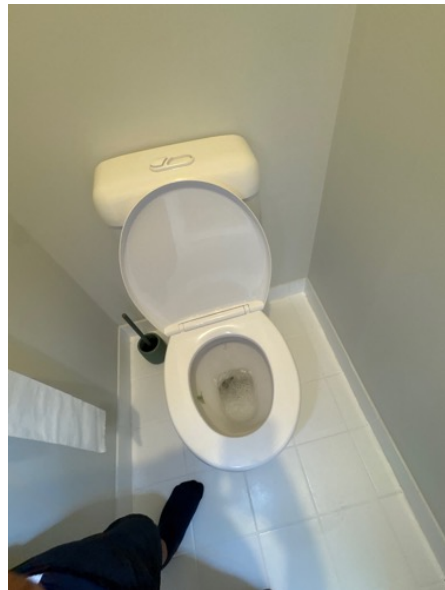
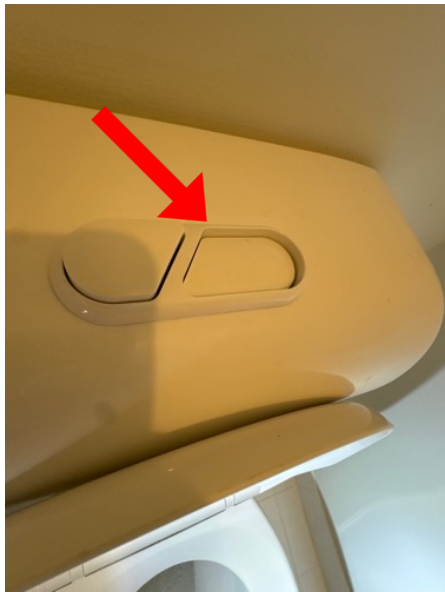
Minor Defect 2.04

Location: Upper Floor Toilet

Finding: No visible Leak

No visible leak was observed at the time of inspection.

The flexible hoses are prone to deteriorate. It is always recommended to replace the flexible hoses every five years.

It is recommended to have the sticking flush button adjusted to prevent the water from running.

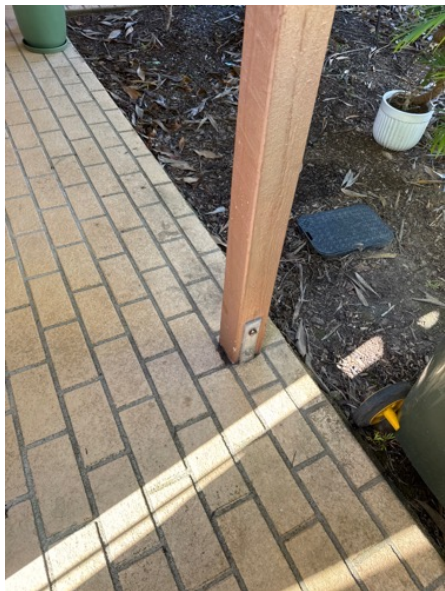
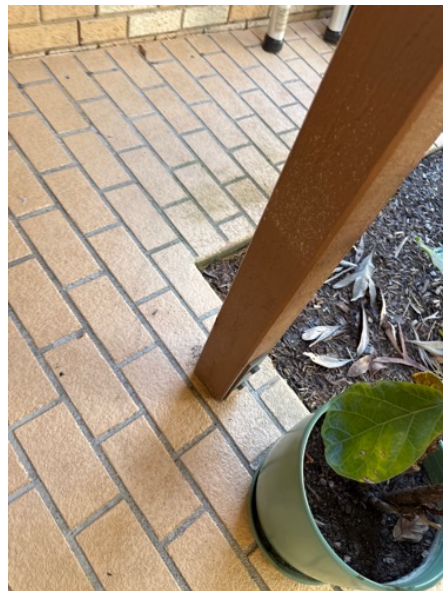
Minor Defect 2.05

Location: External Walls, Eaves And Gutters

Finding: Timber posts in contact with the ground.

The timber posts supporting the structure are in direct contact with the ground. This may act as a catalyst for deterioration. Therefore, it is recommended to alter the member or the ground surface to create a 75mm clearance from the base of the timber member and the ground.

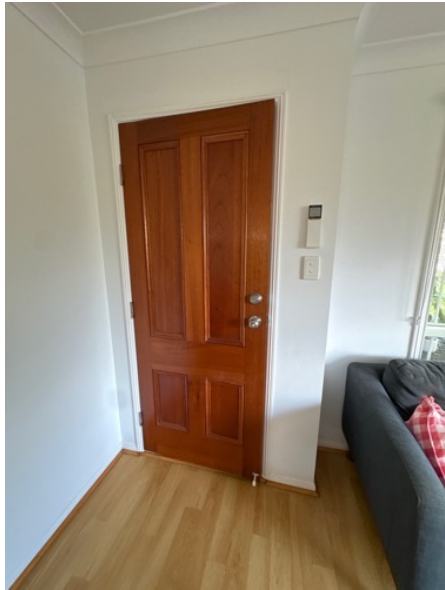
Minor Defect 2.06

Location: Entry/Living/Dining

Finding: Door binding with jamb.

The door is binding along the hinge-side of the door jamb. Therefore, it is recommended to engage a qualified, licensed and experienced carpenter and joiner to repair as required.

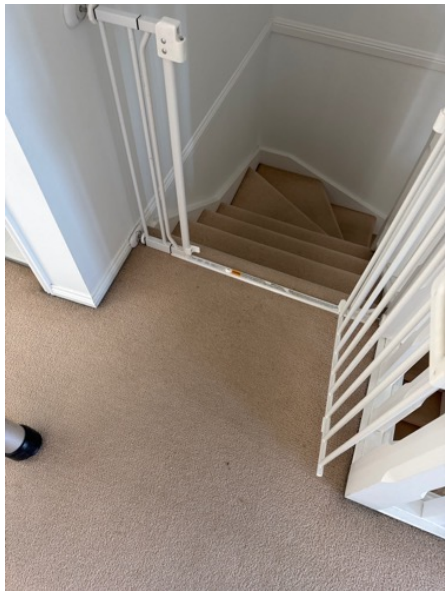
Minor Defect 2.07

Location: Upper Floor Hallway

Finding: Noticeable creak to floor.

There is a noticeable creak to the floor.
It recommended to investigate the cause and repair as required.

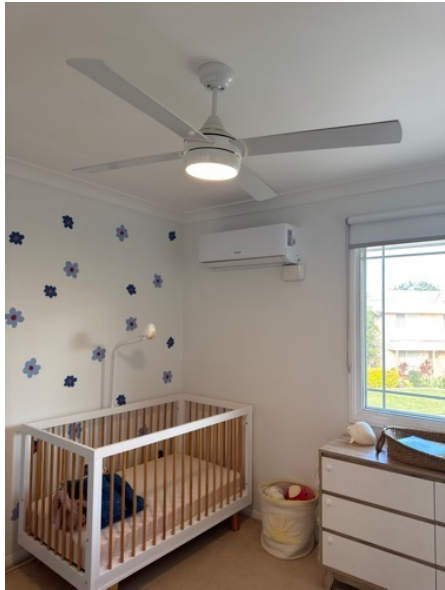
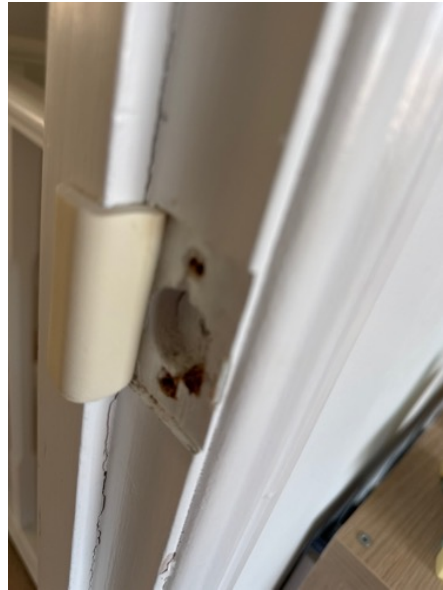
Minor Defect 2.08

Location: Bedroom 3

Finding: It is recommended that a handyman be hired to install the missing striker plate.

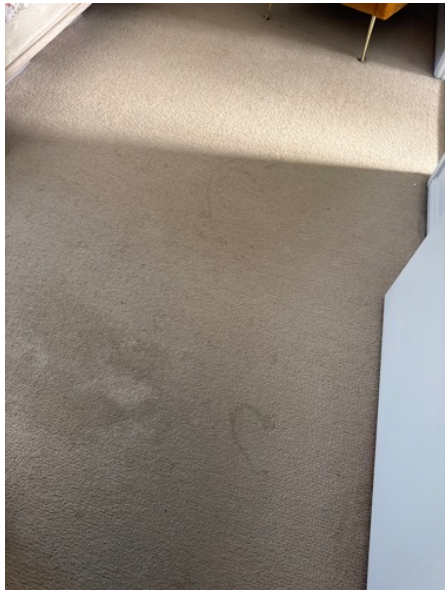
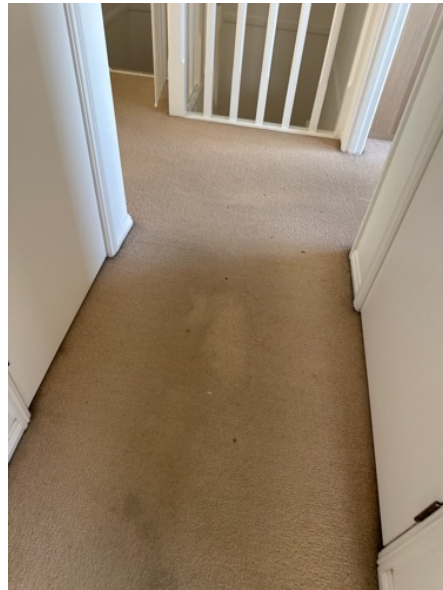
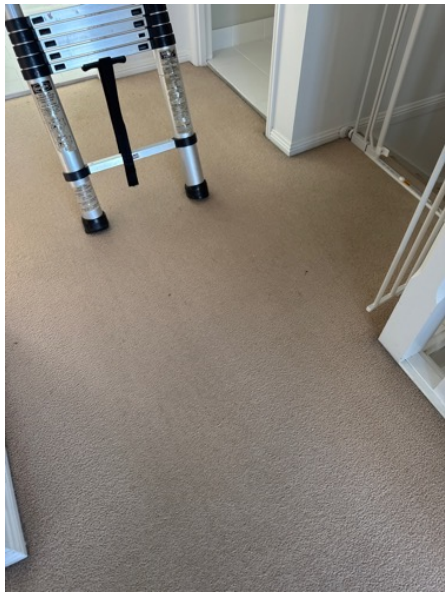
Minor Defect 2.09

Location: All Internal Areas
Finding: Stains to carpet- clean/replace as needed.

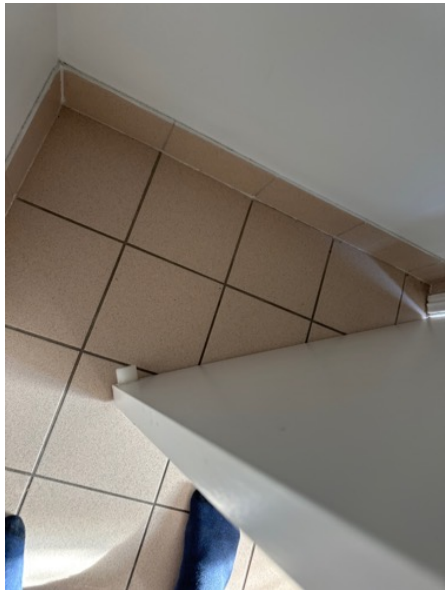
Minor Defect 2.10

Location: Powder Room

Finding: Install missing bump stop to protect the wall from damage.

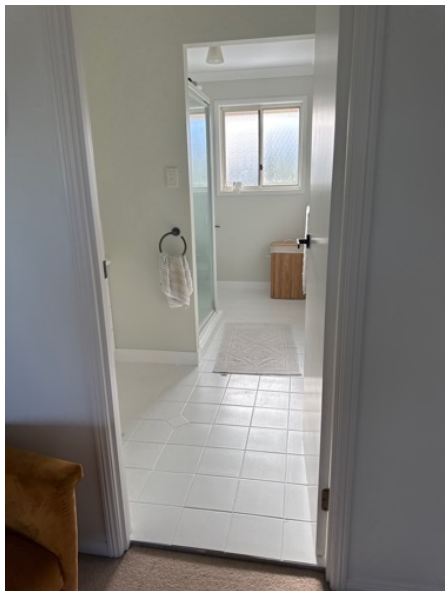
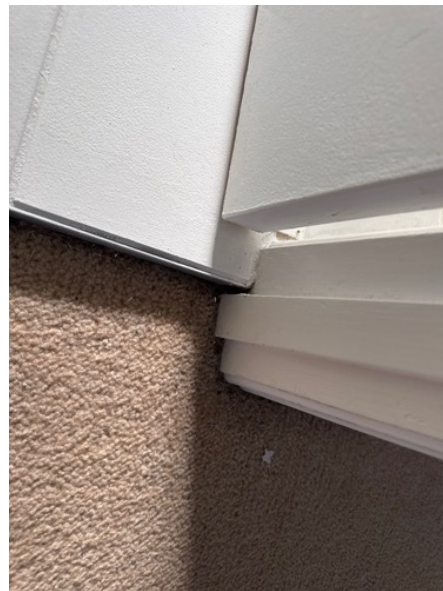
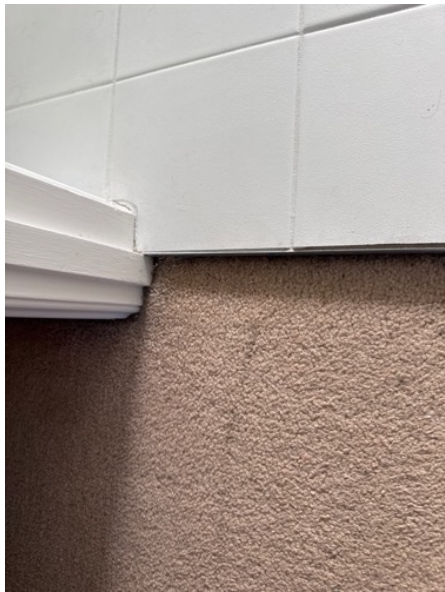
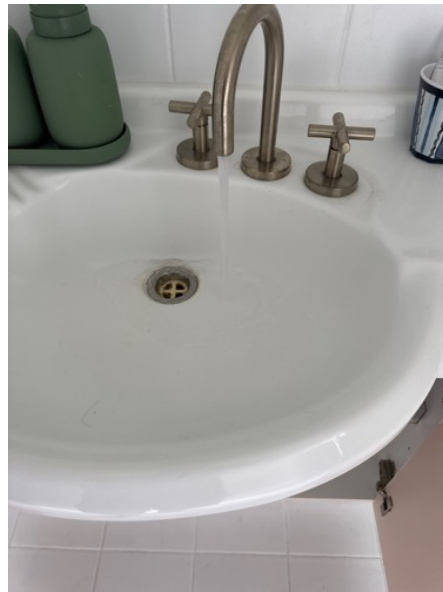
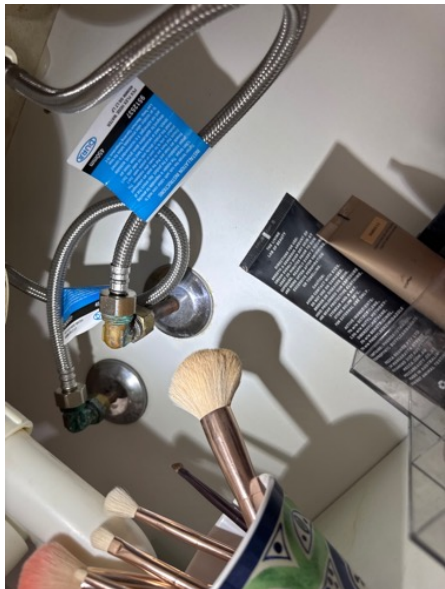
Observation 3.03

Location: Ensuite

Finding: No visible Leak

No visible leak was observed at the time of inspection.
The flexible hoses are prone to deteriorate. It is always recommended to replace the flexible hoses every five years.

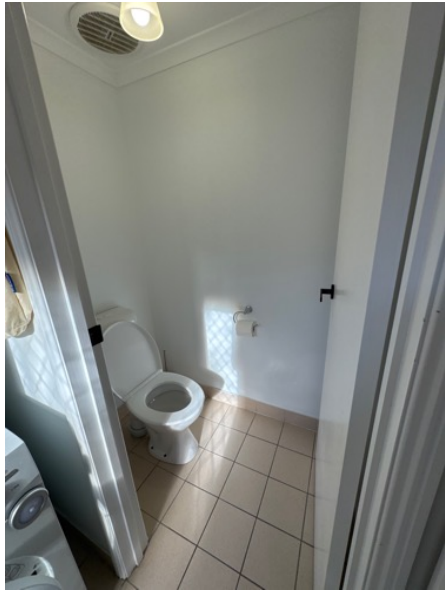
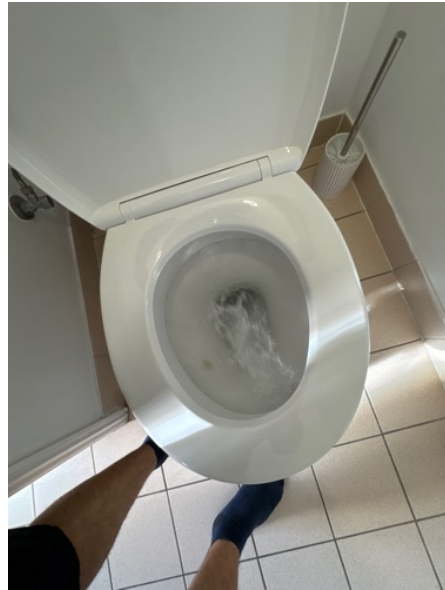
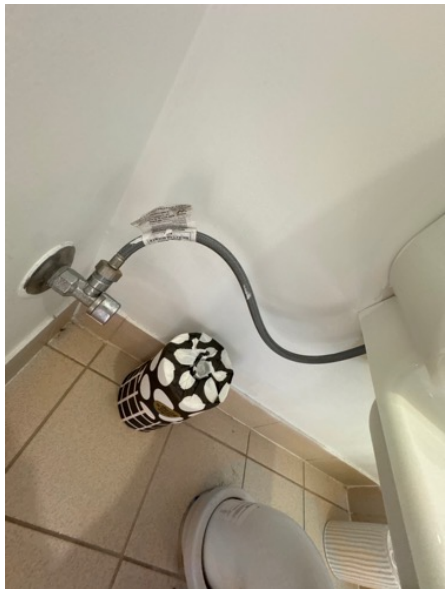
Observation 3.04

Location: Powder Room

Finding: No visible Leak

No visible leak was observed at the time of inspection.
The flexible hoses are prone to deteriorate. It is always recommended to replace the flexible hoses every five years.

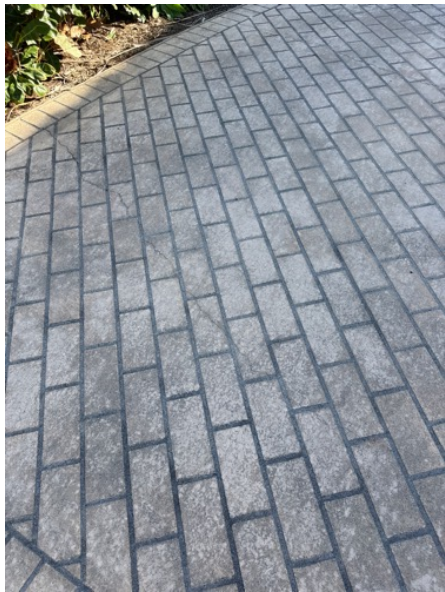
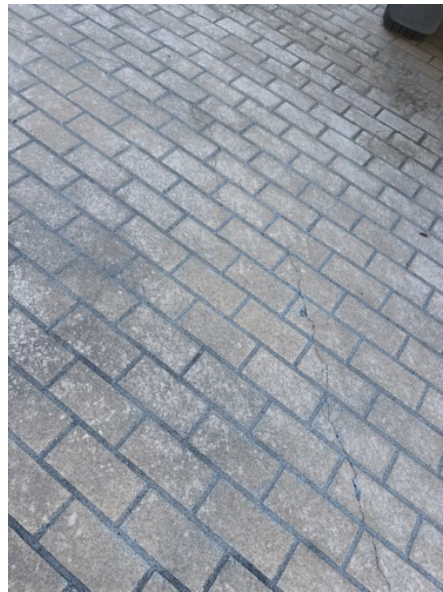
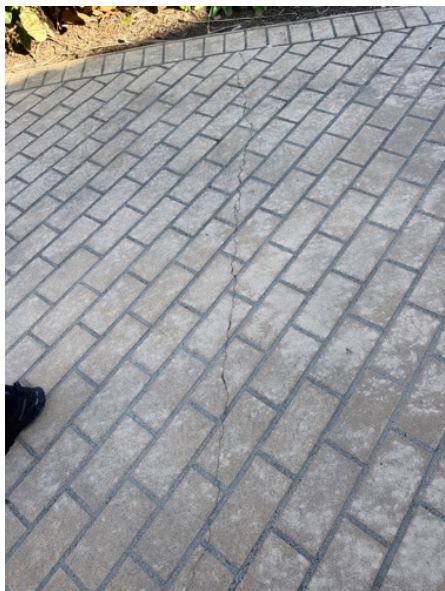
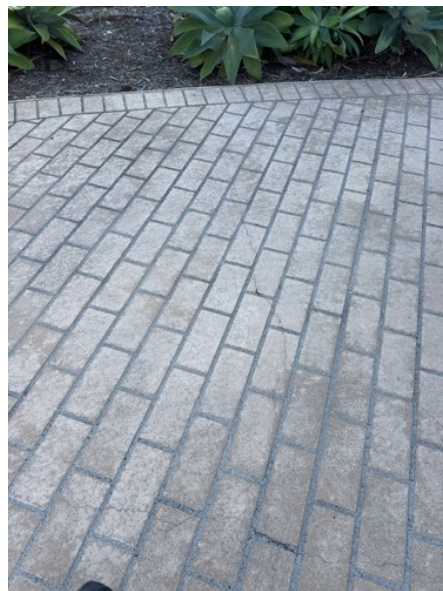
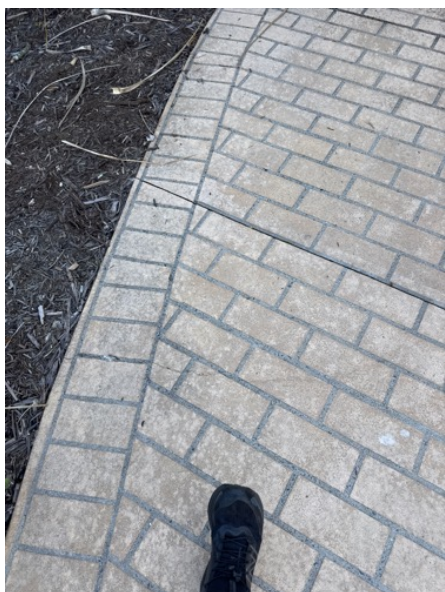
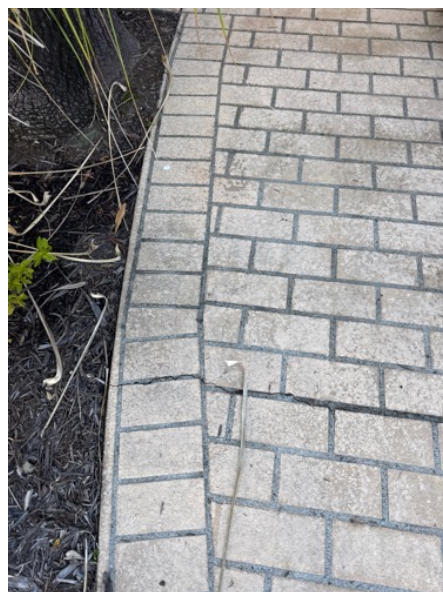
Observation 3.07

Location: Driveway
Finding: Driveway Condition

On visual inspection, the general condition of the driveway is in a serviceable condition. Concrete Cracking evident to the driveway is generally typical and what is normally observed. Note: Regardless of the appearance of the cracks a Pre-Purchase Building Inspector is unable to determine the expected consequences of the cracks. A structural engineer should be consulted in relation to all cracking.

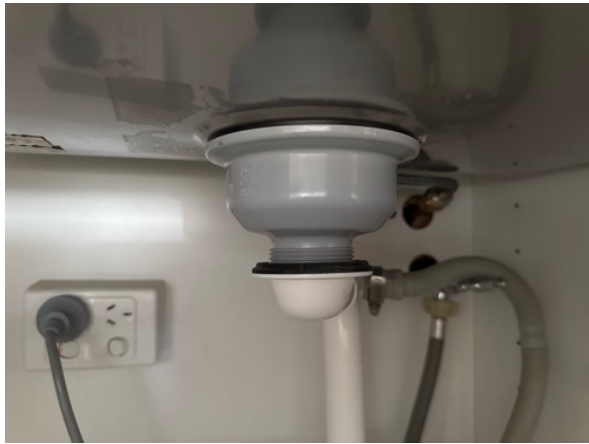
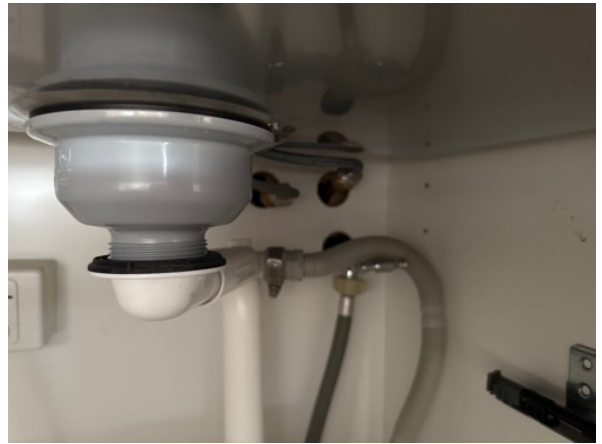
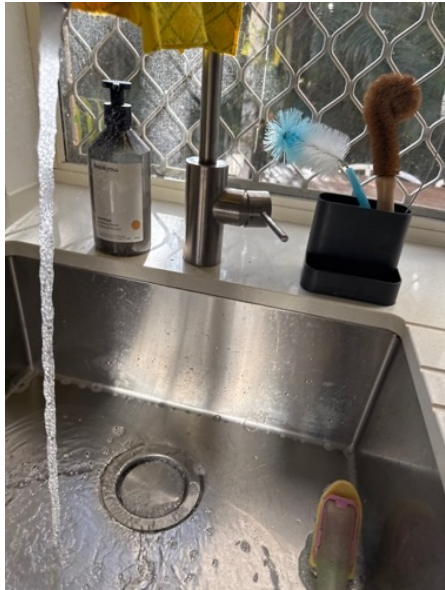
Observation 3.11

Location: Kitchen
Finding: No visible Leak

No visible leak was observed at the time of inspection.
The flexible hoses are prone to deteriorate. It is always recommended to replace the flexible hoses every five years.

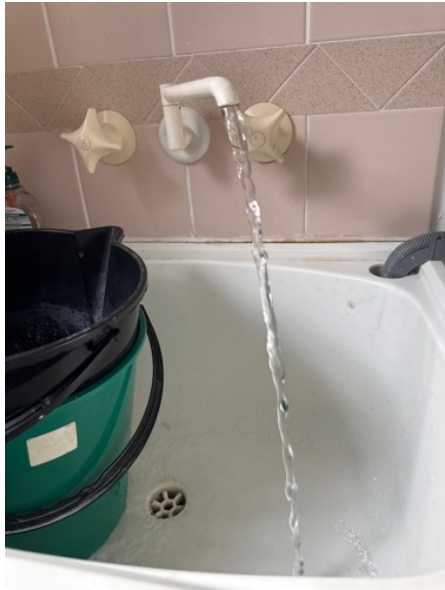
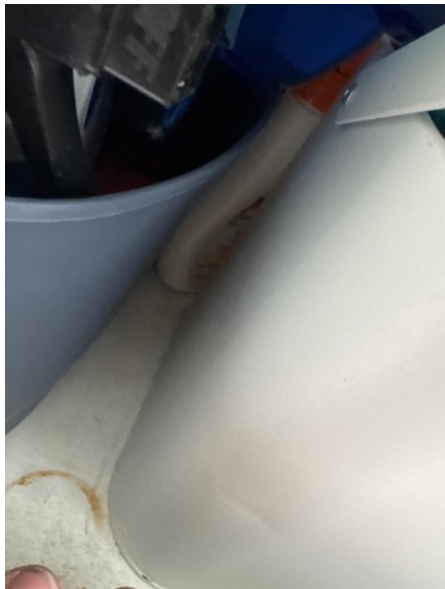
Observation 3.12

Location: Laundry

Finding: No visible Leak

No visible leak was observed at the time of inspection.

The flexible hoses are prone to deteriorate. It is always recommended to replace the flexible hoses every five years.
