VISUAL BUILDING INSPECTION REPORT

Complies with Australian Standard AS 4349.1-2007 Inspection of Buildings Part 1: Pre-Purchase Inspections - Residential Buildings - Appendix "C"

Inspection Date: 01/07/2025.

121 Mayes Ave, Kingston QLD 4114.

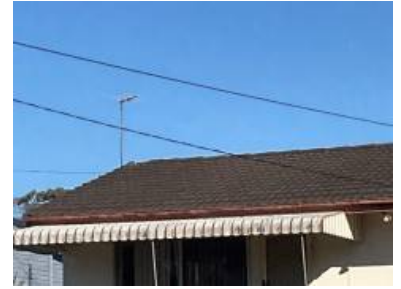
The overall condition of the roof coverings is fair. Cracked/damaged capping tiles noted to sections of capping. Recommend to replace/refix these tiles to prevent possible moisture penetration.

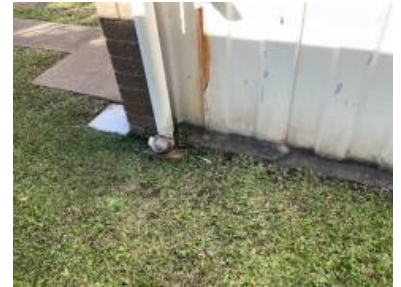
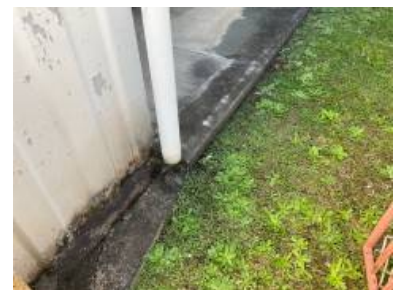
Gutter(s) and/ or Downpipe(s) are not connected to a under ground stormwater dispersal system. It is good building practice for roof stormwater that exits via downpipes be piped away from buildings footings/foundations to a legal point of discharge. The legal point of discharge is available through local authorities.

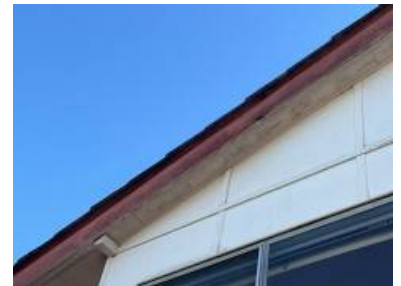
The overall condition of the eaves lining is fair. The eaves are lined with asbestos cement (suspected) and fibre cement sheeting.

Refer to comments under the Important Information heading Definitions - 4.9 Asbestos, The paint work to the eaves is deteriorating and maintenance is required.

The overall condition of the fascias/bargeboards is fair. The paint work is deteriorating and maintenance is required.

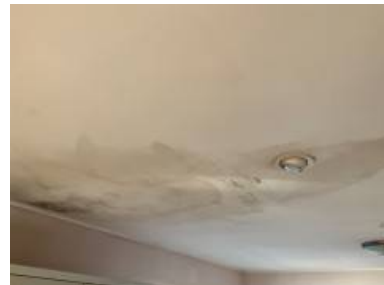
Ceiling Condition: Sagging was noted to the ceiling lining. It is this inspectors observation that most ceilings may over time sag. Popped nails and cracking may occur. This may be the result of lack of adhesion and/or movement in the timber framing. Periodic maintenance may be required and ceilings, sections may need to be re-secured. Recommend a Plastering contractor to further assess and give probable cost of rectification. Evidence of current water penetration through ceiling. See notes in roofing section. Repairs are required. Peeling paint was noted to ceilings.

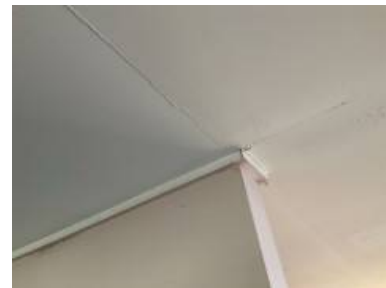
Minor settlement cracks were noted and these are typical of this type of material. This is considered to be an appearance defect. Periodic maintenance may be required.

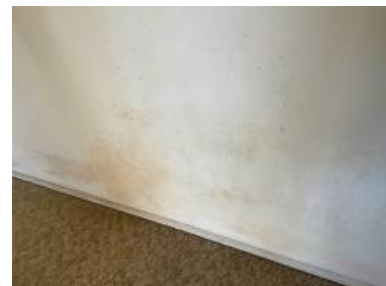
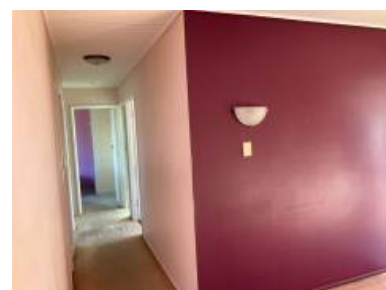
The condition of the walls is generally fair. General wear and tear is noted. Mould was noted to the walls. The cause should be investigated and rectified. Handyman quality works noted to painting in areas, this does not indicate that the work is inadequate, simply stating that all factors to do with professional finish may not have been considered.

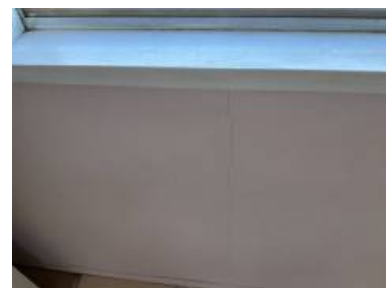
Minor settlement cracks were noted and these are typical of this type of material. This is considered to be an appearance defect. Periodic maintenance may be required.

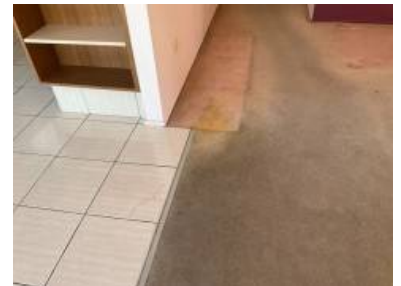
Floors are concealed by floor coverings to various areas. Minor cracking was noted to floor tiles. This is considered an appearance defect. Floor coverings are deteriorating/in poor condition.

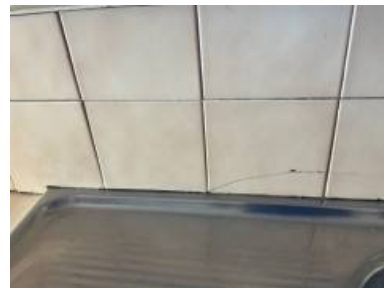
The condition of the tiles is generally fair. All sealants to kitchen walls/splashbacks need maintenance due to deterioration/gaps appearing to prevent moisture penetration. Some cracked tiles were noted to.

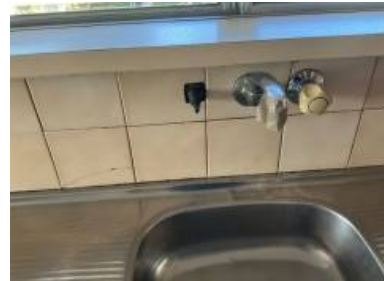
Missing tap. Replacement recommended.

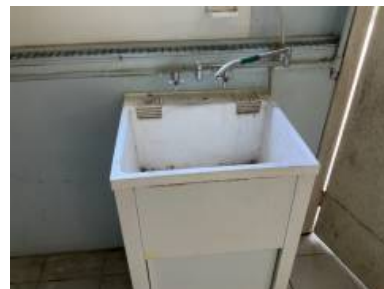
The cabinet is rusting, recommend to paint/ rust treatment. Tap faulty due grit build up. Repairs/ maintenance are needed.

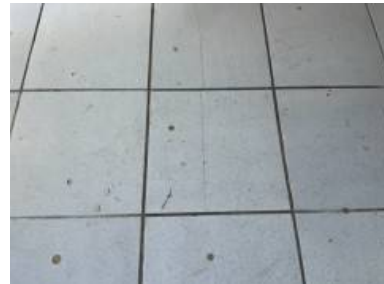
Cracked floor tiles are present.

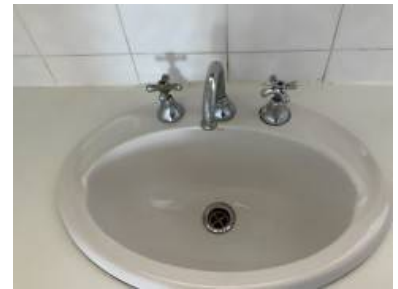
The basin & taps appear serviceable. Tapware is missing the temperature indicator buttons, replacement required.

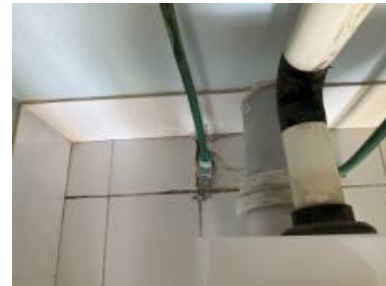
The toilet is a single flush type. Flush pipe rubber is perished. Recommend to replace. Tap is leaking .A licensed plumber should be called to make further evaluation and repairs as needed.

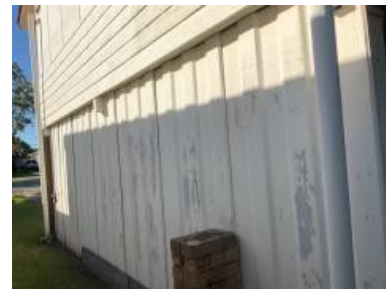
The condition of the walls is generally fair. General wear and tear is noted. Paint deterioration was present to external surfaces.

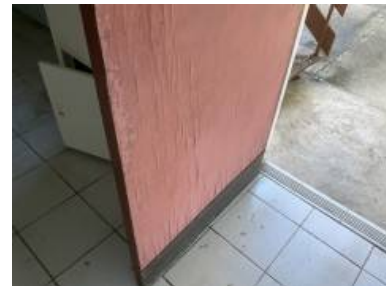
The condition of the exterior of the windows is generally fair. General wear and tear is noted. The face is lifting off the external side of some doors. This is due to weathering. Repair or replacement of door is recommended.

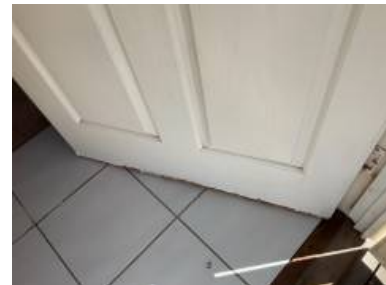
The bottom of some doors have moisture damages and swelling at the base of the door, this is due to not all of the door has been sealed/ painted to prevent moisture entering timber. Recommend to replace door or maintain, seal/paint all edges to prevent further deterioration.

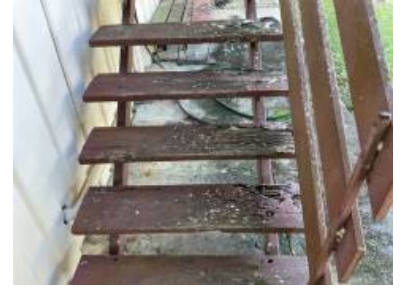
The overall condition of the rear stairs is poor. The stairs are constructed primarily of metal and timber. Severe wood decay to sections of timbers, repairs are required. Further investigation is recommended.

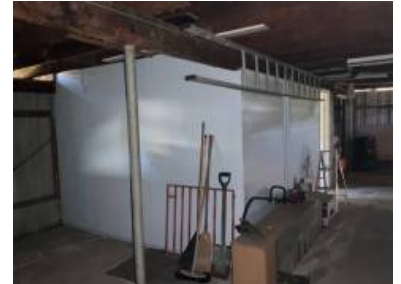
Ant caps are inadequate, refer Timber Pest Report. Downstairs/ subfloor walls, no consideration to Termite proofing has been given. Refer Timber Pest Report.

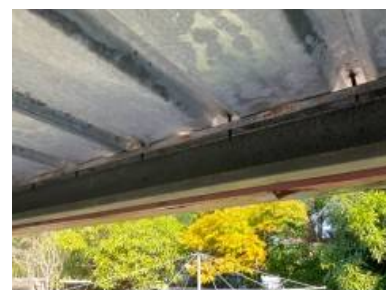
Wall Condition: The condition of the walls is generally fair. Rust and corrosion noted to sections of metal rust treatment is required to prevent further deterioration.

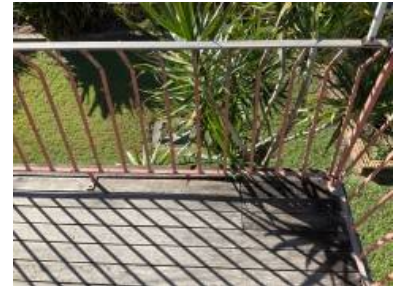
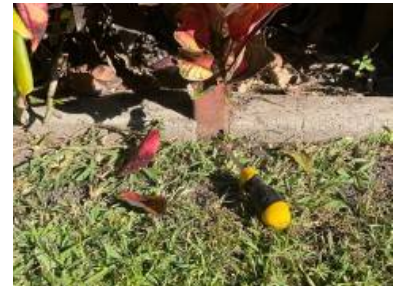
All accessible areas 1 metre off the ground requires handrailing and/or barrier to comply with building codes. Rails are required to be 1 metre high x 125mm maximum spacing between members. The handrails/balustrade do not comply with the current building codes safety standards, eg. heights and/or spacing, it is this inspectors opinion that they be upgraded. Deck floors are weathered. Timber treatment is recommended to prevent deterioration.

Moderate to extensive rust/corrosion to metal posts supporting structure. Rectification required.

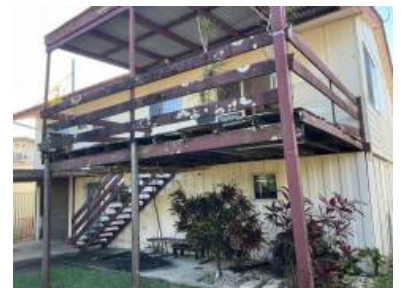
Constructed from timber and metal The general condition of this structure is poor. Repairs or maintenance is required.

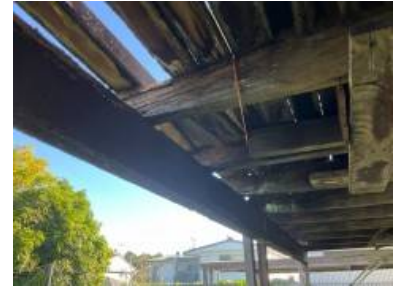
Defects or Maintenance Items: Severe wood decay is present to the structure. Repairs or replacement of some timbers will be required. The area is considered to be structurally unsound and the area should not be used until it is repaired and/or replaced.

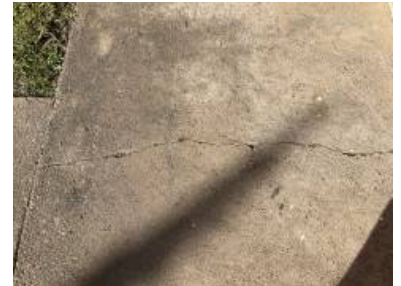
Cracking of Building Elements The concrete shows signs of minor cracking. This is considered an appearance cracking, recommend to monitor these areas regularly for any changes.

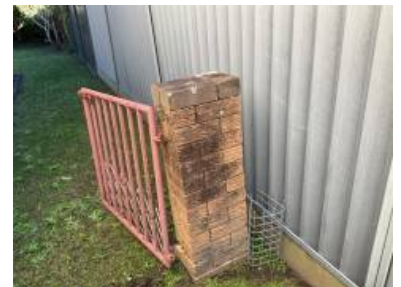
Fences Type & Condition: The fences are constructed from, Timber. Metal. Brick. The fences are generally in fair condition. Some fence piers and/or panels are loose/ not secured adequately and repairs are required.

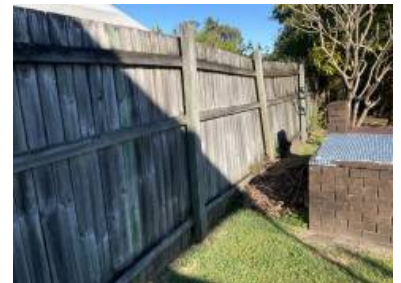
Fences have signs of decay. Repair/Replace where required. The fences are leaning and repairs are required.

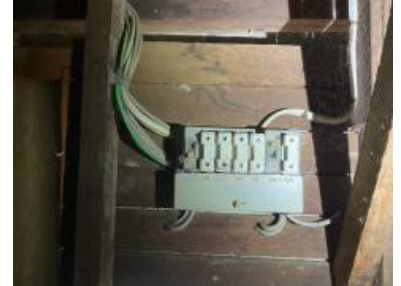
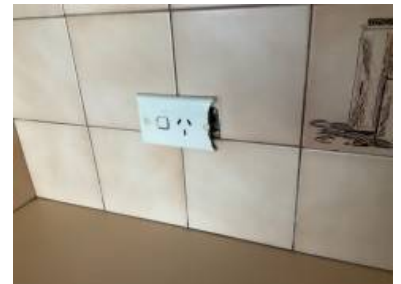
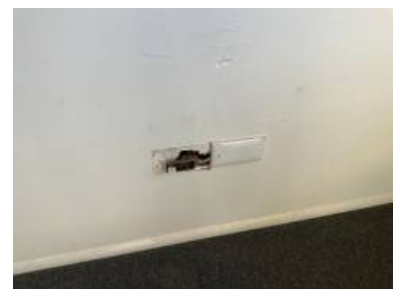
No Safety Switch installed. The law states that an earth leakage circuit breaker (safety switch) be installed. An electrician should be engaged to install a safety switch.

Some electrical switches/ power points require maintenance and should be checked by an appropriately qualified contractor.

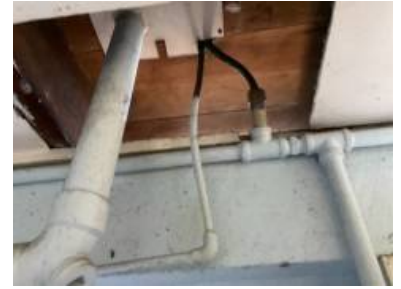
The visible water lines are in copper and galvanised steel. The galvanised pipe will corrode internally and should be replaced with copper or polybutylene. Due to the age of the building, it is essential that a separate special purpose report be obtained from a licensed Plumbing contractor on the entire plumbing system.
