## **VISUAL PEST INSPECTION REPORT**

Inspection Date: 01/07/2025.

121 Mayes Ave, Kingston QLD 4114.

# VISUAL TIMBER PEST INSPECTION REPORT

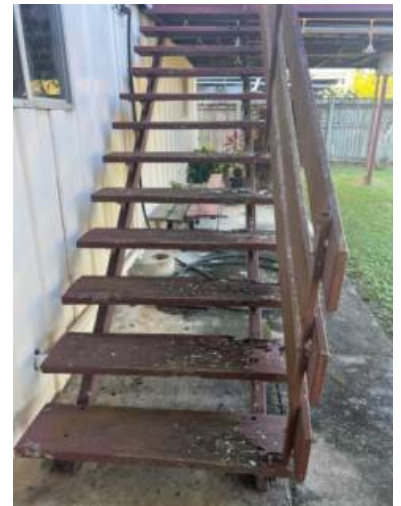
Steps/stair timbers.

Visible timber damage appears moderate to severe however, this opinion is based on a visual inspection. We recommend a special purpose report to this area be carried out by a licenced and practicing Builder. Refer to the definitions section of this report.

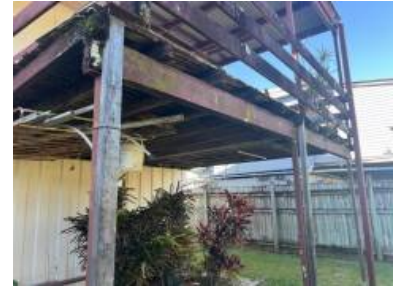
Decking timbers. Handrail timbers.

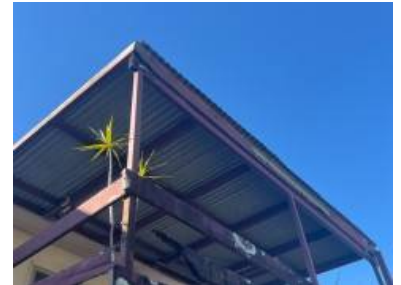
Verandah timbers.

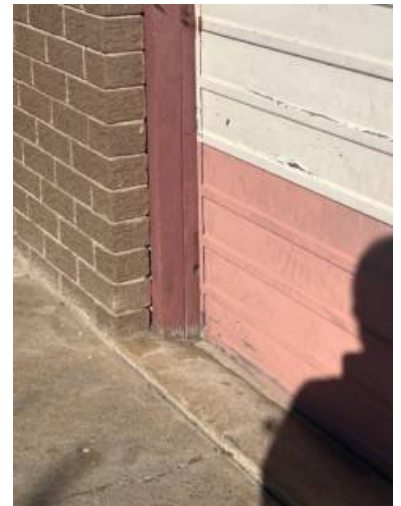
Some external timbers are in contact with the ground. These should be modified so that timber to ground contact does not occur.

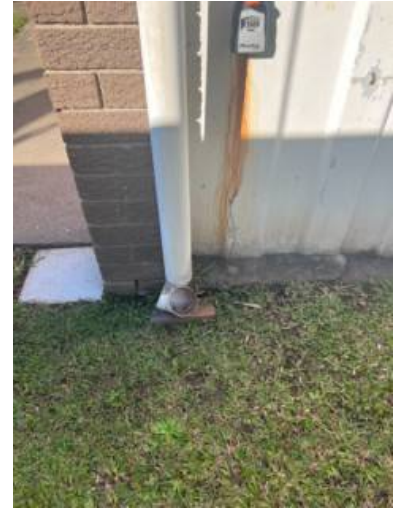
Some gutters and/or downpipes appear to discharge rainwater directly adjacent to the foundations of the structure. These should be connected to a stormwater dispersal system.

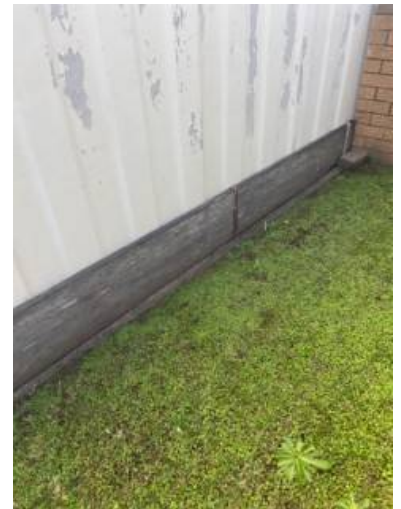
We strongly recommend the immediate removal of stored timbers adjacent to external walls of the building. Stored timbers such as these are highly attractive to termite attack and can allow currently concealed termite entry to the building.

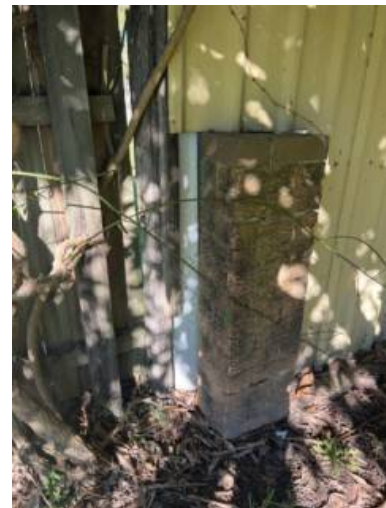
Left hand side:

Yes - Inspection revealed currently inactive termite attack (damaged timbers and/or termite workings) within this area including but not necessarily limited to the following timbers and the areas listed below.

Visible timber damage appears minor to moderate however, this opinion is based on a visual inspection. A special purpose report can offer a more detailed description. Refer to the definitions section of this report.

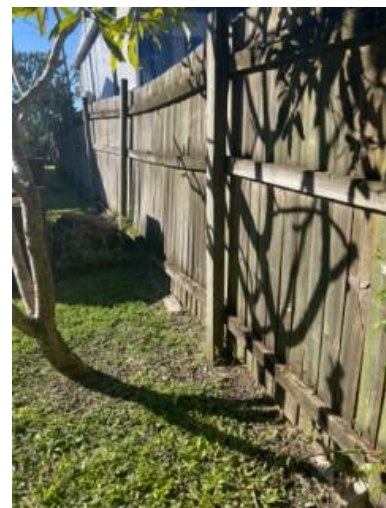
Left hand side:

Yes - Wood decay damage was noted to the following timbers/areas.

Visible timber damage appears minor to moderate however, this opinion is based on a visual inspection. A special purpose report can offer a more detailed description. Refer to the definitions section of this report.

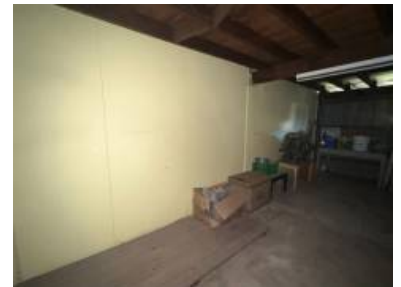
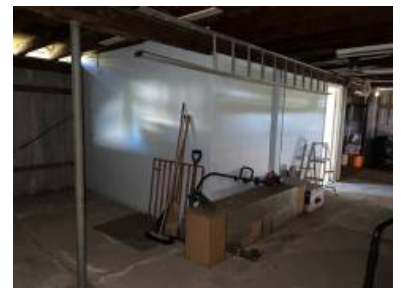
**Description** Partition walls/ lined sections in subfloor do not have adequate ant capping and therefore are at risk of undetected termite entry. These walls should be modified to allow a visual inspection of presently concealed timbers. A chemical treatment or physical termite barrier may be installed to minimize the risk of undetected termite entry.

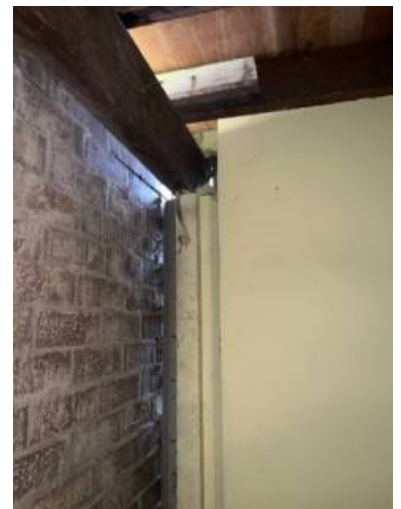
We note the general lack of ant capping or deficiencies. The purpose of ant capping is to reduce the risk of concealed termite attack. As the Ant capping is not continuous or adequate, the option to replace ant capping is not normally economical. Ant capping is installed at the time of construction, and therefore is embedded in the buildings structure. So in this case the most economical procedure is to install a termite management system in accordance with the current building codes and best practices the termite management.

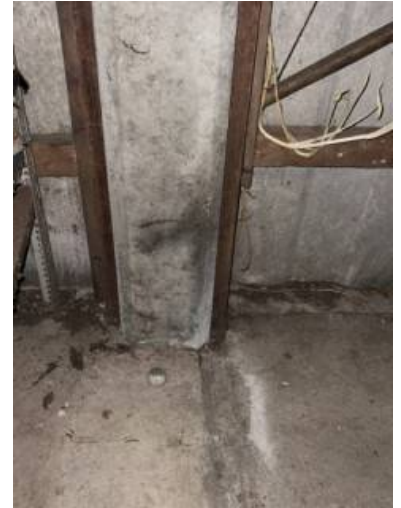
Some timber battens/screening is in contact with ground. These should be modified so that timber to ground contact does not occur.
