# Timber Pest Inspection Report

## F04 Timber Pest Inspection Report

23 Oct 2024

**AS 4349.3-2010: Inspection of Buildings - Timber Pest Inspections**

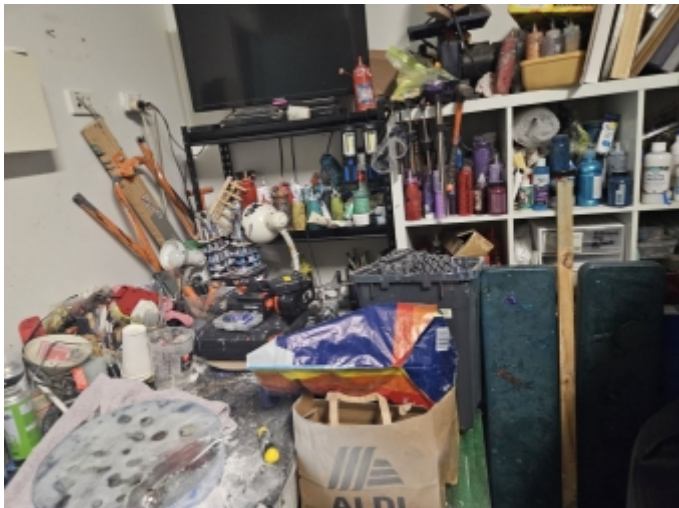
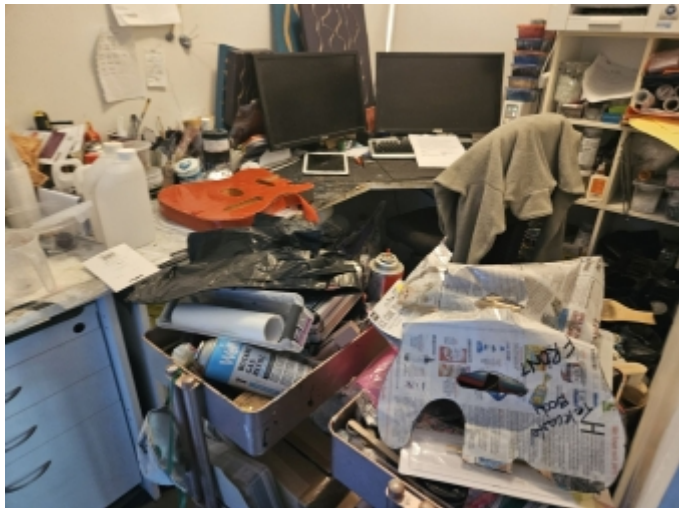
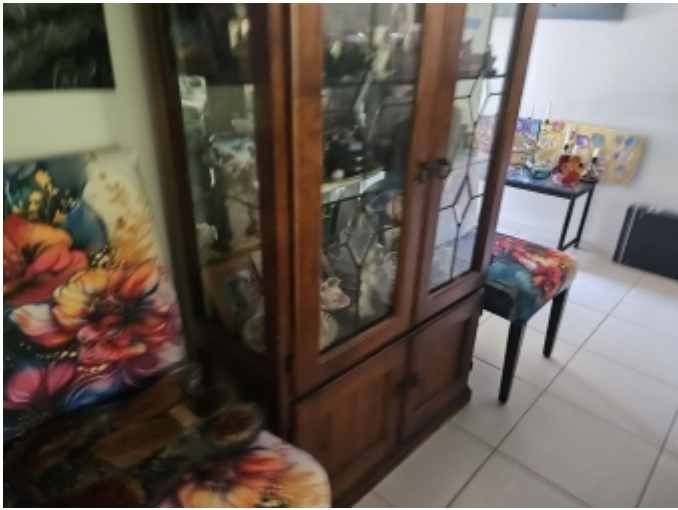
Additional Comments: Obstructed access to walls in garage/ due to stored items The visual inspection of the external wall was obstructed due to no access (zero boundary)

It is important to note that as an inspection of the above areas was not possible at the time of the inspection, timber pest activity or damage may therefore exist in these areas.

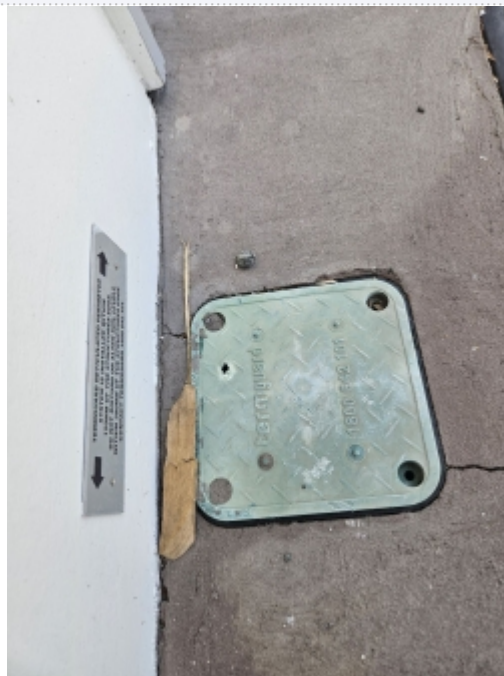
Description of the evidence found:	Other
------------------------------------	-------

Other	Termite reticulation
-------	----------------------
