# **VISUAL BUILDING INSPECTION REPORT**

Inspection Date: 22/07/2025.

27 Cramp St, Goodna QLD 4300.

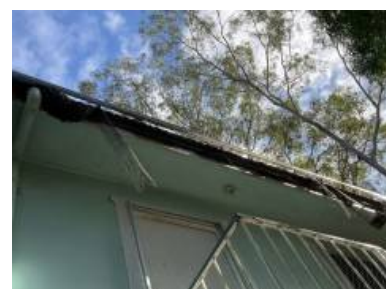
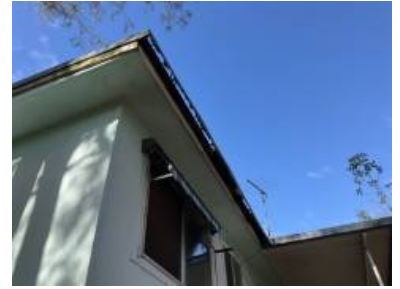
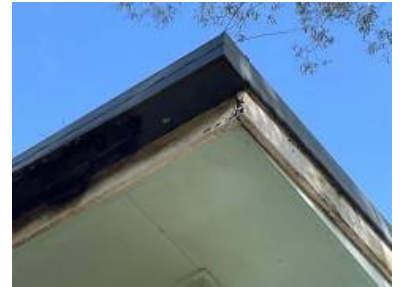
**Condition:** Gutters are rusting. These should be repaired or replaced where necessary.

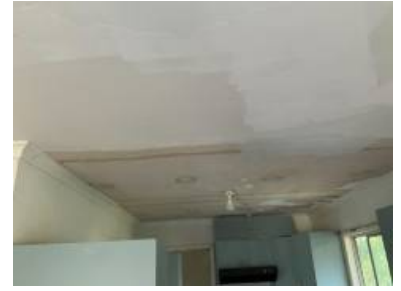
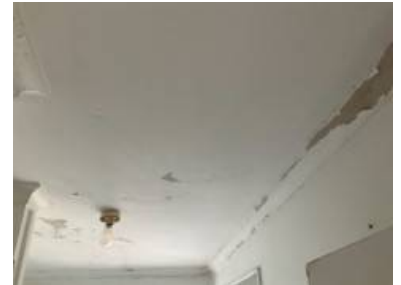
The condition of the ceilings is generally poor. Handyman quality works noted to painting in areas, this does not indicate that the work is inadequate, simply stating that all factors to do with professional finish may not have been considered. Peeling paint was noted to ceilings. Patching and painting will improve overall appearance.

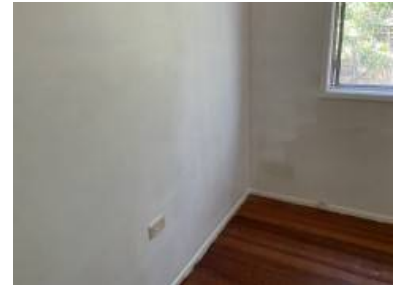
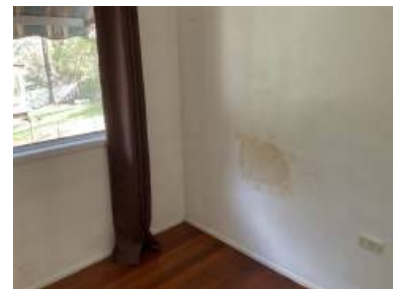
The condition of the walls is generally poor. Mould was noted to the walls. The cause should be investigated and rectified. Handyman quality works noted to painting in areas, this does not indicate that the work is inadequate, simply stating that all factors to do with professional finish may not have been considered. Patching and painting will improve overall appearance.

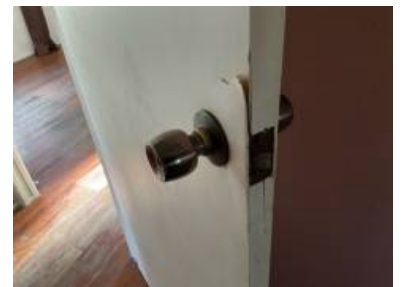
The condition of the doors is generally poor. Splitting to door near lock noted. Repair or replacement of door in recommended.

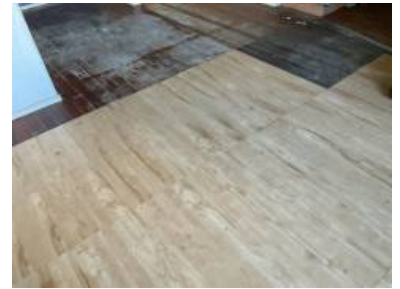
Floors are concealed by floor coverings to various areas. Handyman quality works noted to timber flooring, this does not indicate that the work is inadequate, simply stating that all factors to do with professional installation or finish may not have been considered.

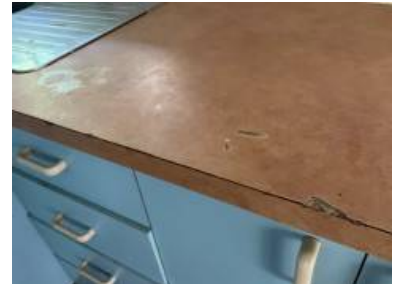
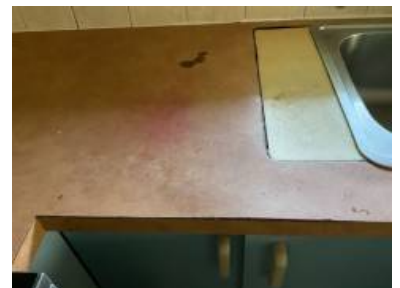
The condition of the fixtures is generally poor. Budgeting for replacement should be considered.

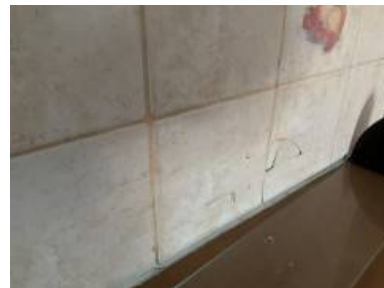
Some cracked tiles were noted to walls in areas.

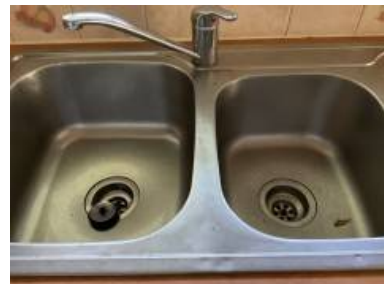
Appears serviceable, Drain appears serviceable. Blemishes to the surface of the sink.

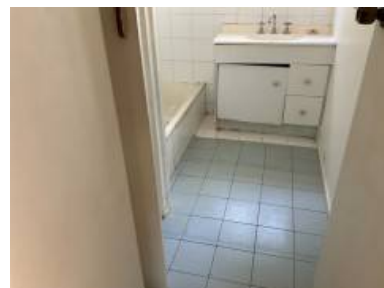
Paint peeling on ceiling from bathroom steam. Improvement to room ventilation is recommended. Timbers in bathroom areas such as corner mouldings, skirtings and architraves will need to remain sealed/painted to prevent moisture penetration and deterioration.

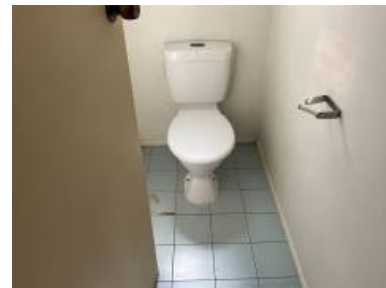
The toilet is a dual flush type. The Flush button to toilet is faulty and requires repair or replacement.

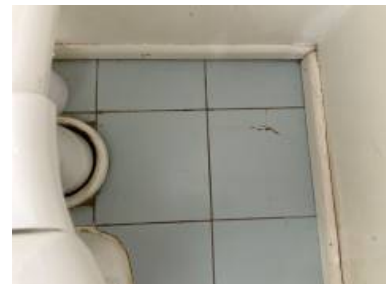
Cracked floor tiles are present.

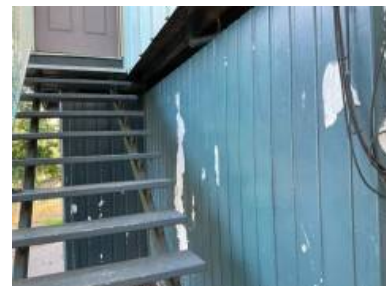
The condition of the walls is generally fair. General wear and tear is noted. Paint deterioration was present to external surfaces. The exterior of the structure requires overall maintenance, further advice into the extent of maintenance & associated costs should be obtained.

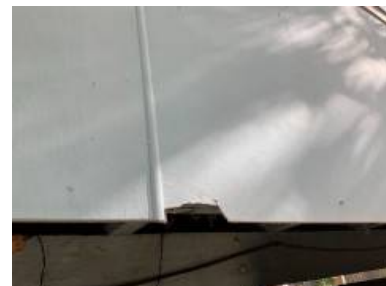
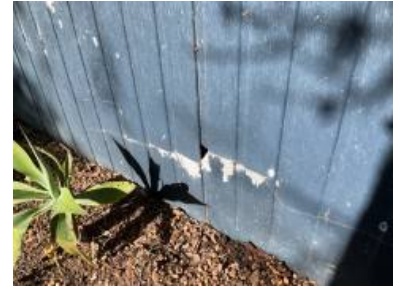
The external Asbestos (suspected) fibro wall cladding is damaged and deteriorated to various external areas. Repairs/ replacement are required. Further investigation in relation to asbestos containing products must be conducted. Contact an appropriately licenced asbestos specialist to advise on the extent of repair/ replacement and associated costs.

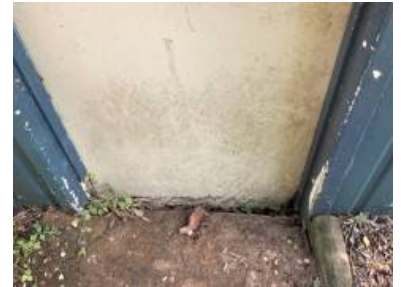
The condition of the exterior of the windows is generally fair. The face is lifting off the external side of some doors. This is due to weathering. Repair or replacement of door is recommended. The bottom of some doors have moisture damages and swelling at the base of the door, this is due to not all of the door has been sealed/ painted to prevent moisture entering timber. Recommend to replace door or maintain, seal/paint all edges to prevent further deterioration. Some general repairs and maintenance required to screens and frames (e.g. Replace damaged screens & self closers to doors where required).

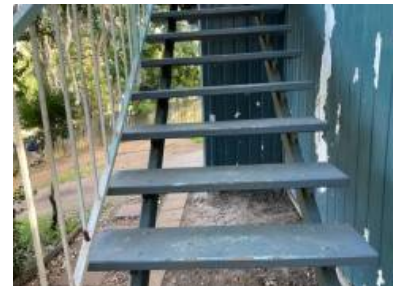
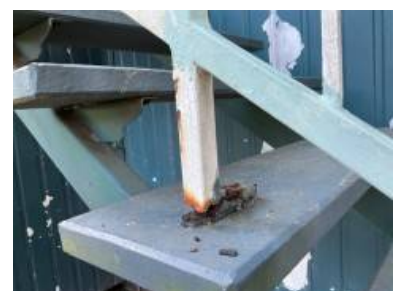
The overall condition of the stairs is fair. The stairs are constructed primarily of metal and timber. Moderate to extensive rust/ corrosion to sections of metal handrail, rectification required.

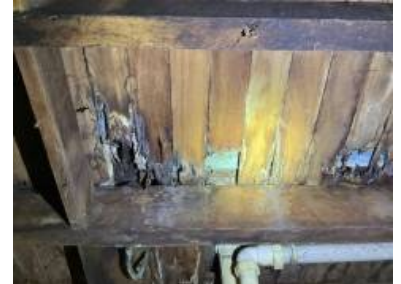
**Description:** Severe wood decay damage was noted. Further investigation, repairs/replacement of members will need to be carried out.

**Affected subfloor timbers** Flooring timbers.

**Below the following location or area:** Bathroom.

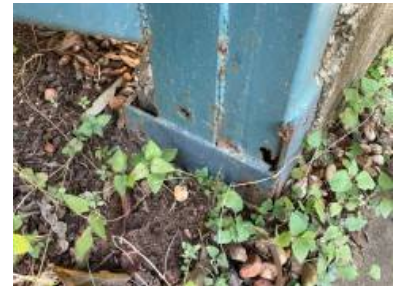
**Type & Condition:** Moderate to extensive rust/corrosion to metal posts supporting structure. Rectification required.

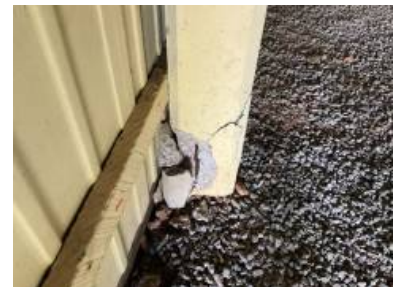
Cracked concrete stumps noted. The reinforcement steel to stumps is rusting and causing stumps to crack. This is considered a serviceability defect. Recommend a suitable experienced restumping contractor to further investigate and give probable cost of replacement/rectification.

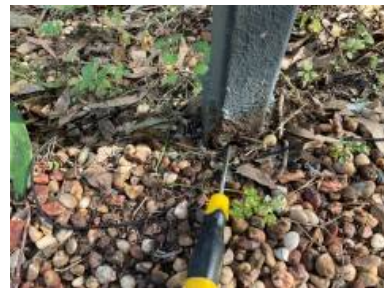
**Defects or Maintenance Items:** Moderate to extensive rust/corrosion to metal posts supporting structure. Rectification required.

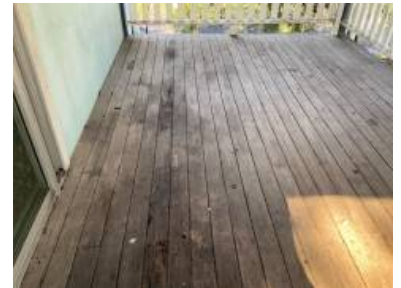
Leaves and debris are present in gutters. These should be cleared. Removal of debris will extend life of guttering and prevent water penetration to roof cavities.

Fixing of handrails to posts should be upgraded due to the age of the fixing. Loose vertical timbers noted. Handrailing to decks and stairs requires some repairs and maintenance. Safety concerns. Deck floors are weathered with some moderate wood decay to areas. Some deterioration to tops of floor joists would be expected if floor is lifted. Some maintenance is advised.

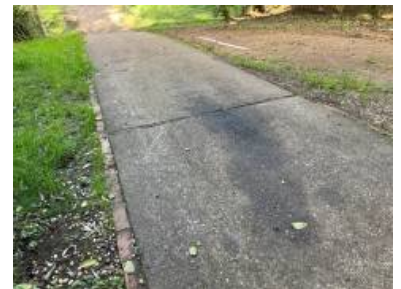
The concrete shows signs of minor cracking. This is considered an appearance cracking, recommend to monitor these areas regularly for any changes.

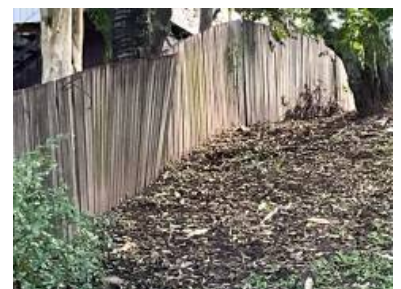
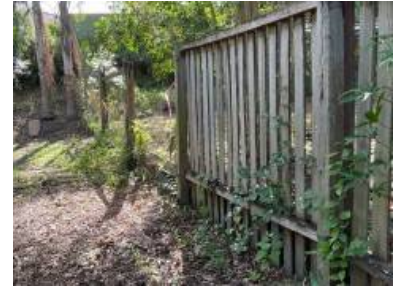
The fences are constructed from, Timber. The fences are generally in poor condition. Fences have signs of decay and termite activity/damage. Refer to timber pest inspection report. The fences are leaning and repairs are required.

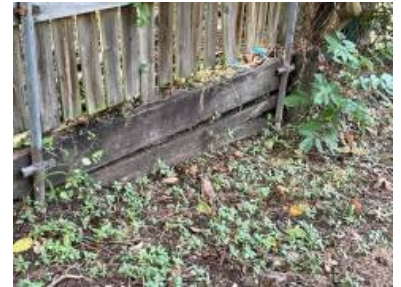
The timber retaining walls show normal deterioration and should be monitored. Moderate wood decay damage was noted. Repairs and maintenance are recommended.

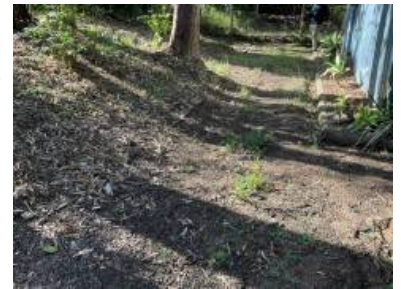
Surface water run off appears to be directed in the direction of the dwelling. All surface water should be diverted away from house footings/foundations. The retention of water from inadequate surface run off could have effect on the foundation material which in turn could affect the footings of the building. Recommend to install surface diversions/drainage to control the flow of surface water.

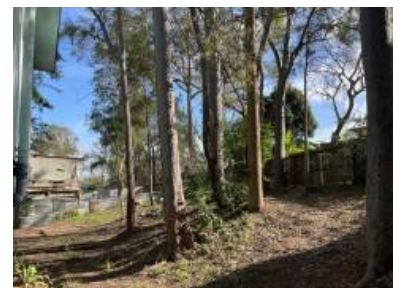
Mature trees located in close proximity to the building. Having trees close to the building can lead to problems such as leaves blocking gutters and downpipes, tree branches falling onto house, and are conducive to undermining/movement of the building foundations. Recommend engaging a suitably qualified and experienced arborist (tree specialist) or tree lopping contractor to advise on the best course of action and associated costs.
