## **VISUAL PEST INSPECTION REPORT**

Inspection Date: 22/07/2025.

27 Cramp St, Goodna QLD 4300.

# VISUAL TIMBER PEST INSPECTION REPORT

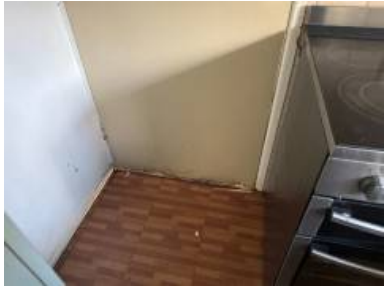
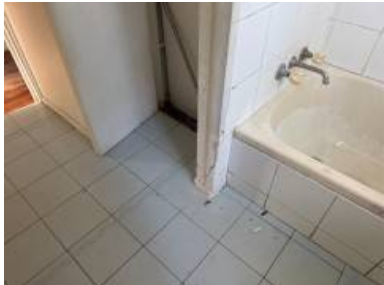
| <b>Description</b> | Yes - Wood decay damage was noted to the following timbers/areas. |

Doors, Skirting timbers. Architrave timbers.

Bathroom. Kitchen.

Visible timber damage appears minor to moderate however, this opinion is based on a visual inspection. A special purpose report can offer a more detailed description. Refer to the definitions section of this report.

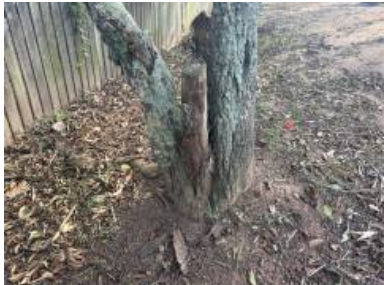
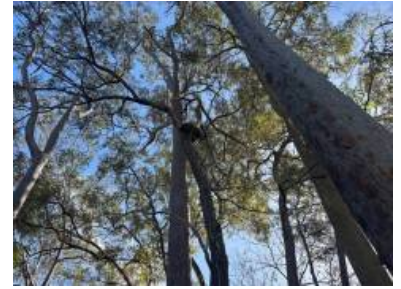
Tree(s).

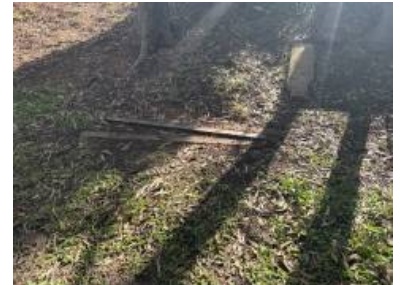
Loose timbers on ground or in ground.

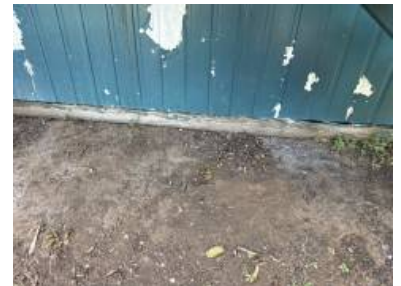
Yes - Inspection revealed currently inactive termite attack (damaged timbers and/or termite workings) within this area including but not necessarily limited to the following timbers and the areas listed below.

Sleepers or timber landscaping materials.

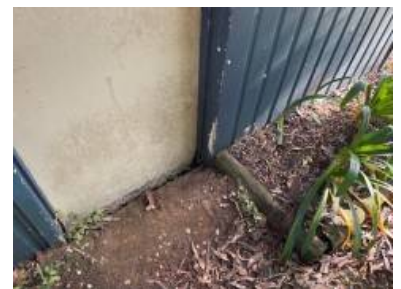
Door frame timbers.

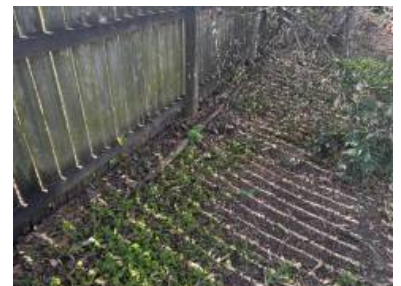
Loose timbers on ground or in ground.

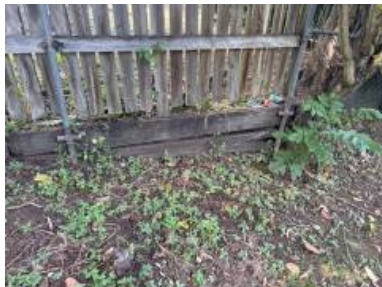
| Description | Yes - Wood decay damage was noted to the following timbers/areas. | | |
| Affected external timbers | Timber retaining walls. | | |

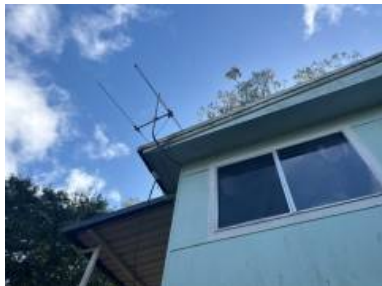
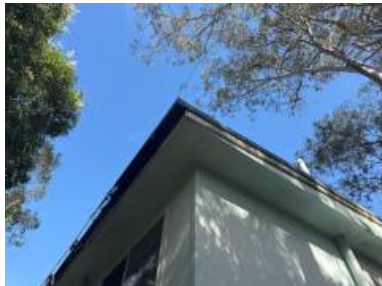
| | Fascia timbers. | | |

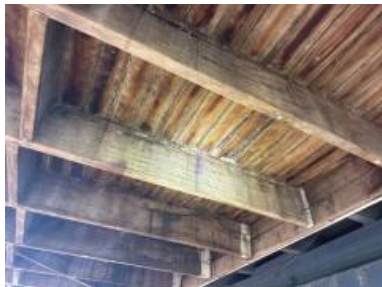
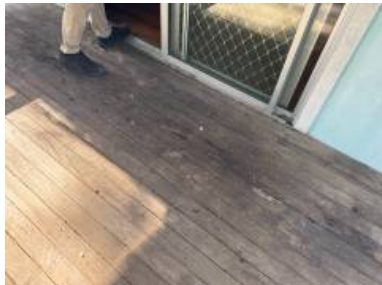
| | Decking timbers. | | |

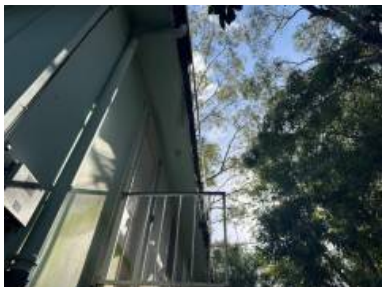
| <b>Description</b> | Some gutters and/or downpipes appear to discharge rainwater directly adjacent to the foundations of the structure. Due to damaged pipes or poor connections. These should be repaired as moist soil conditions are highly conducive to timber pest attack. | |

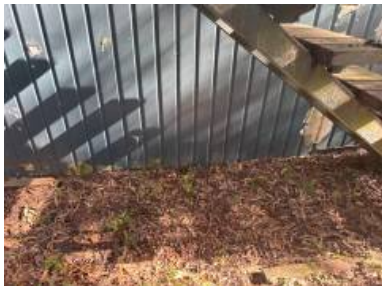
| | External cladding/ screening is in contact with the ground/ & or in very close proximity to the ground. This can allow concealed termite entry and we recommend modifications be made so that ground is not in contact with cladding. | |

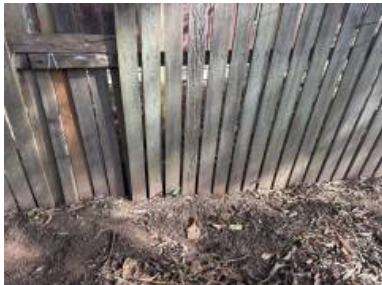
| <b>The termites are believed to be</b> | <i>Microcerotermes</i> spp. | |
| <b>Affected fence timbers</b> | Right hand side fence: Left hand side: | |
| <b>Severity</b> | Visible timber damage appears minor to moderate however, this opinion is based on a visual inspection. A special purpose report can offer a more detailed description. Refer to the definitions section of this report. | |

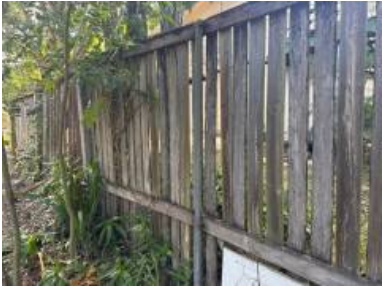
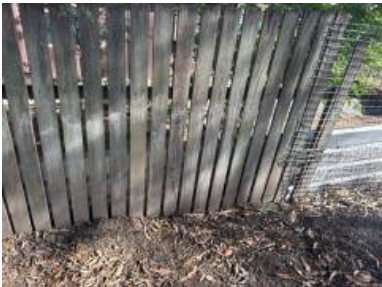
| <b>Damage caused by termites found</b> | Yes - Inspection revealed currently inactive termite attack (damaged timbers and/or termite workings) within this area including but not necessarily limited to the following timbers and the areas listed below. |
| <b>Affected fence timbers</b> | Various fencing timbers: <div></div> |
| <b>Severity</b> | Visible timber damage appears minor to moderate however, this opinion is based on a visual inspection. A special purpose report can offer a more detailed description. Refer to the definitions section of this report. |

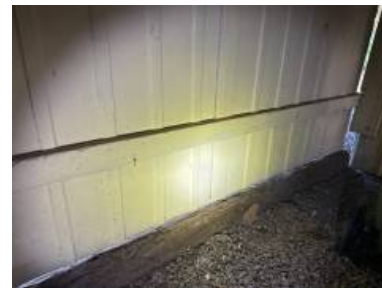
Landscaping timbers and muddying on screen screening.

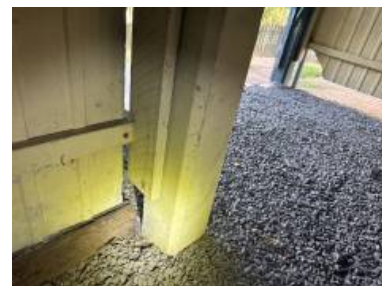
Evidence of muddy on concrete piers.

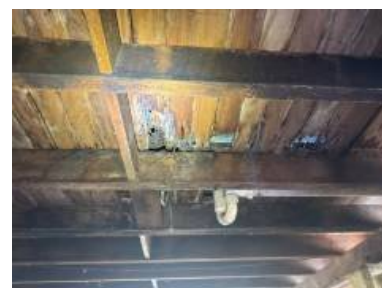
Visible Wall frame timbers. Flooring timbers.

Visible timber damage appears moderate to severe however, this opinion is based on a visual inspection. We recommend a special purpose report to this area be carried out by a licenced and practicing Builder. Refer to the definitions section of this report.

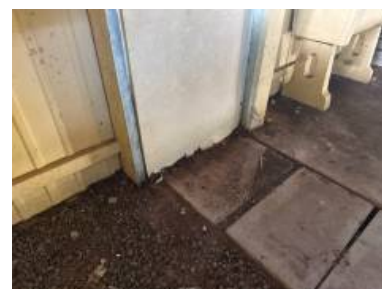
Door frame timbers. Door.

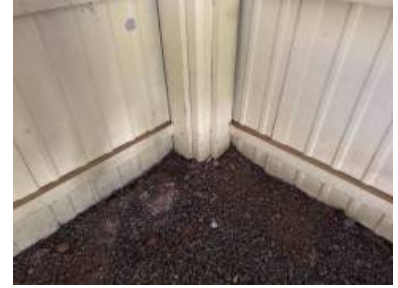
Some timber battens/screening is in contact with ground. These should be modified so that timber to ground contact does not occur.

**Below the following location or area** Right hand section of the structure.
