# Building & Timber Pest Report

Inspection Date: 22 Jul 2025

Property Address: 72 Lower Brighton Terrace Sandgate 4017

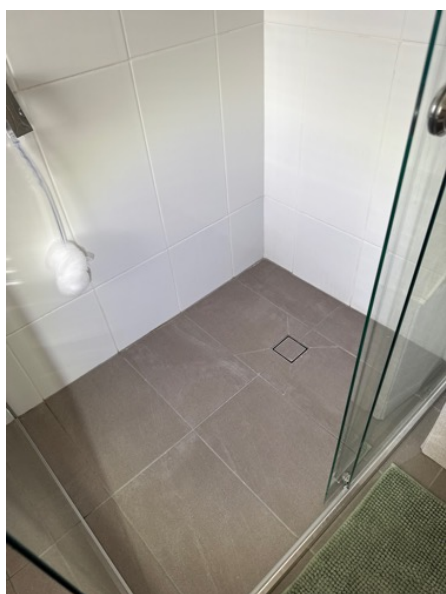
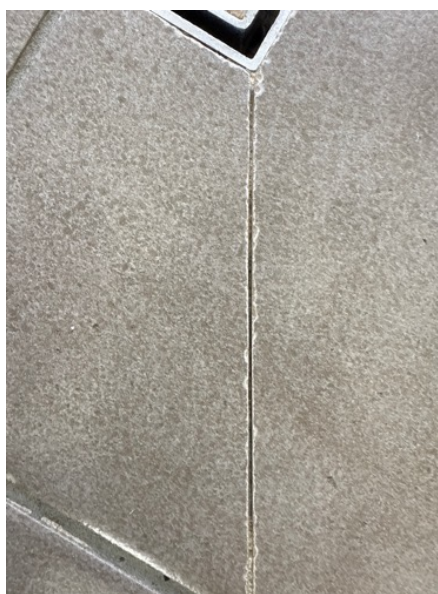
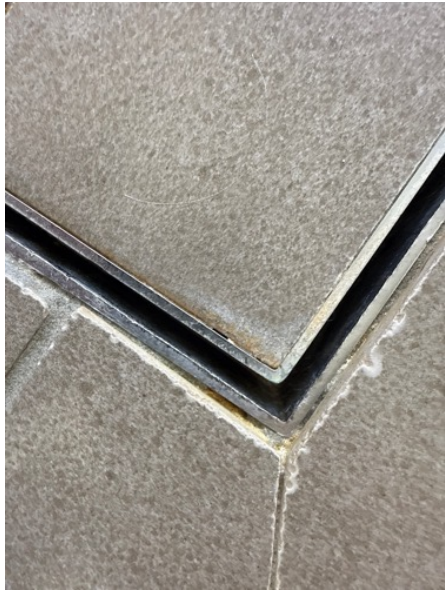
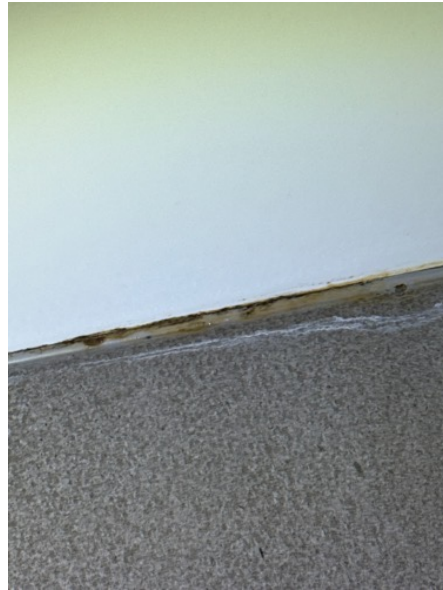
### Minor Defect 1.01

**Finding:** Deterioration to grout and silicon

Deterioration was found to the grout and silicon in the shower area. It is recommended the grout and silicon be replaced to the tiled areas to reduce the risk of water penetration through these areas.

It is recommended a shower restoration company or licensed tiler be engaged to carry out this work.

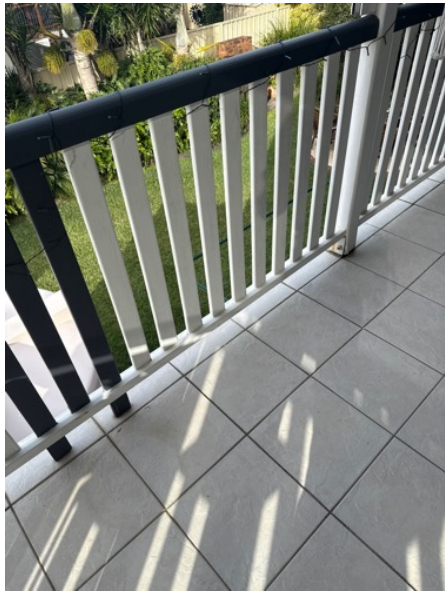
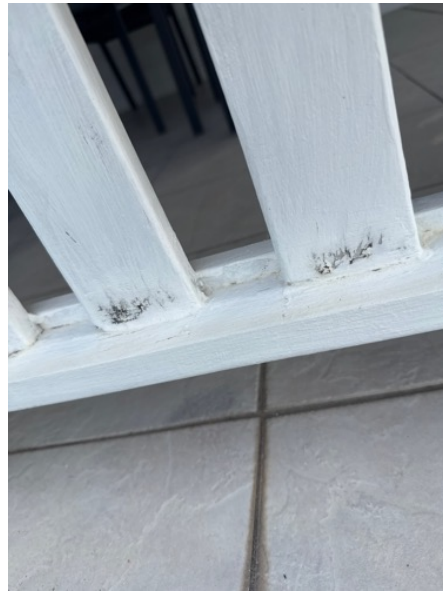
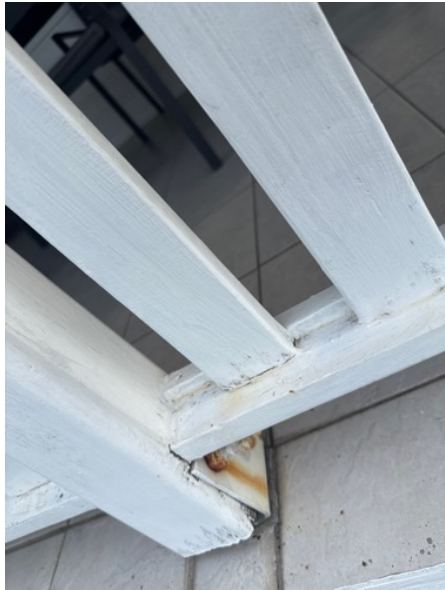
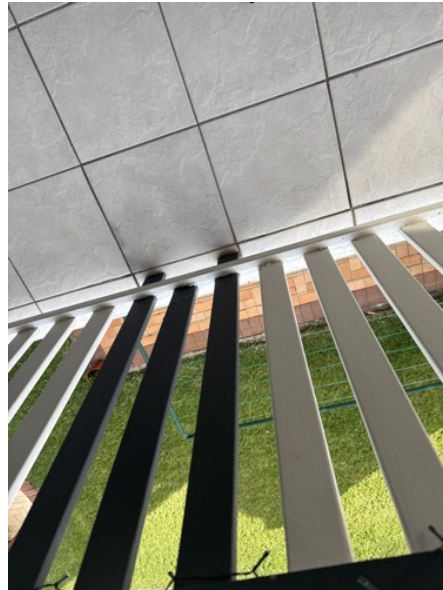
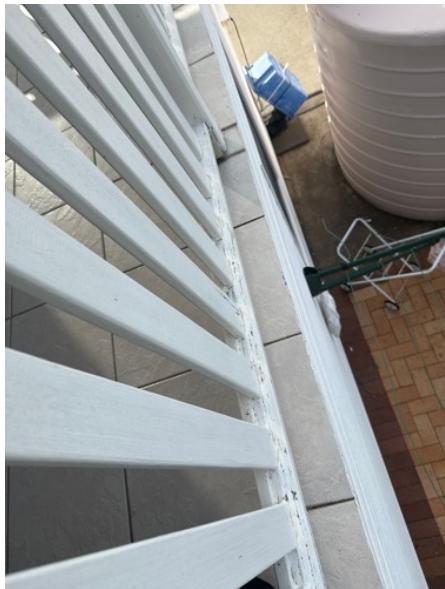
## Minor Defect 1.02

**Location:** Rear Deck

**Finding:** Deterioration to handrails

Deterioration was found in the bottom of the handrails on the rear deck. Some areas will require repair and replacement to ensure safety hazards do not develop. It is recommended a carpenter is engaged to re-nail or replace the balustrades where required.

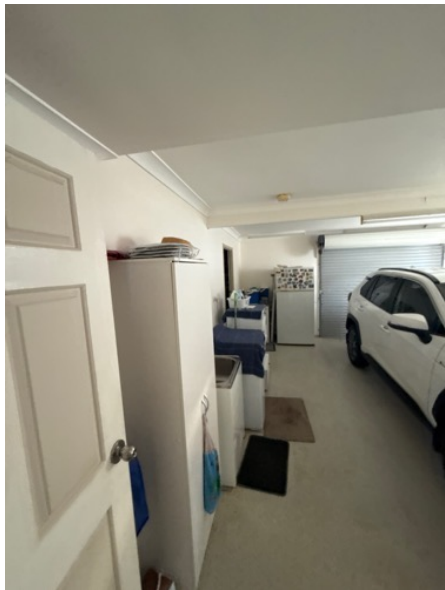
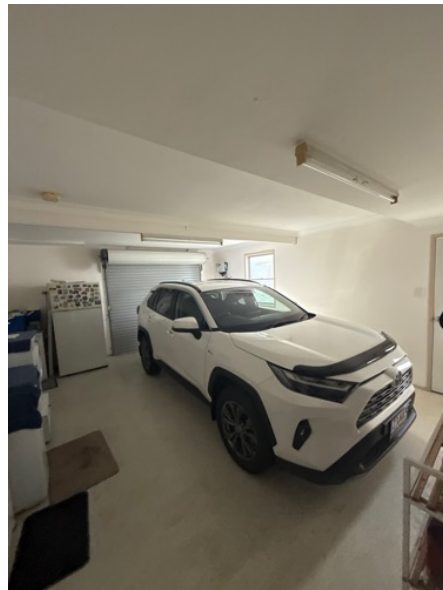
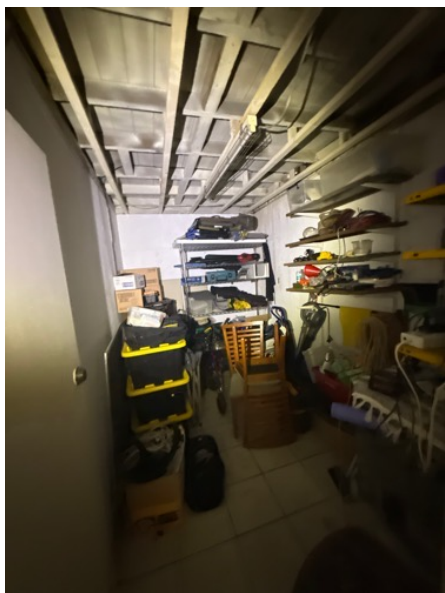
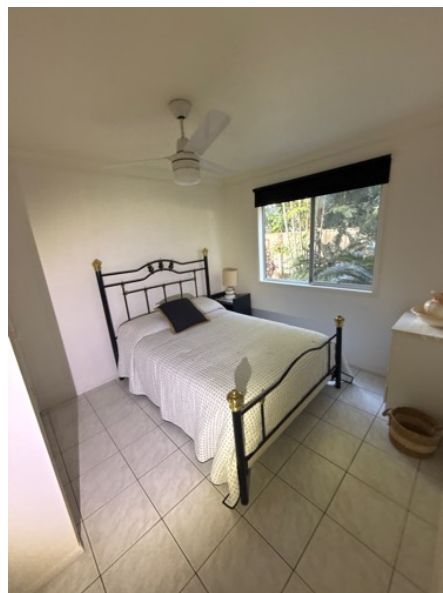
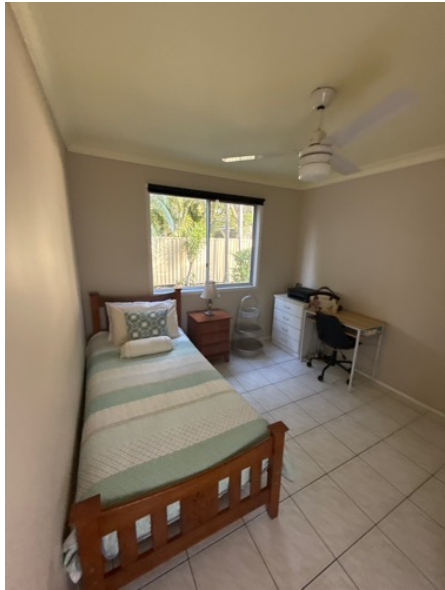
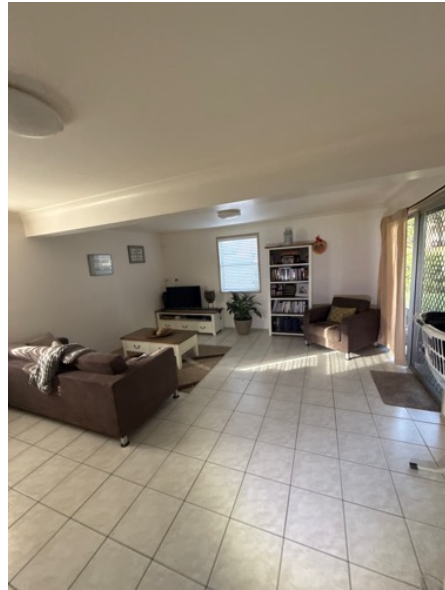
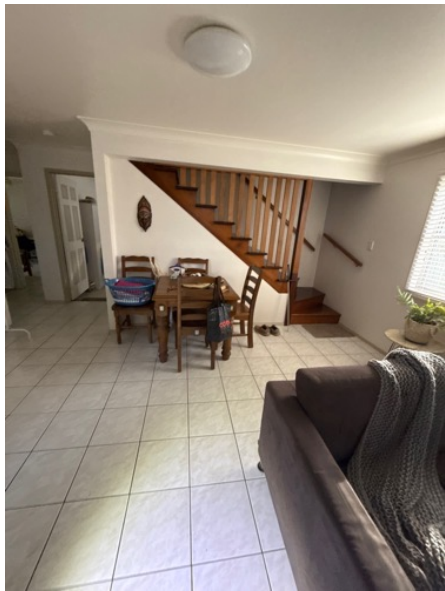
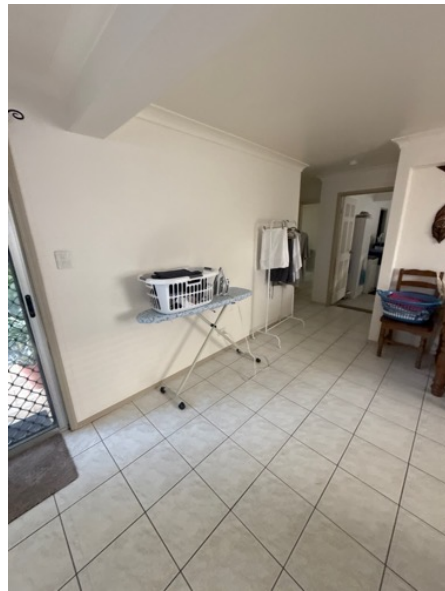
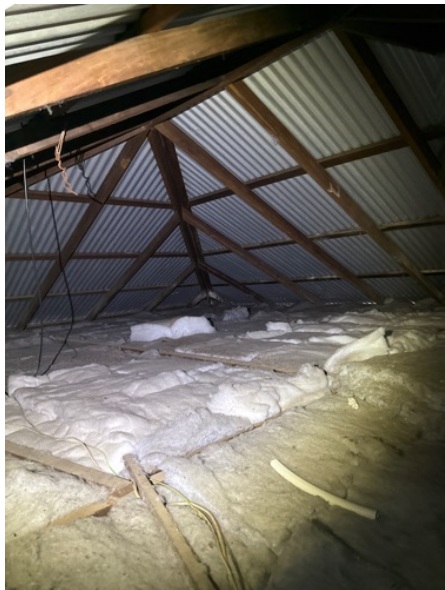
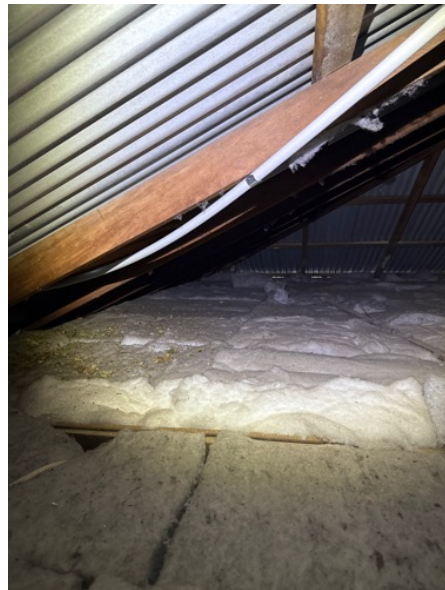
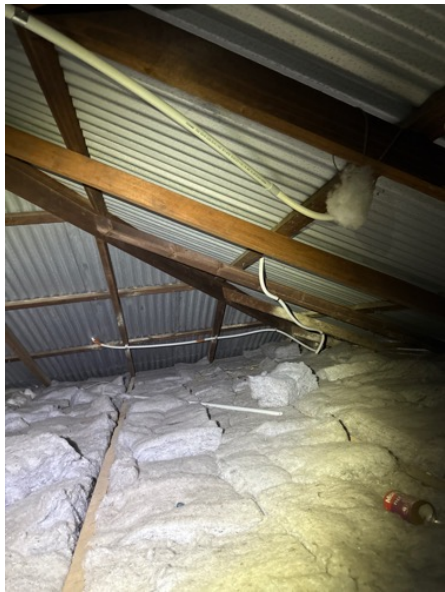
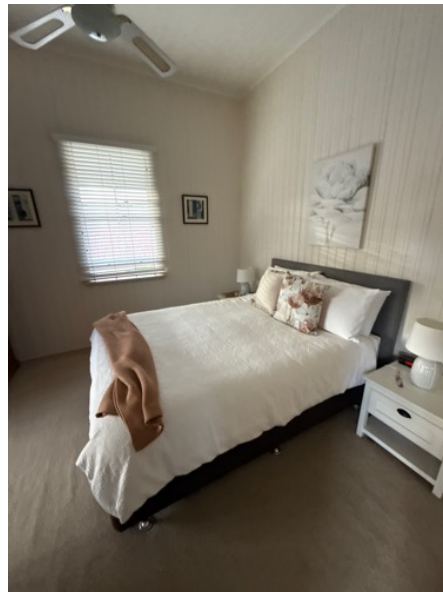
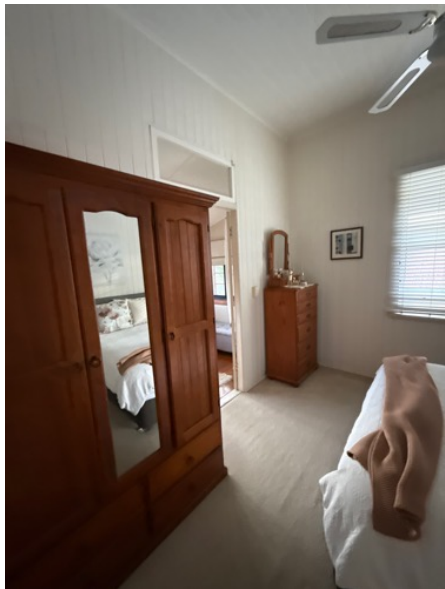
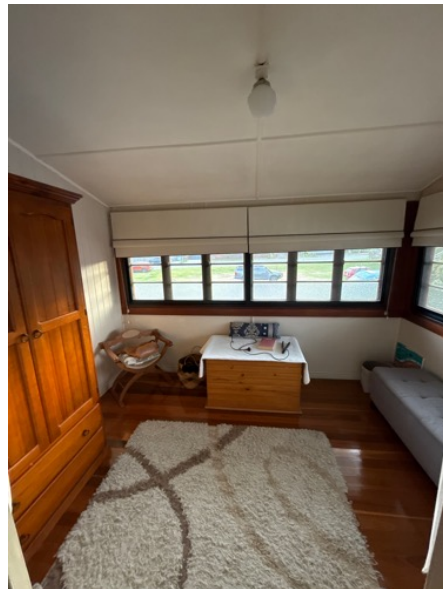
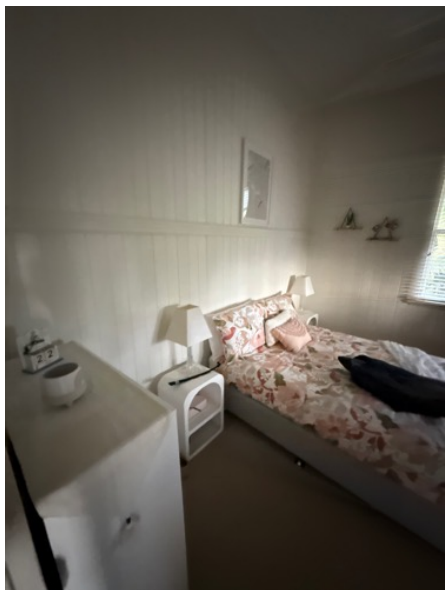
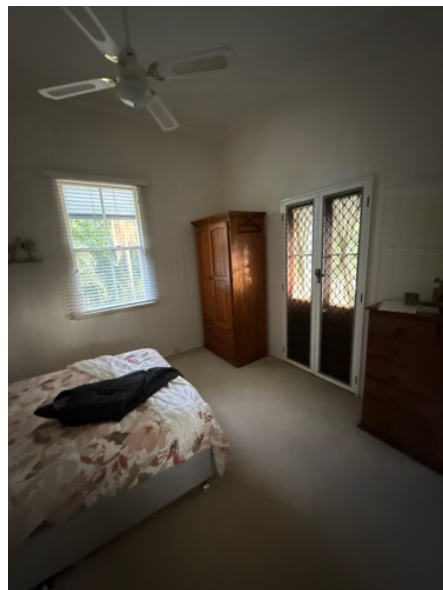
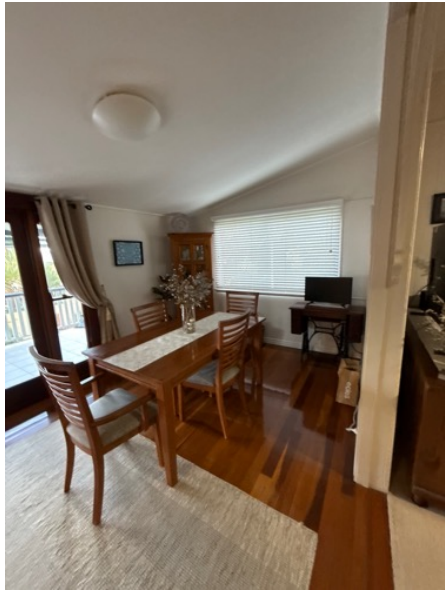
**Finding:** Obstructions and limitations

These photographs are an indication of the obstructions and limitations which impeded full inspection of the property at the time of inspection. These items were unable to be removed or disturbed during the inspection. Where items cannot be removed the level of risk for undetected defects increases.

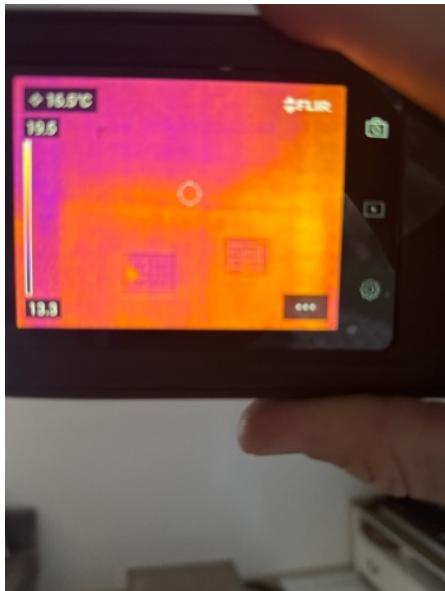
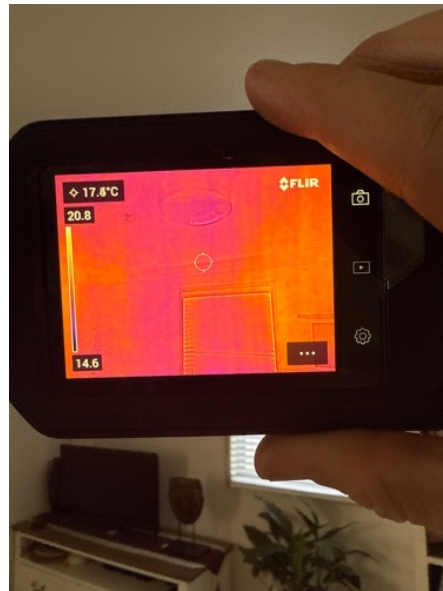
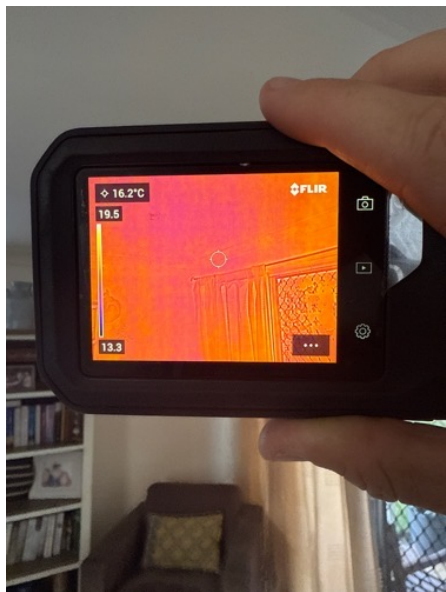
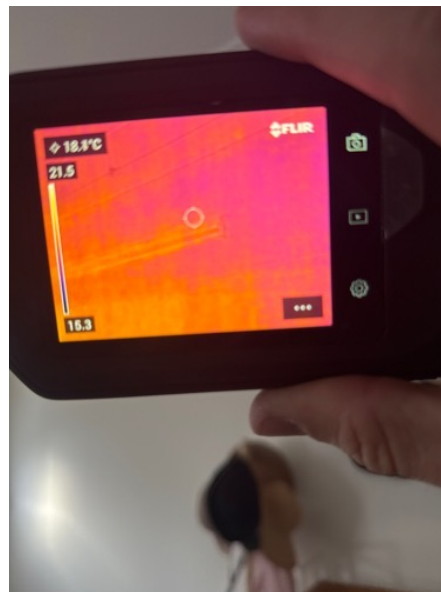
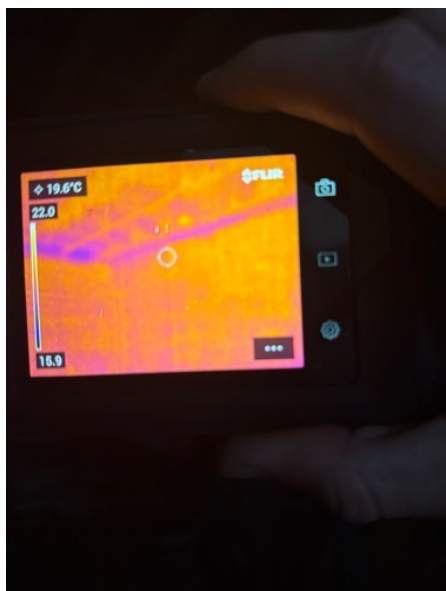
## For your information 2.02

**Location:** All areas

**Finding:** Thermal imaging notes

Thermal imaging was carried out on the property as part of the inspection process. No thermal abnormalities were detected at the time of inspection.

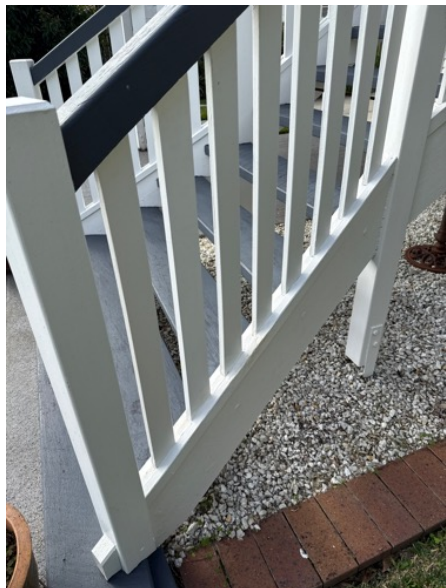
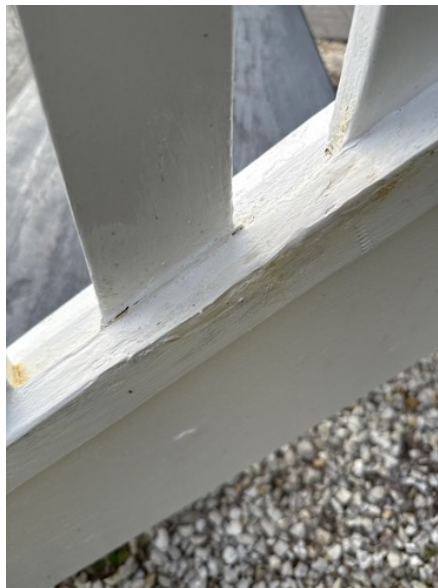
**Finding:** Minor fungal decay in handrails

Minor fungal decay was found in the handrails to the front stairs. The handrails should continue to be monitored as they will continue to slowly deteriorate over time due to their exposure to regular moisture. Repairs and maintenance should be carried out as required over time.

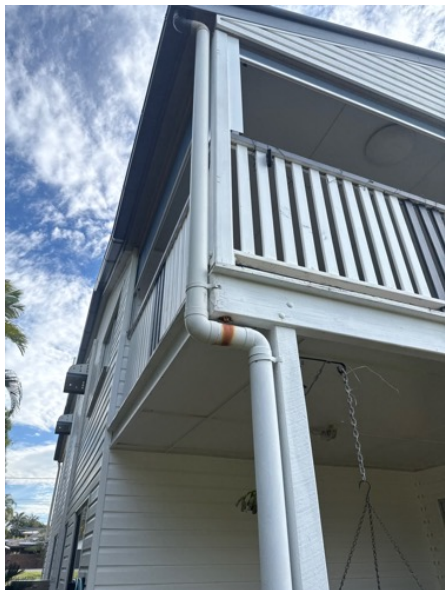
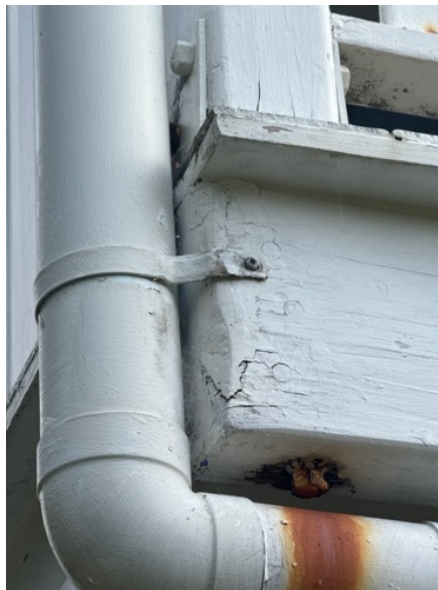
## Timber pest attack 3.02

**Location:** Rear Deck

**Finding:** Fungal decay in corner of bearer

Fungal decay has developed in the corner of the bearer on the rear of the deck. Moisture penetration most likely through the post bracket above has caused decay to develop over time.

The area has been patched which will help prevent further fungal decay however it is likely to slowly deteriorate over time. It is recommended the area around the base of the upper level post be resealed to reduce the risk of any further water penetration. The area should continue to be monitored and re-patched and repainted when required.

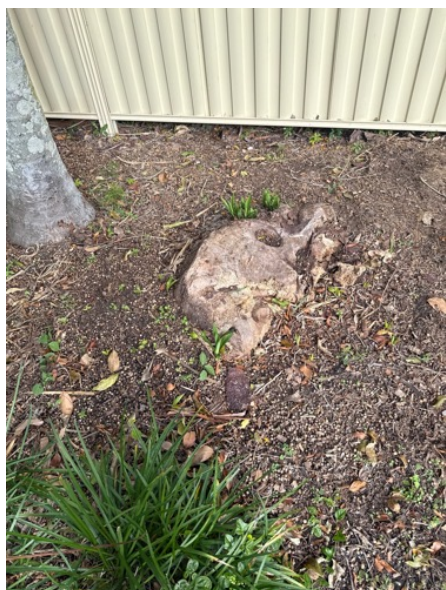
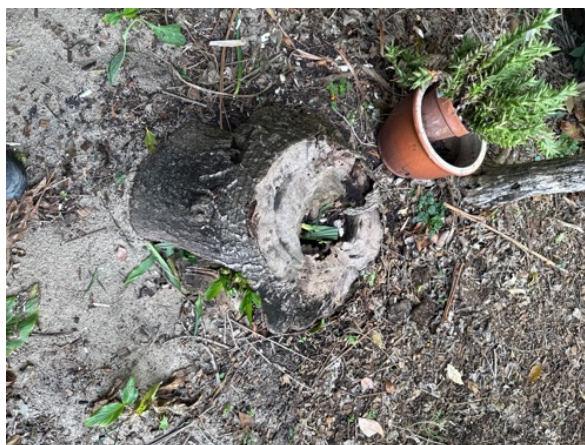
### **Conditions conducive to timber pest attack 3.03**

**Finding:** Tree Stumps in Yard

Tree stumps were found in the yard. Tree stumps are an ideal habitat for termites and make ideal nesting locations. It is recommended they be removed by stump grinding or excavation. Where tree stumps cannot be removed they should be monitored on a regular basis (monthly) by a licensed pest inspector for signs of termite infestation and activity.
