Property Inspection Report

**50 Grove Street,
Albion, 4010, QLD**

Inspection Prepared for:
Jessica Vine

Date of Inspection: 29/7/2025 | Time: 9:00 AM
Weather: Sunny 15 C
Real Estate Agent: Jessica Vine - Vine Property

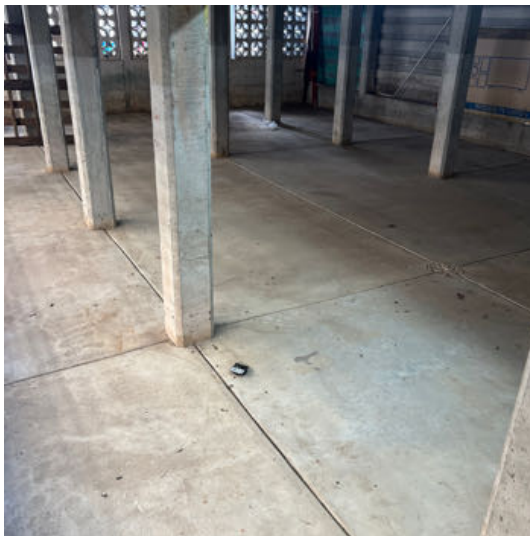
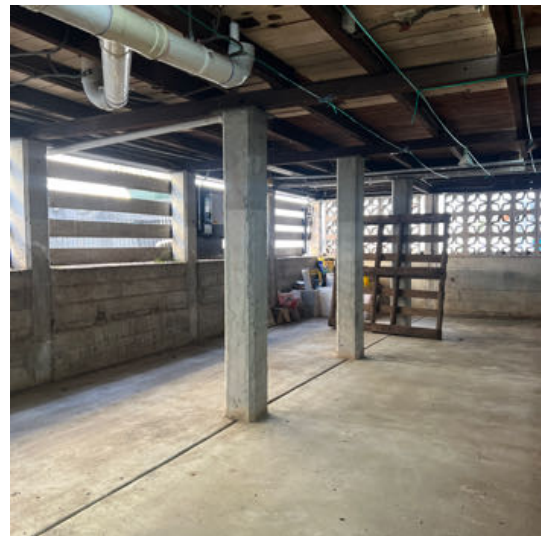
1. Slab Foundation

- There is an infill slab to the home, this slab may or may not be an integral part of the foundation. Joins along these slabs may be vulnerable to entry by moisture and or timber pests such as termites.

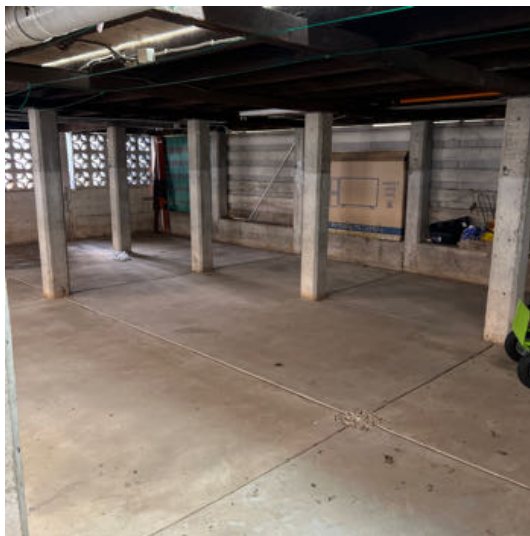
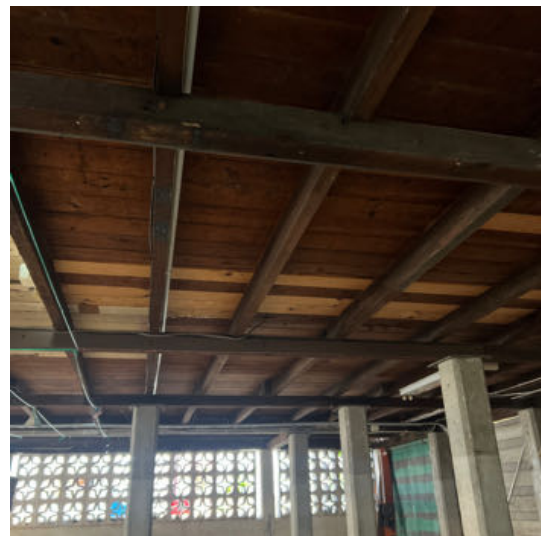
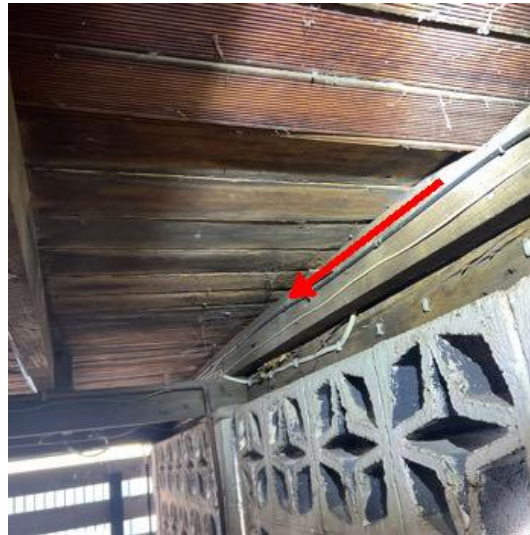
2. Raised Foundations

- Concrete piers
- Timber Beams noted.

- The foundations appear to be performing satisfactorily.
- Some minor wood decay observed on the timber beams.

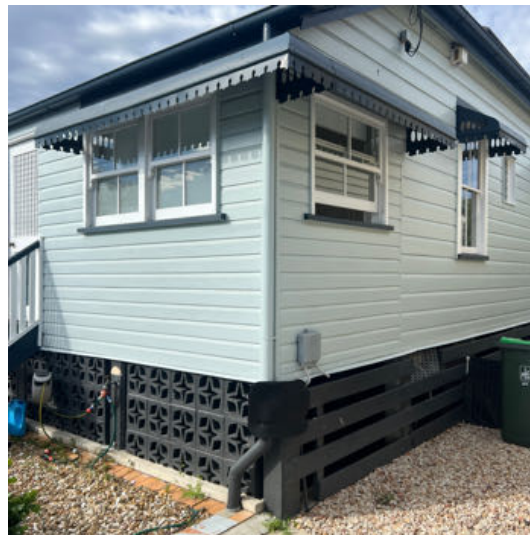
1. Wall Structure

- The wall structure components appeared functional.
- Externals walls are of cladged timber frame construction.

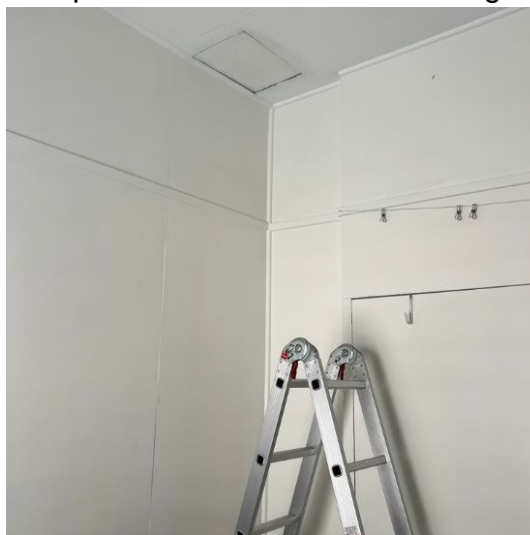
2. Ceiling Structure

- The internal roof space was not inspected as access was not possible on the day of inspection due to the hatch being inaccessible.

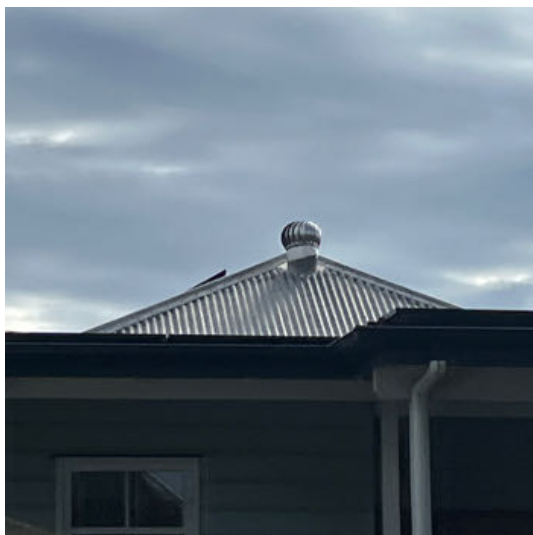
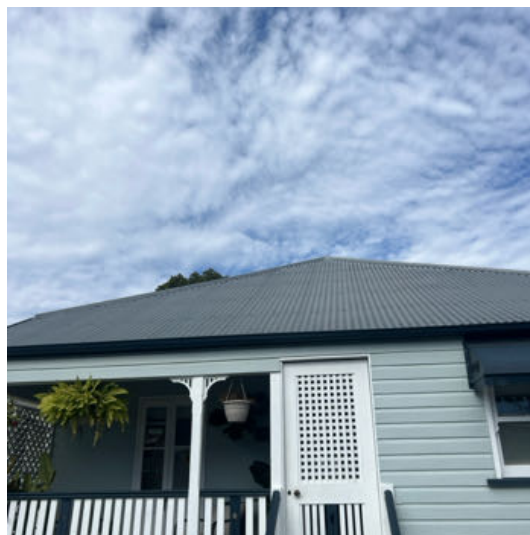
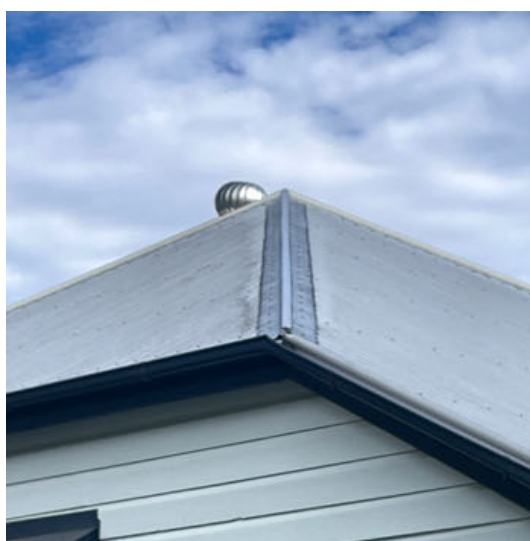
1. Roof Structure

- The metal roofing material appears to be in satisfactory condition.

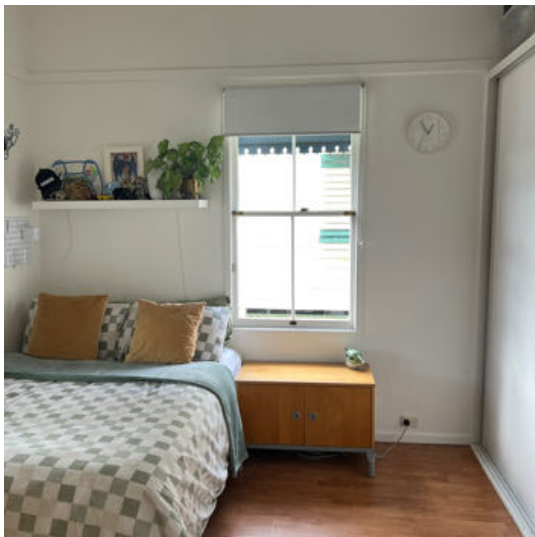
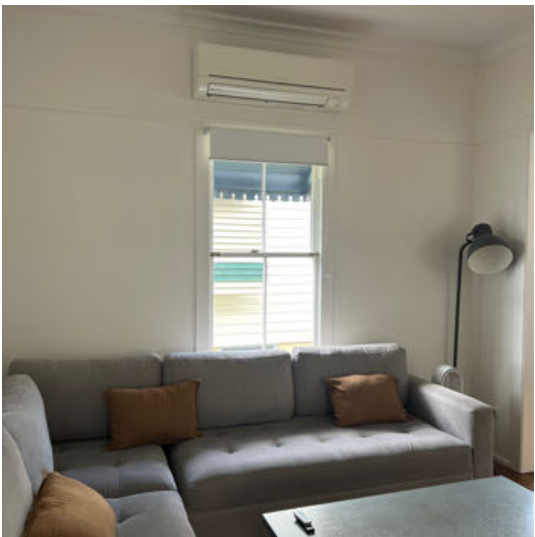
1. Wall Condition

- Plasterboard/gyprock walls noted which appeared functional.

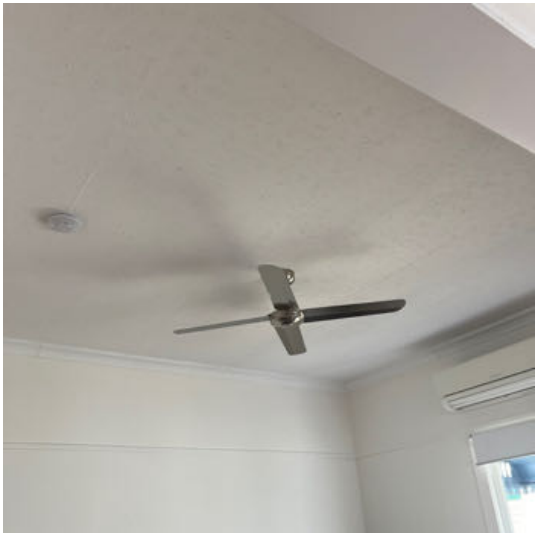
2. Ceiling Condition

- There are plasterboard/gyprock ceilings in the home which appear functional.

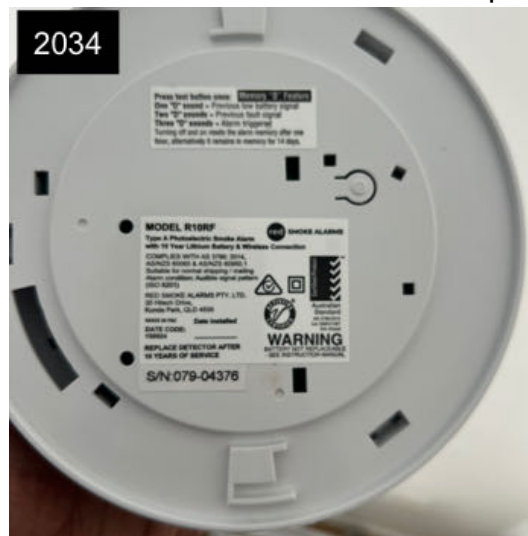
- The property seller must declare on a "form 24"to the buyer as part of the transfer process that the obligation has been discharged.
- There appears to be interconnected smoke alarms installed in the hallways and bedrooms of the home. The service replacement year is noted as 2034

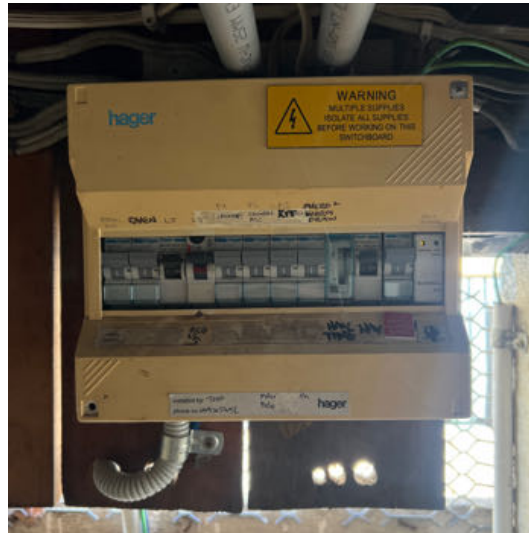
- Main Panel Location:
- East side of the house.

- Sub Panel Location:
- In the basement.

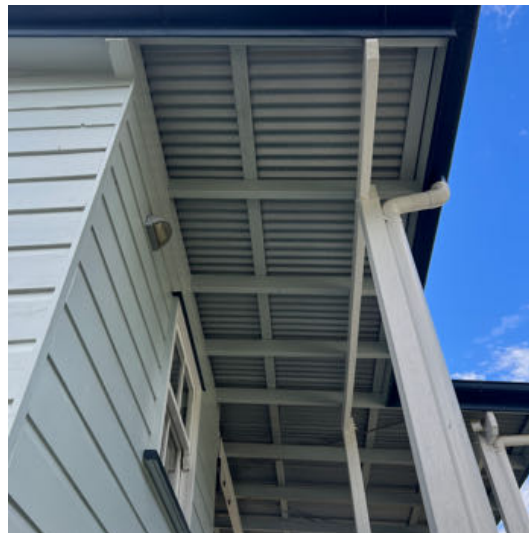
1. Eaves & Fascia

- The eaves are in satisfactory condition.

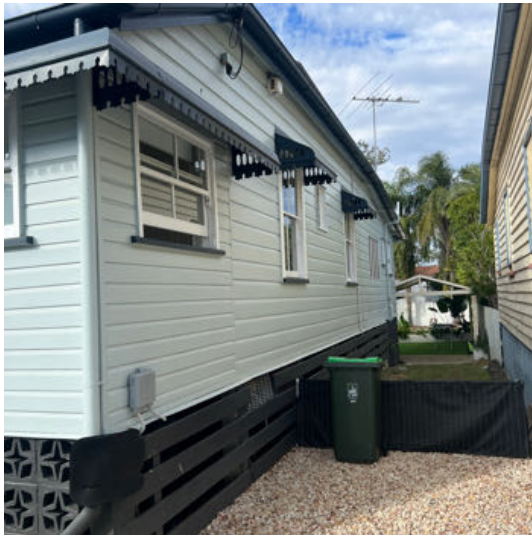
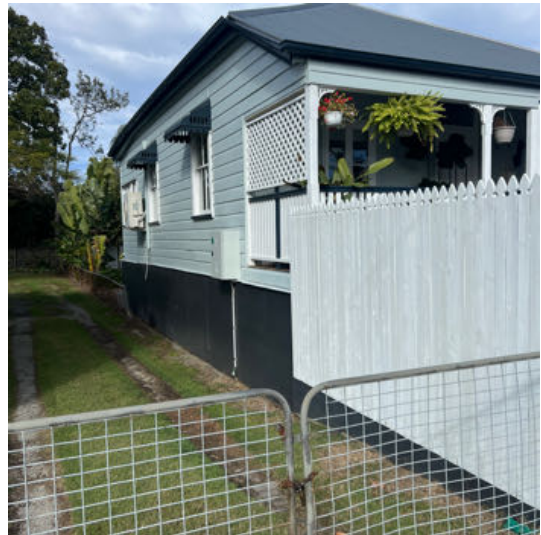
2. Cladding Condition

- External cladding appears to be in satisfactory condition relative to its age.

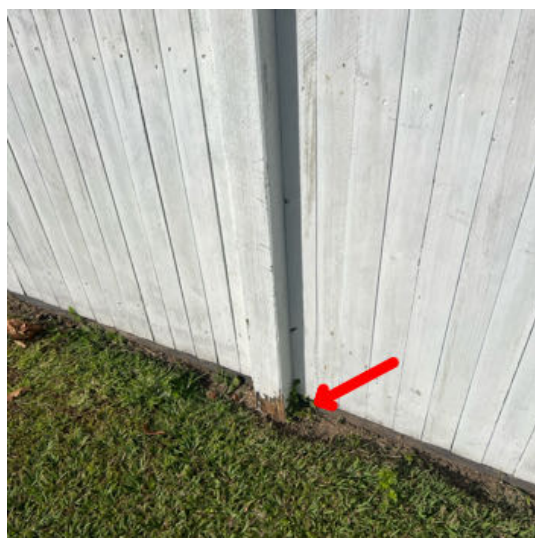
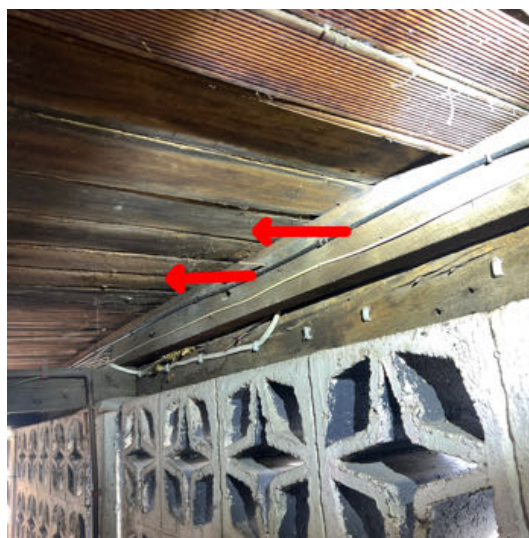
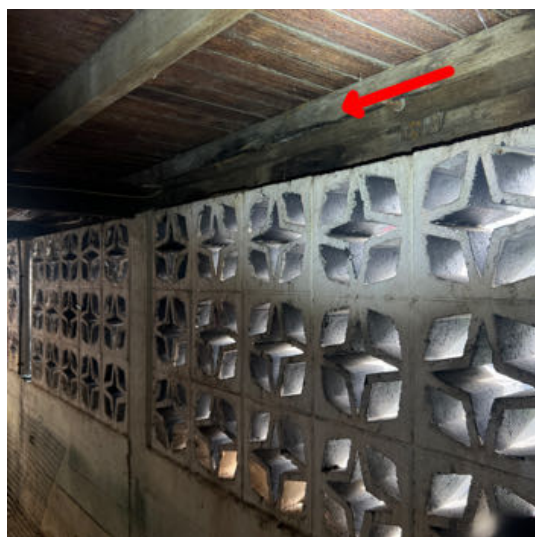
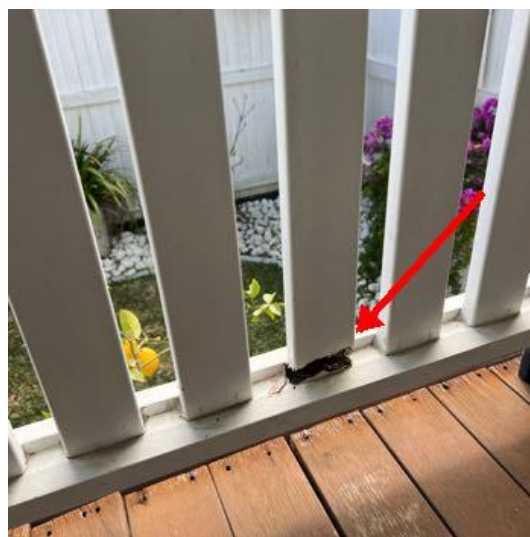
- Wood decay/fungus was detected in external fences, timber beams, hand rails.

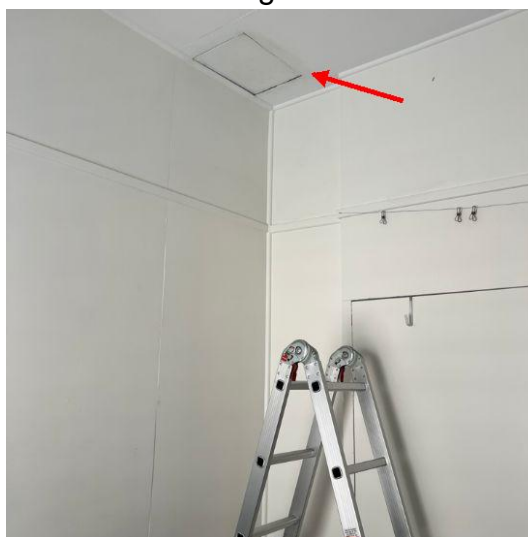
The internal roof space did not have reasonable access available because the access hole was too high to reach.

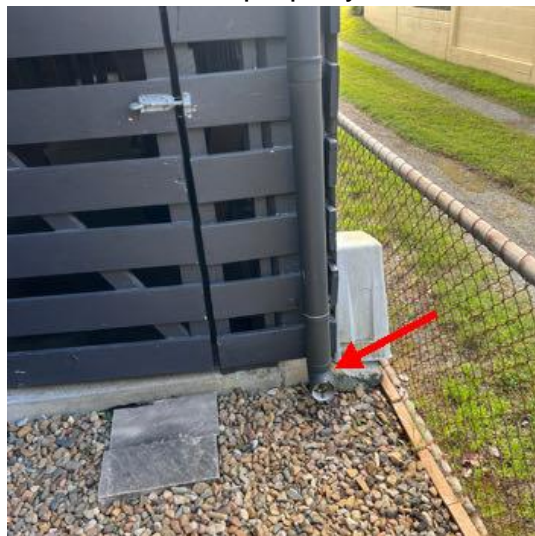
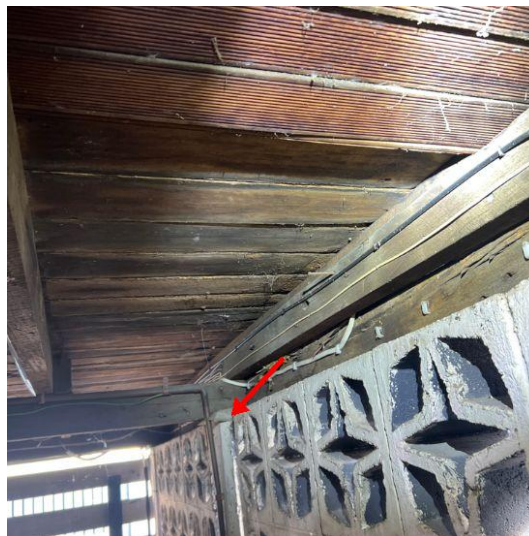
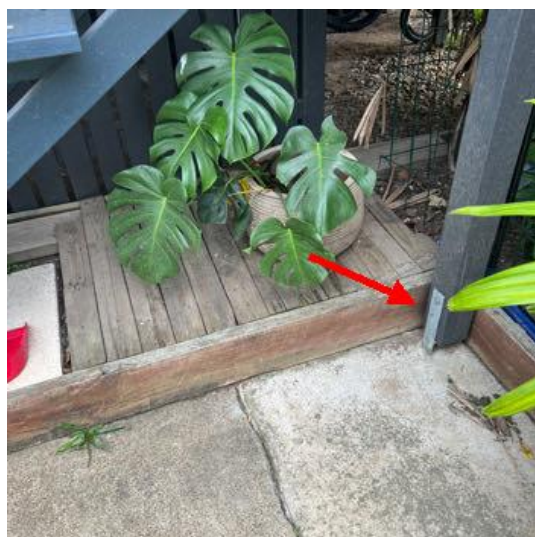
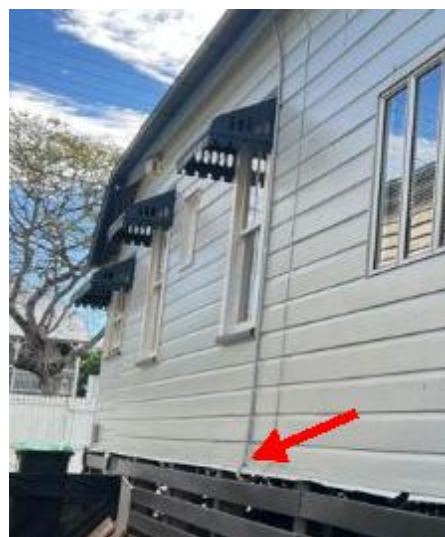
The additional walls and sheeting installed to the raised foundations after the home was built, bridge the termite barrier (termite Caps) in numerous places rendering them ineffective in protecting the home. in this a case regular timber pest inspections are required.

Inspected deck can cause a bridge over any termite installed barriers. It is recommended that the deck should be isolated from attaching to the property, or the soil under and next to the deck should be treated.

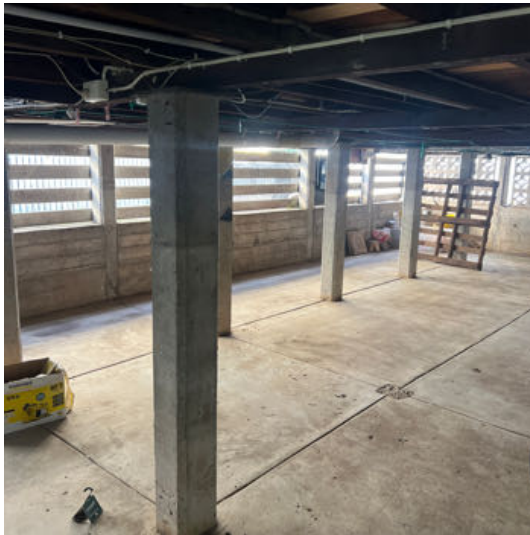
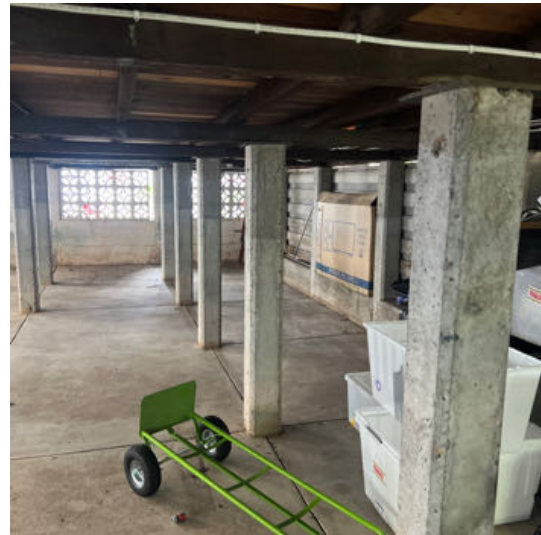
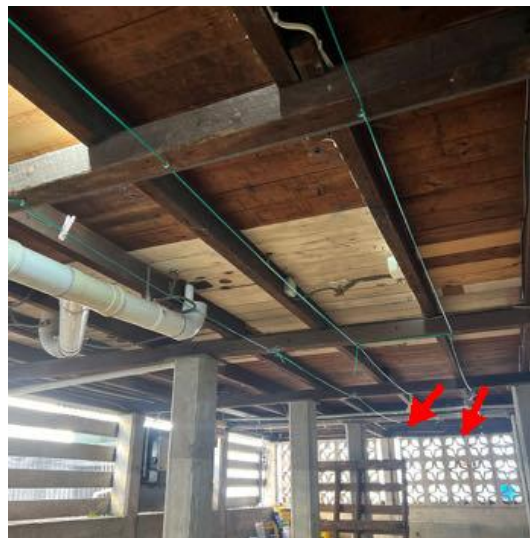
4. Susceptible Timber

- The termite shields (sometimes termed as ant caps) are adequate.
- The additional walls and sheeting installed to the raised foundations after the home was built, bridge the termite barrier (termite caps) in numerous places rendering them ineffective in protecting the home. In this situation regular timber pest inspections are required.
- Subfloor ventilation appeared satisfactory.

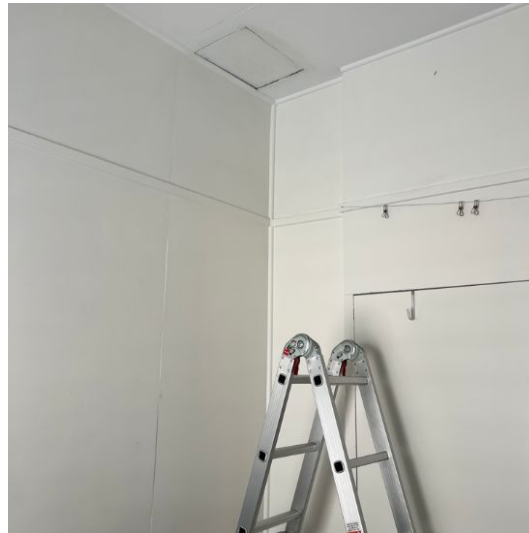
1. Roof Observations

- Access was available through a manhole in the bedroom.
- Due to access restrictions the inspection of the internal roof space was not undertaken.

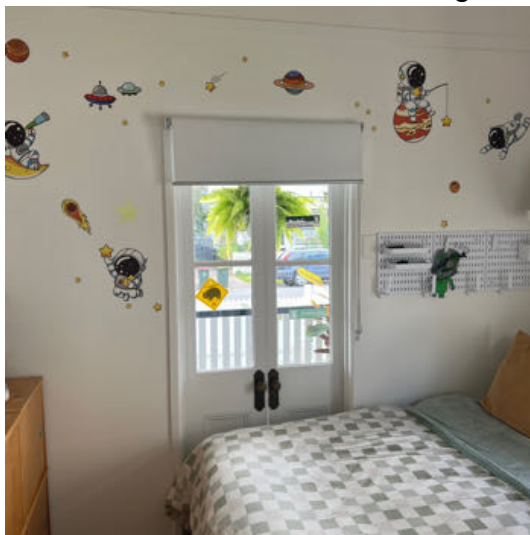
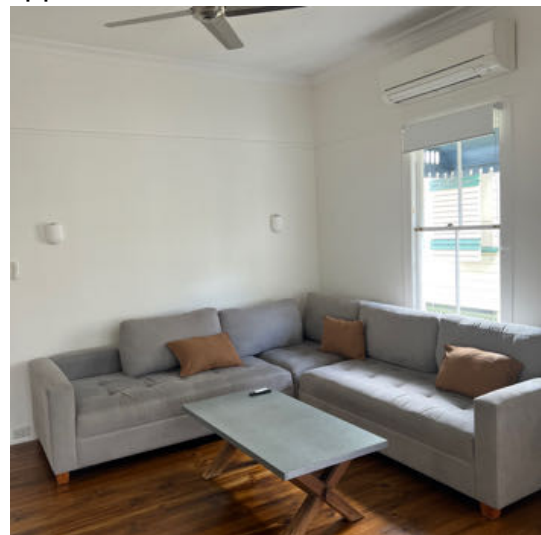
1. Wall Condition

- Timber skirting and door frames appear functional.

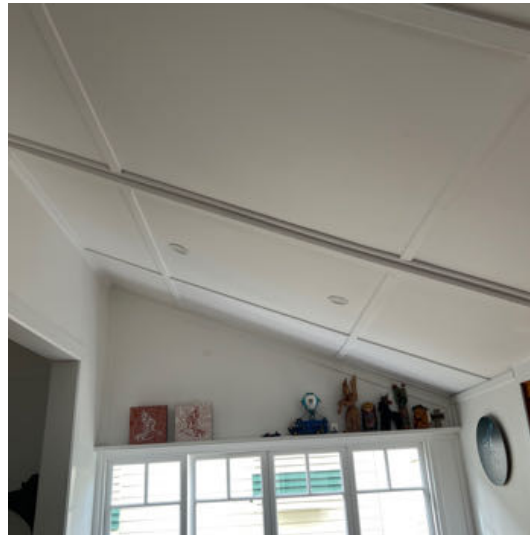
2. Ceiling Condition

- There are plasterboard/gyprock ceilings in the property which appear functional.

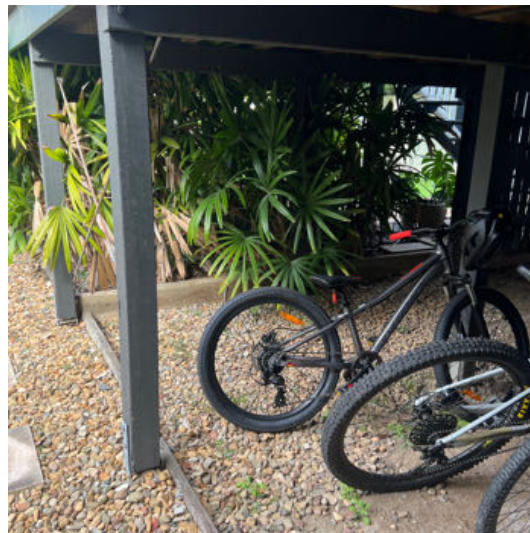
1. Pest Environment

- There is landscaping/stored timber, or old tree stumps in contact with the ground that provides possible breeding grounds for subterranean termites. These should be removed.

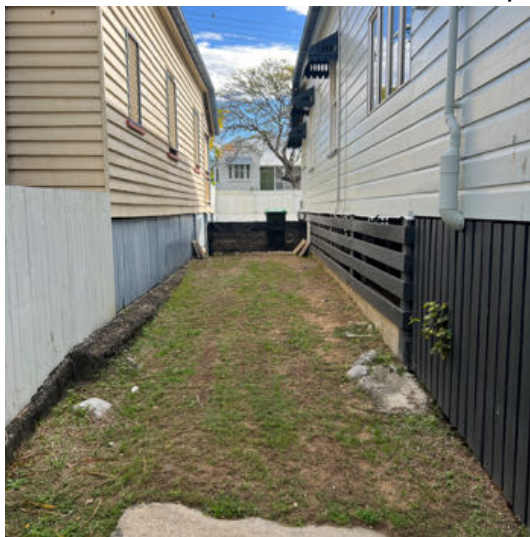
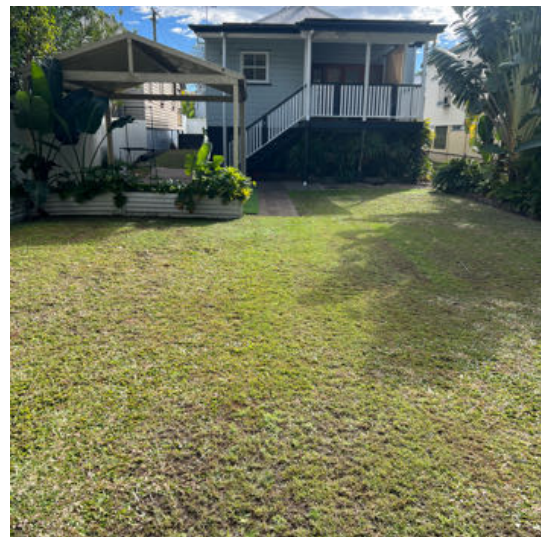
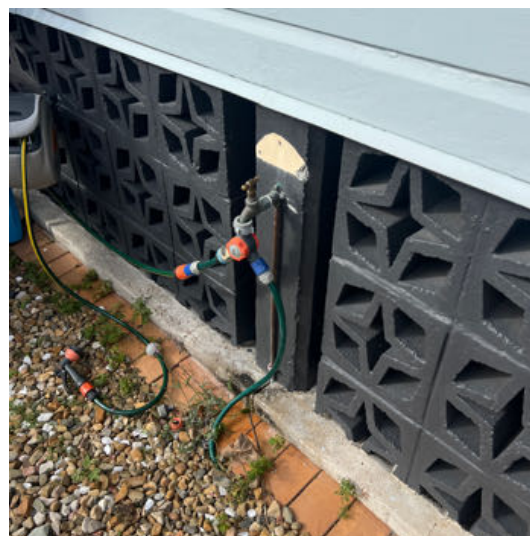
2. Grading and Drainage

- It is important to redirect moisture away from the property to limit areas of excess moisture. Faulty gutters and downpipes in poor condition can cause water to seep into the foundations, causing conditions conducive to termites and fungal decay.
- Surface drainage conditions within 3 metres of the inspected structure appeared satisfactory given the prevailing weather conditions at the time of inspection. There was no evidence noted of water pooling at or around the building structure. These areas should be monitored during periods of heavy rainfall for a full representation of drainage conditions.
- There are no drains located beneath the outdoor taps. This can cause water pooling if the taps were to leak. Recommend drains be installed beneath the taps. Where this is not possible it is important to ensure taps are well maintained to prevent leaks.

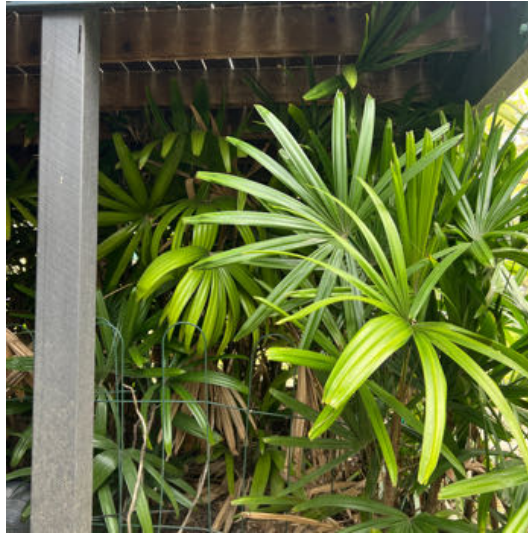
3. Vegetation Condition

- Prune or remove any plants that are in contact or proximity to home to eliminate pathways of wood destroying insects.

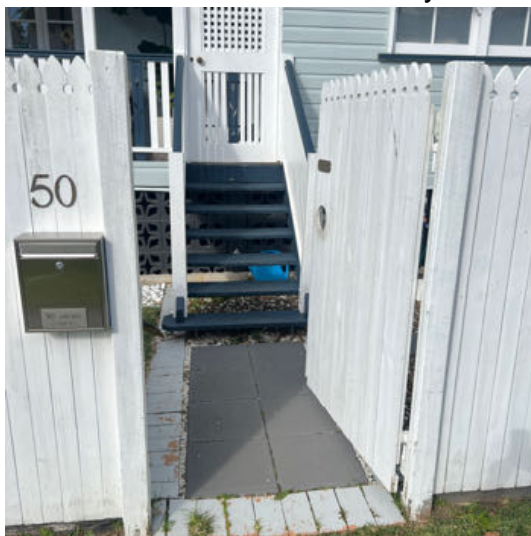
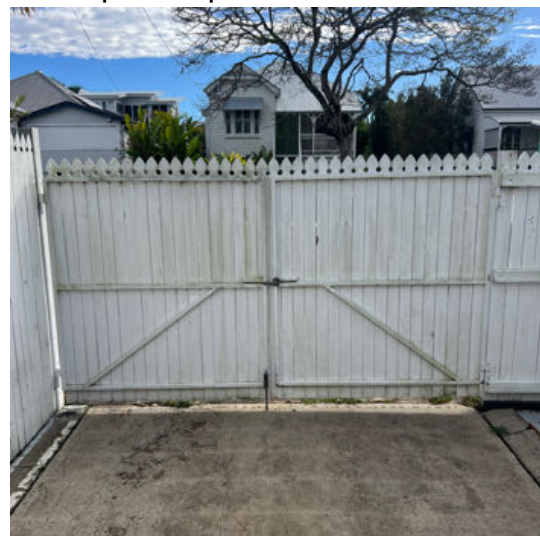
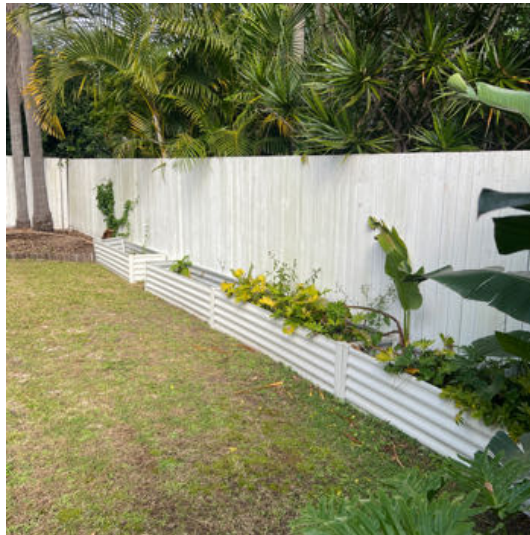
4. Fences Condition

- Timber gate is in good condition.
- Timber fences are in functional condition.
- Wood decay observed. Recommend repairs/replacement as needed.

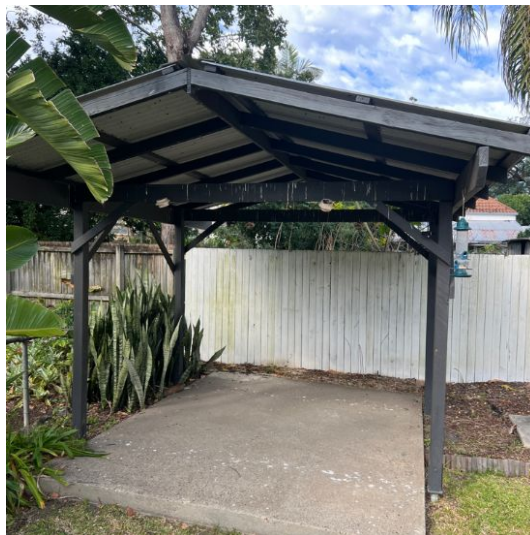
5. Patio / Pergola

- The pergola is in good condition.

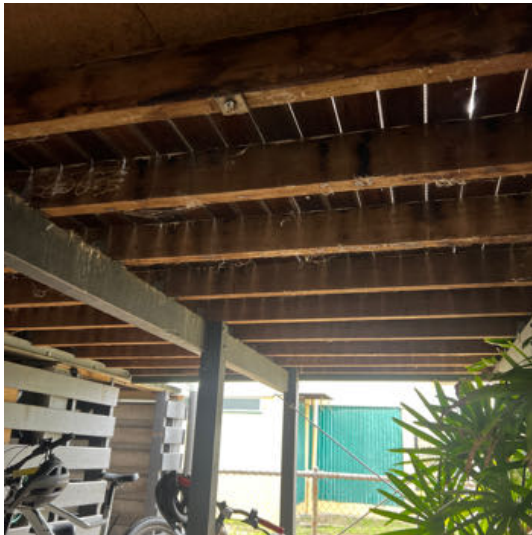
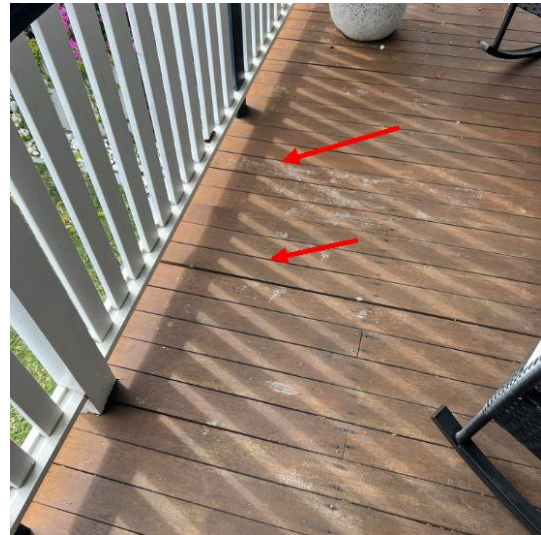
6. Deck

- Inspected deck was in functional condition at the time of the inspection.
- Weathered wood surfaces observed to the deck. Wood deterioration and rot can occur. Prep, prime and paint as needed.

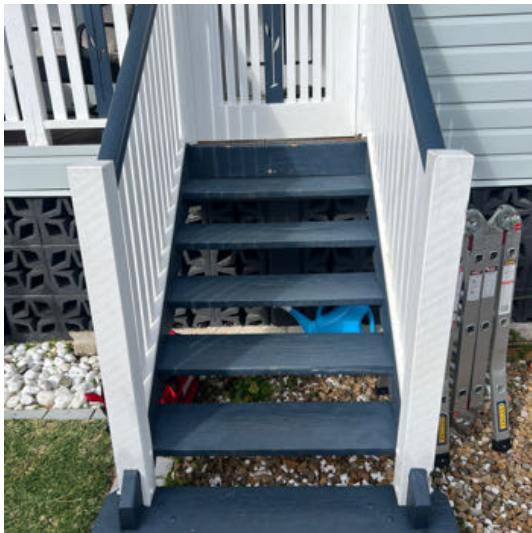
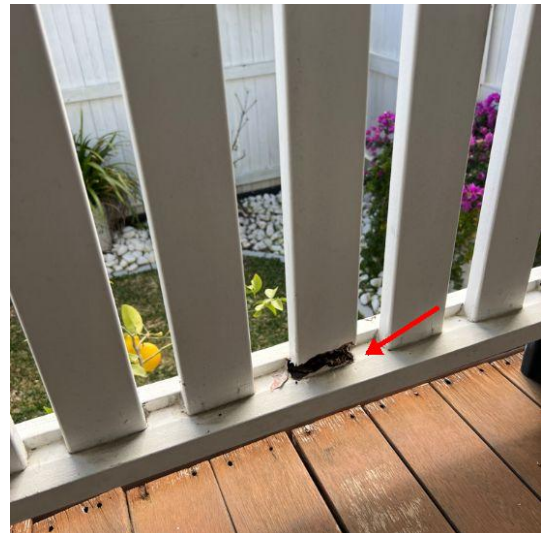
7. Stairs and Handrail

- Inspected steps were in good condition at the time of the inspection.
- Inspected Handrails were in functional condition at the time of the inspection.
- Wood Decay damage noted in handrail.

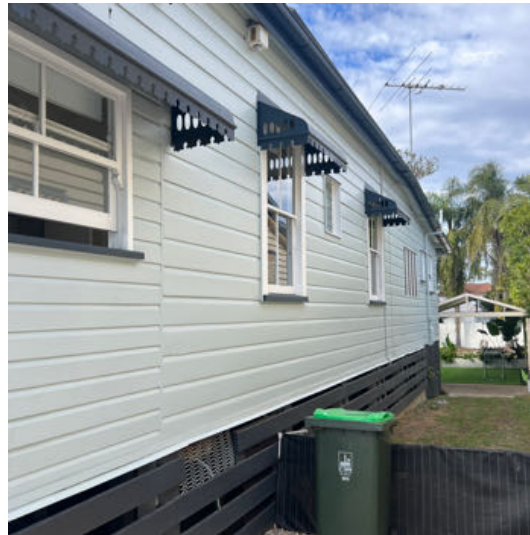
1. Wall Observations

- Painted wood/weatherboard cladding.

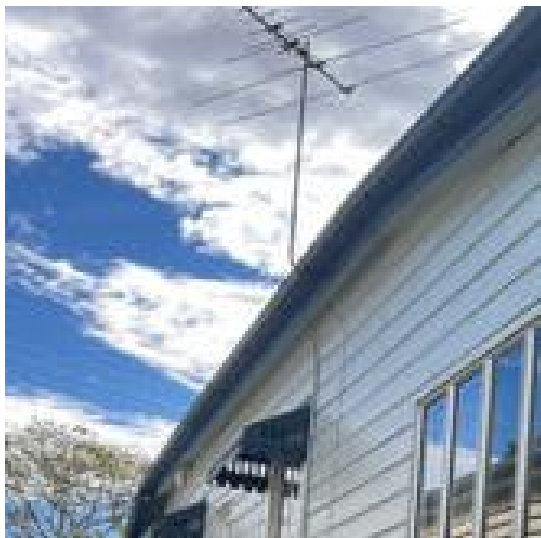
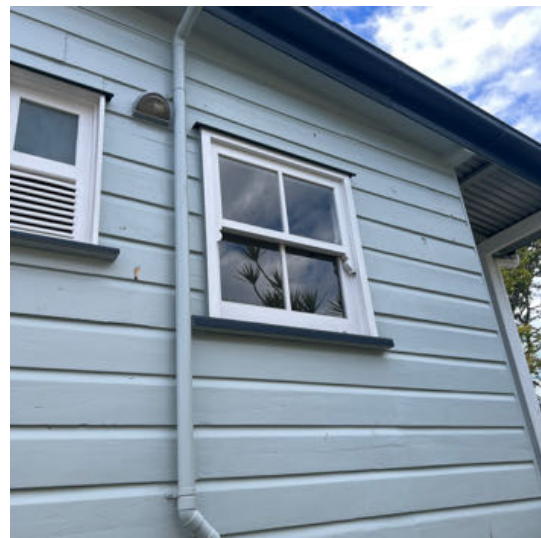
2. Eaves Condition

- The eaves are in satisfactory condition.

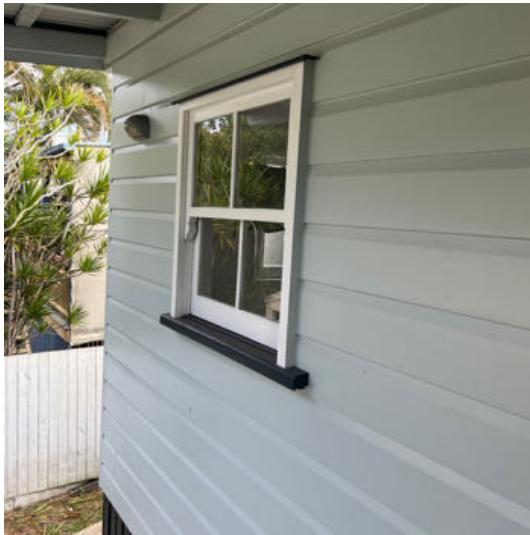
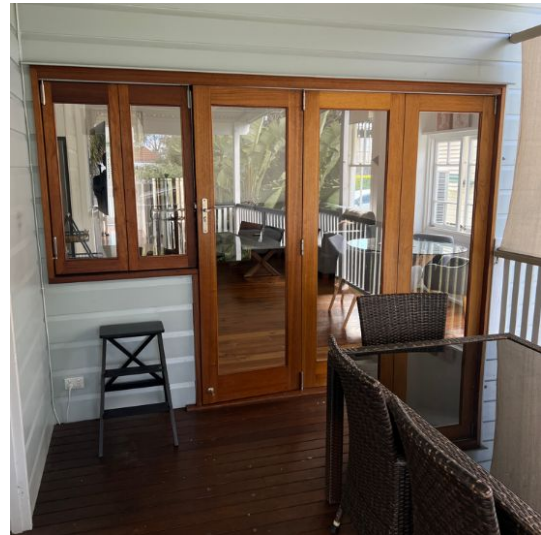
3. Exterior Observations

- Wood framed windows noted.
- Wood framed doors noted.
