10 Year Strata Maintenance Plan

1 Harper terrace South Perth

Client Name : The Owners Strata Plan 70215
Report Number : 9870
Inspection Date : Friday 28th May -18 June 2021
Weather Conditions : Fine
Inspected by : Brian Connor B.App.Sc
Registered Builder 100541
Member of Building Inspectors association of WA

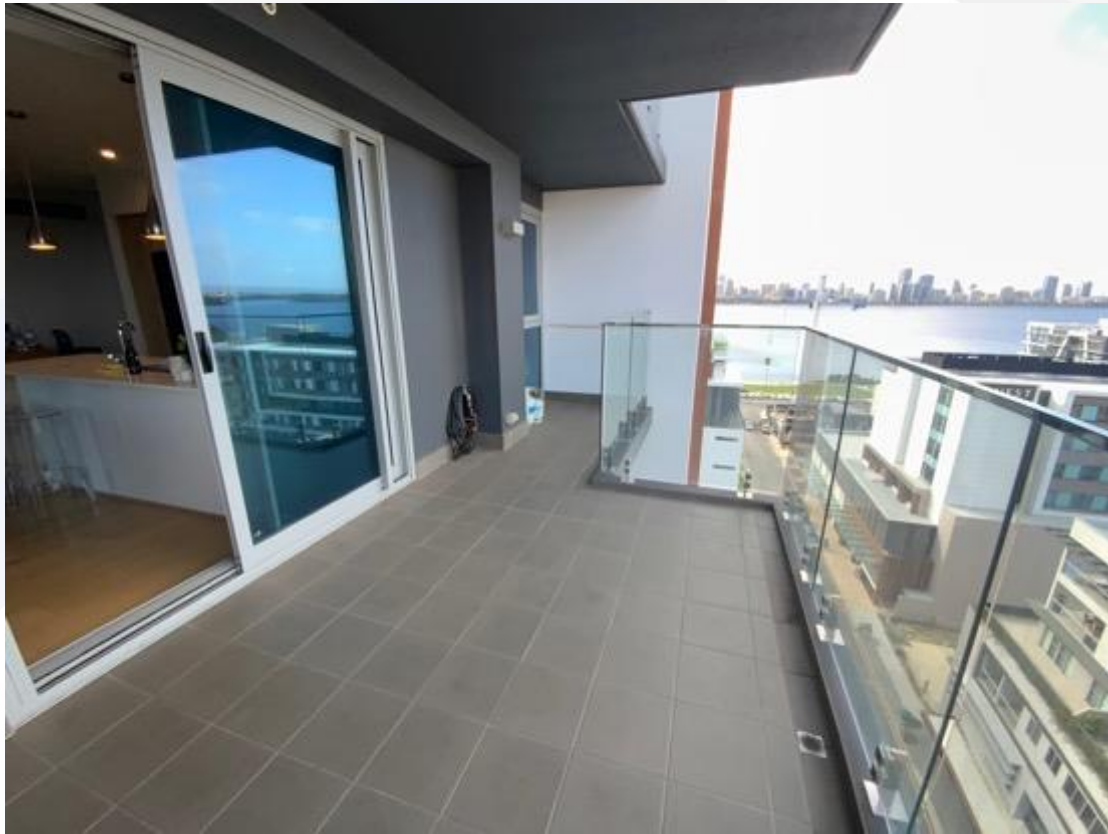
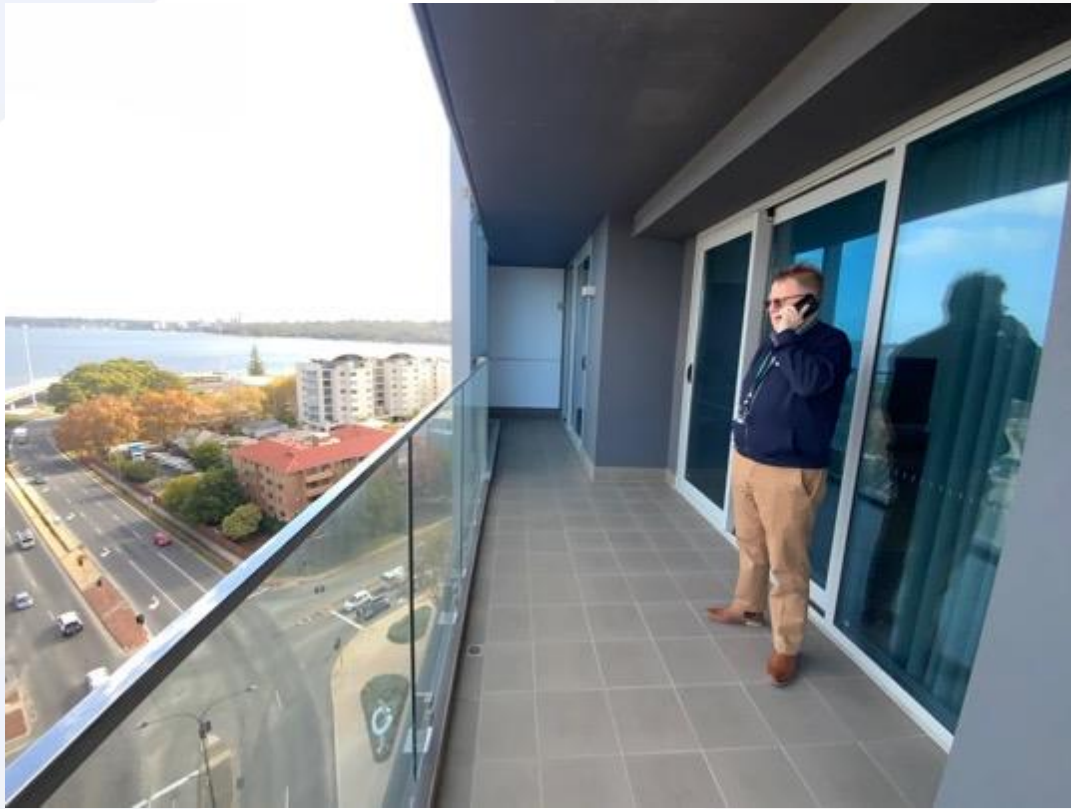
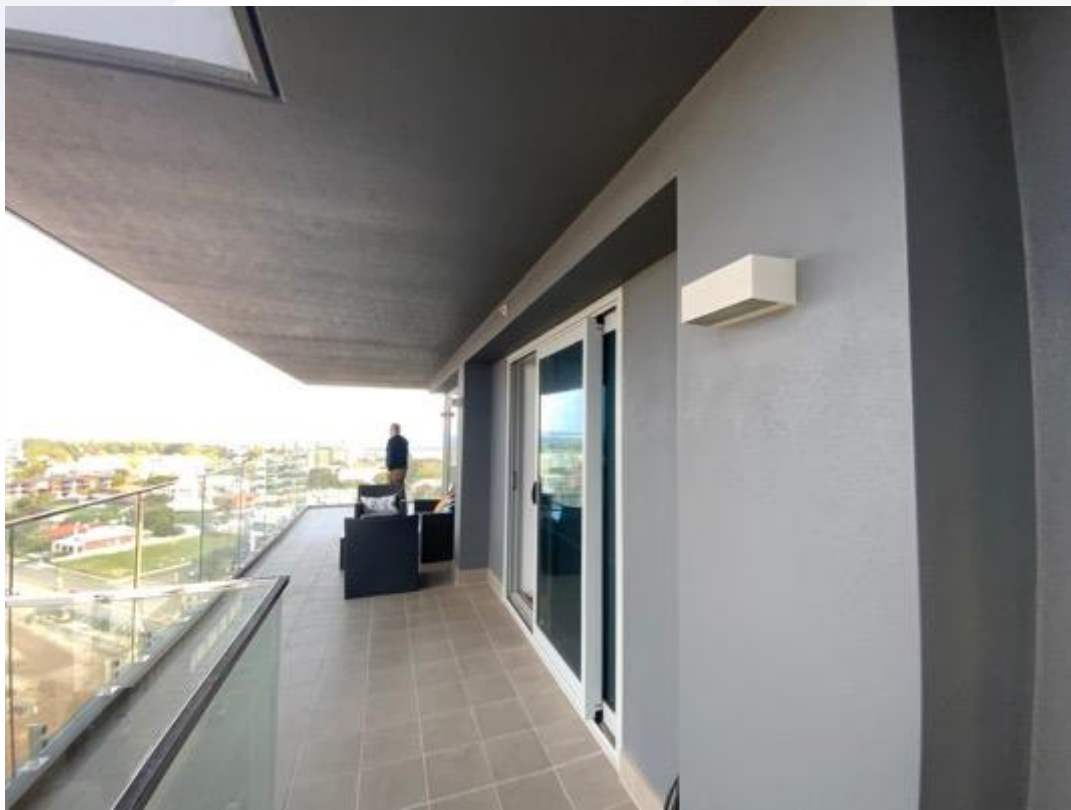
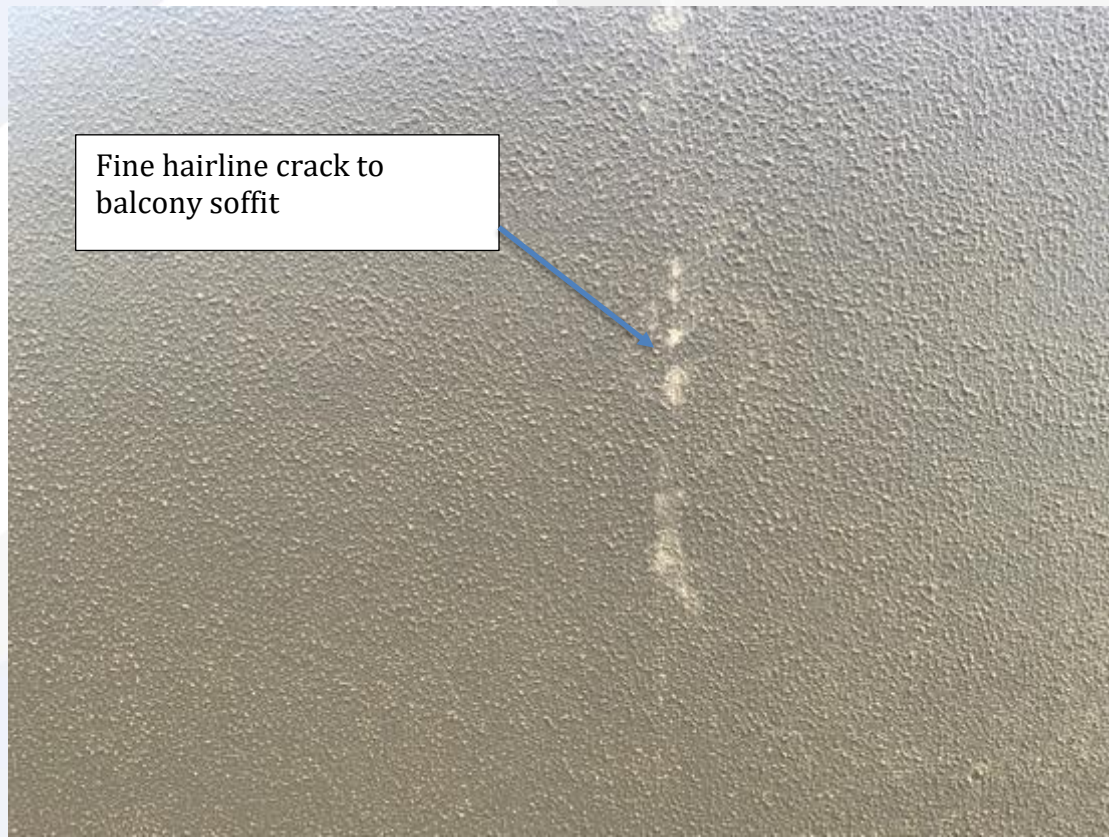
Unit 1103

1. Fine hairline crack to balcony soffit above and signs of water ingress through the balcony slab

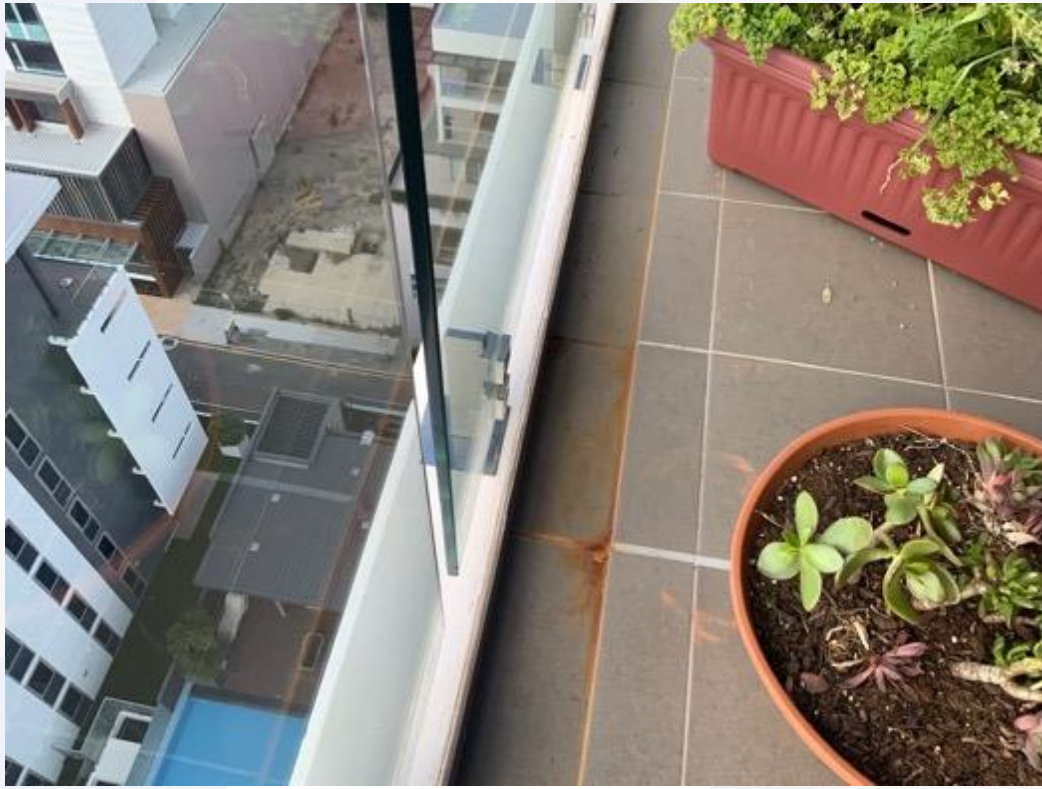
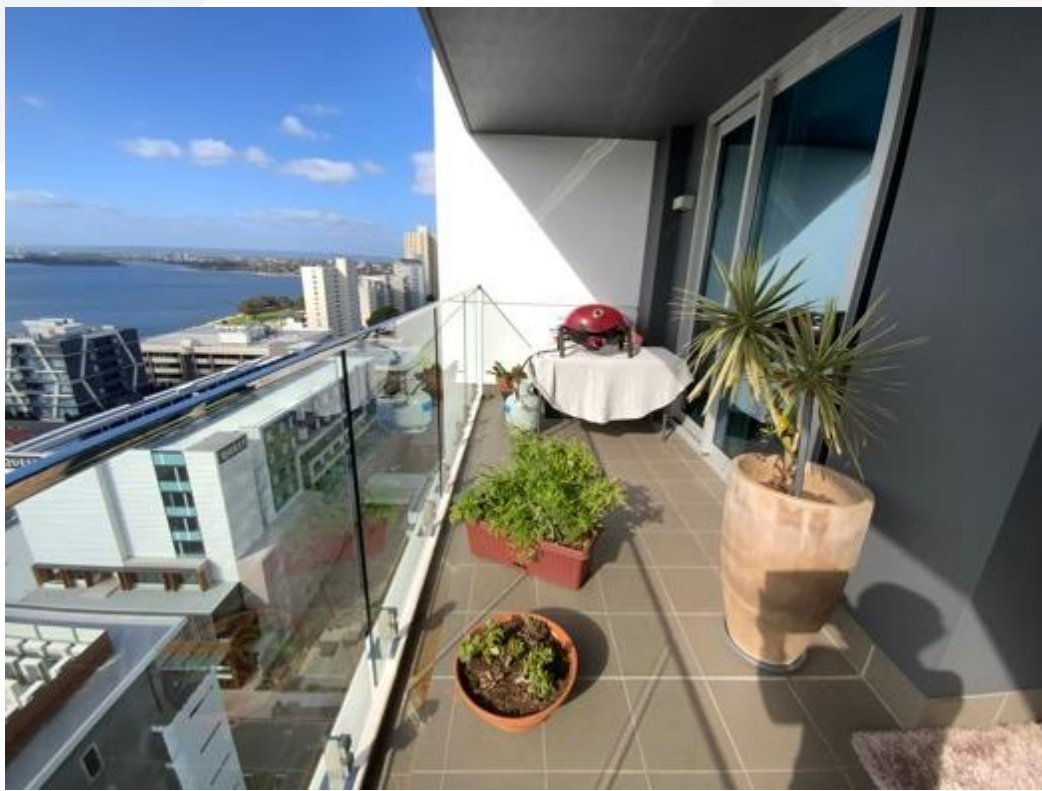
Unit 1501

2. Rust staining to the north balcony spoon drain likely cause is rusting reinforcement steel, requires further investigation and repair by builder

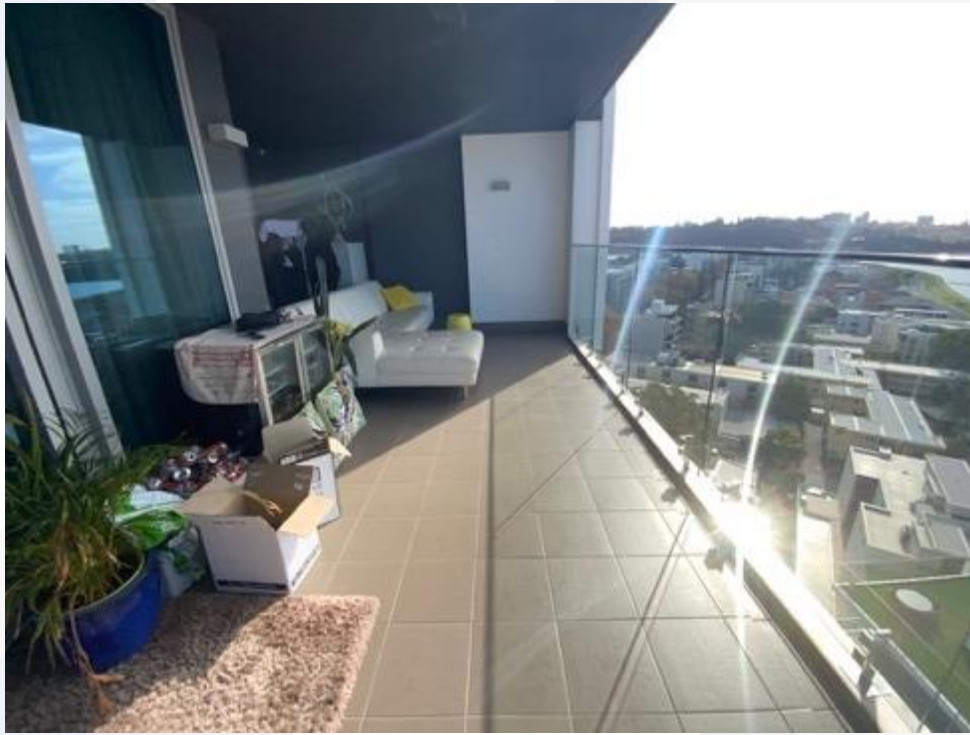
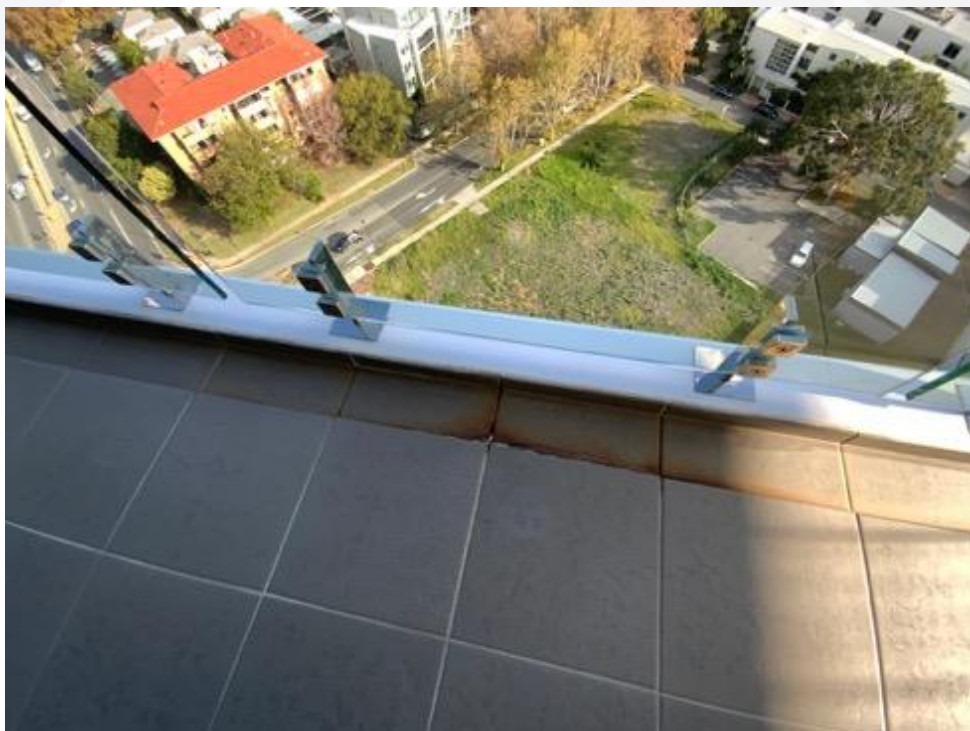
Unit 1507

3. Water pooling on west side balcony spoon drain rust visible between drainage wastes, likely rusting reinforcement steel in balcony slab

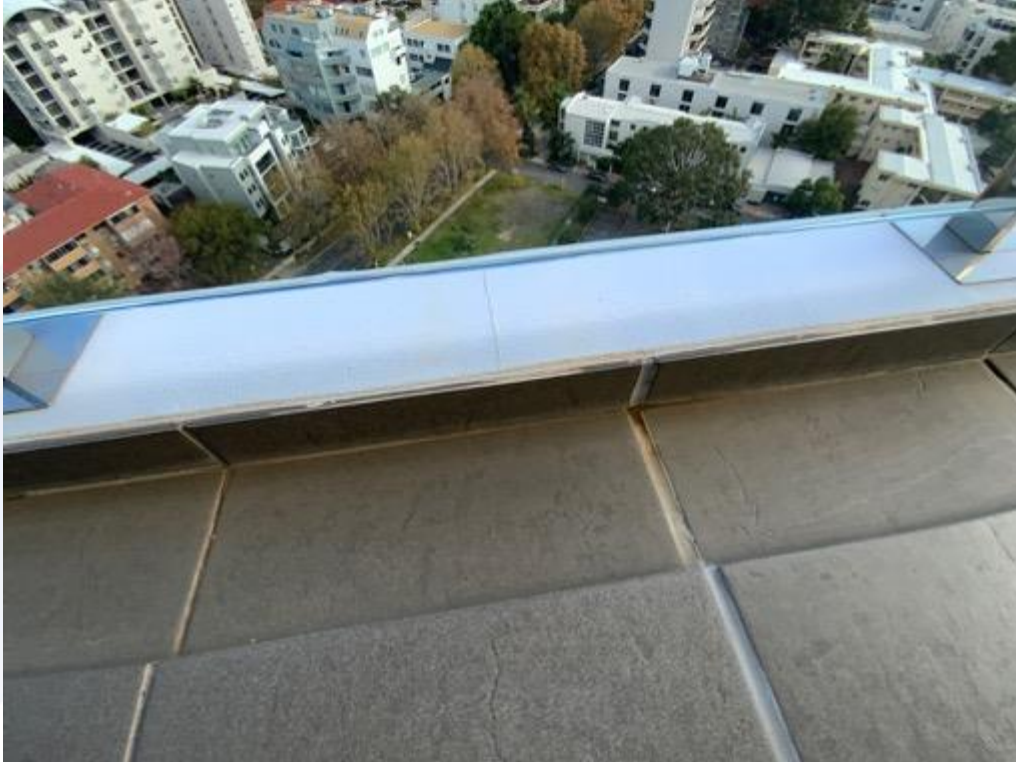
There is also some cracking the balcony cantilevered floor slabs at construction joints to the west, south and north sides. Only the cracking to the west side balcony floor slabs is considered a builder's defect currently as the cracking and misalignment is quite noticeable and extends from level 4 to level 20.

4. Cracking balcony west side at construction joint through concrete noticeable all of the way up the building level 4-20
5. Sealant cracked in spoon drain and hairline crack through the balcony edge

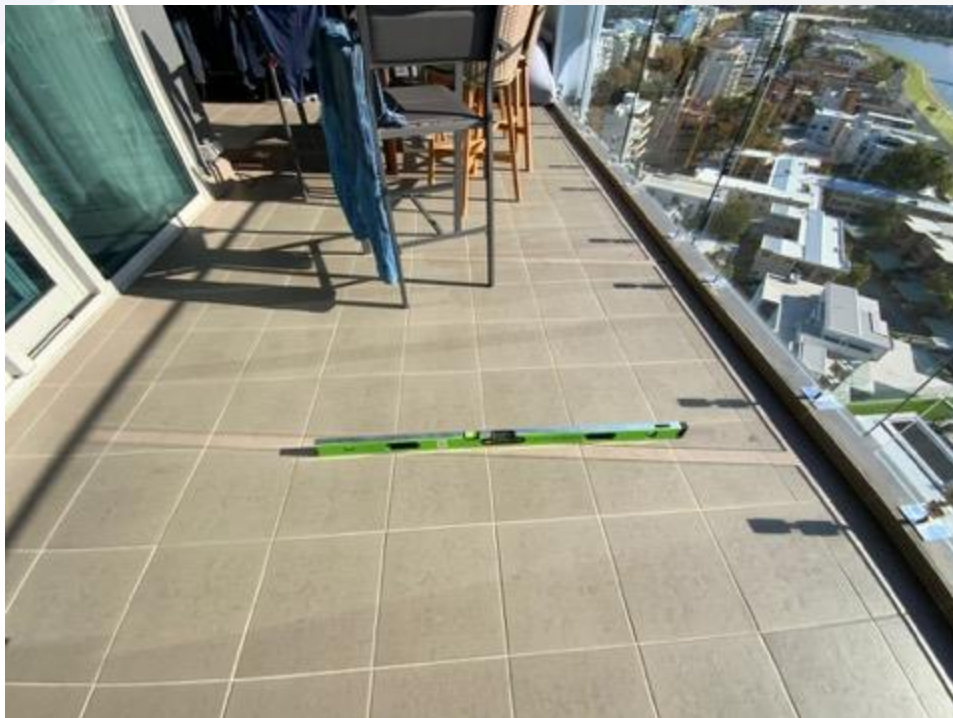
Unit 1701

- 8. Balcony fall ok
- 9. No defects noted

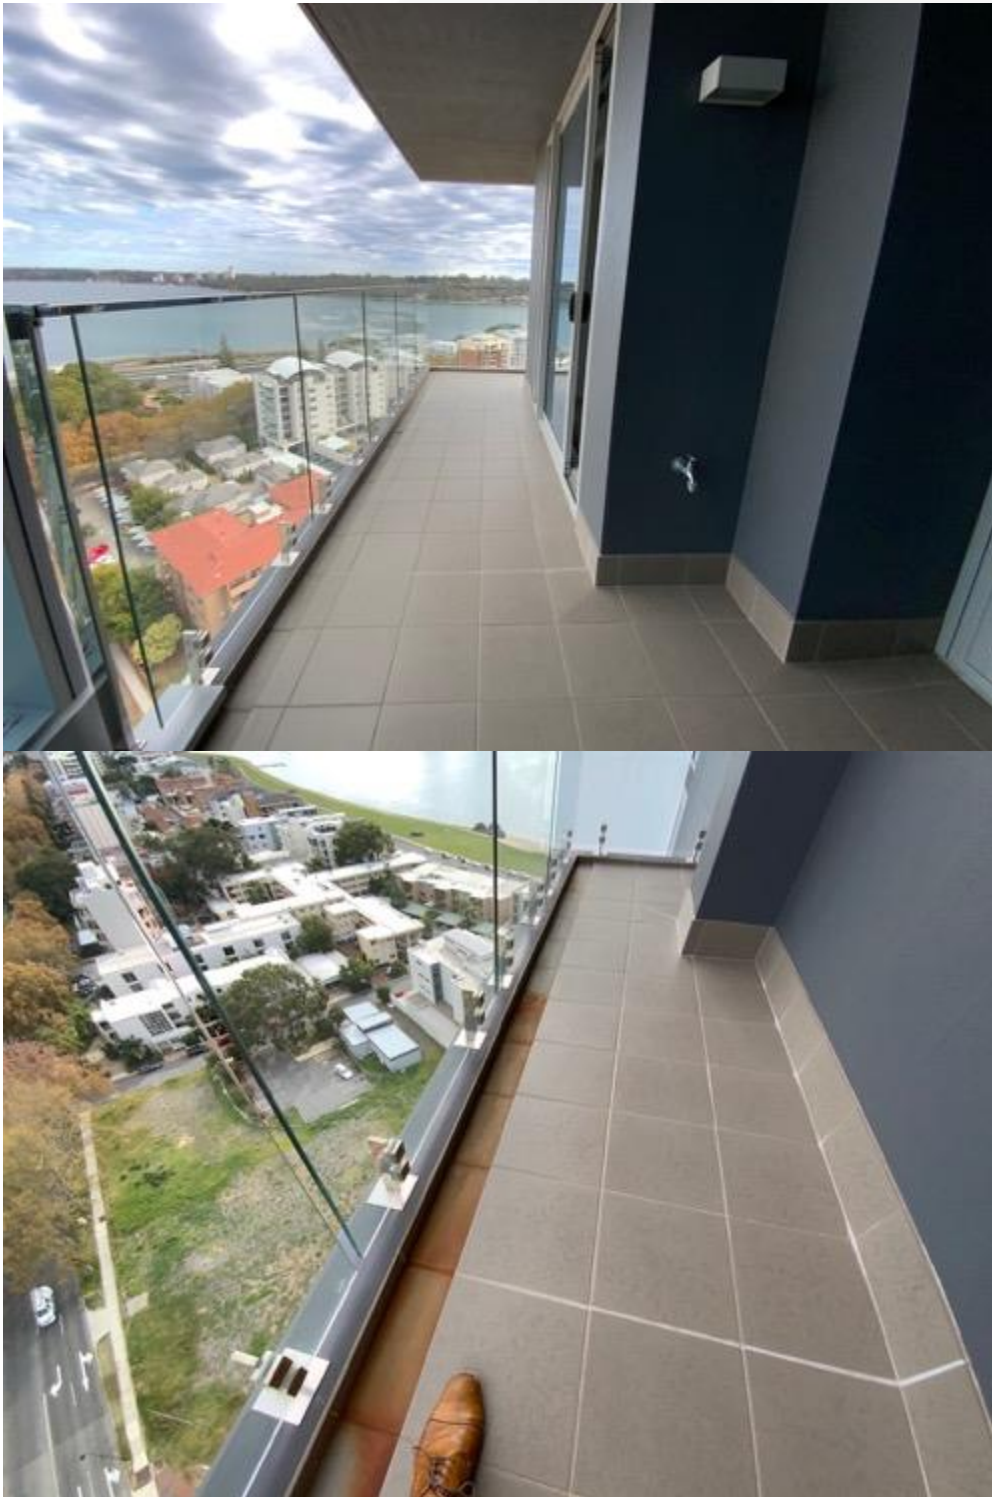
Unit 1806

10. rust staining to spoon drain facing west

11. hairline cracking to building west facing wall

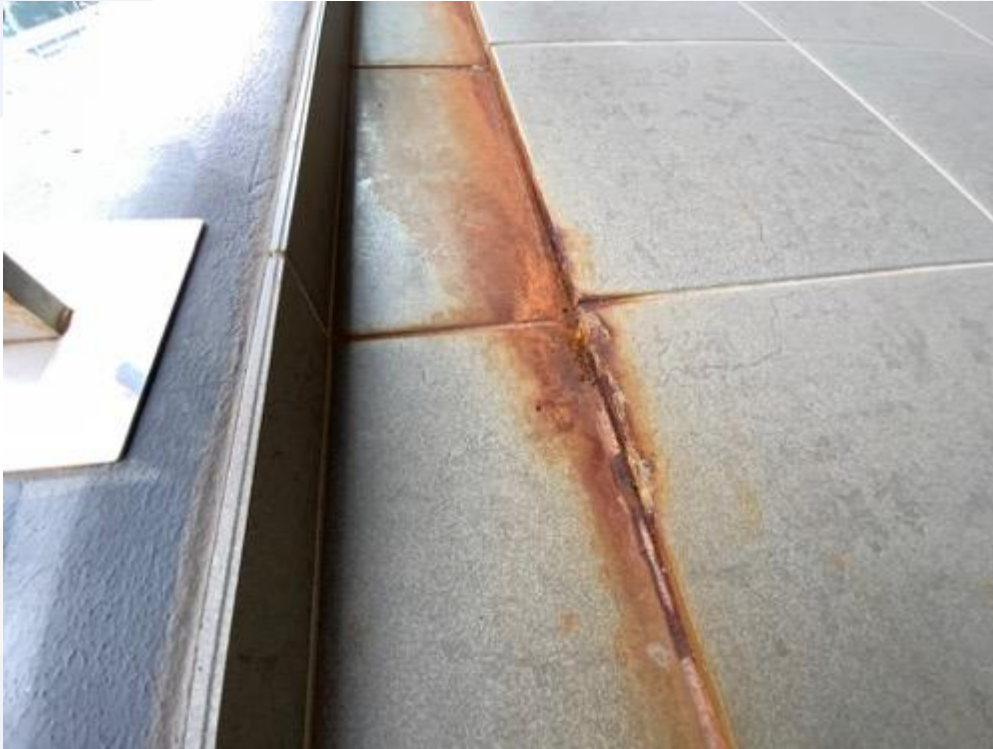
12. Sealant bulging at base of sliding door sill facing south

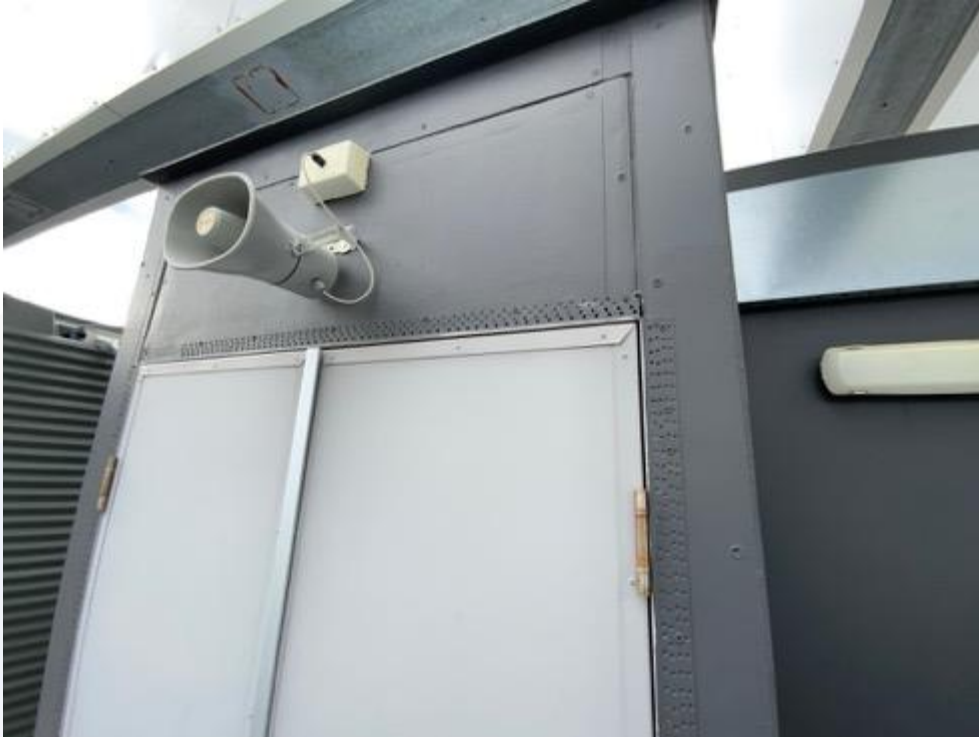
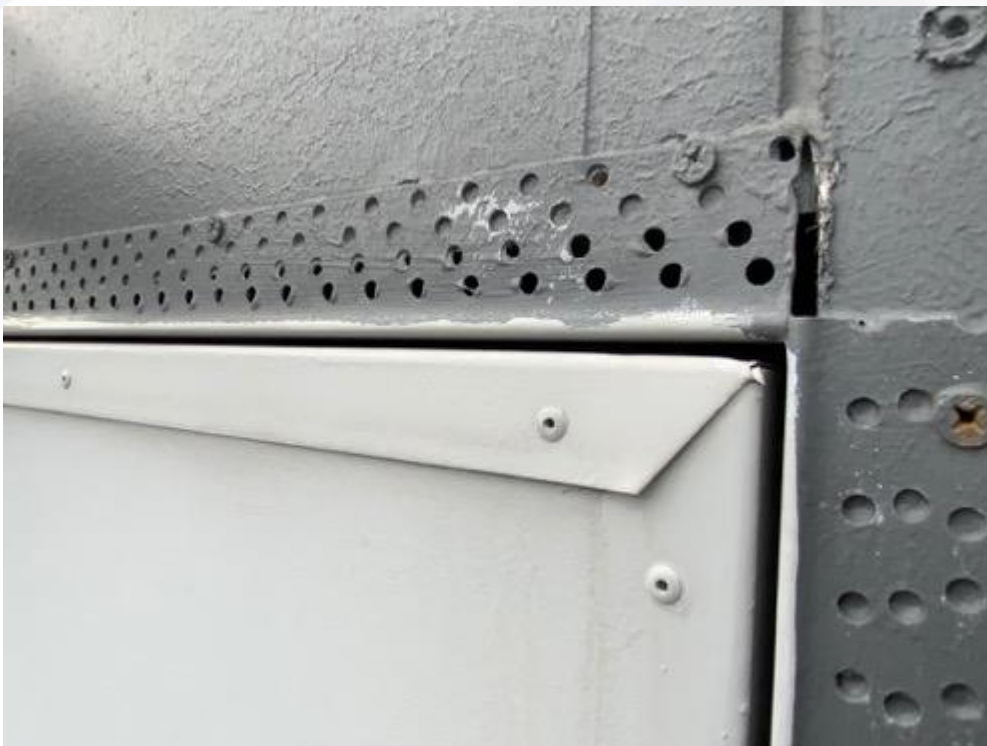
16. External of electrical cupboard not waterproof gaps visible around the external plaster angle can see into the wall and the door frame will rust out also requires a head flashing

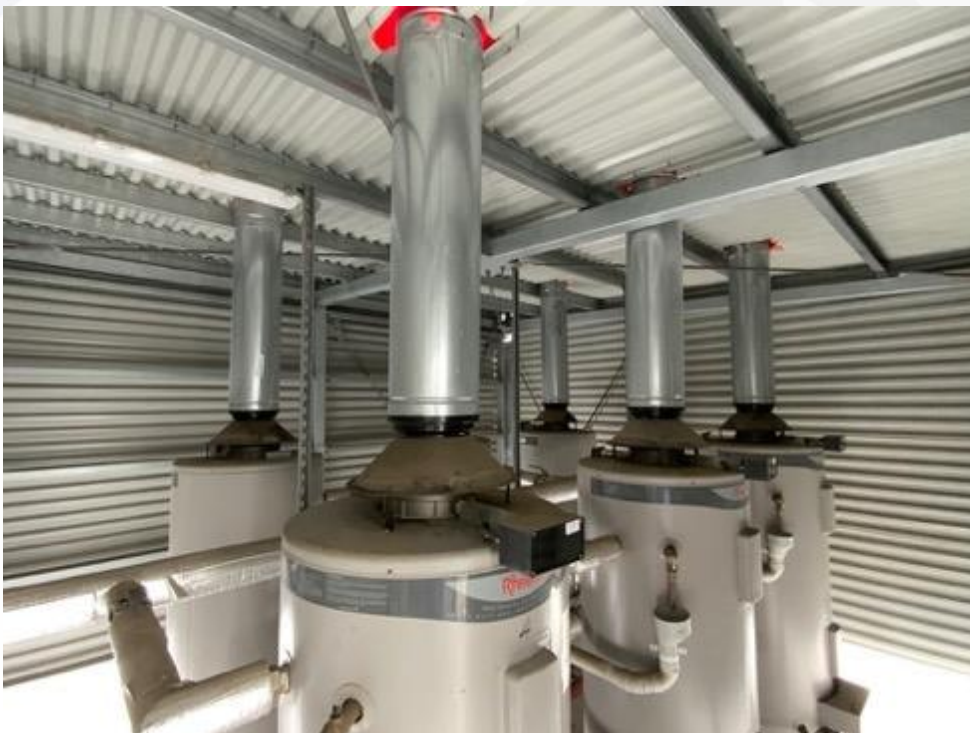
19. Hot water heating 6 storage units do all of the residential

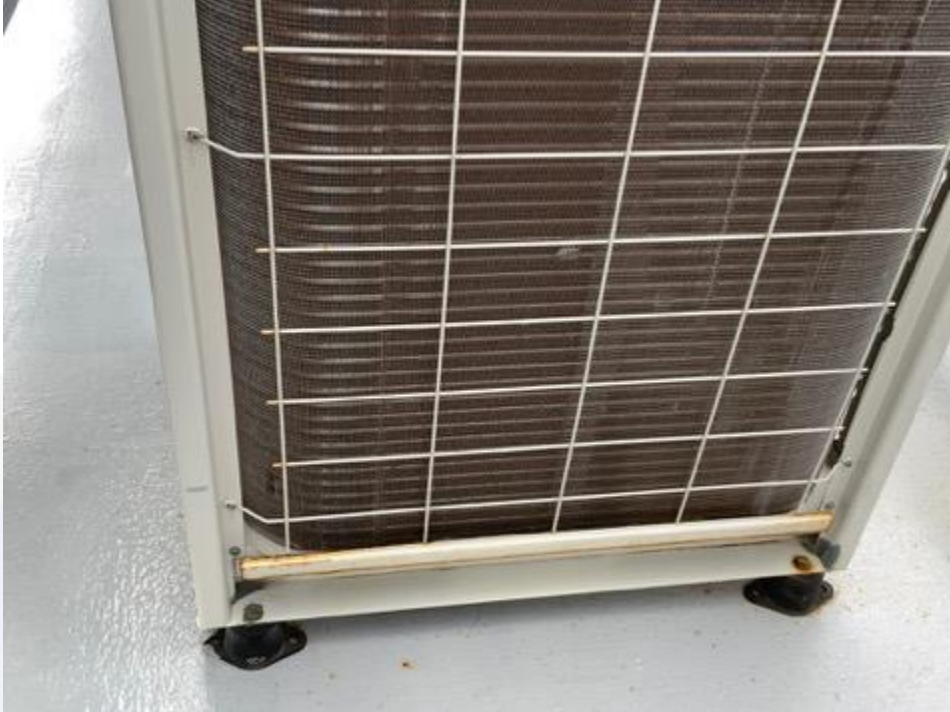
24. Corrosion of evaporative unit metalwork one-unit corrosion of base of steel frame above plant requires priming galvanizing

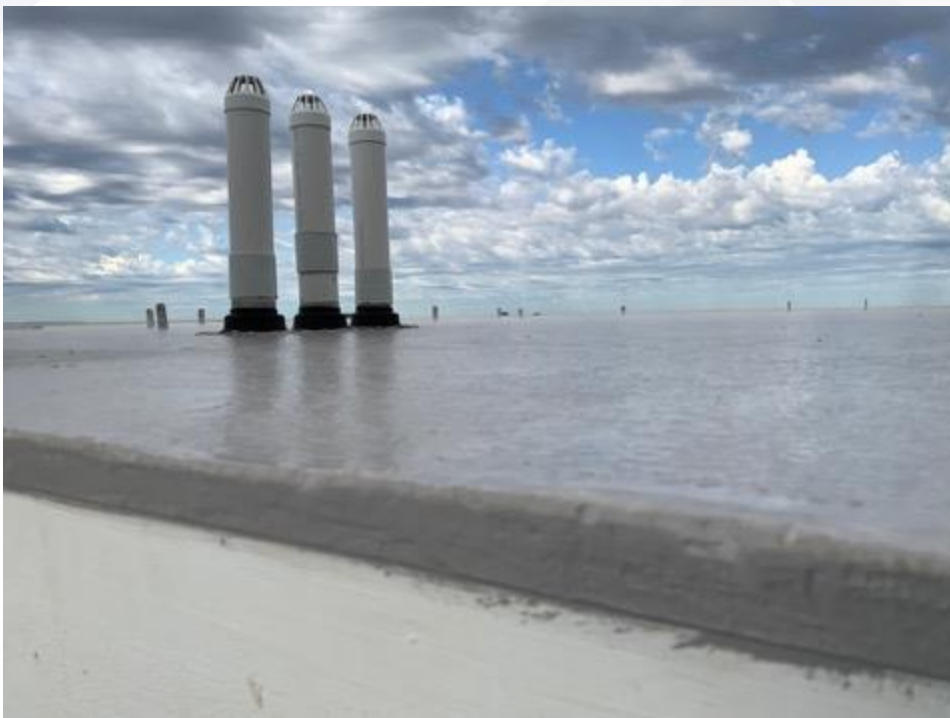
25. Lift stair roof has fall less than 1 to 100

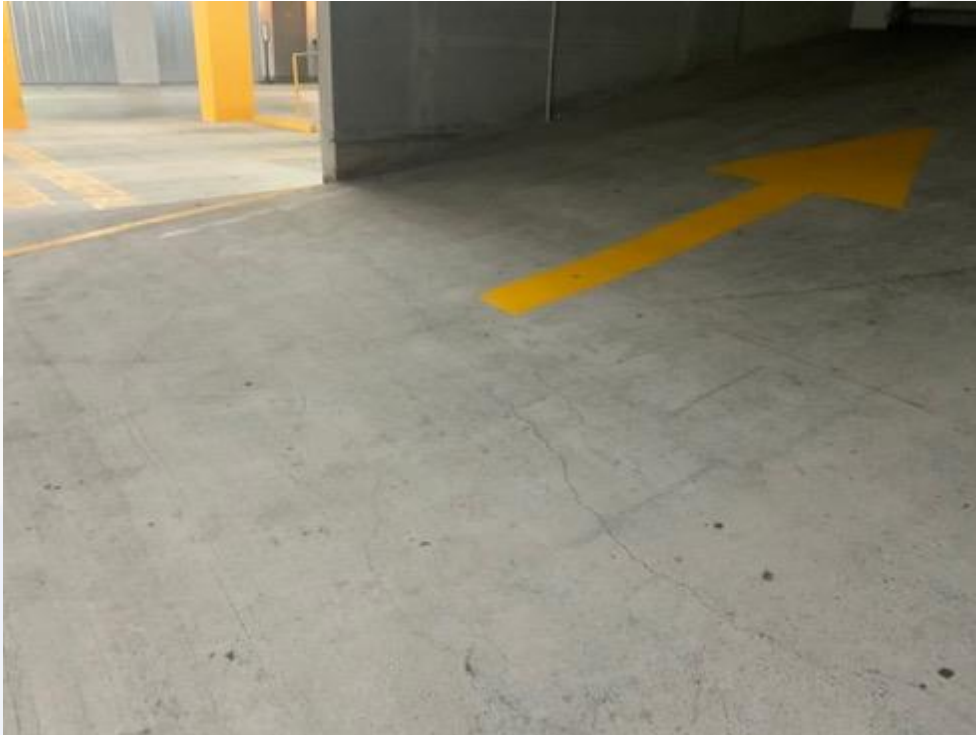
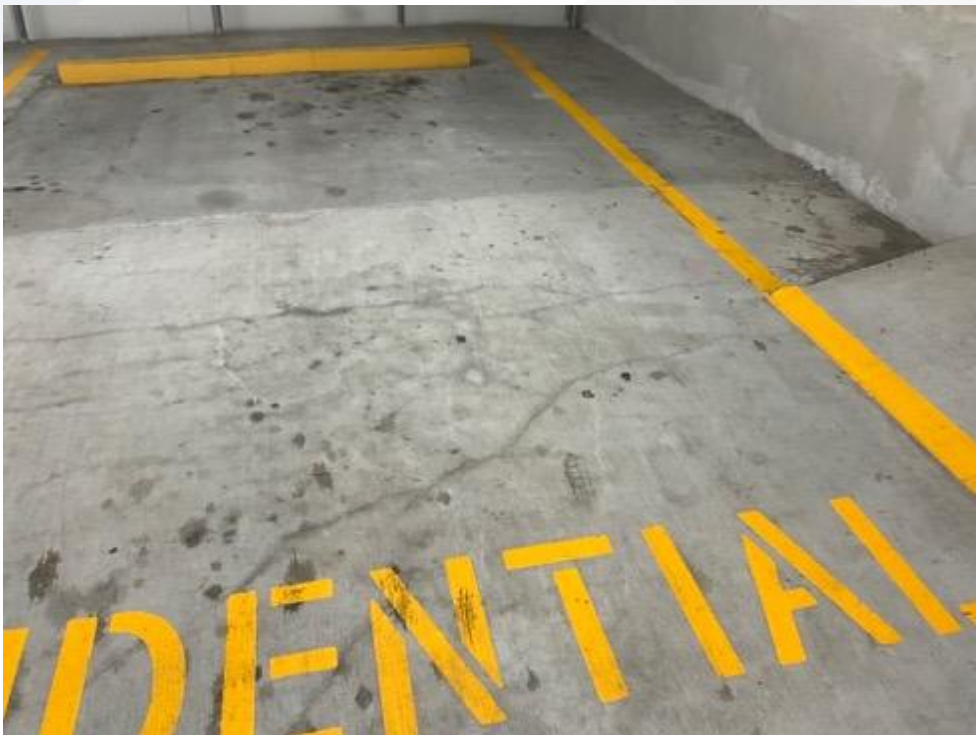
39. Hairline cracking to base of level 1 up ramp visible extending to residential visitor bays

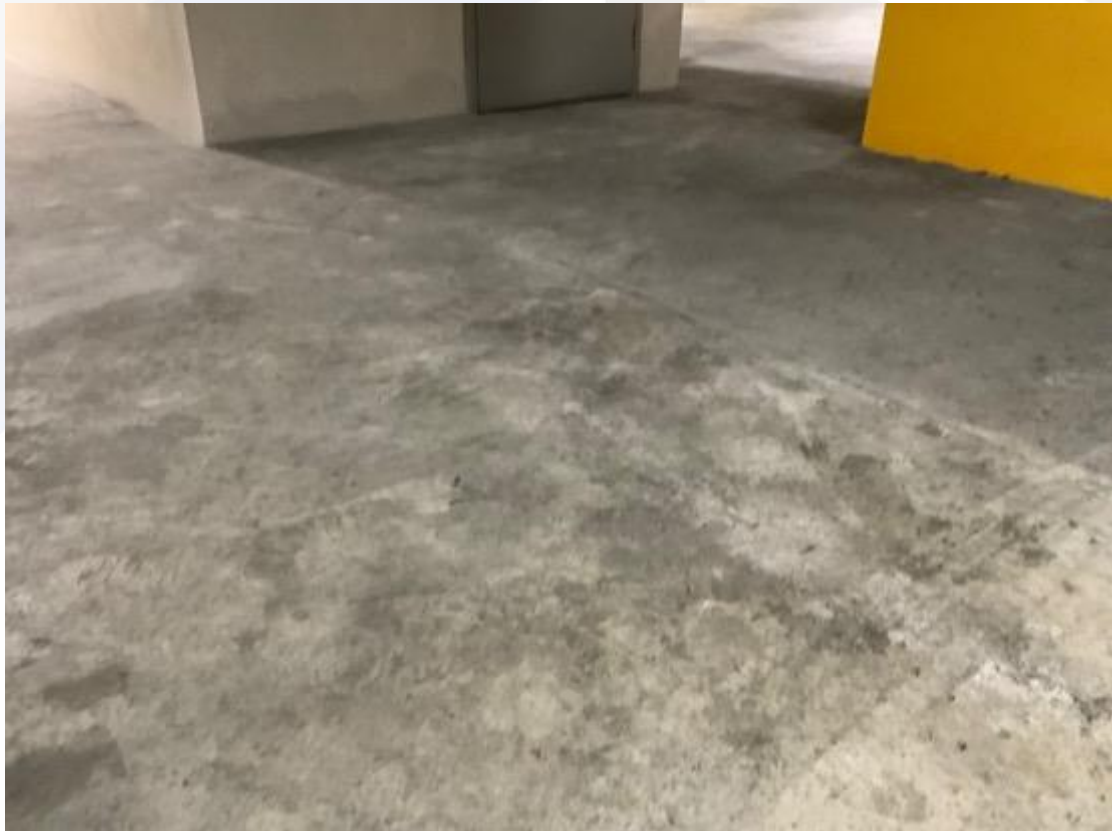
Basement B1 carpark

- 40. Pitted concrete surface to B1 base of ramp from ground floor carpark 30 m2 affected requires floor levelling compound by builder
- 41. Repairs have been made to north and east wall skirting by builder
- 42. Efflorescence and salt build up at base of skirting from Com 103 to substation
- 43. Floor cracking across driveway in several places between yellow columns north of substation
- 44. Concrete residue south of substation requires removal

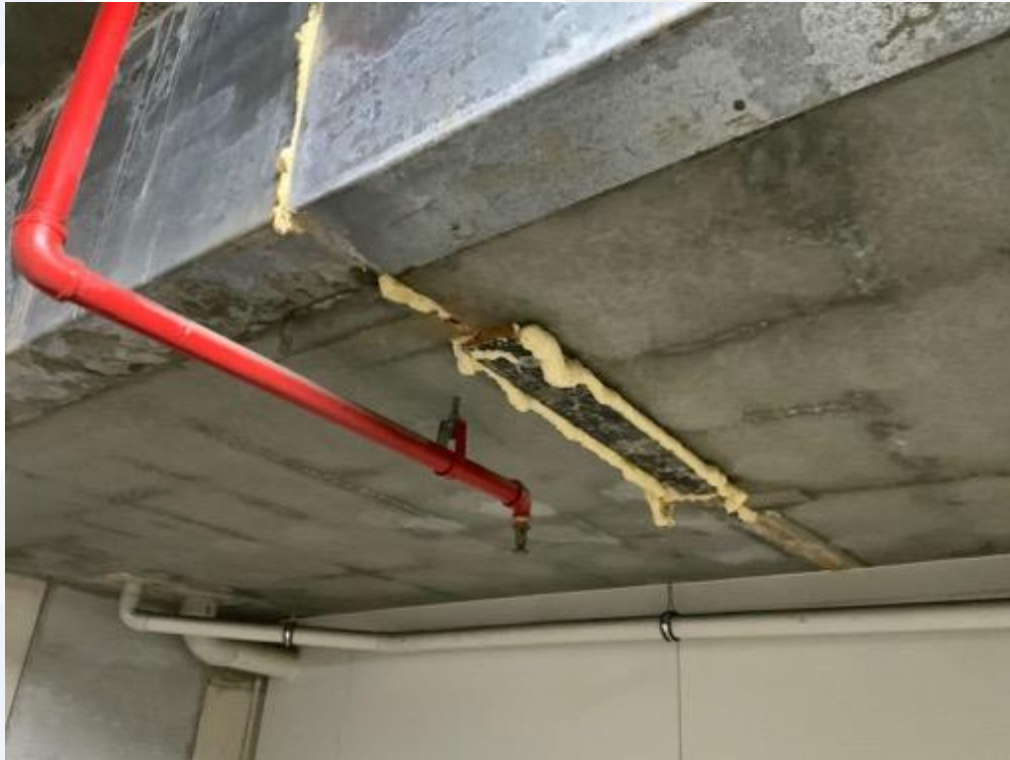
45. Old formwork requires removal outside south east switch room

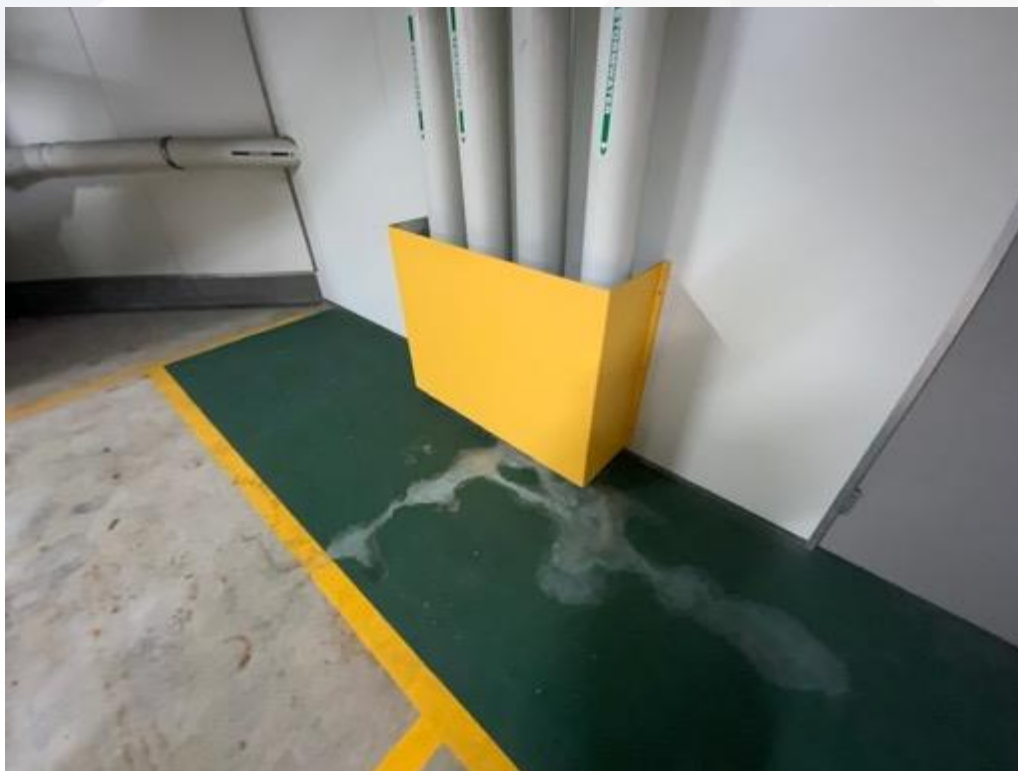
46. Repair floor where storm water leaks to south east corner

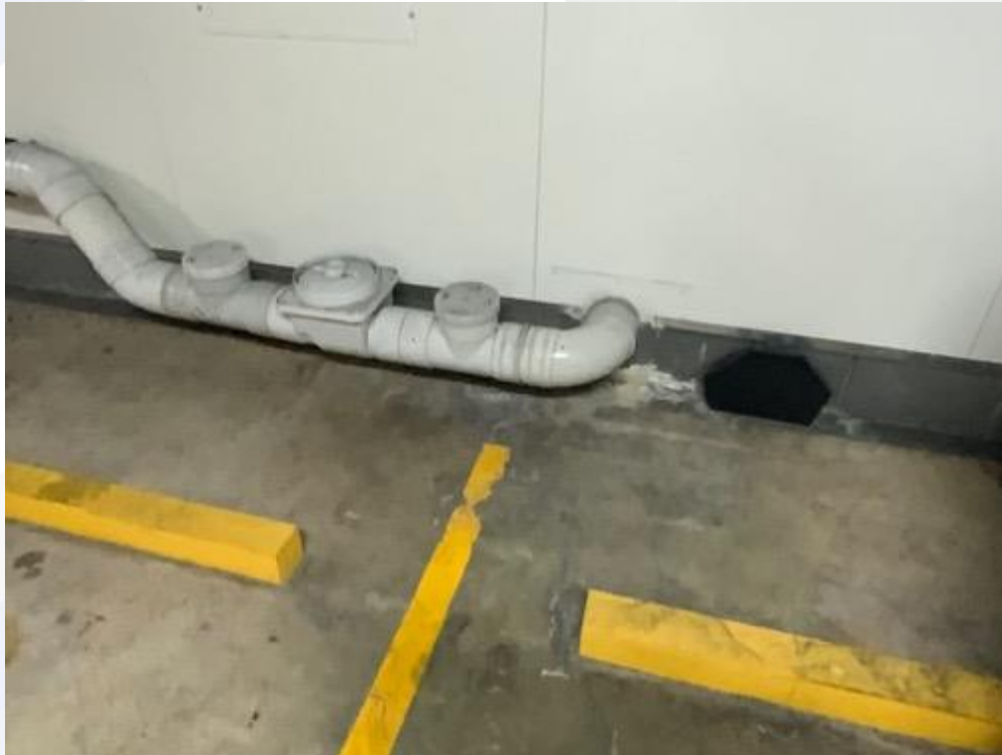
47. Efflorescence leaking from south wall com G05

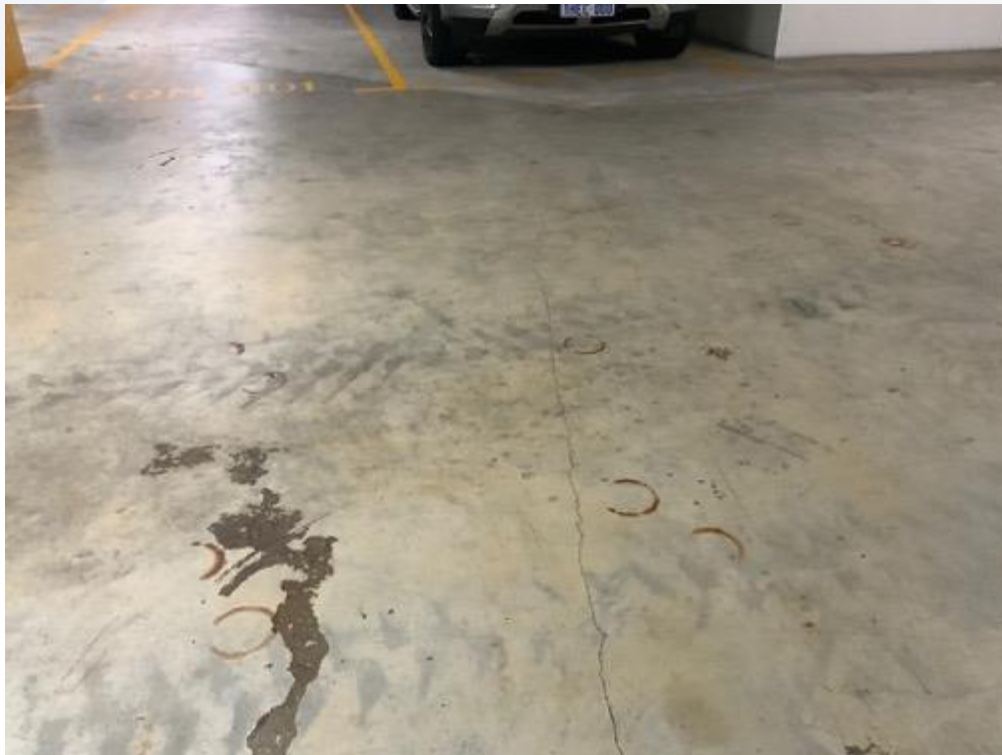
48. Cracking driveway west side opposite COMM G02

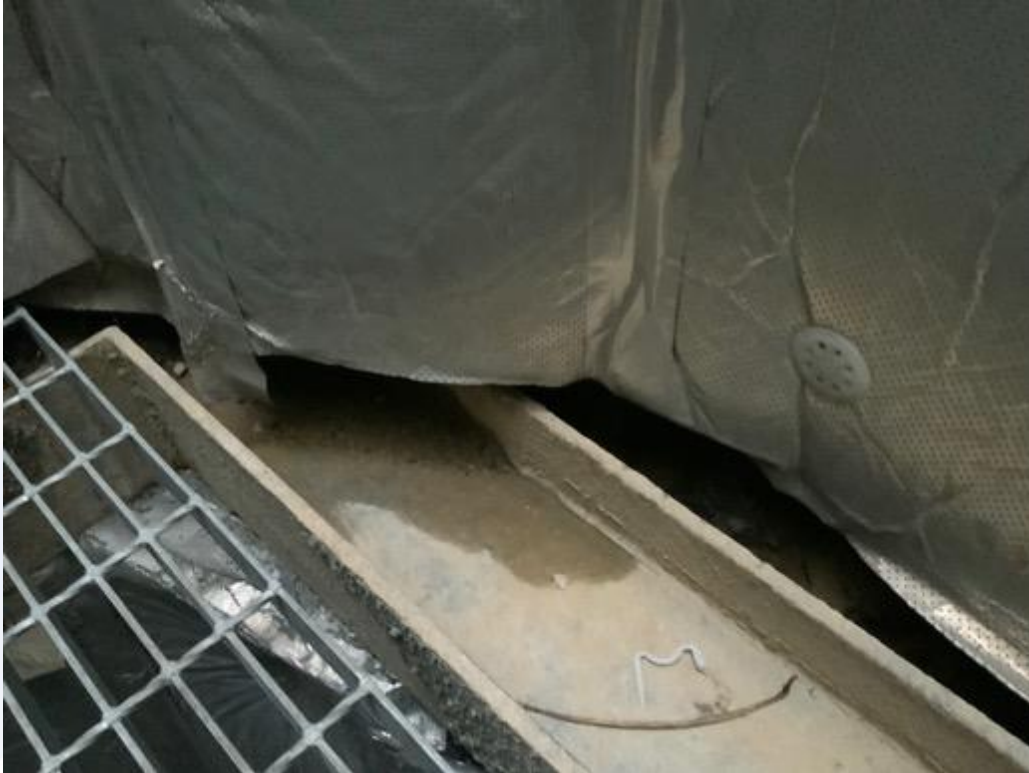
49. Efflorescence to skirting 2 metres only opposite Comm G02 west side
50. Walls wet in mechanical fan room north west corner water pooling in base of shaft

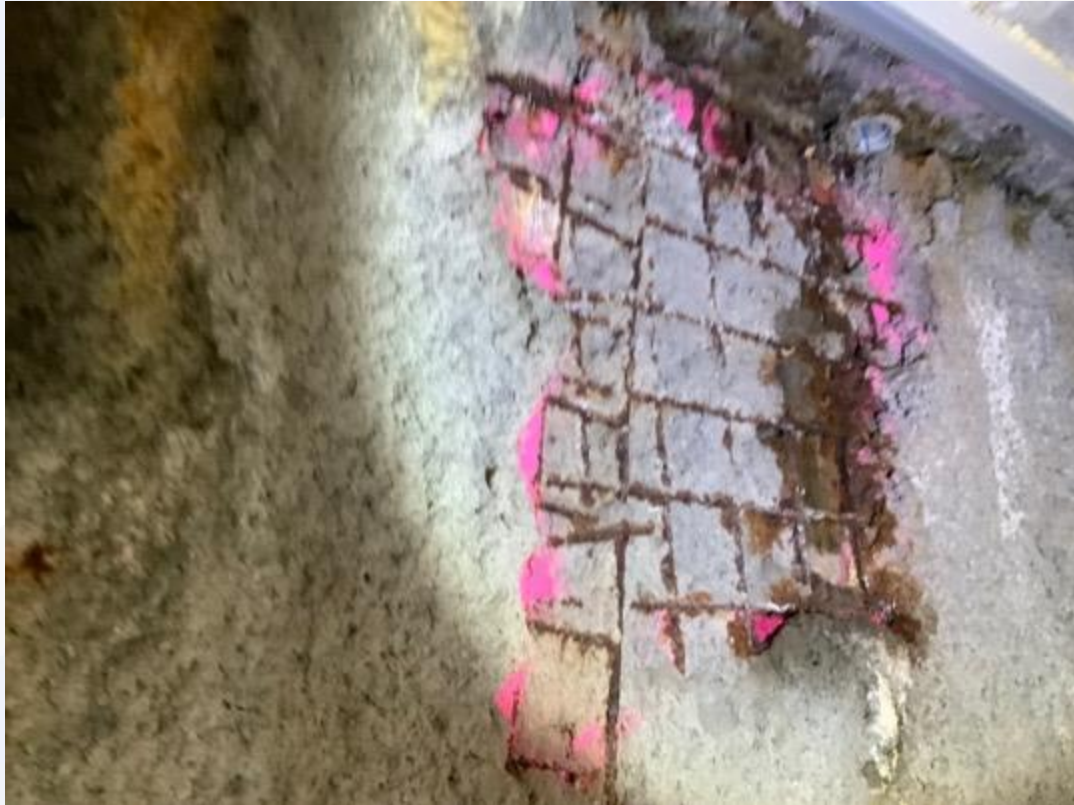
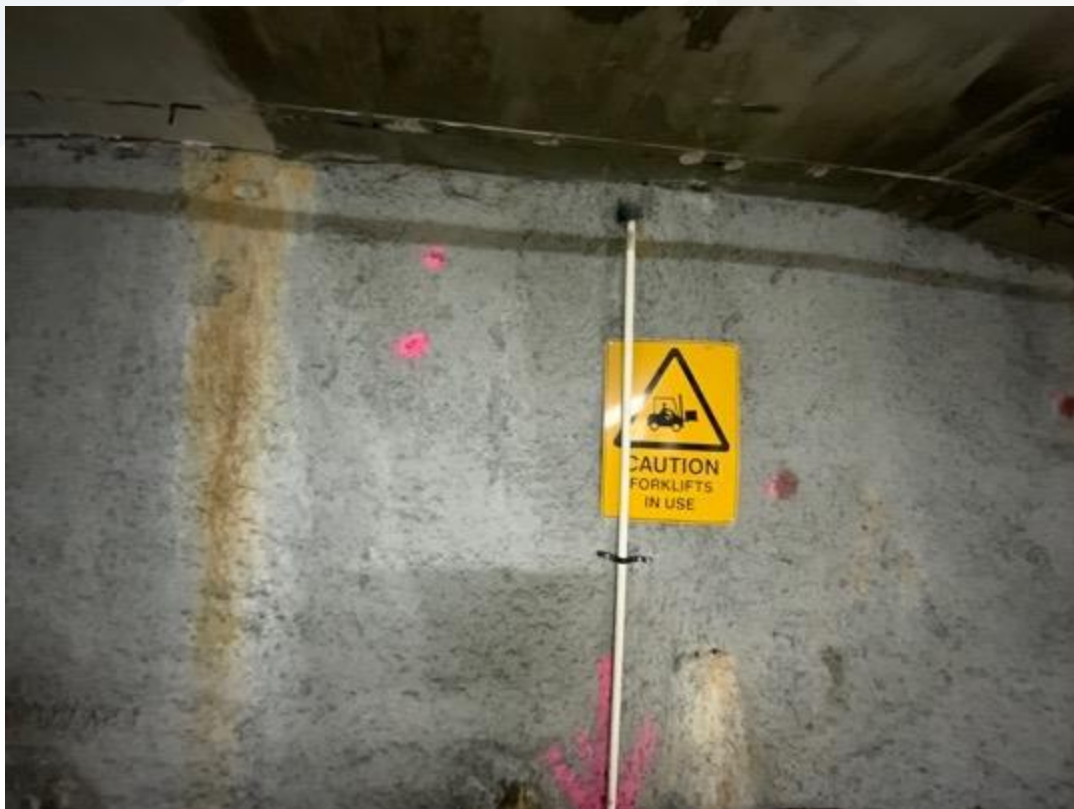
59. Photos taken 18th June 2021 workers have stripped wall and are creating a new drain and installing the new panels in front of the old 'B2 down to B3
