10 Year Strata Maintenance Plan

1 Harper terrace South Perth

Client Name : The Owners Strata Plan 70215
Report Number : 9870
Inspection Date : Friday 28th May -18 June 2021
Weather Conditions : Fine
Inspected by : Brian Connor B.App.Sc
Registered Builder 100541
Member of Building Inspectors association of WA

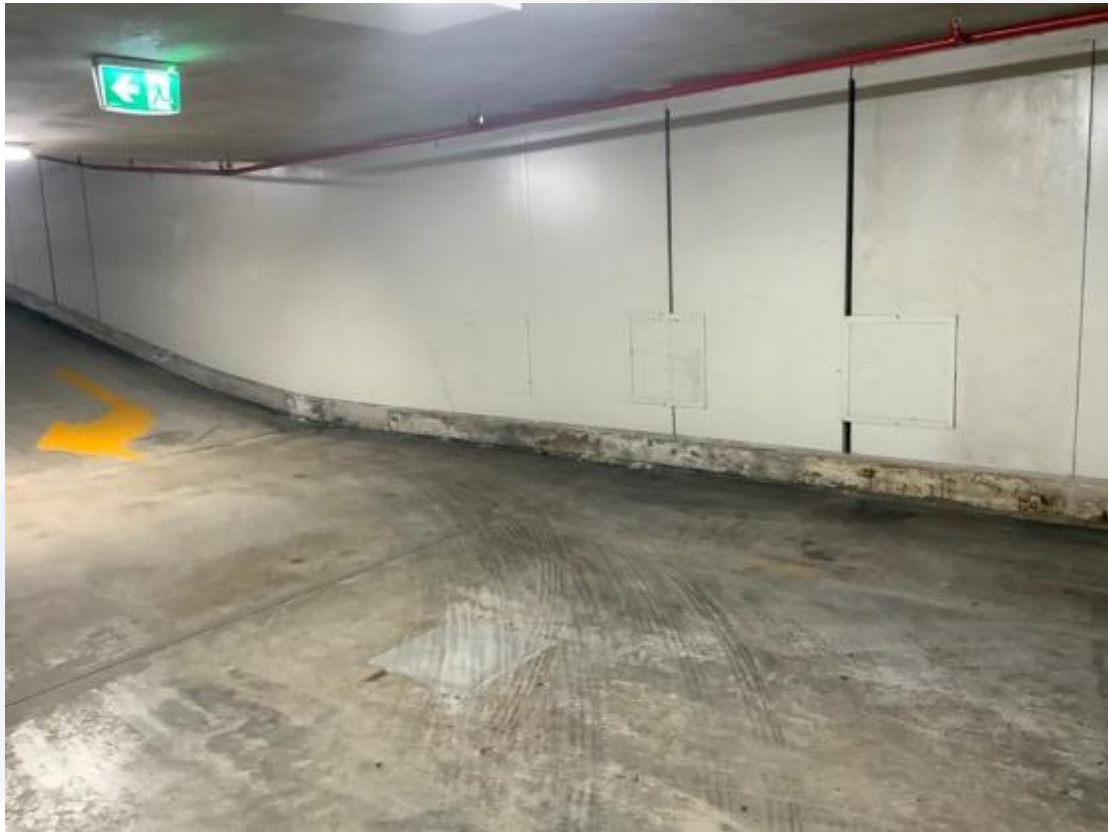
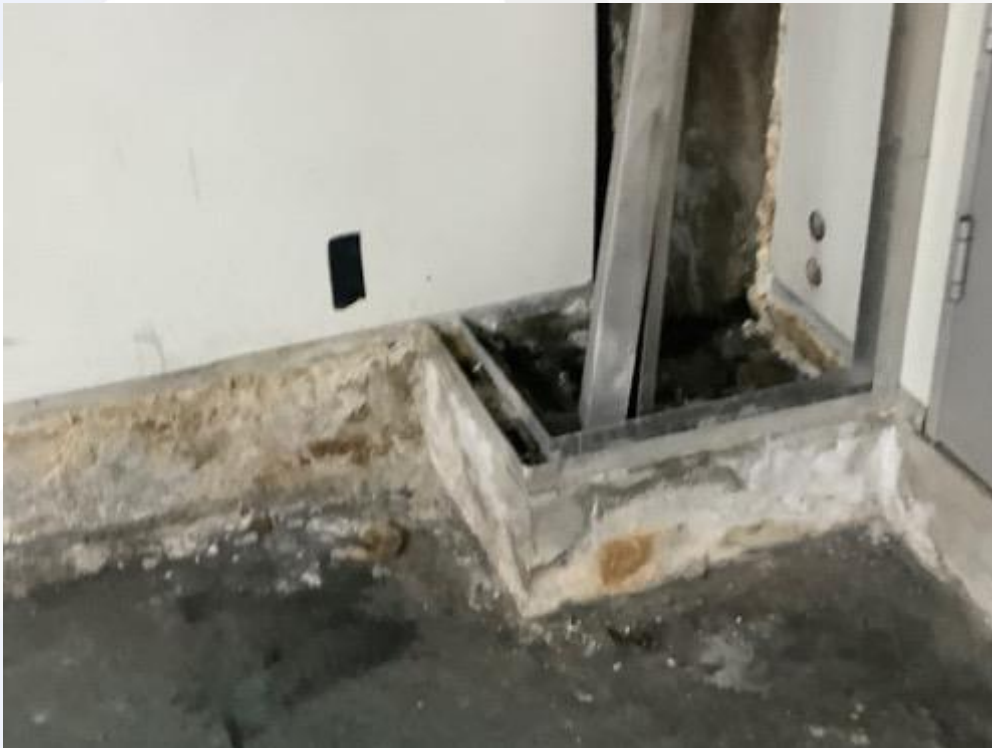
Carpark B3 carpark

60. Extreme salt build up /wall damage to skirting level from mechanical fan room northeast corner and west including up ramp

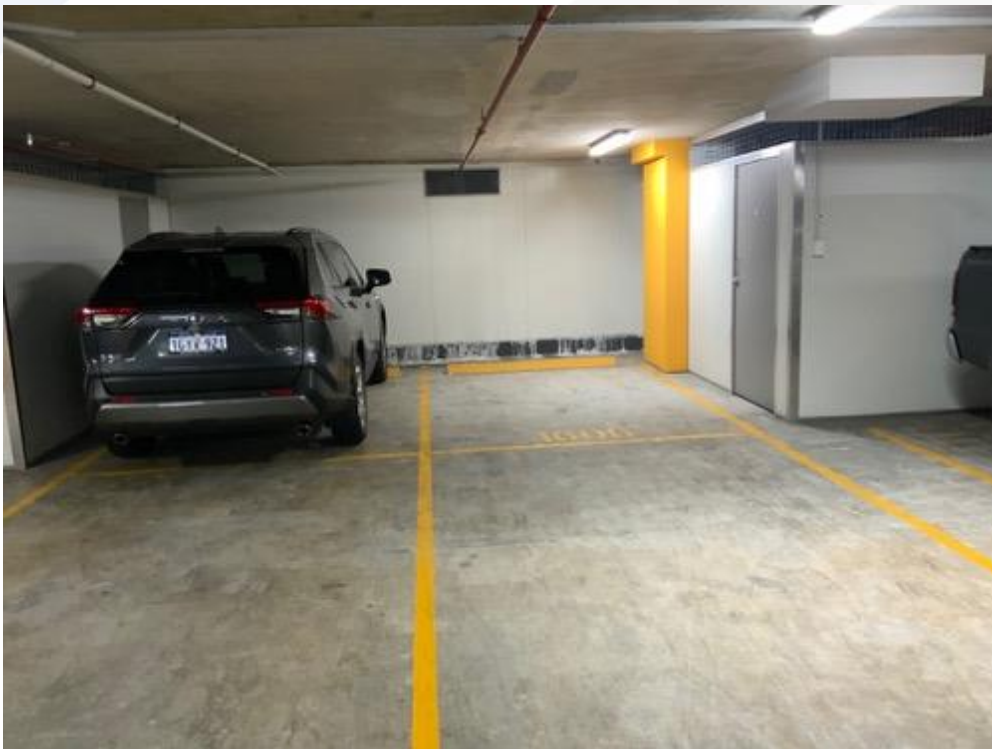
61. Water leaking through fan room wall and wet on the floor

62. Leaking east wall car bay 1606

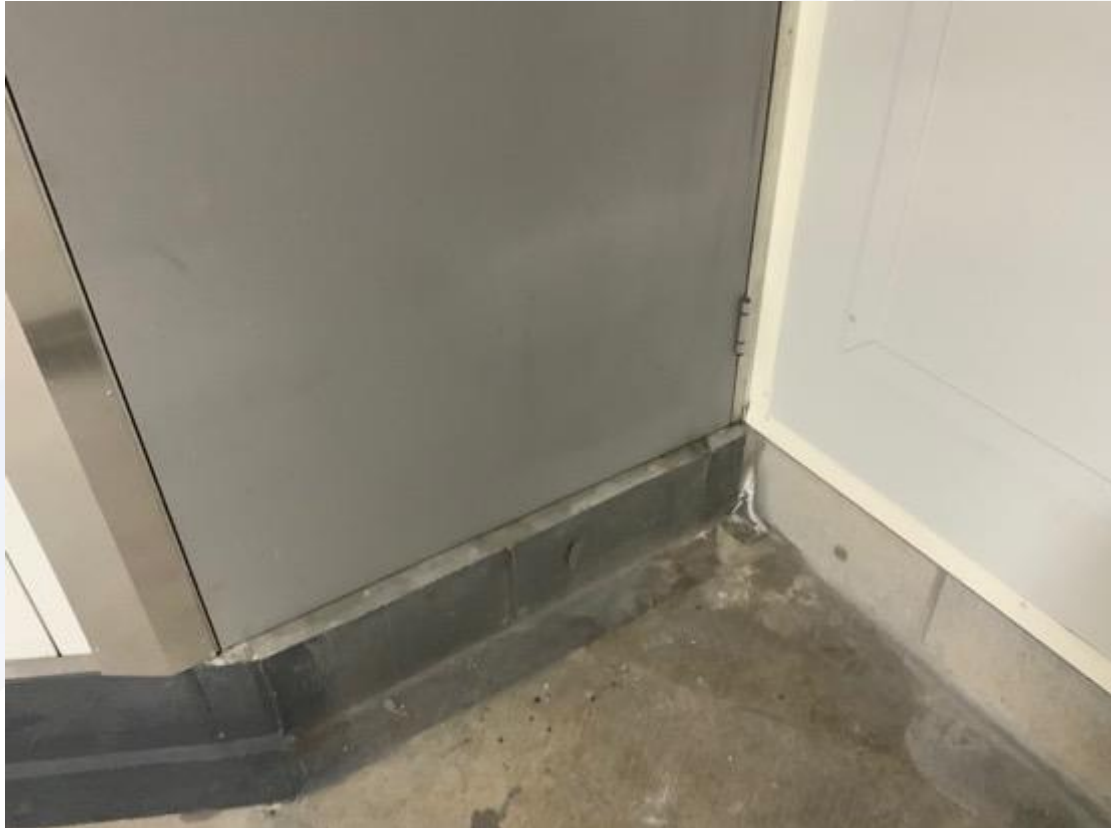
- 63. Ditto south wall 1307
- 64. Ditto car bay 1403 and car bay 1506 in photo
- 65. Ditto to west wall scooter bay south west corner
- 66. Ditto west wall opposite car bay 1203
- 67. Small leak outside north west fan room in corner, leaking from fan room

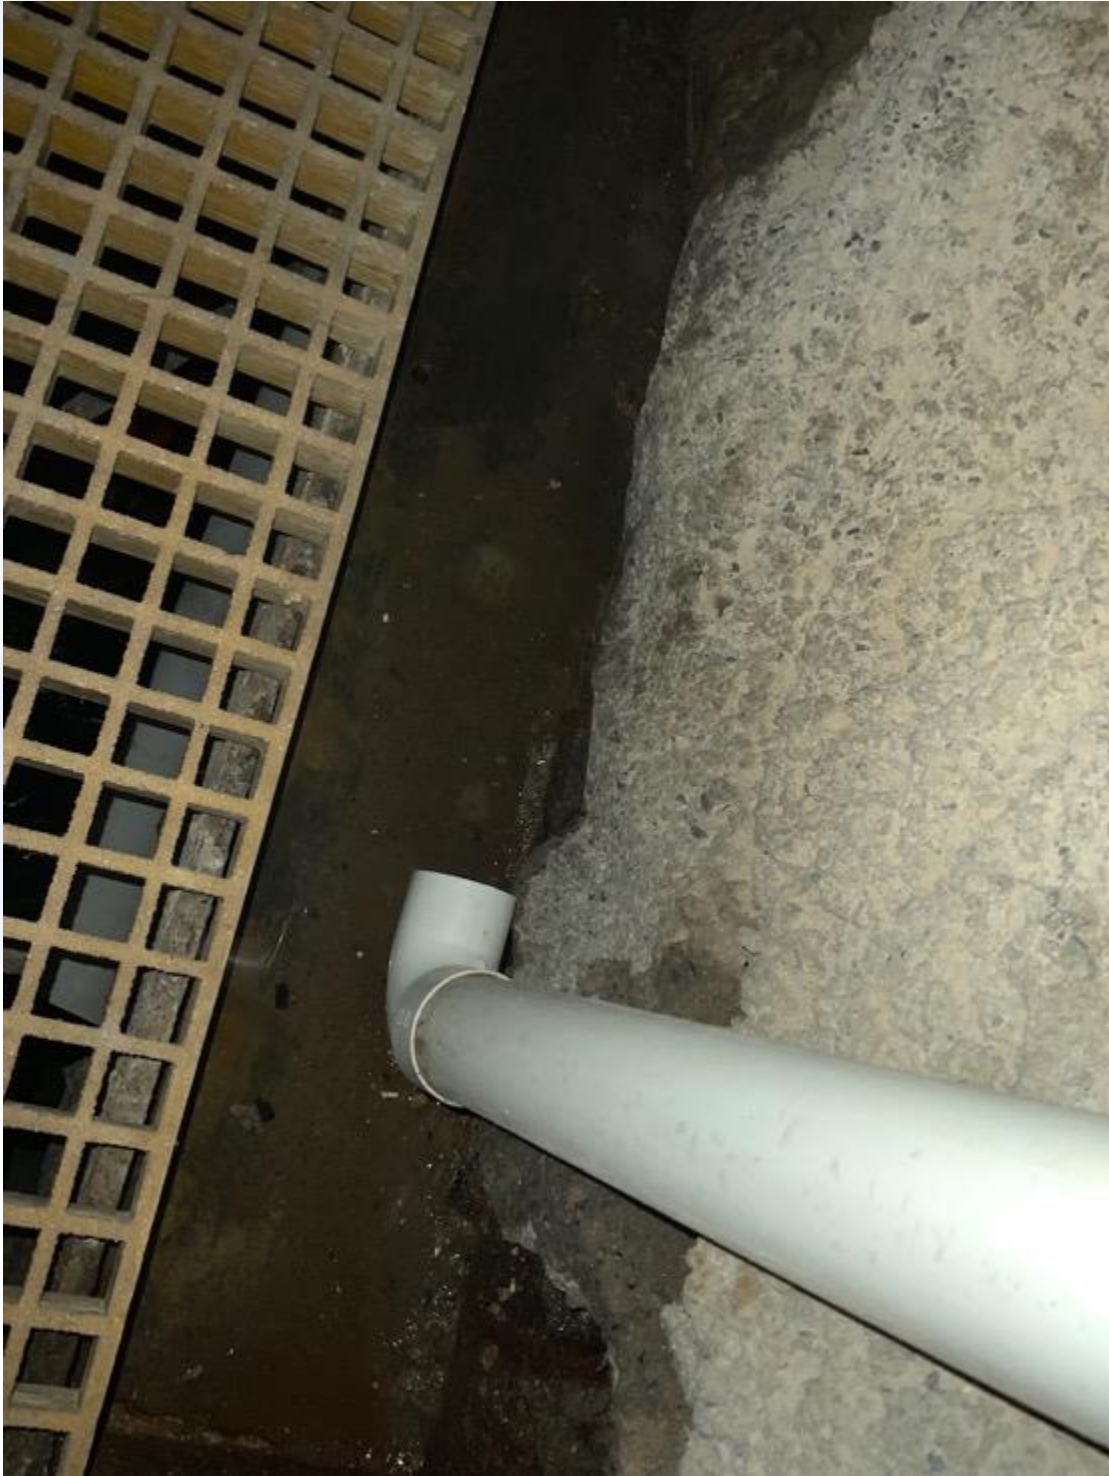
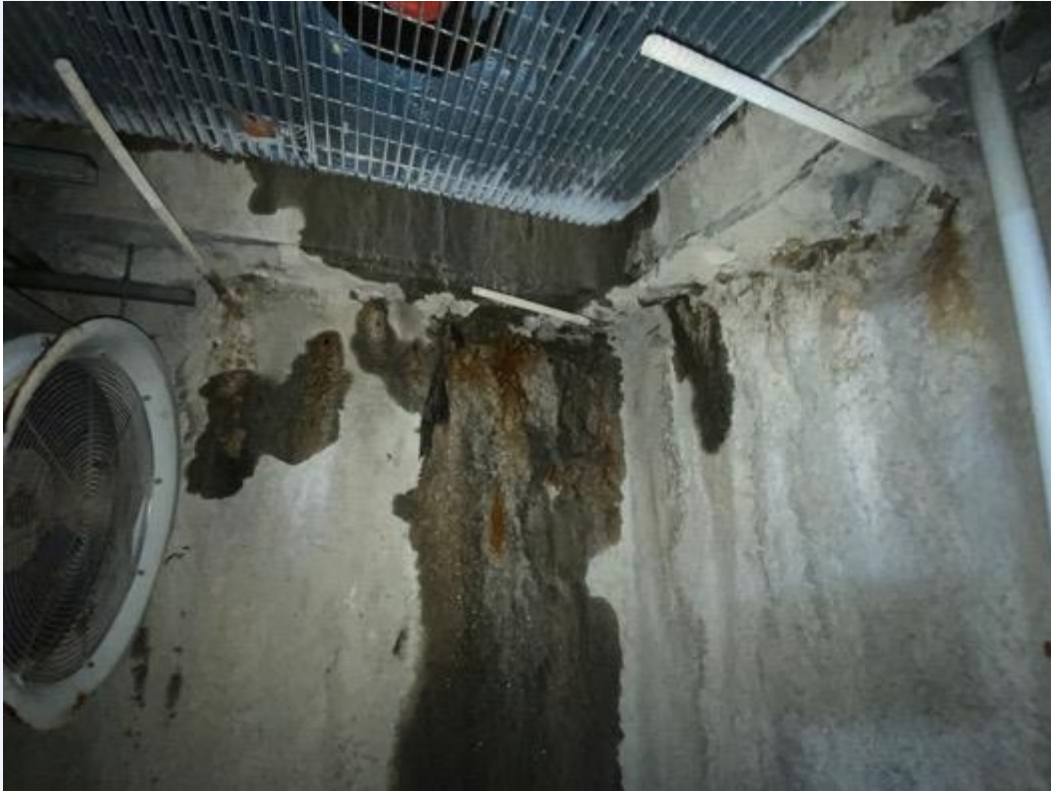
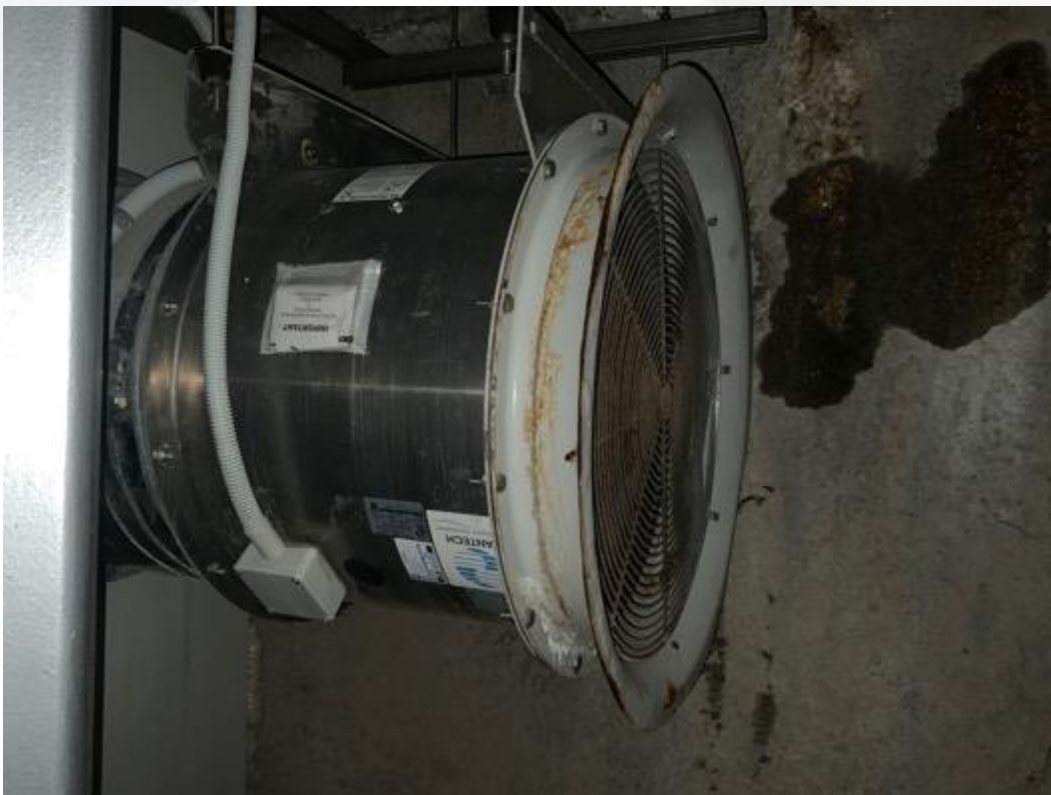
- 68. Inside water steaming down the west wall
- 69. Water has caused fan to rust requires replacement

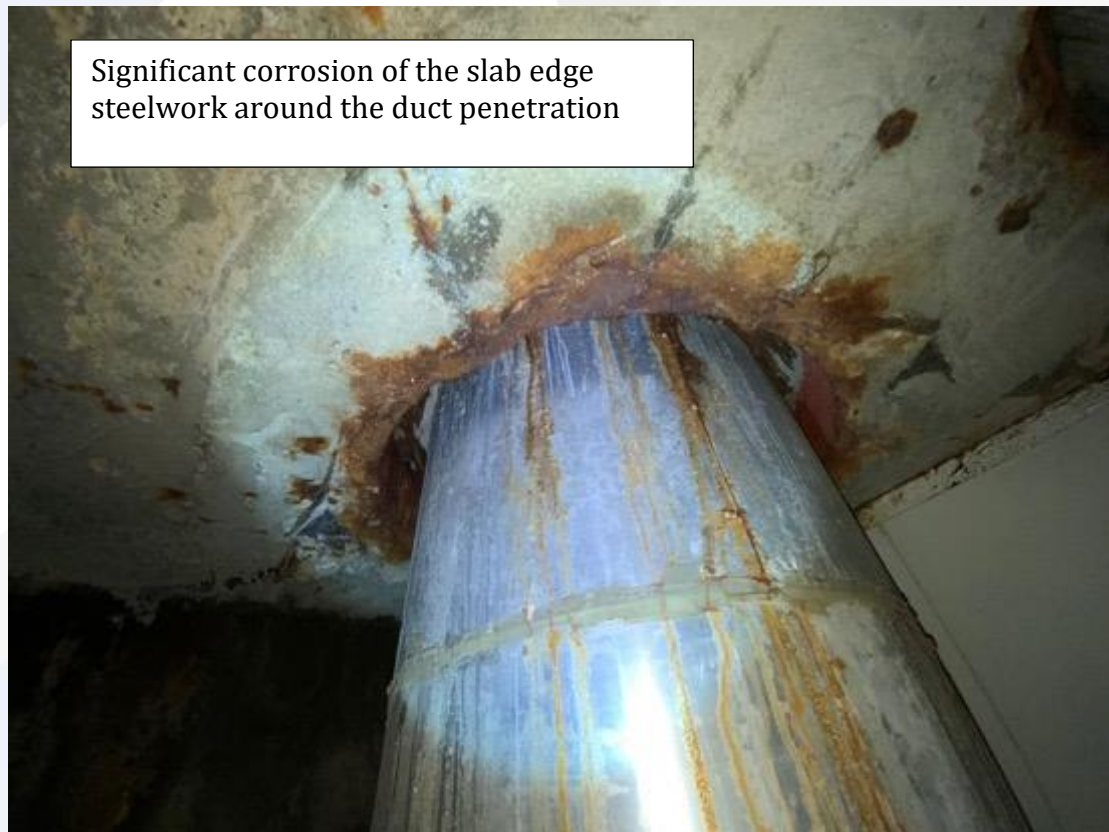
- 72. Corroded reinforcement steel to north wall
- 73. Corroded reinforcement steel to east wall in the corner
- 74. Corrosion to fan ductwork
- 75. Corroded steelwork and reinforcement steel around duct opening concrete ceiling soffit
- 76. Walls wet and floor wet

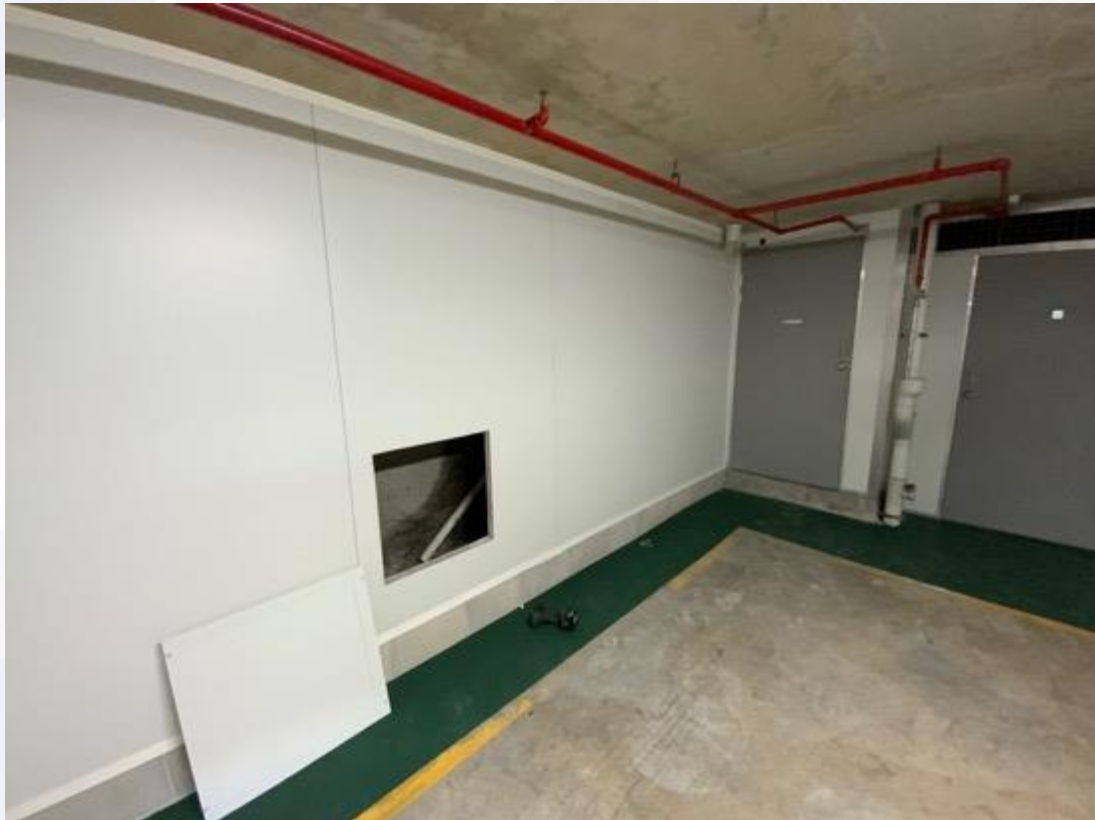
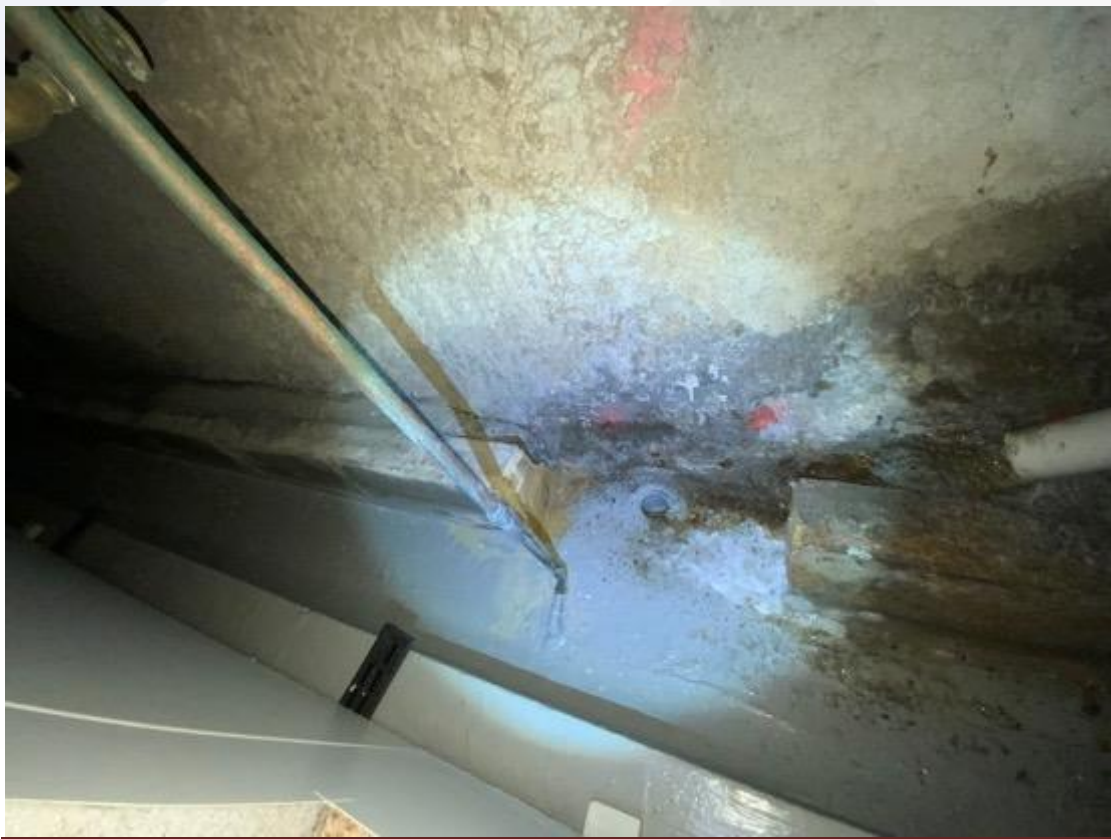
Access panel to north wall 3 m west of fan room

- 77. Appears drain has been epoxy coated grey recently by builder
- 78. Drains from above drain to the level below
- 79. Drainage conduits 20mm hanging out of the wall these drains are too small and should be increased to 40mm minimum where possible
- 80. Wall is wet for several metres approximately 3 metres west of access hatch and immediately to the east of the access hatch for 800mm and very wet in the Mech fan room
- 81. Leaking efflorescence to skirting rear of car bays 1306 and 1103

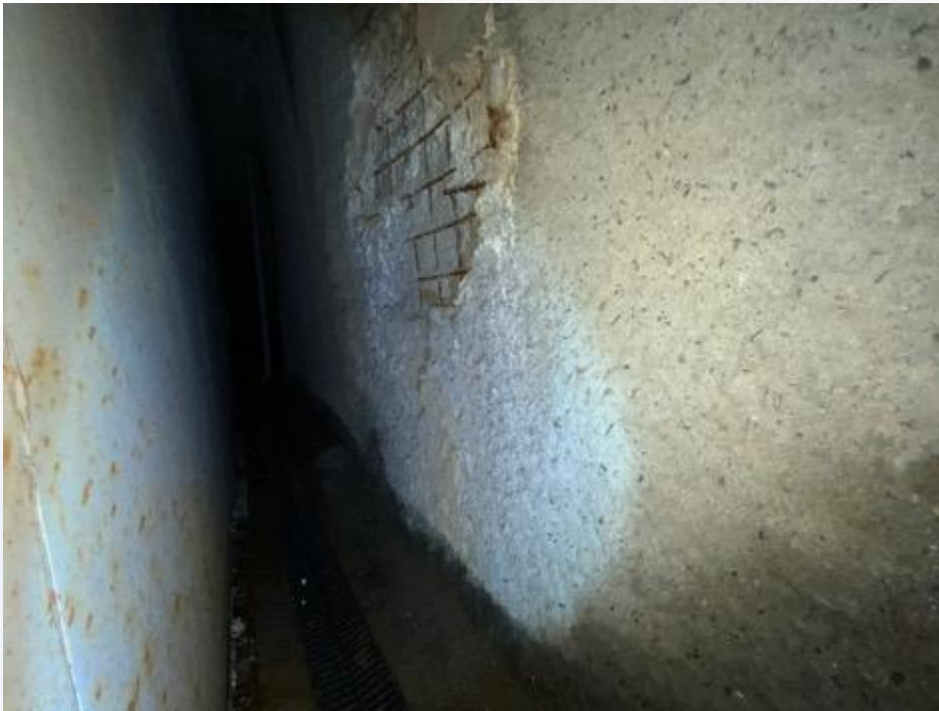
84.2 metres of missing concrete to the wall exposing the reinforcement mesh
(Mesh appears to be 8mm bar in 100mm squares)

Concrete cover to the reinforcement steel generally appears to be 40mm

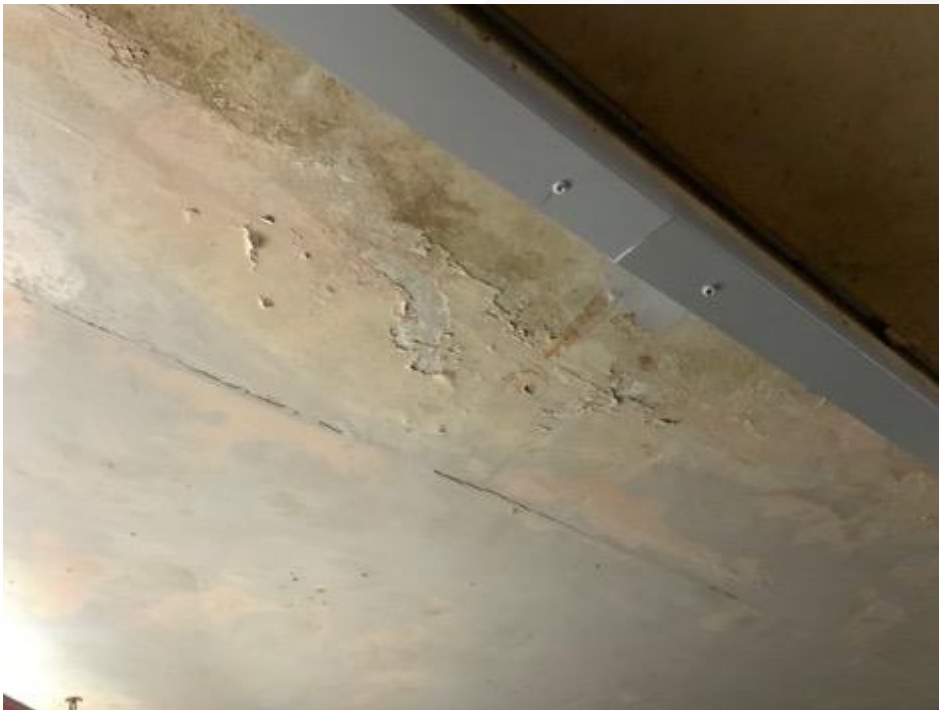
85. Flaking skim coat above carpark 1504

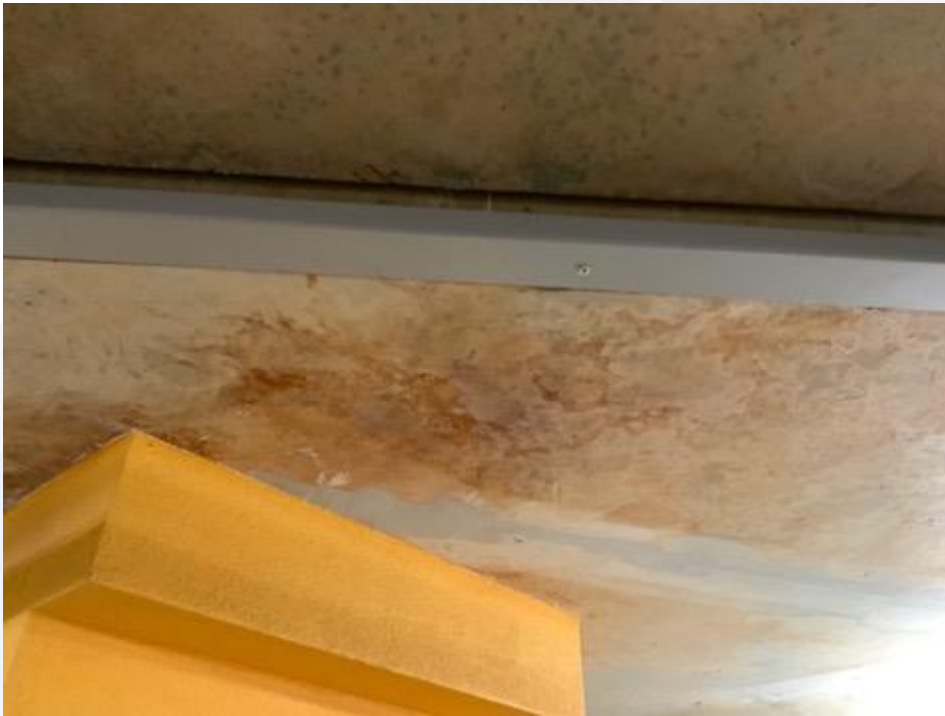
86. Brown staining possible water ingress to concrete ceiling soffit around yellow column same area

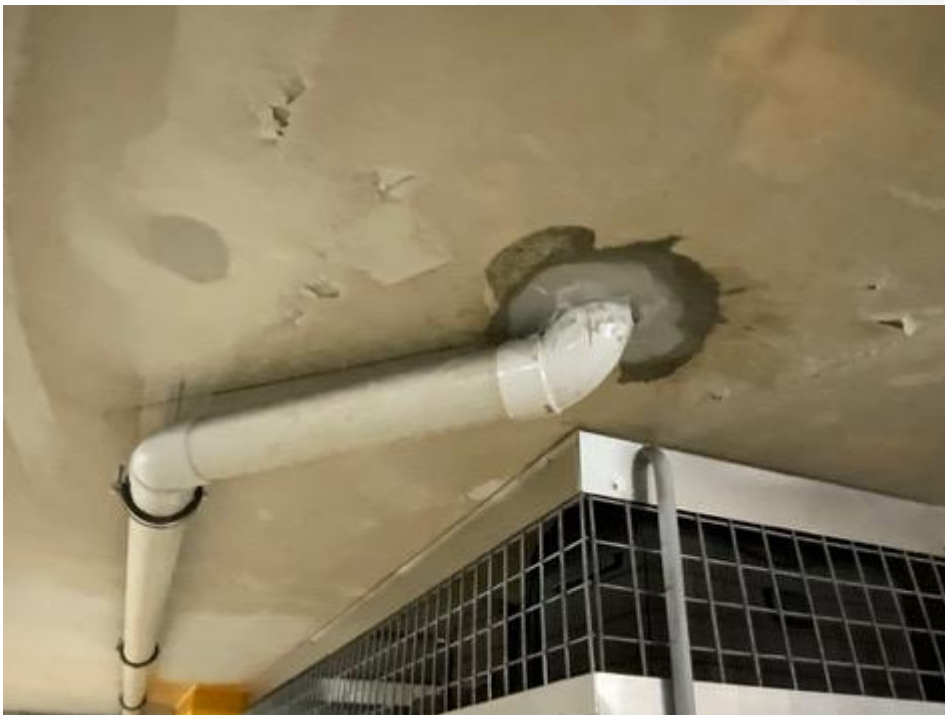
87. Moisture around pipe penetration ceiling north of storage unit 1504

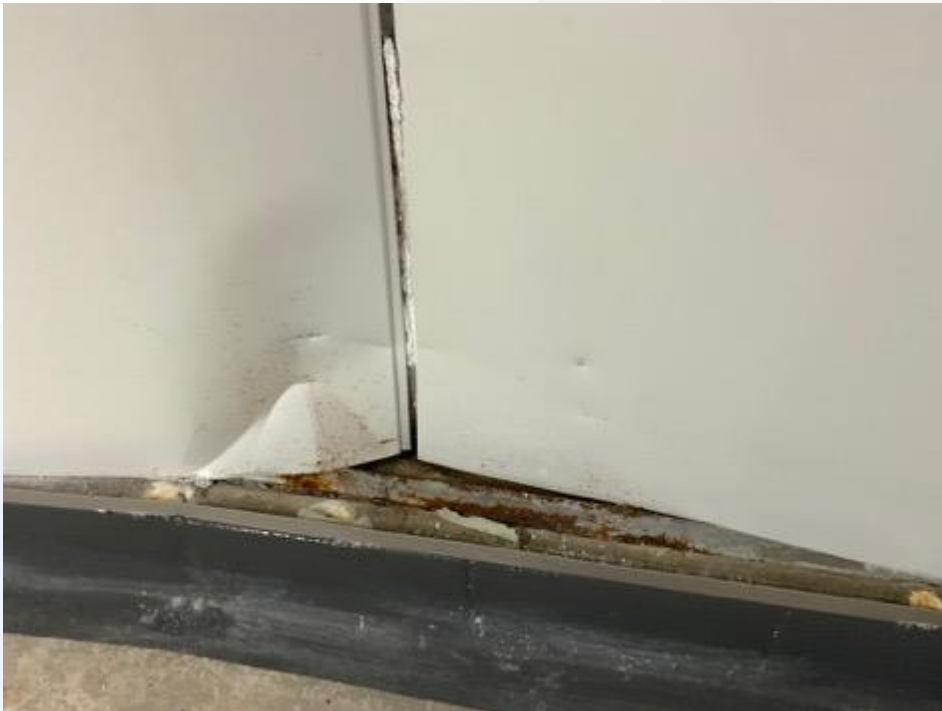
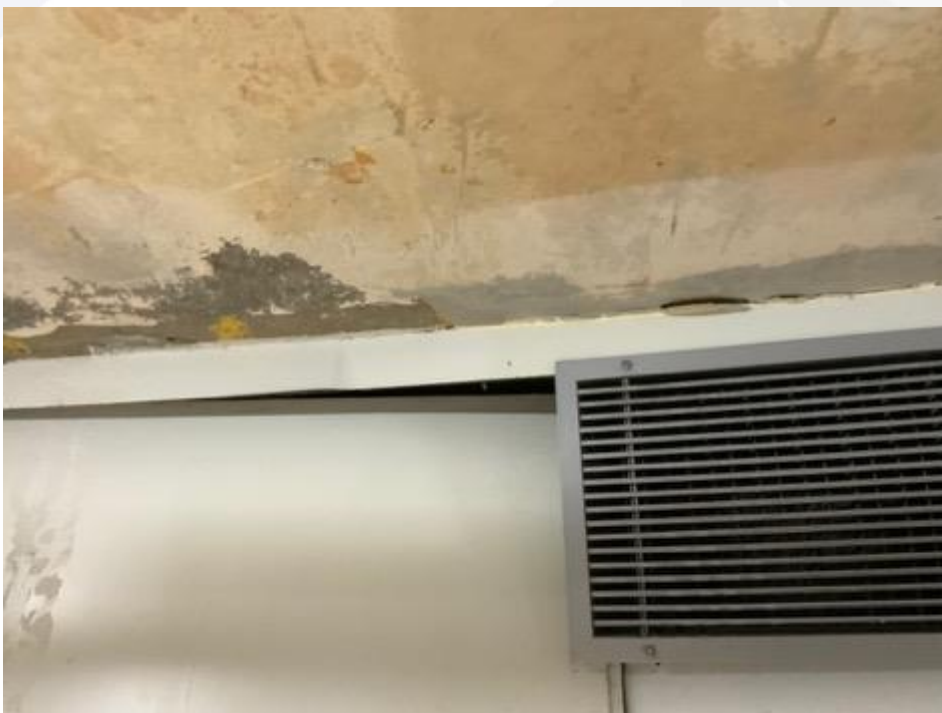
88. Damage to east insulated wall panels adjacent car bay 702

89. Rust to panel internal fixing angle full length corroding due to water ingress.

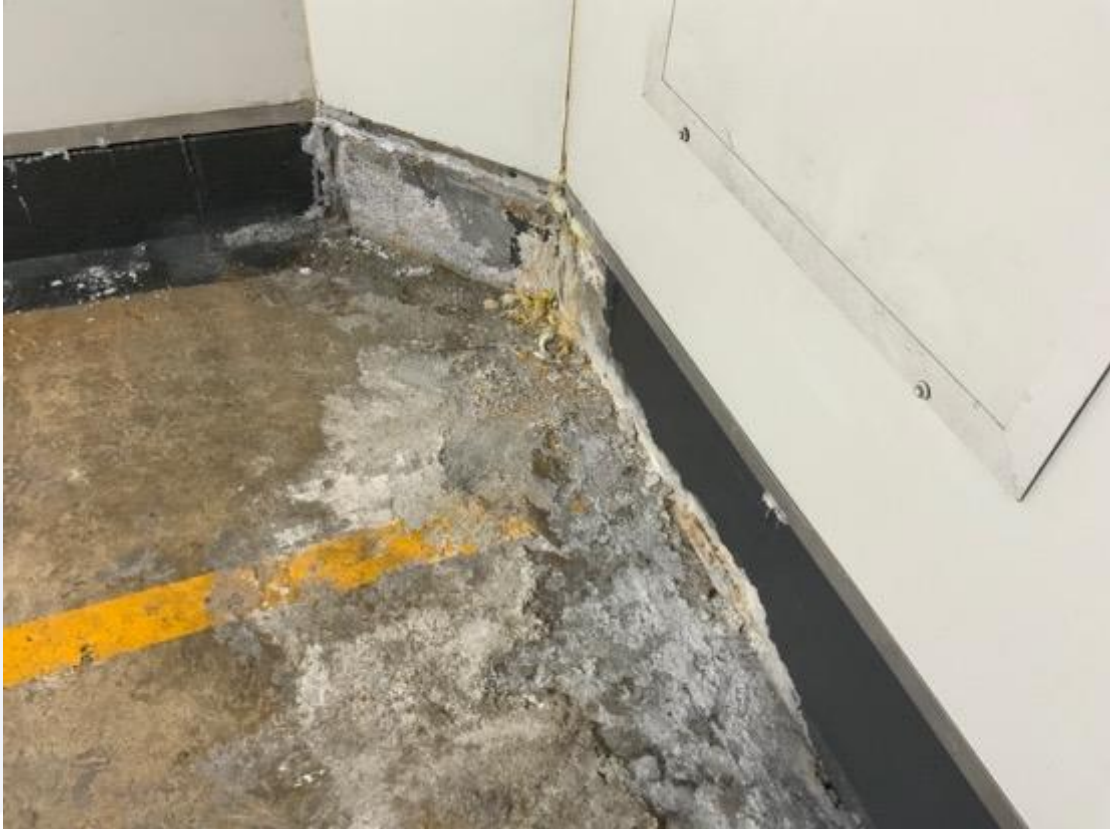
90. Significant leak to south east corner below access panel rear of car bay

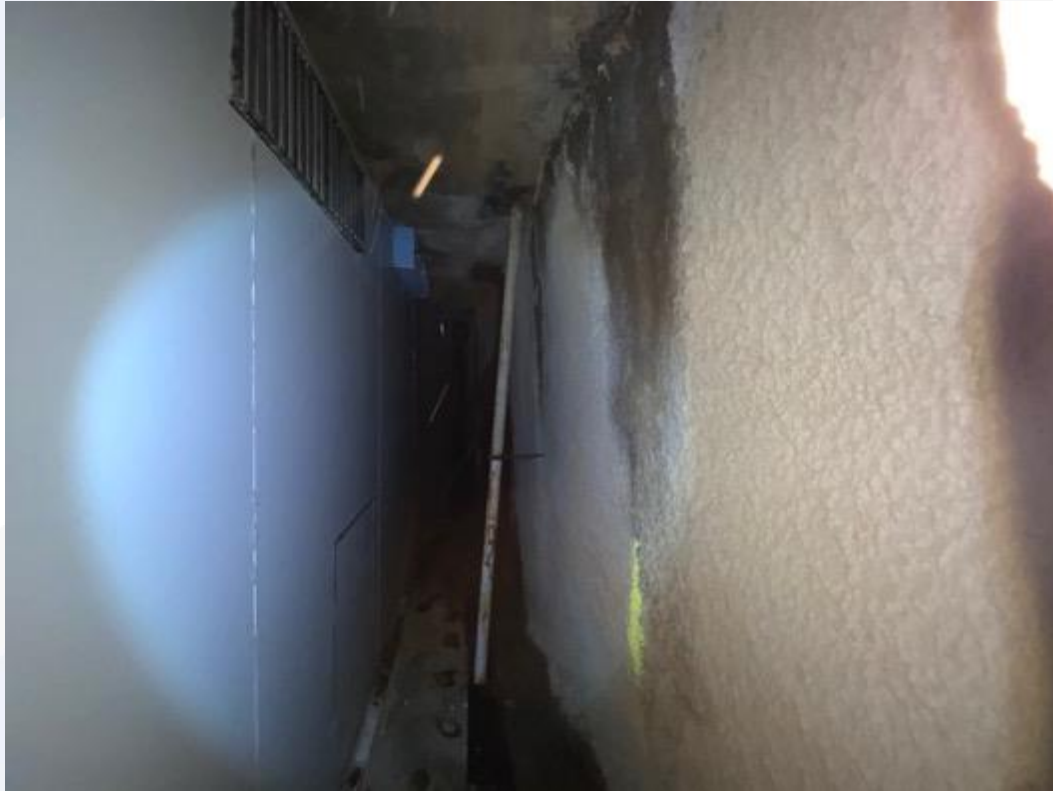
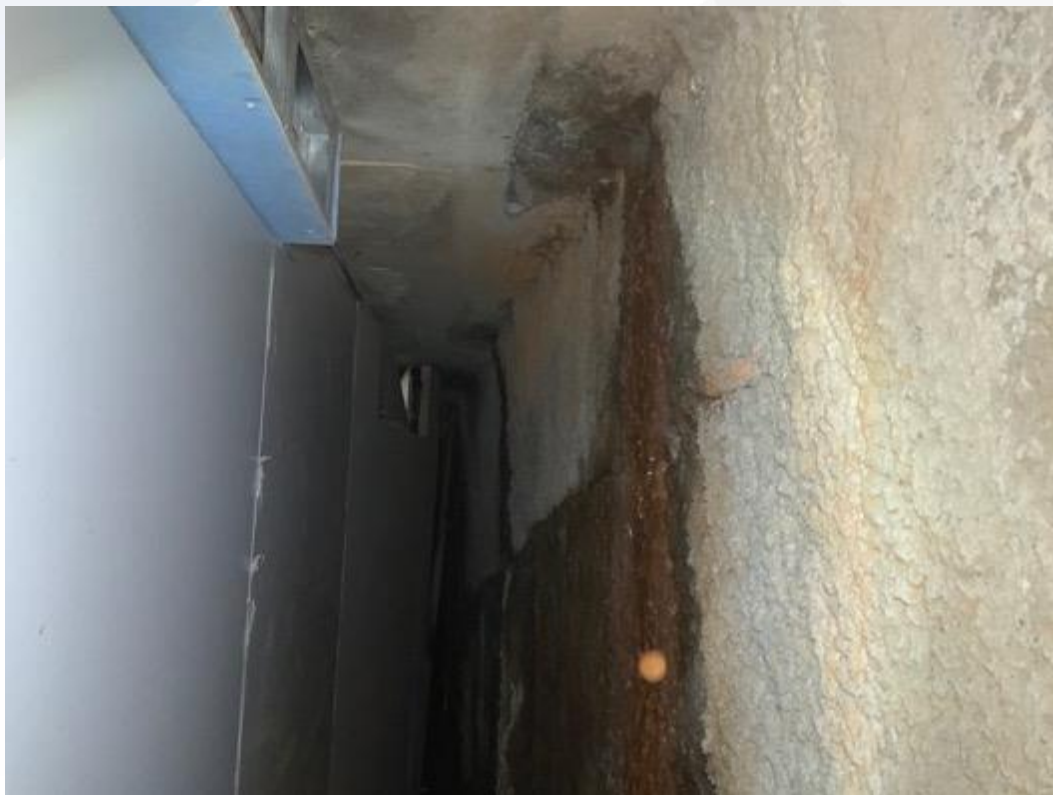
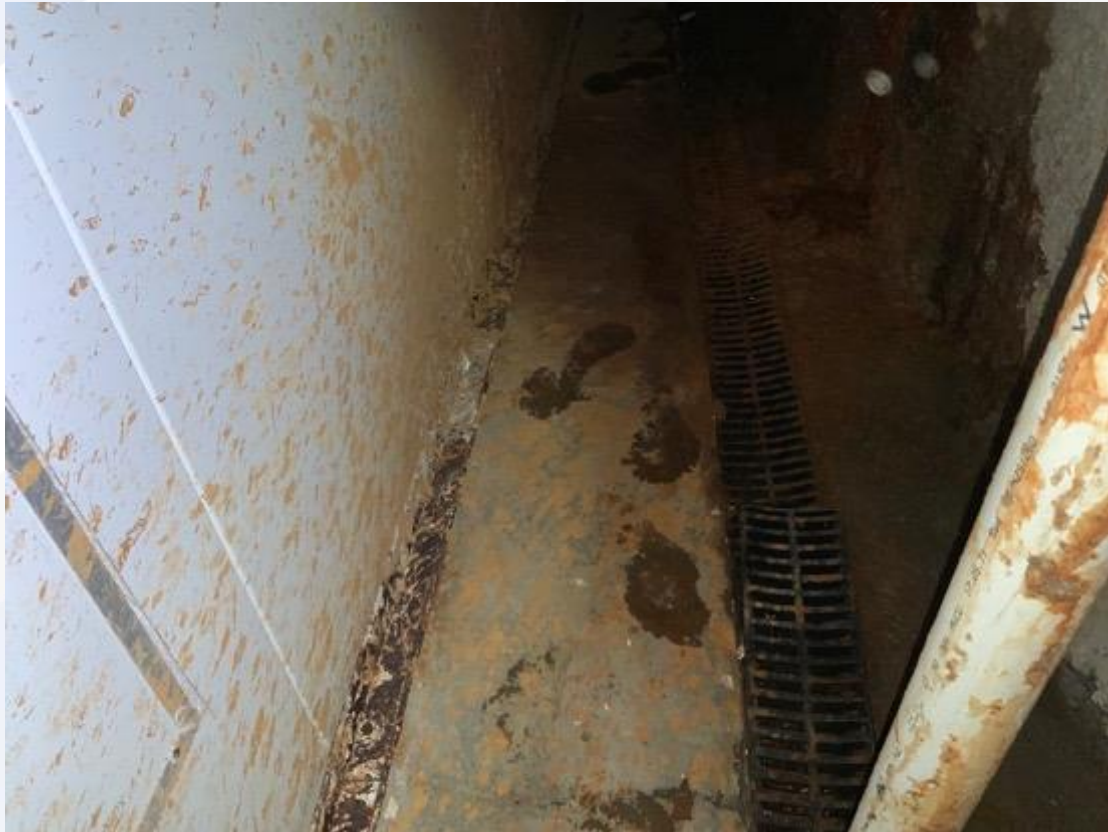
99. Leaking / flaking soffit skim coat to rear of car bay 903 caused by leaking to drain
100. Leaking /minor salt build up to skirting to west wall behind scooter bay adjacent car bay 701

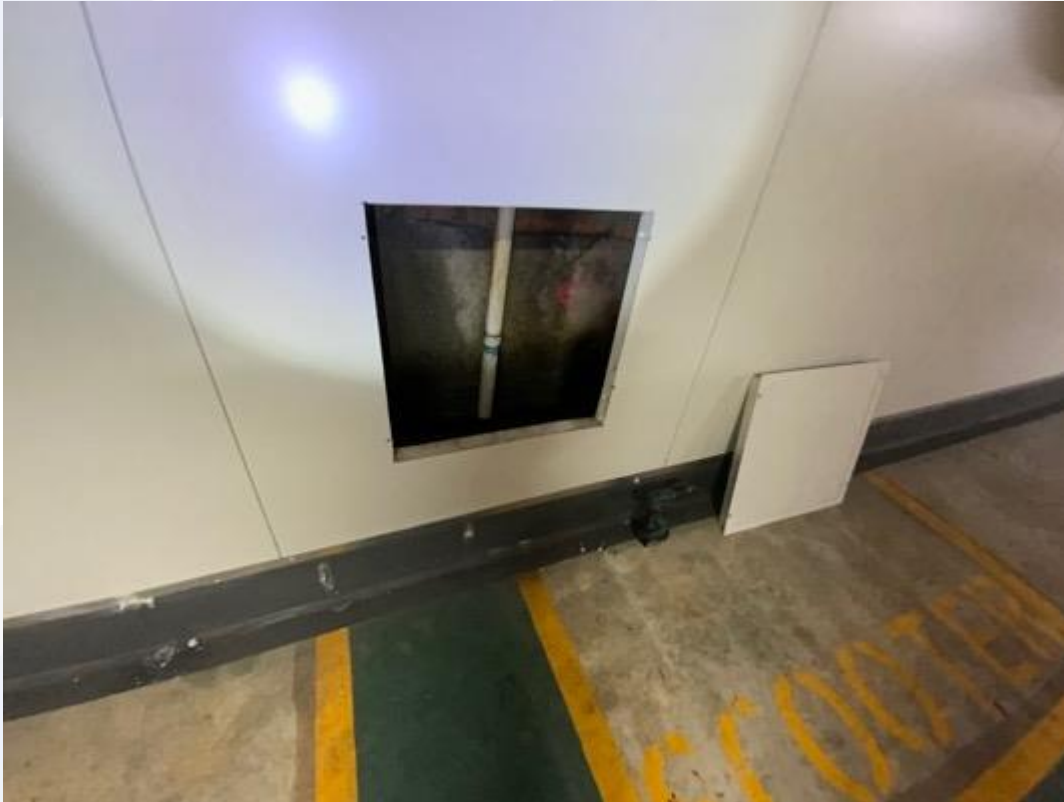
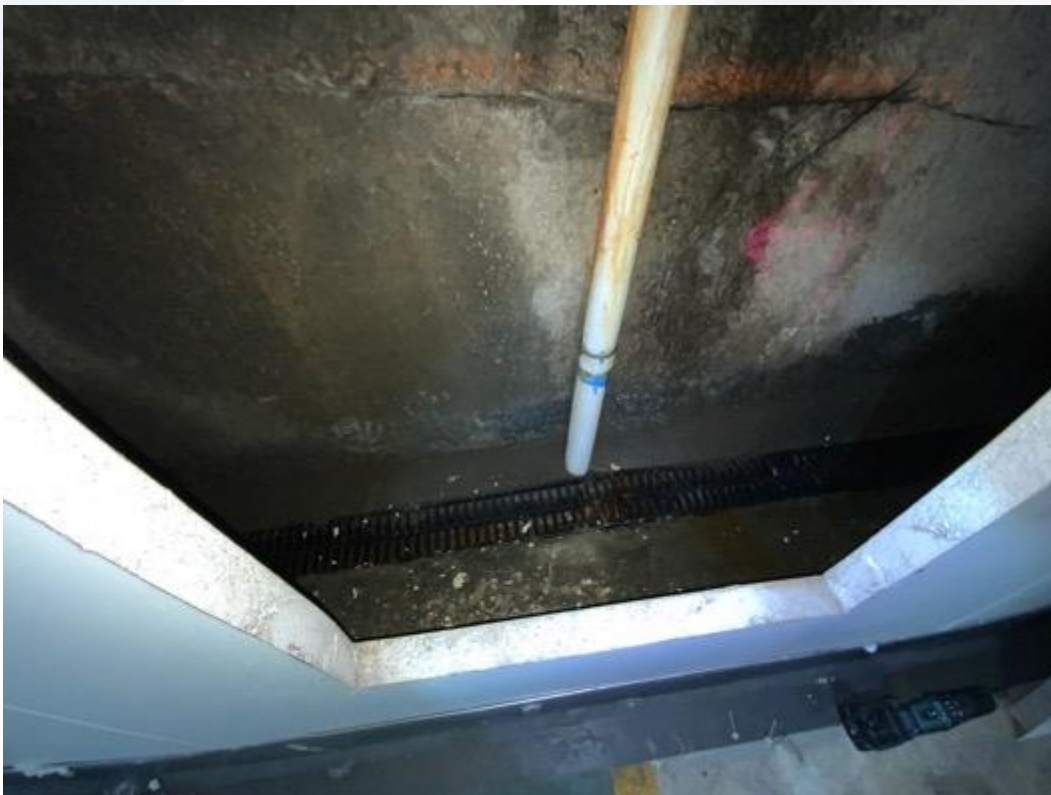
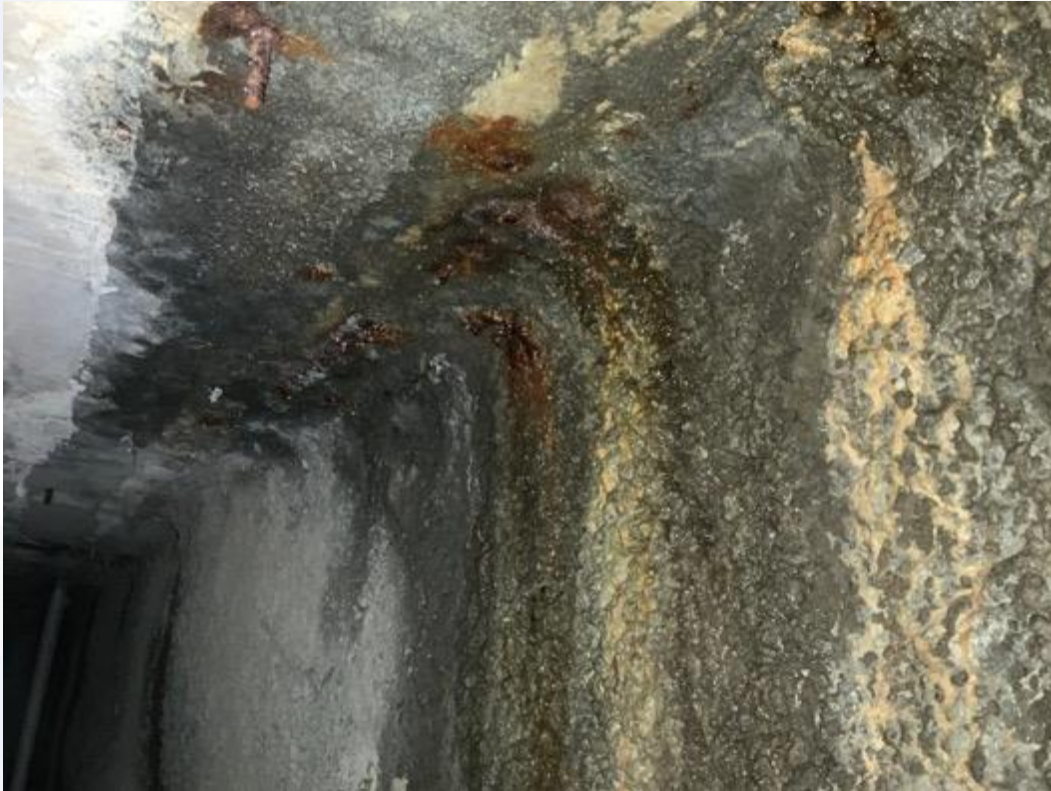
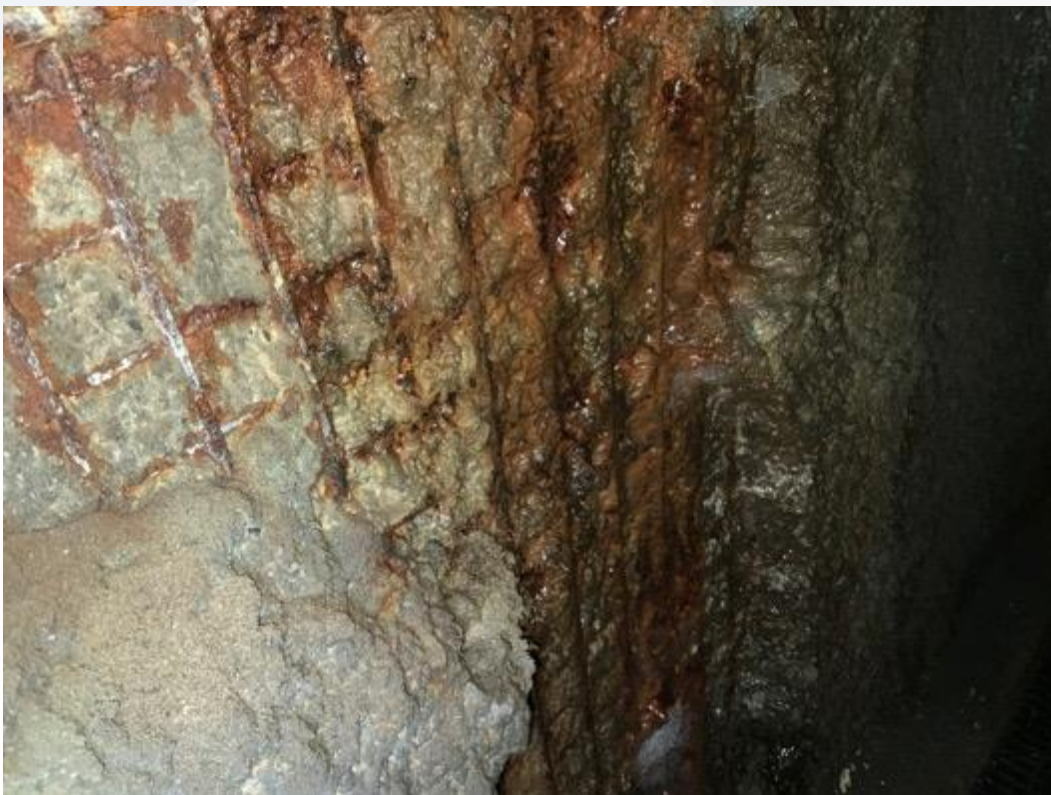
Access hatch west wall scooter bay

- 101. Large leak 2 m north of access hatch corroding reinforcement steel, water running from walls
- 102. Smaller leak water running to 2 metres south of hatch
- 103. Minor leak visible to skirting outside Mech fan room north west corner
- 104. Drummy render to south west corner fire stair requiring repair/patching
- 105. 500mm wide area behind the west wall
- 106. 40mm drain outlet partially blocked
- 107. Leaking /salt build up to skirting to west wall between hatches opposite car bay 906

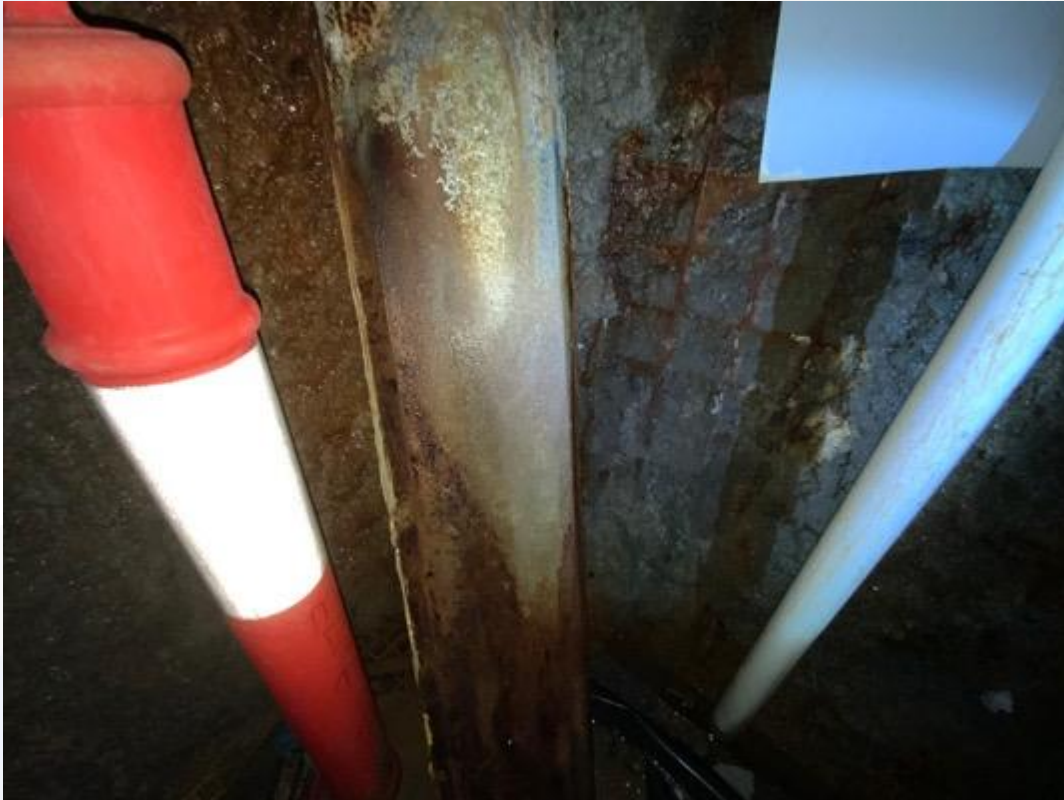
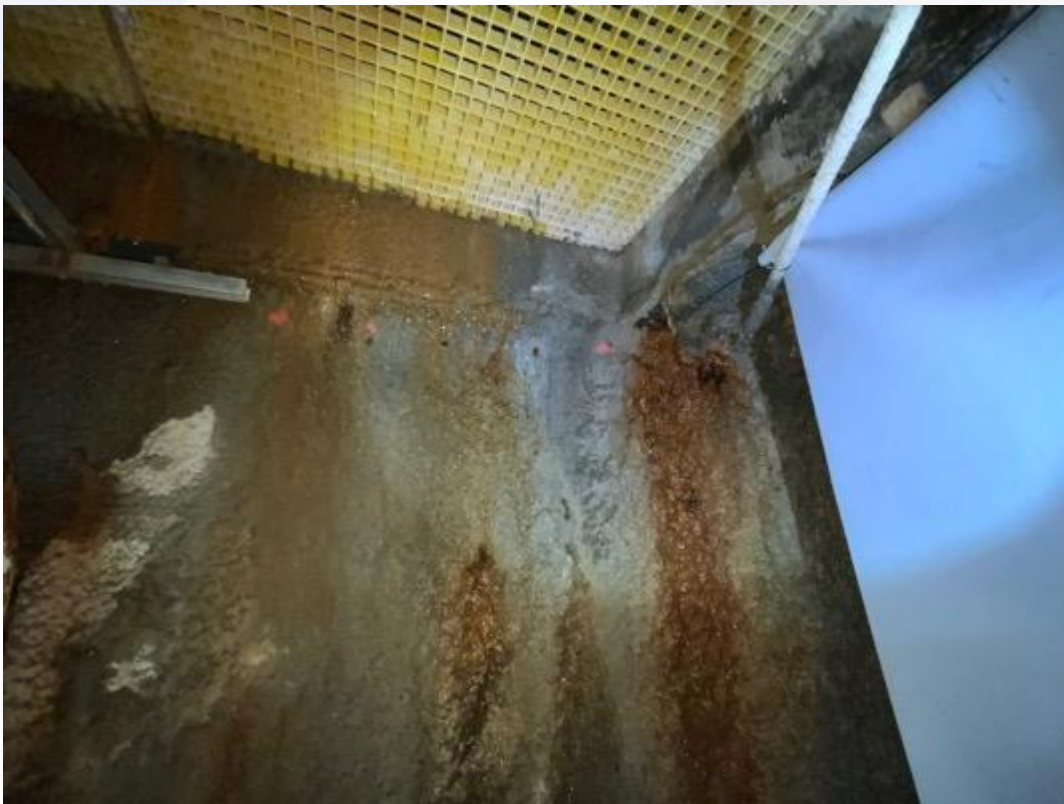
North west Mech fan room

- 108. Rusted fan unit and rusted exhaust ducting
- 109. Rusted metal apron flashing at floor level
- 110. Water running from walls west and north, exposed rusted reinforcement steel to north wall
