10 Year Strata Maintenance Plan

1 Harper terrace South Perth

Client Name : The Owners Strata Plan 70215
Report Number : 9870
Inspection Date : Friday 28th May -18 June 2021
Weather Conditions : Fine
Inspected by : Brian Connor B.App.Sc
Registered Builder 100541
Member of Building Inspectors association of WA

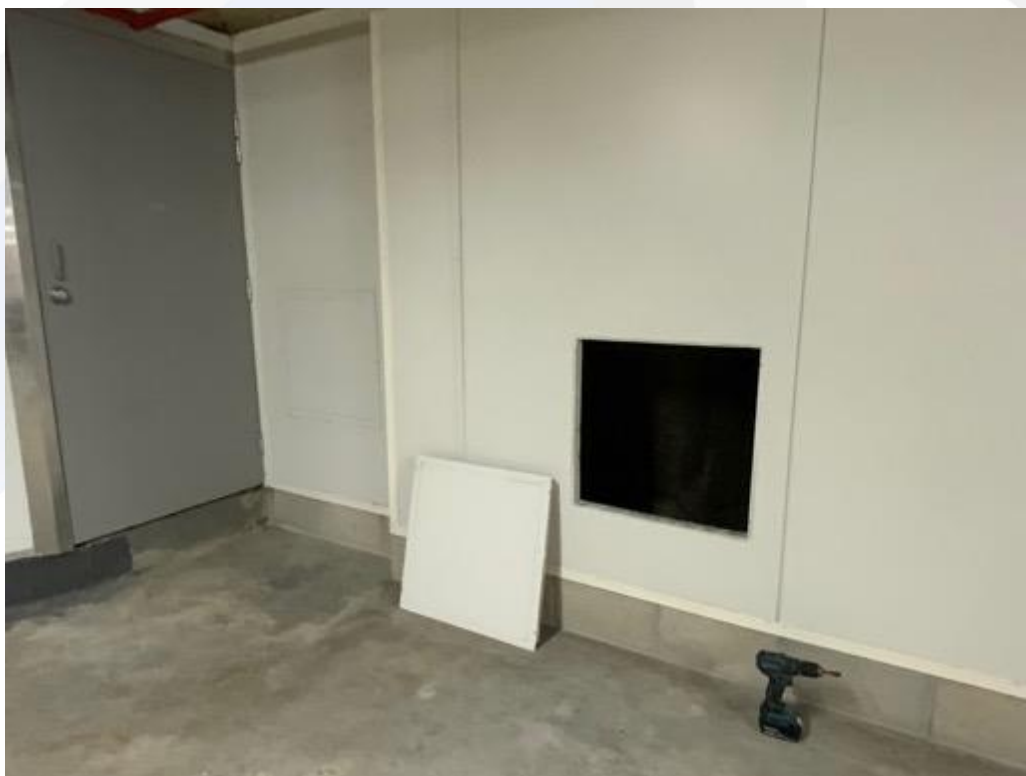
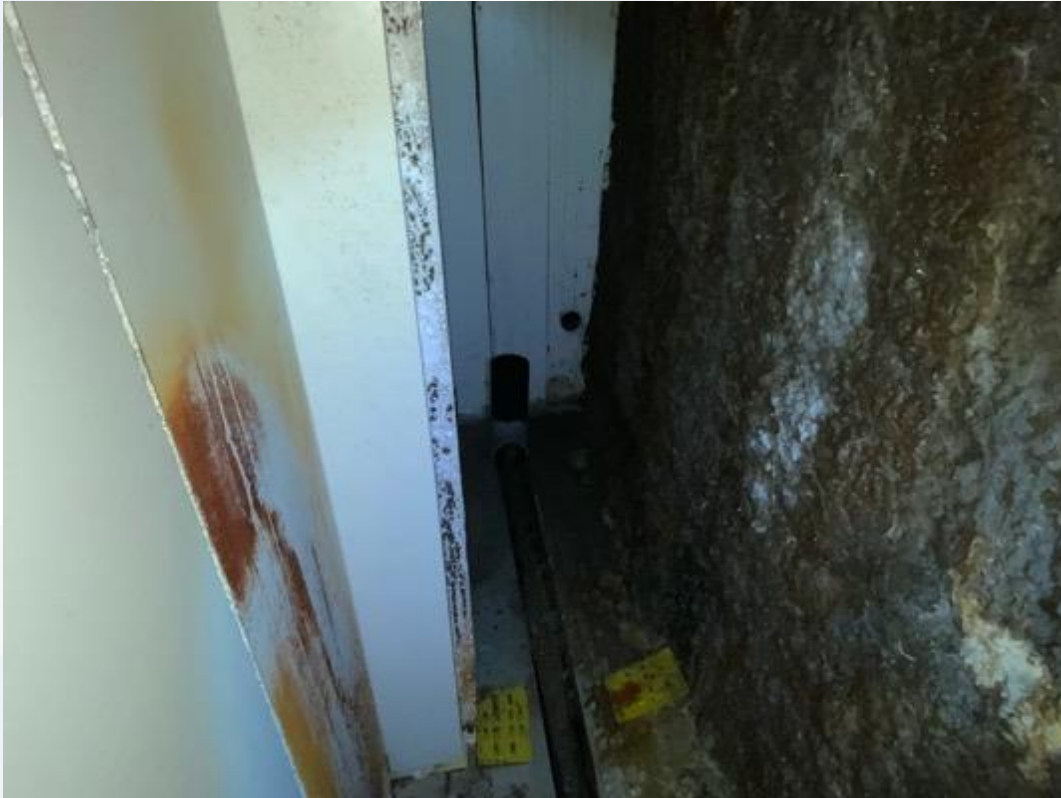
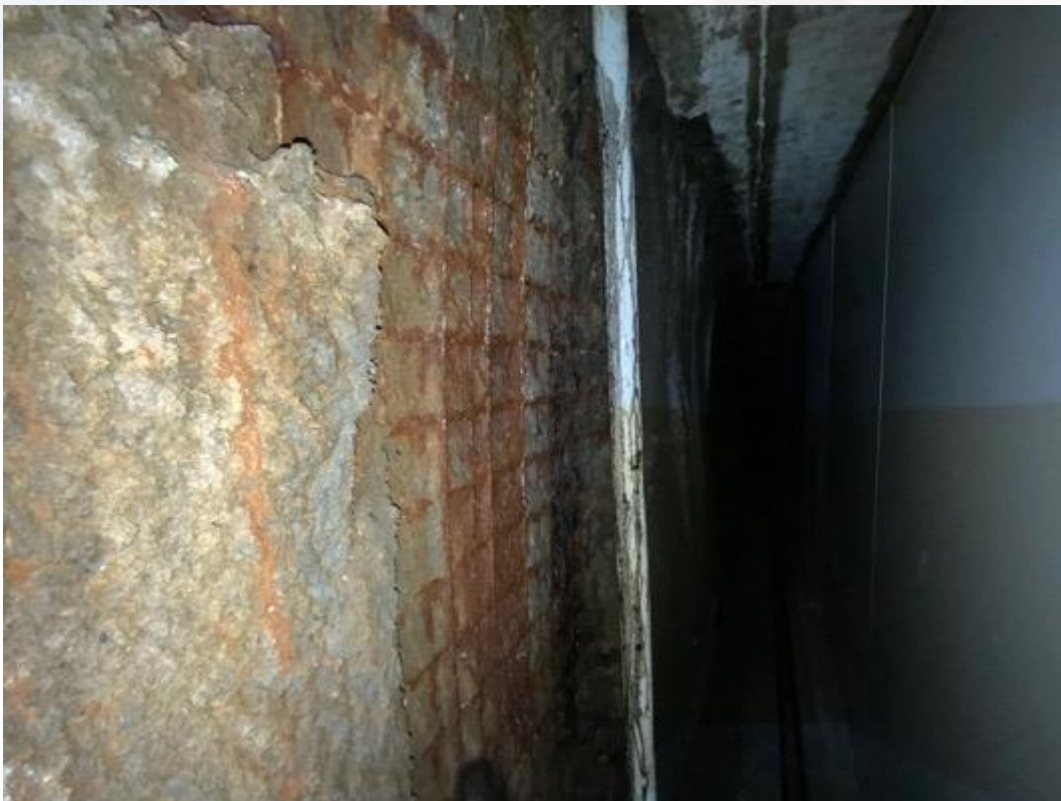
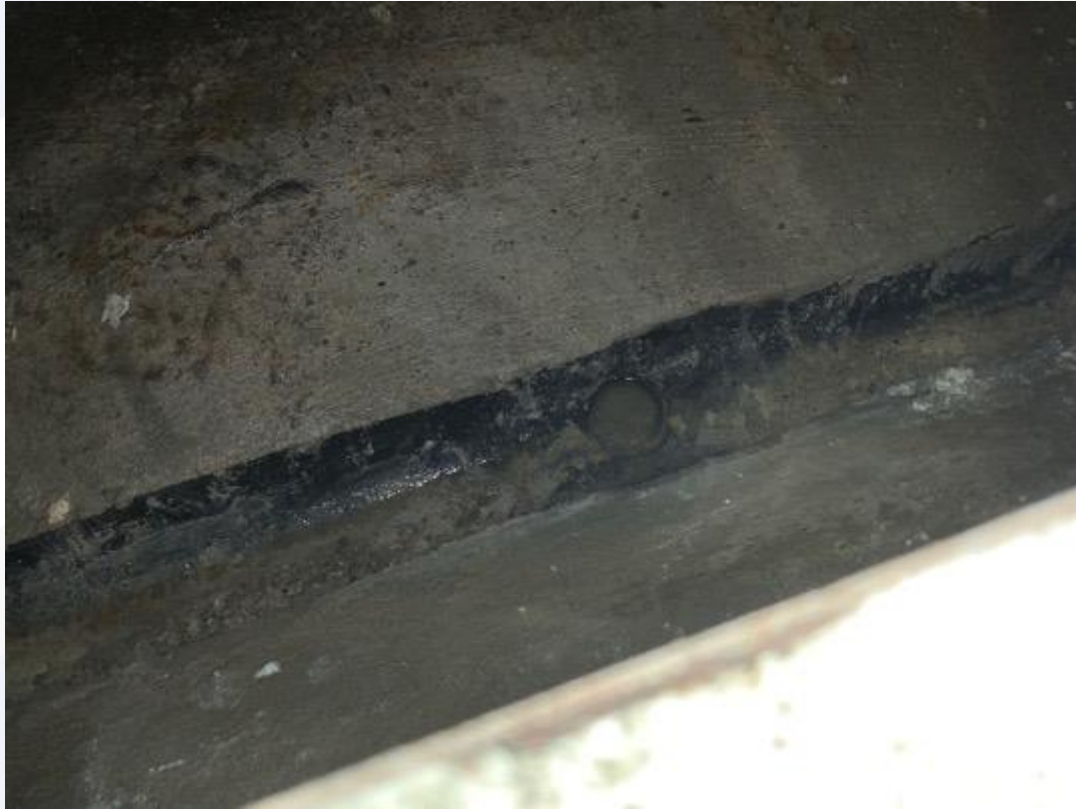
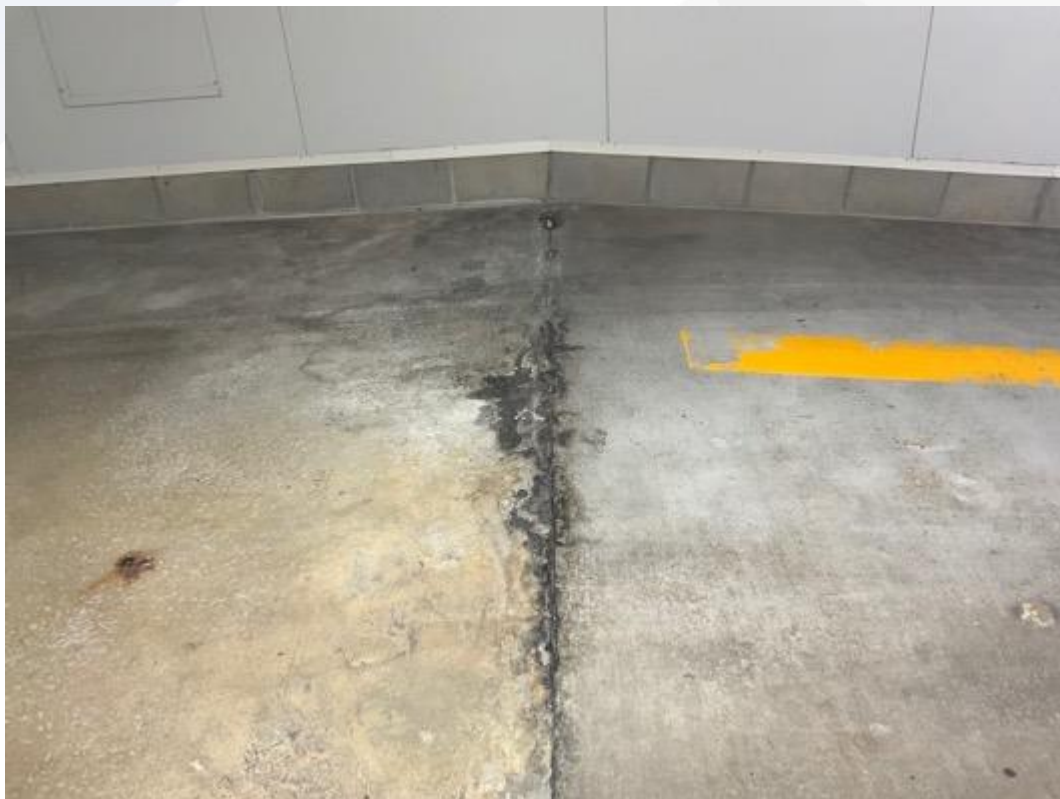
Access panel north wall 3 m east of Mech fan room

- 111. Large 4 m² area of corroded steel reinforcement no concrete cover immediately east of hatch
- 112. Entire wall wet running water 'drain looks good redone but only 75mm wide x 70 deep too small, outlets 40mm max and is blocked with cement residue from wall deterioration will requires cleaning almost weekly
- 113. Salt visible /black colour at top of ramp construction joint
- 114. Ramp drain and skirting redone recently

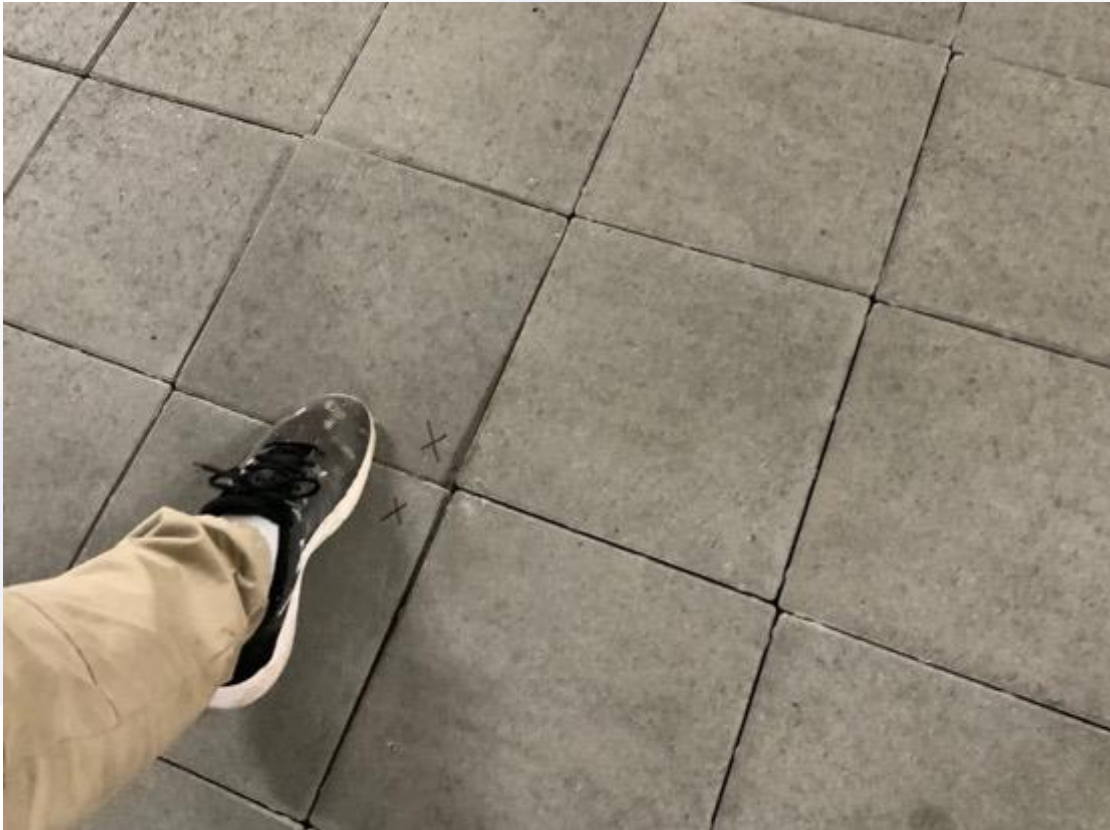
Basement B5 carpark

- 115. Concrete block on spacer system to entire B5 level
- 116. Blocks not properly supported in places x marked on blocks requiring repair by builder

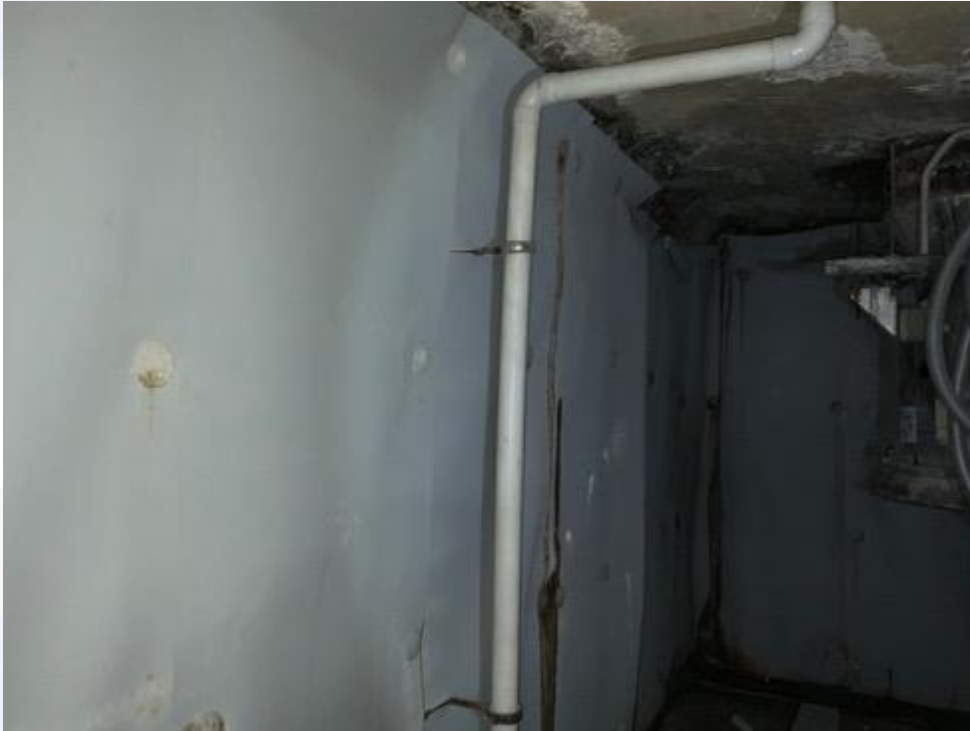
North East Mech fan room

- 119. The corner 'wall has had plastic 1mm sheet liner which prevents viewing the water ingress issues behind.

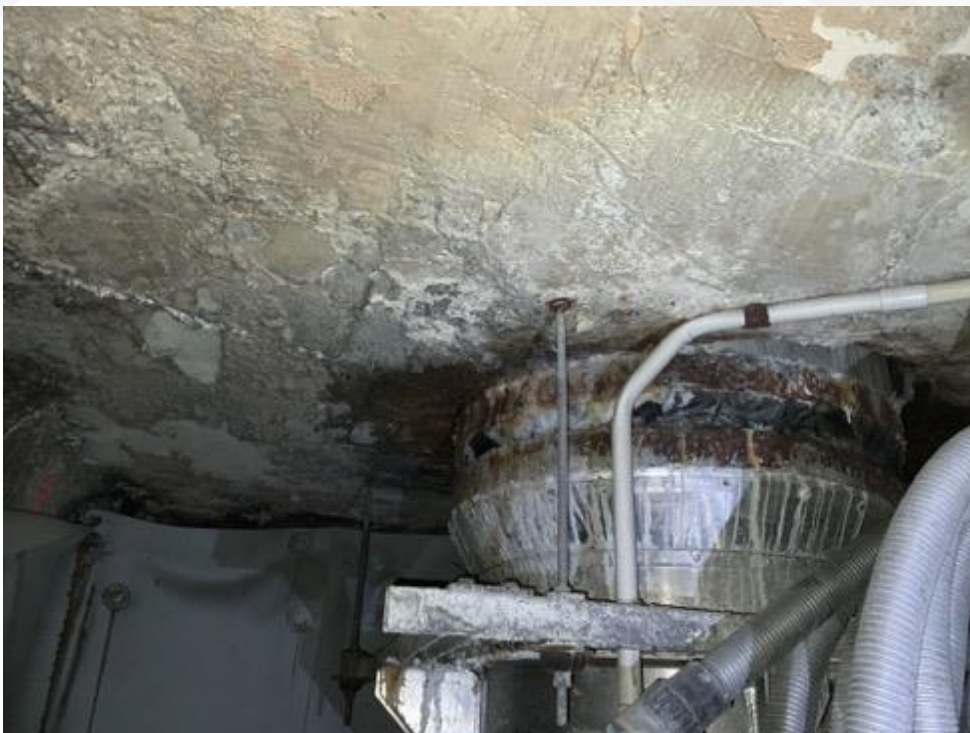
- 120. Water leaking through east and north walls
- 121. Rust to reinforcement steel to fan hole in roof soffit typical all levels
- 122. Rust to fan and duct replace both.

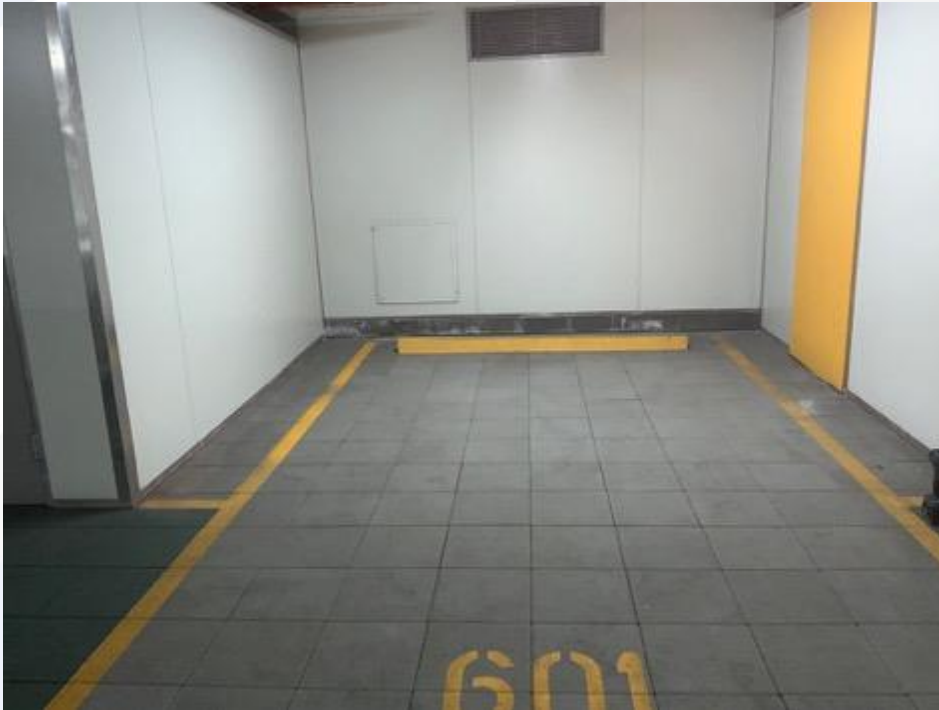
123. Leaking and salt build up to skirting rear of 601

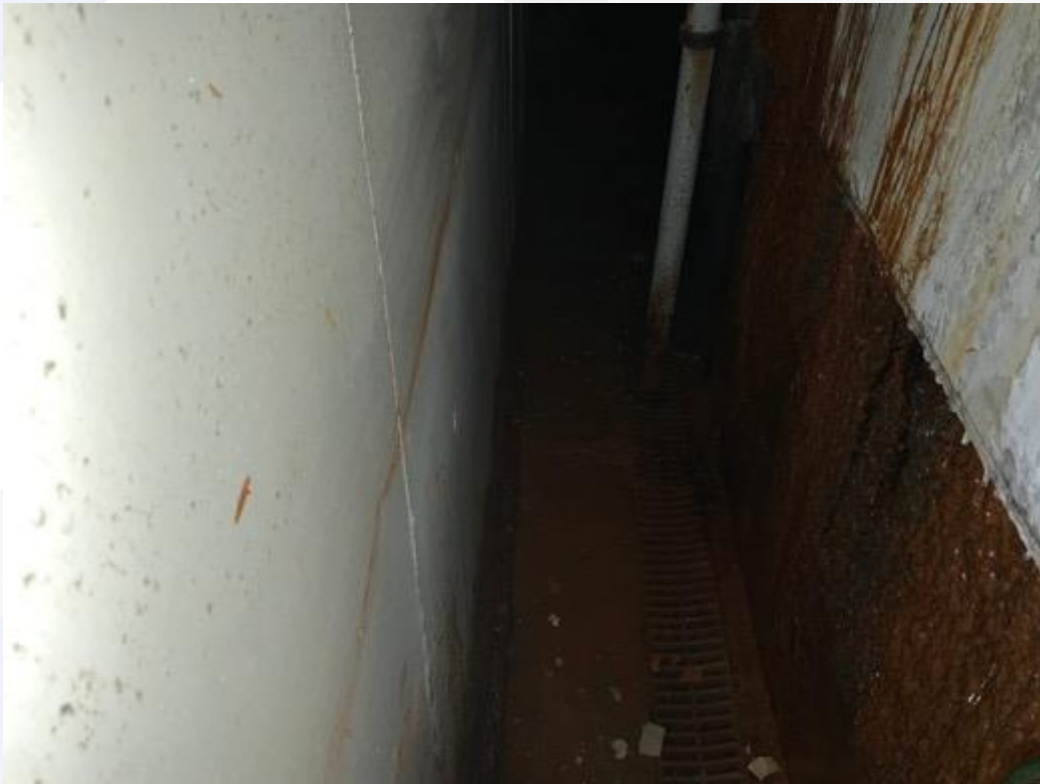
Access hatch rear of 601

124. Water leaking through walls mainly to the north of the hatch 'red sludge' to floor is blocking drains

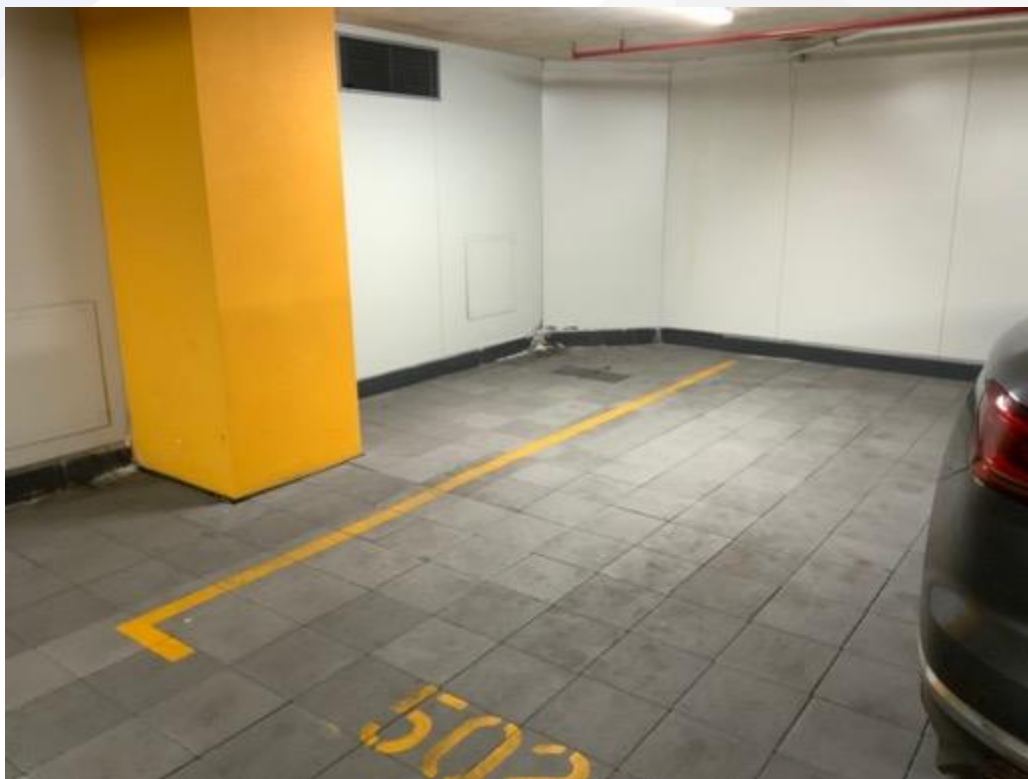
125. Salt build up to skirting to splay corner south east rear of car bay 502

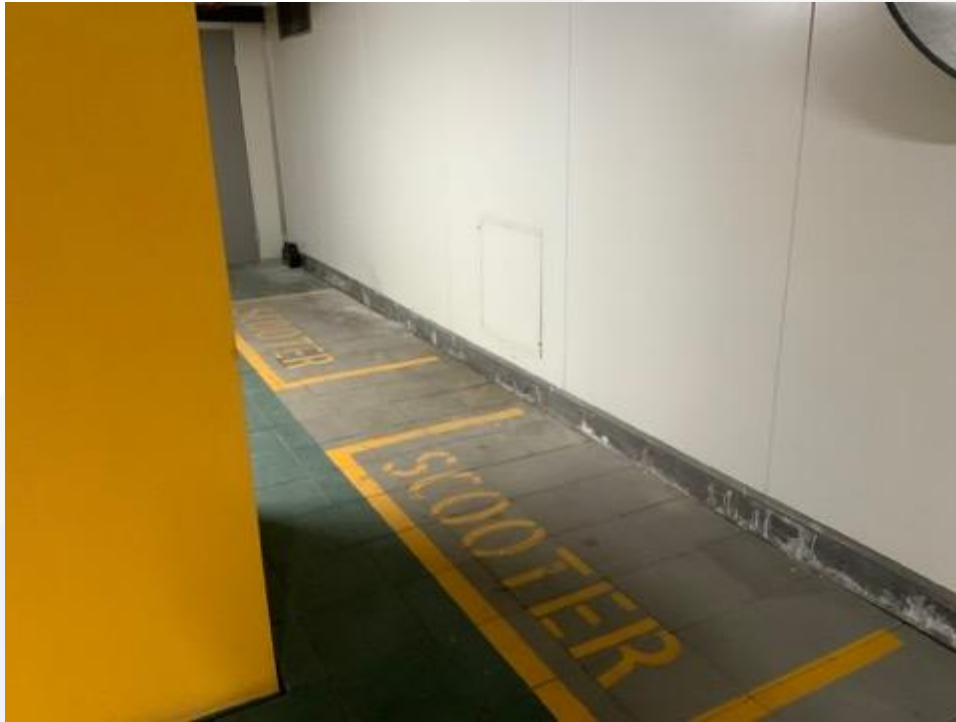
128. Leaking large salt build up to entire west wall

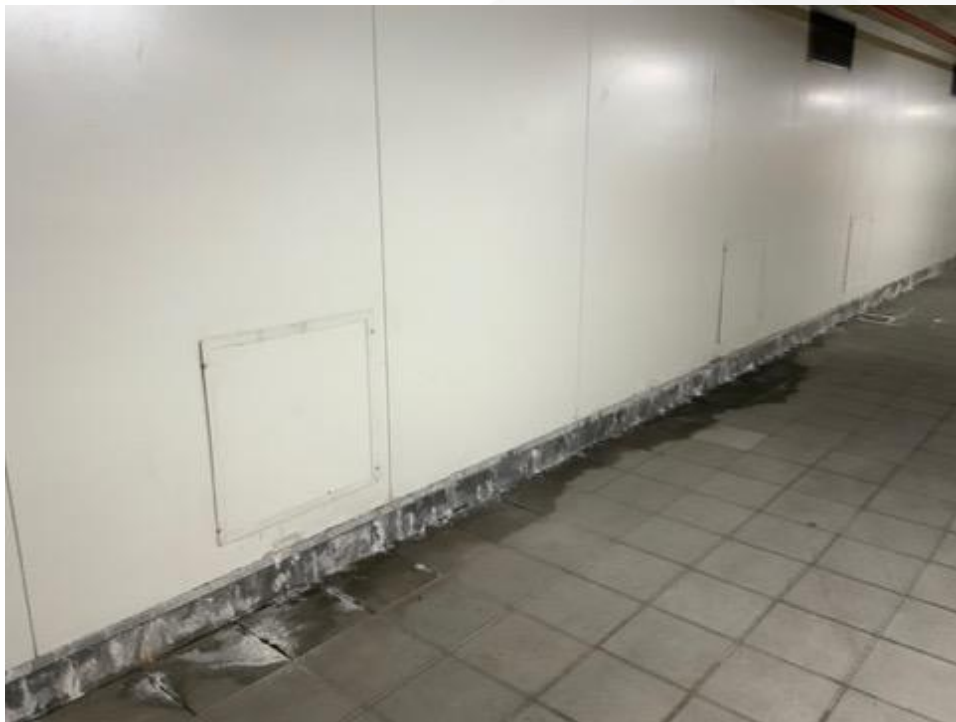
129. Corrosion to base of north end wall panels

130. Leaking salt build up to car park blocks rear of car bay 1105

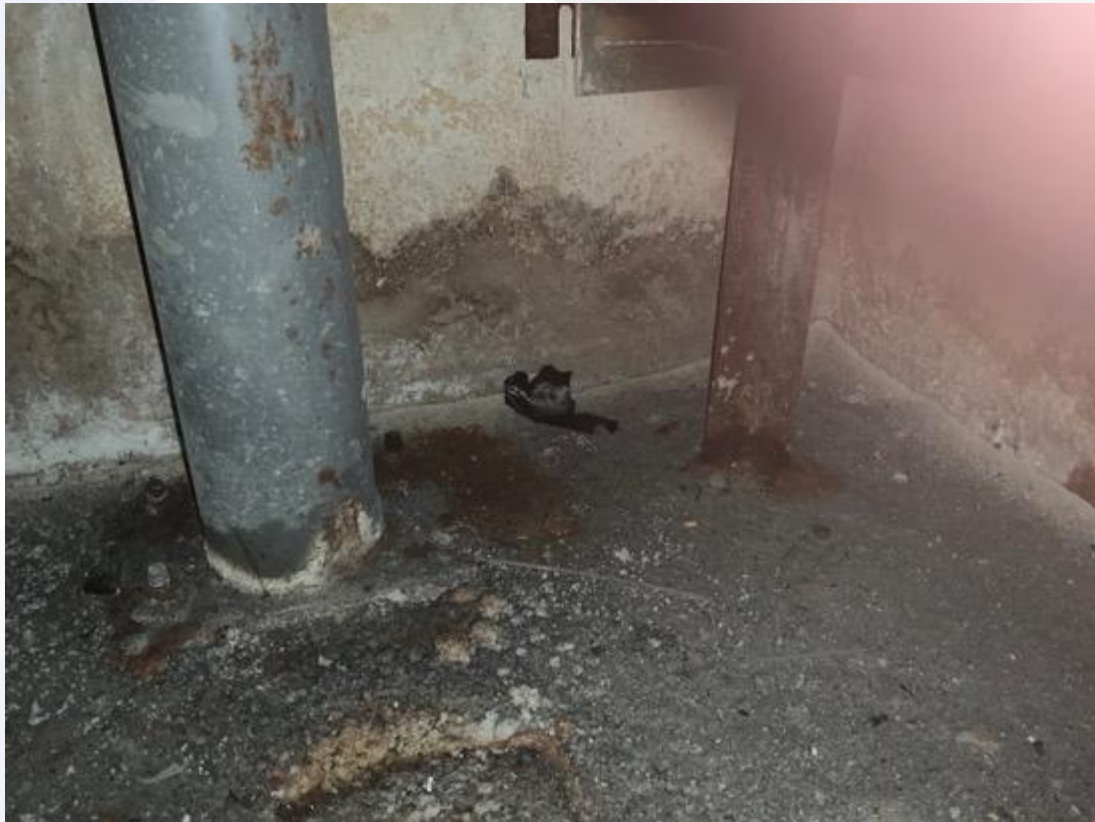
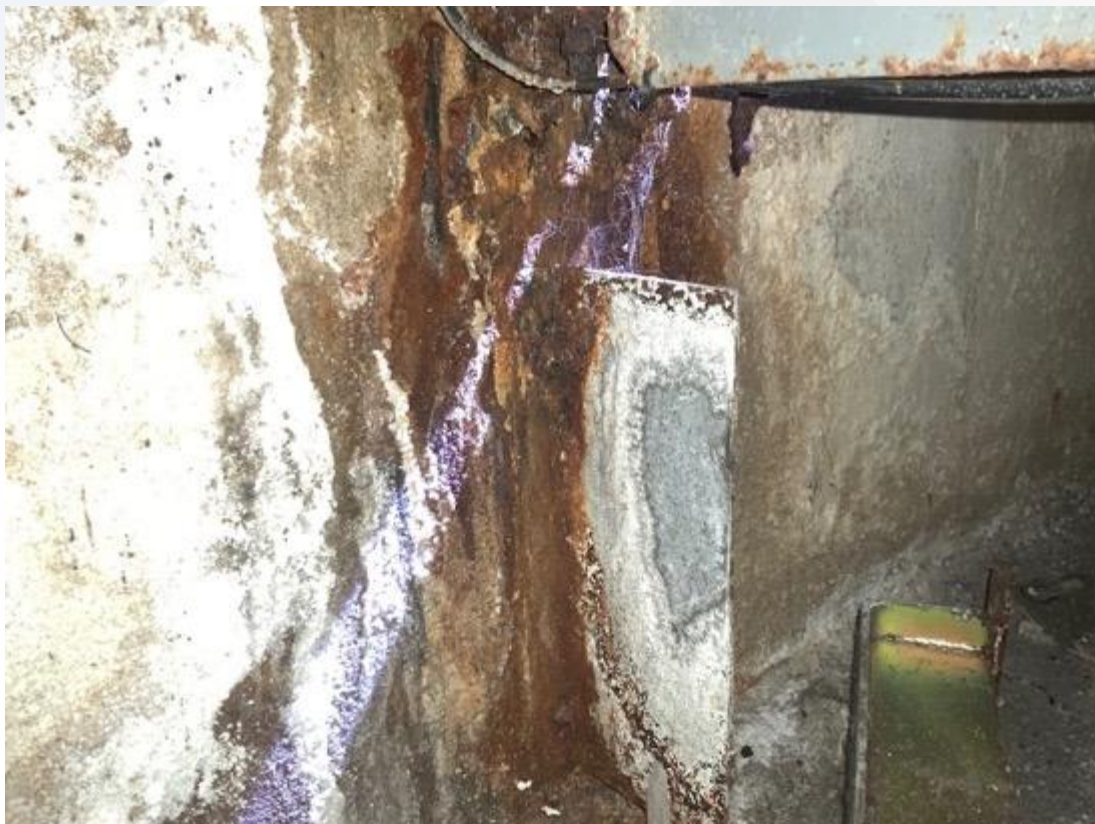
Significant corrosion of steel lift components in the base of the lift shaft visible.
3mm layer of salt build up on the floor of the lift pit, but the base of the pit is currently dry .
