Our Reference : 72182

Strata Title Ten Year Maintenance Report and Building Inspection

Property : 5-7 Cattalini Lane, NORTH FREMANTLE WA 6159

Inspection Date : Tuesday 1st June 2021

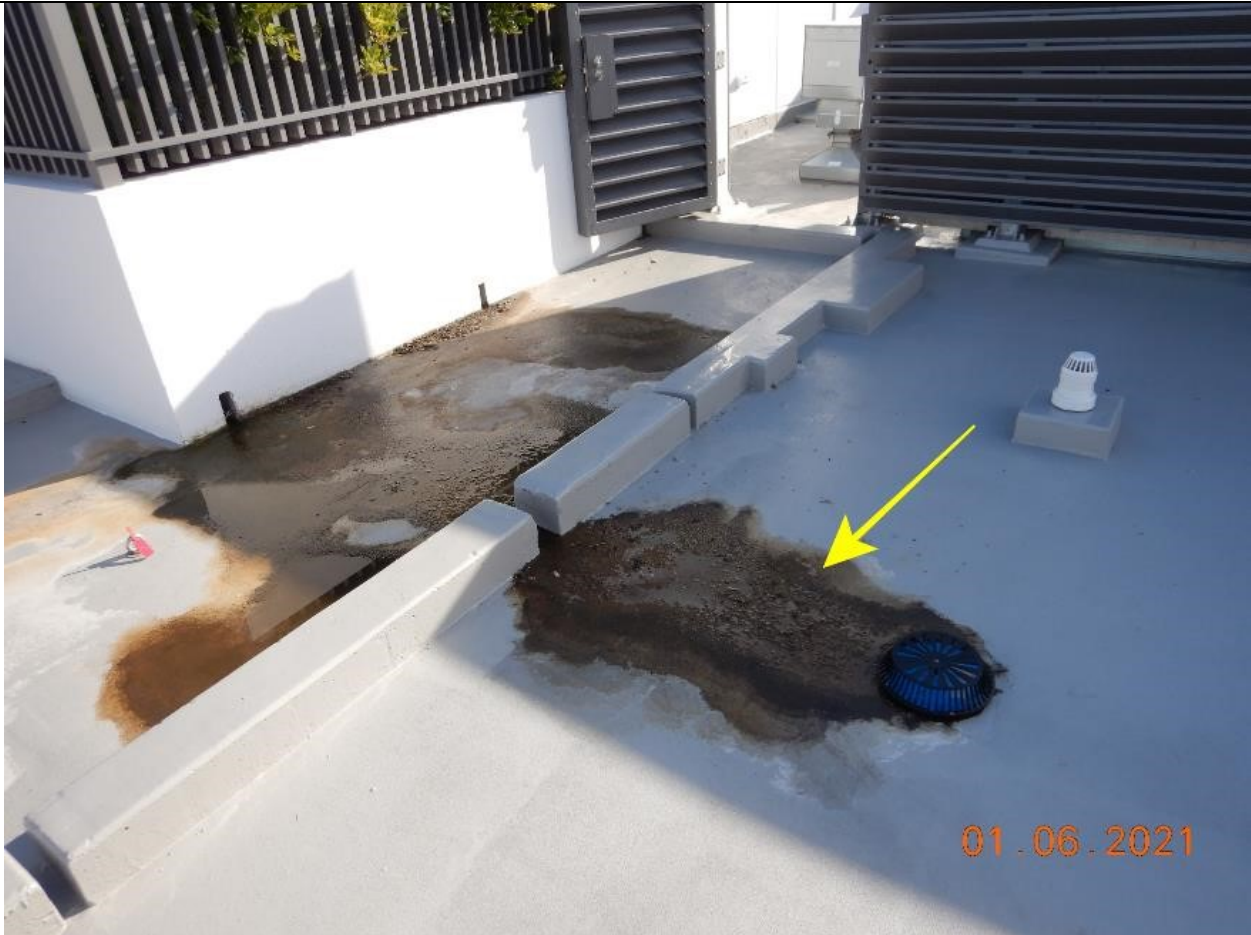
2. Item No**Location** - Multiple locations upper west block

There were multiple areas of ponding water requiring rectification to prevent the premature breaking down of the waterproofing on the concrete that will lead to water ingress into the structure.

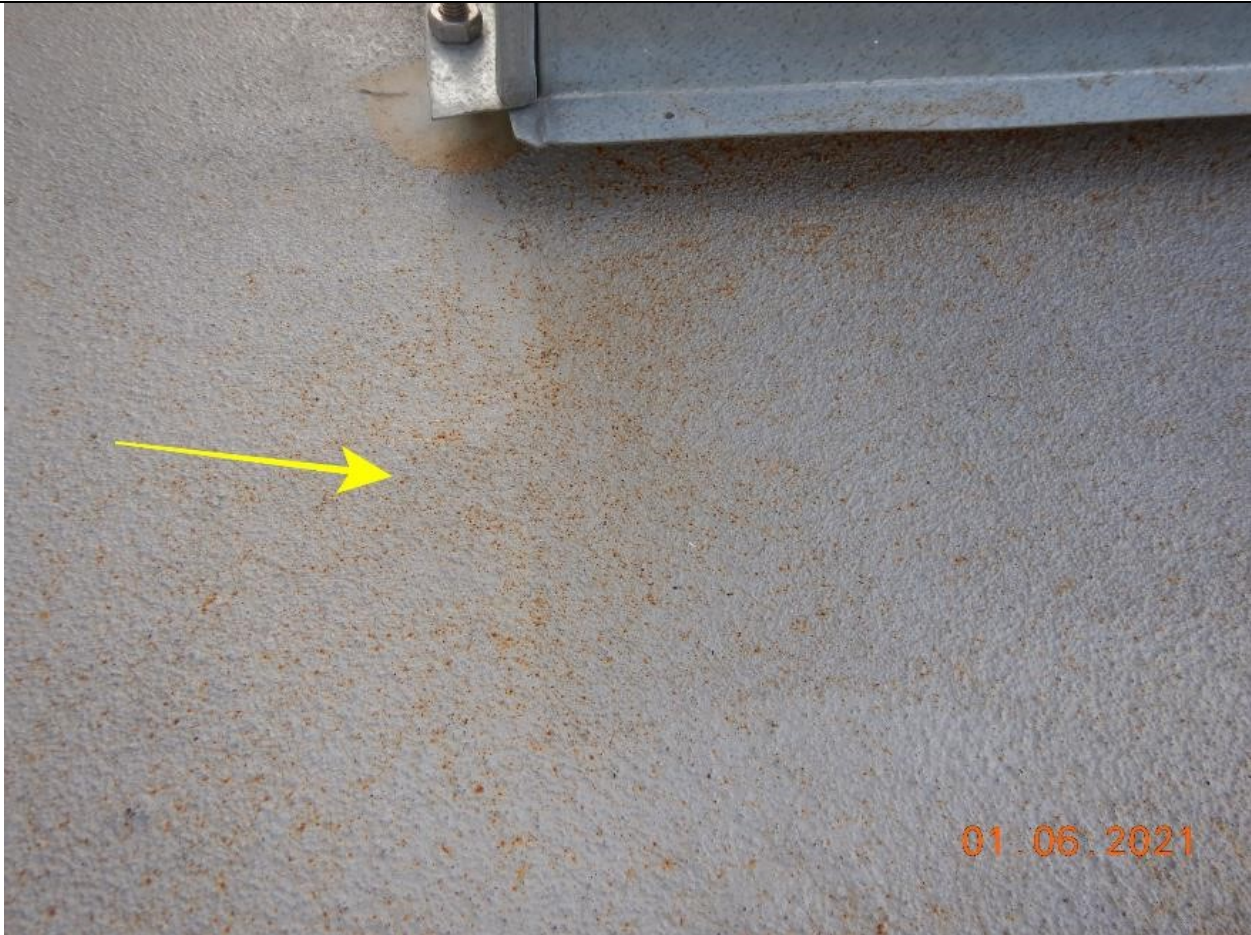
3. Item No**Location - Upper-level east block**

There were multiple areas where there were rust particles in the waterproofing requiring rectification to prevent premature breaking down of the waterproofing product on the concrete roof.

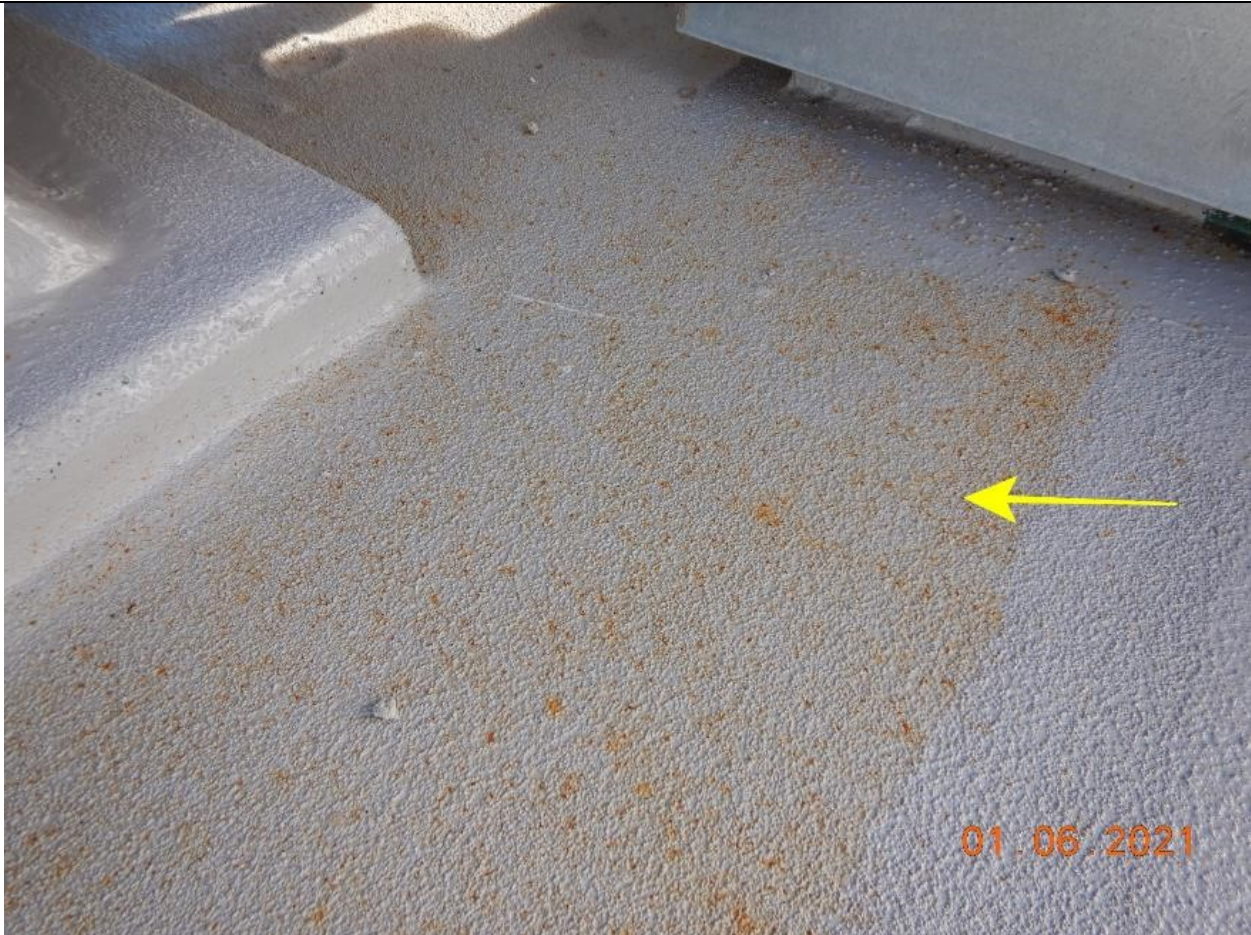
4. Item No**Location - Upper-level west block**

There were multiple areas where there were rust particles in the waterproofing requiring rectification to prevent premature breaking down of the waterproofing product on the concrete roof.

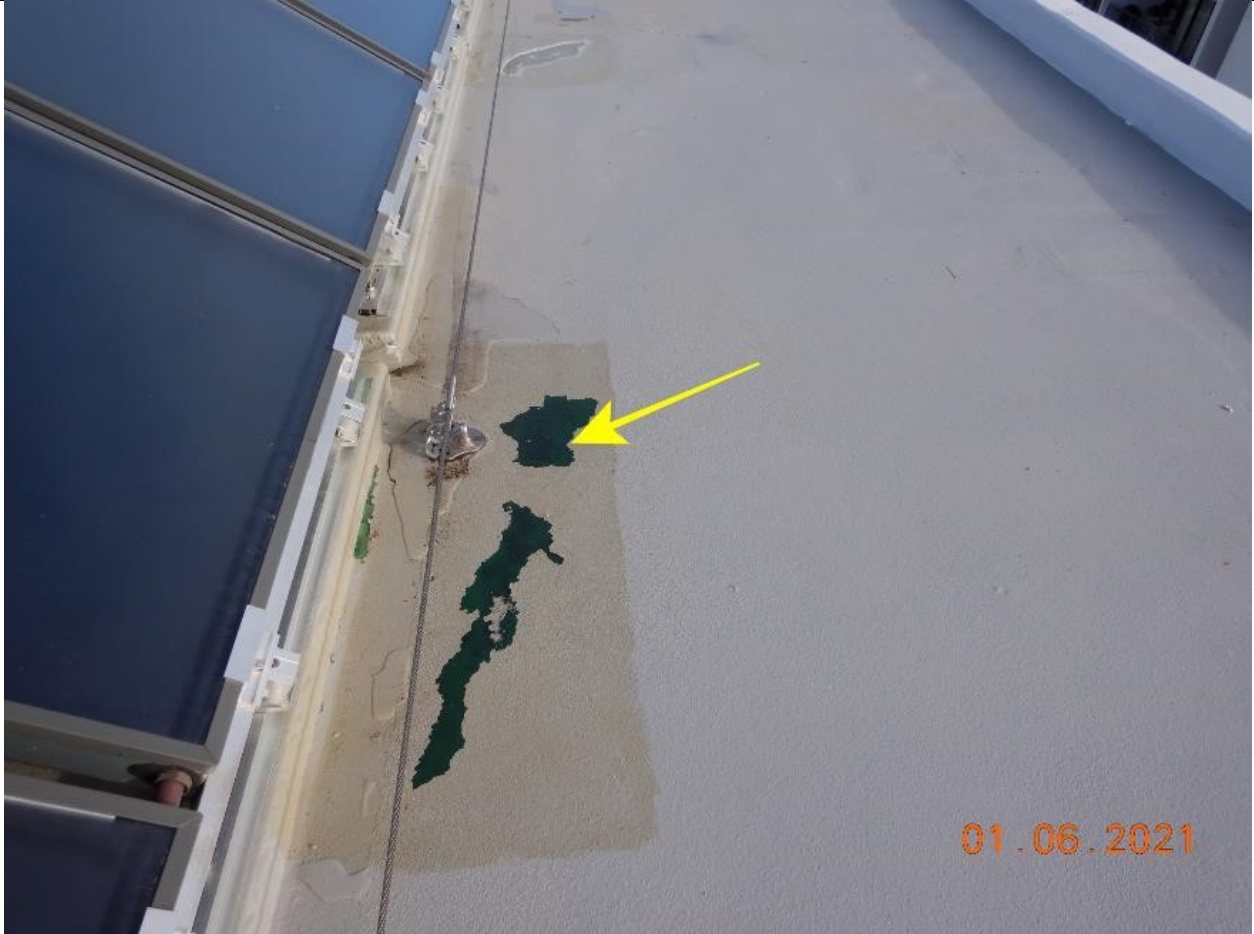
5. Item No**Location** – Upper-level north side of east block

There were areas of peeling topcoat to the waterproofing requiring replacement to prevent moisture ingress into the concrete.

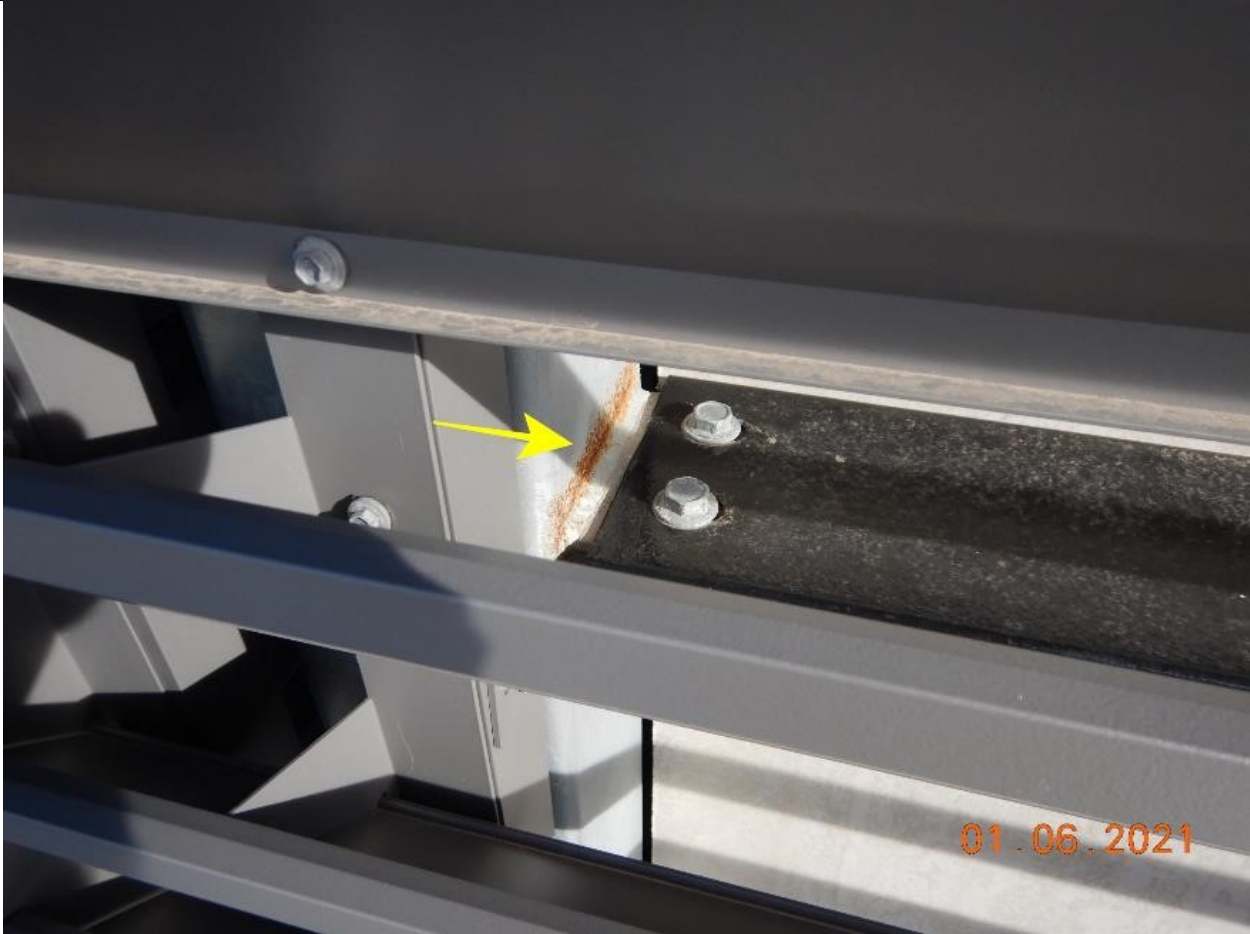
6. Item No**Location - Upper levels east and west blocks**

There were areas of rust to the Louvre screen framework requiring treatment with a rust retardant.

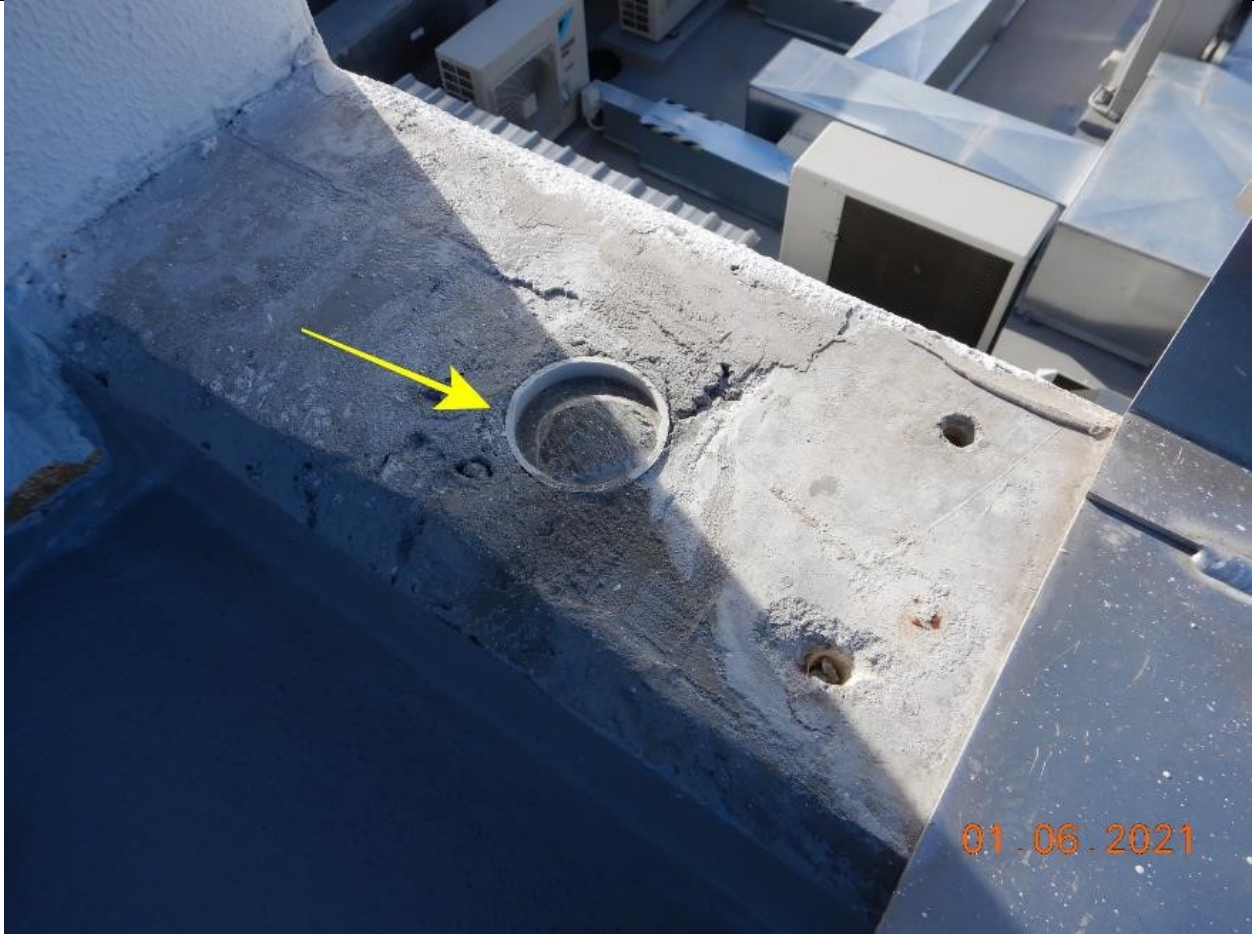
7. Item No**Location** - Upper-level west building roof entry roof

There is a section of unsealed and non-waterproofed parapet capping requiring waterproofing to prevent moisture ingress into the structure.

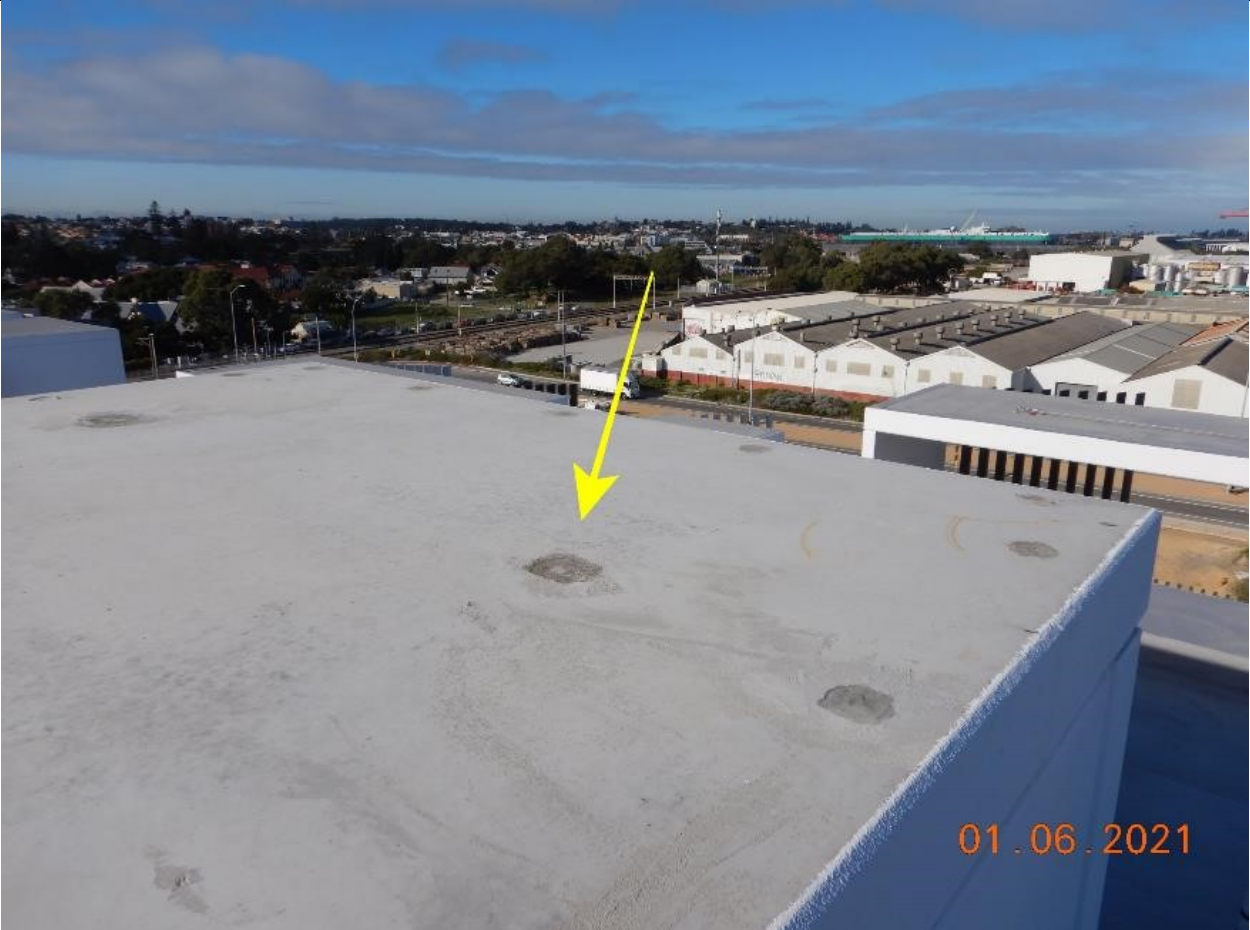
8. Item No	Location - Upper-level west building above lift
There is no visible waterproofing on the concrete slab roof requiring waterproofing to prevent moisture ingress into the structure.

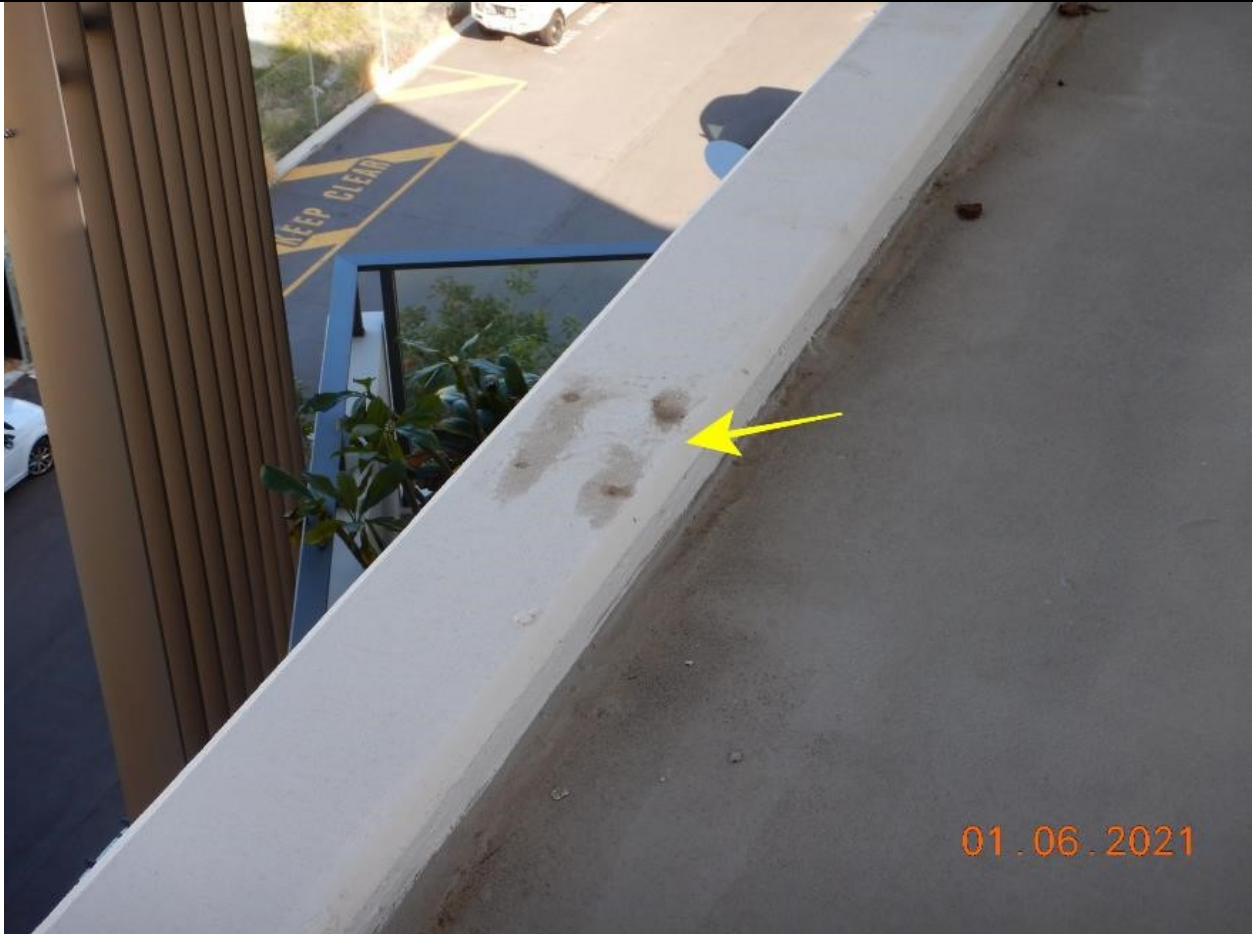
9. Item No	Location - Multiple locations east and west blocks
There are multiple areas where the holes from the handrails have not been patched and sealed as required to prevent moisture ingress into the structure.

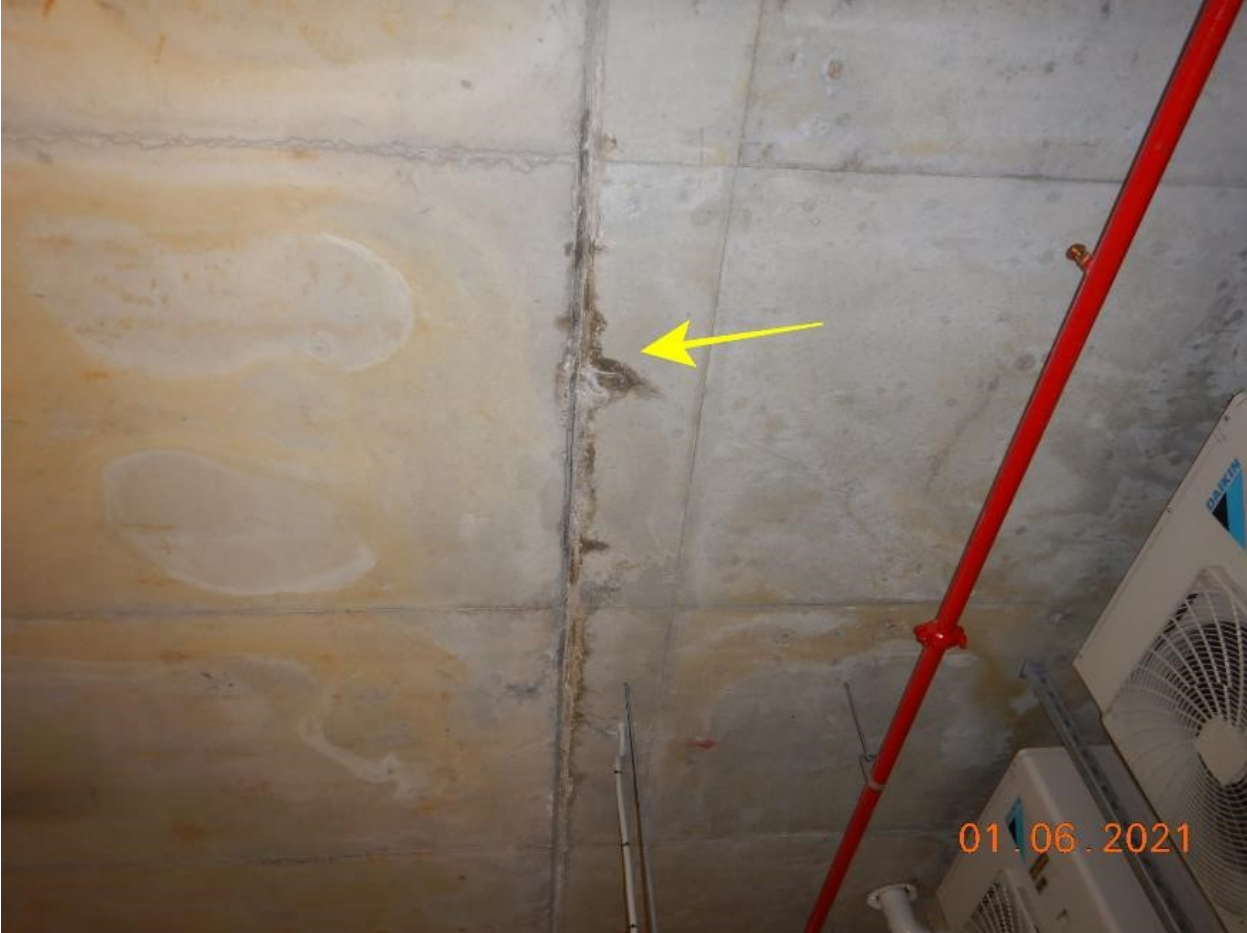
10. Item No	Location - Between car bays W301 and W407
There was visible damp noted to the underside of the concrete slab requiring rectification by a professional waterproofing company.

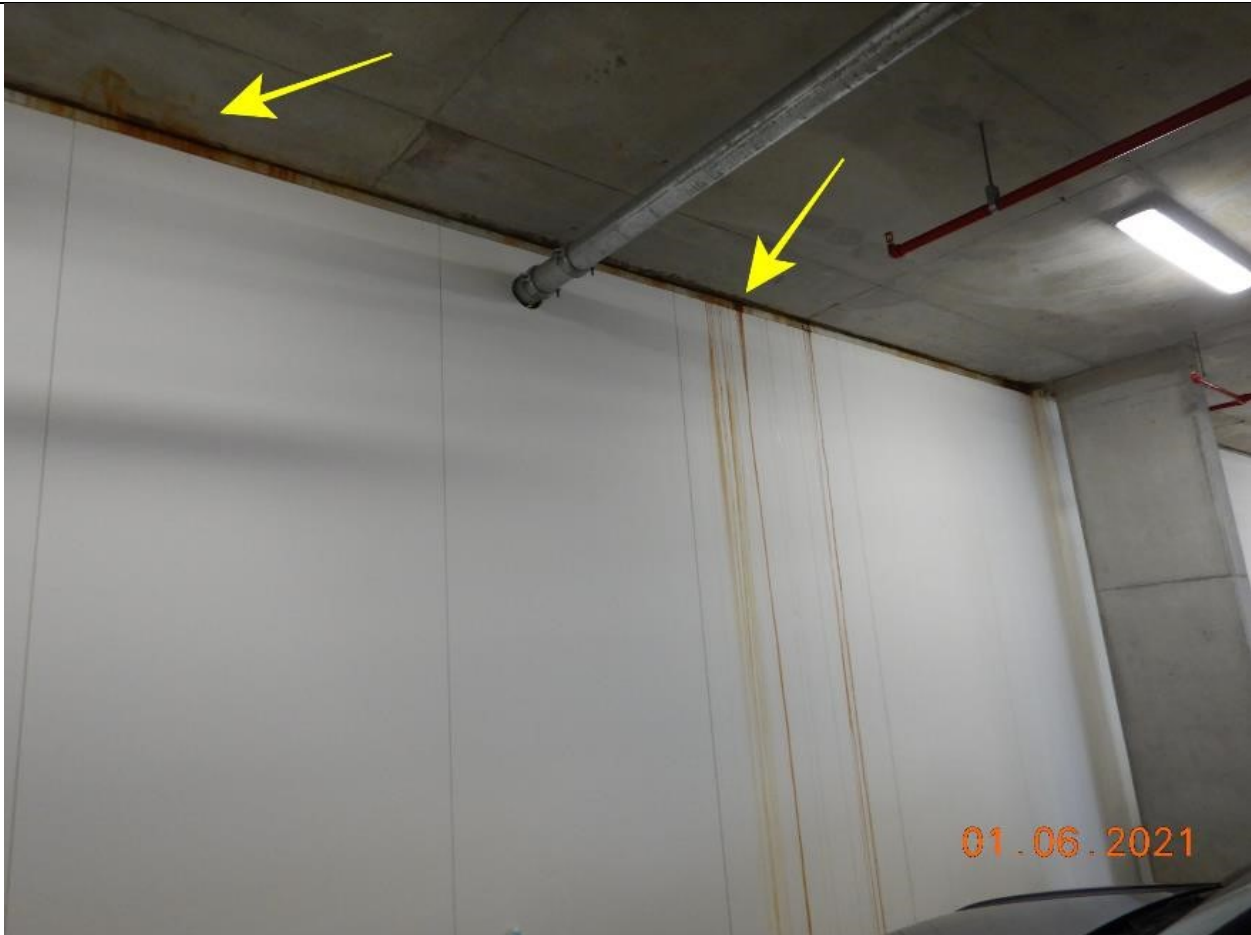
11. Item No**Location - Northern wall and roof slab junction**

There was extensive visible running water and damp noted to the walls and concrete slab requiring rectification by a professional waterproofing company.

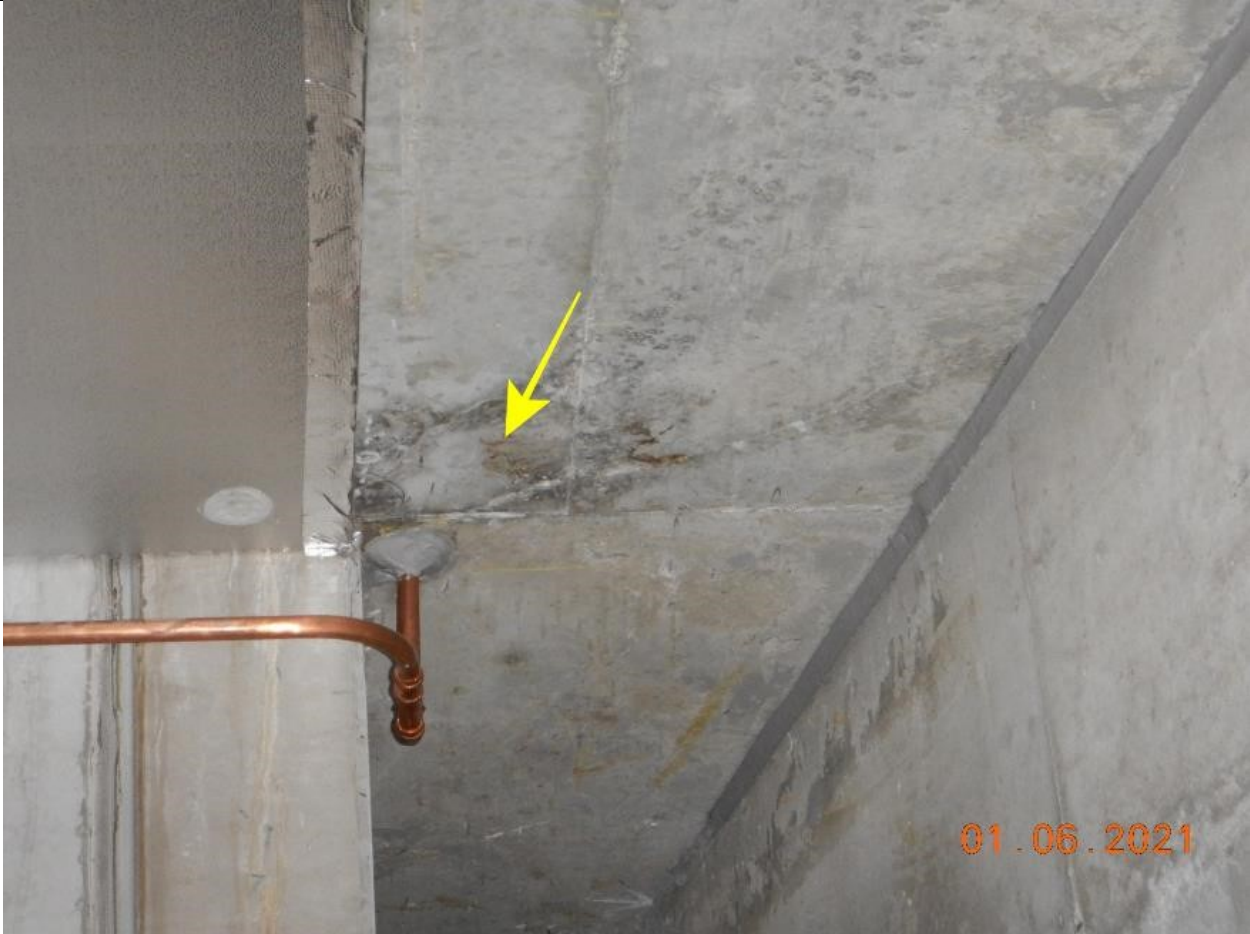
12. Item No**Location** - Above storage cage east side of car bay E201

There was visible damp noted to the underside of the concrete slab requiring rectification by a professional waterproofing company.

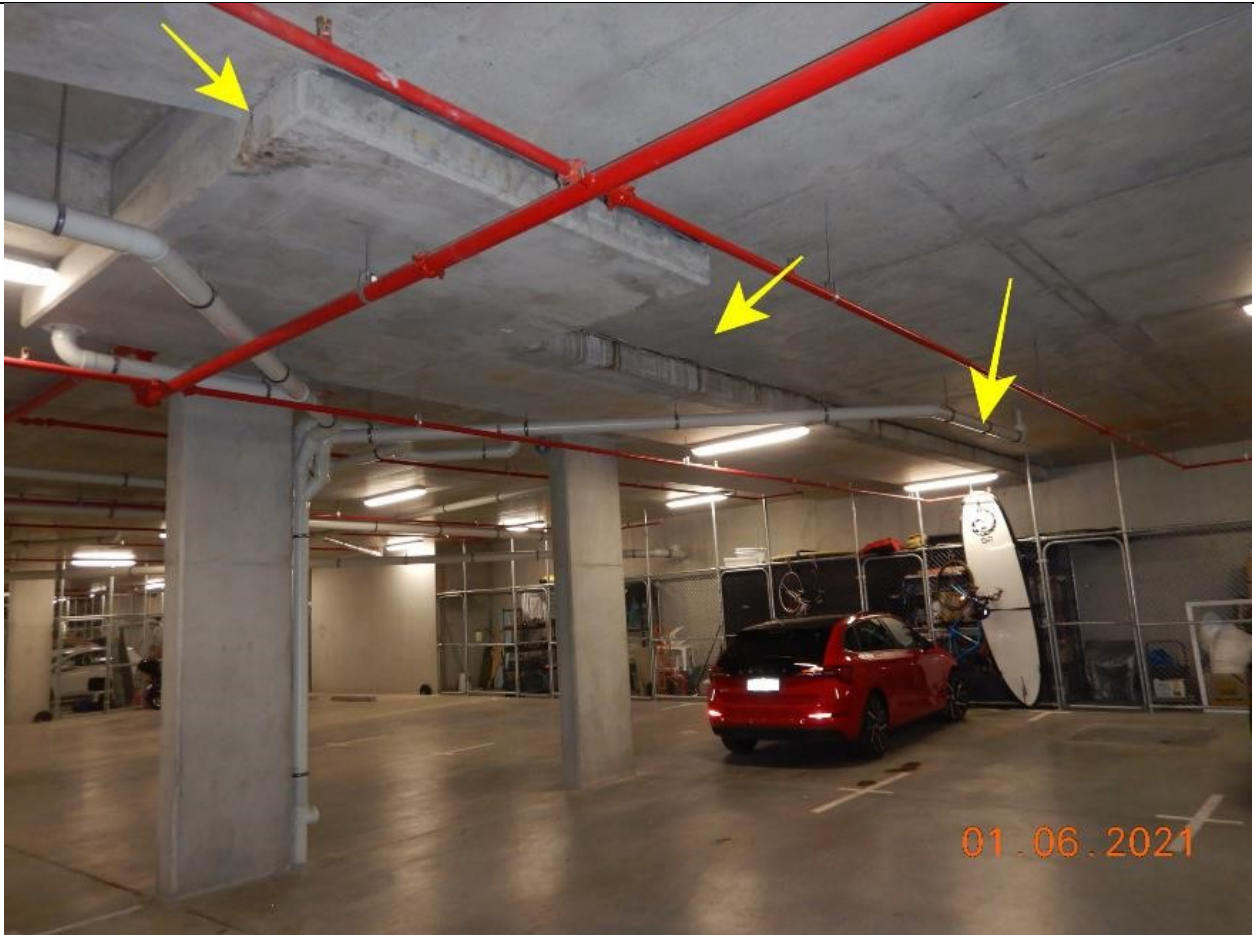
13. Item No**Location** - Middle section around entry ramp

There was extensive visible running water and damp noted to the concrete slab requiring rectification by a professional waterproofing company.

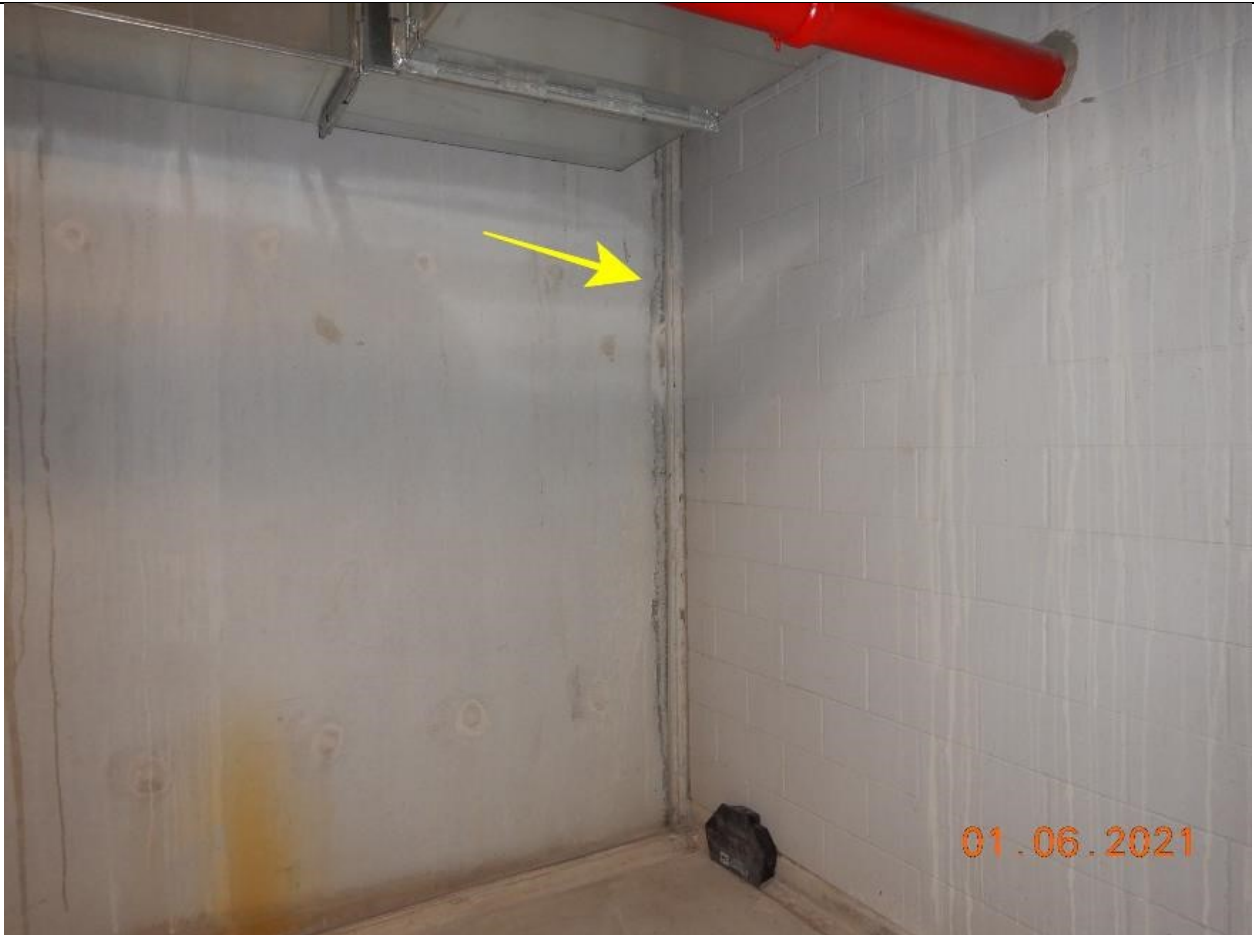
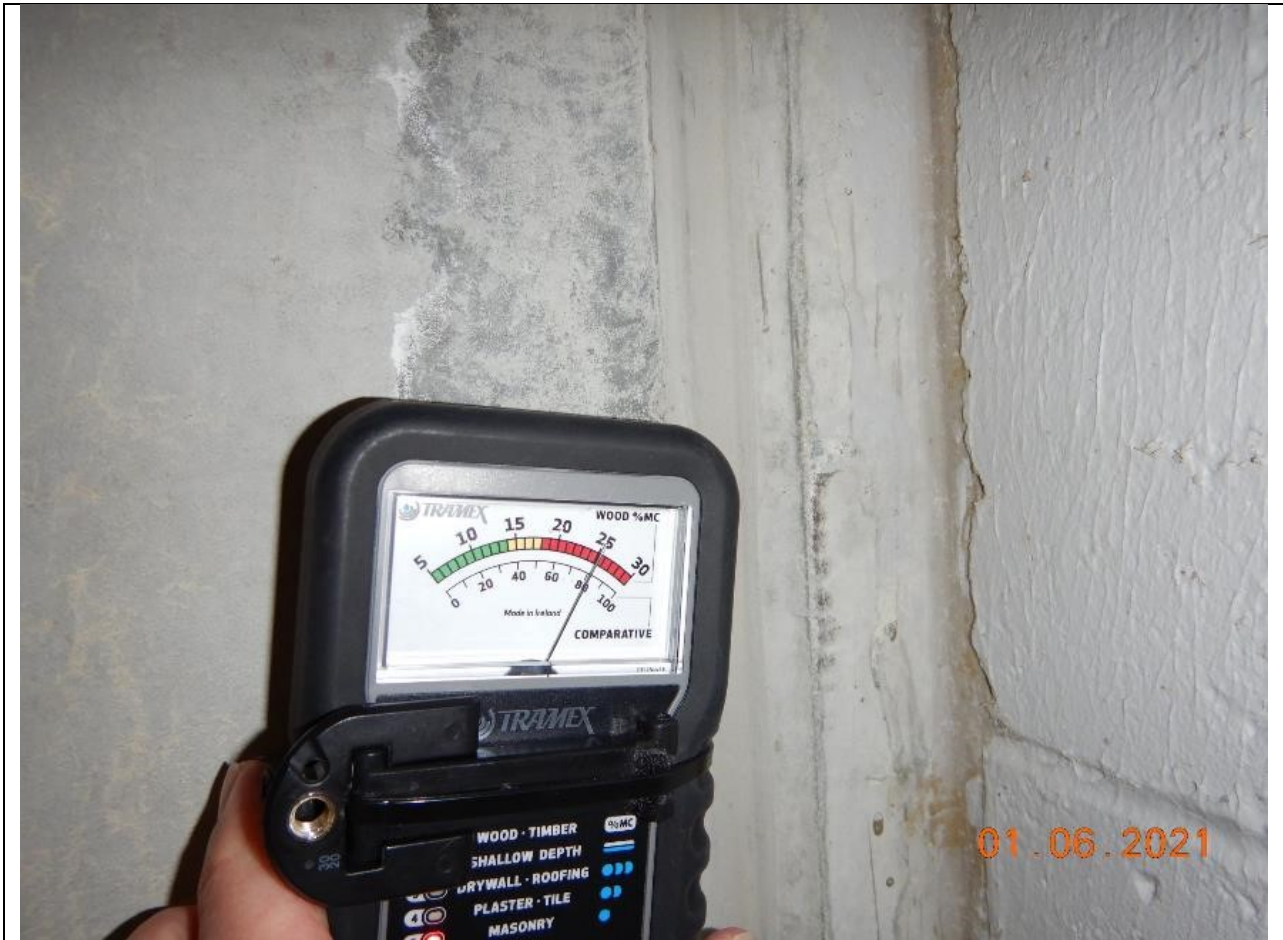
14. Item No**Location** – South-west corner car bay W203

There was damp noted to the wall with a high reading on a moisture meter requiring rectification by a professional waterproofing company.
