14 April 2021  
[stuart@coreeng.nz](mailto:stuart@coreeng.nz)  
T: 022 657 4125  
Job No: 21-0048

**Prepurchase Geotechnical Summary for**  
**4 Lort Point Lane Road, Reotahi (Lot 9 DP 534968)**

As requested, Core Engineering Solutions Ltd has undertaken a pre purchase geotechnical assessment of the above section to provide guidance for a future dwelling designed in general accordance with NZS3604 (Importance Level 2 – NZS1170).

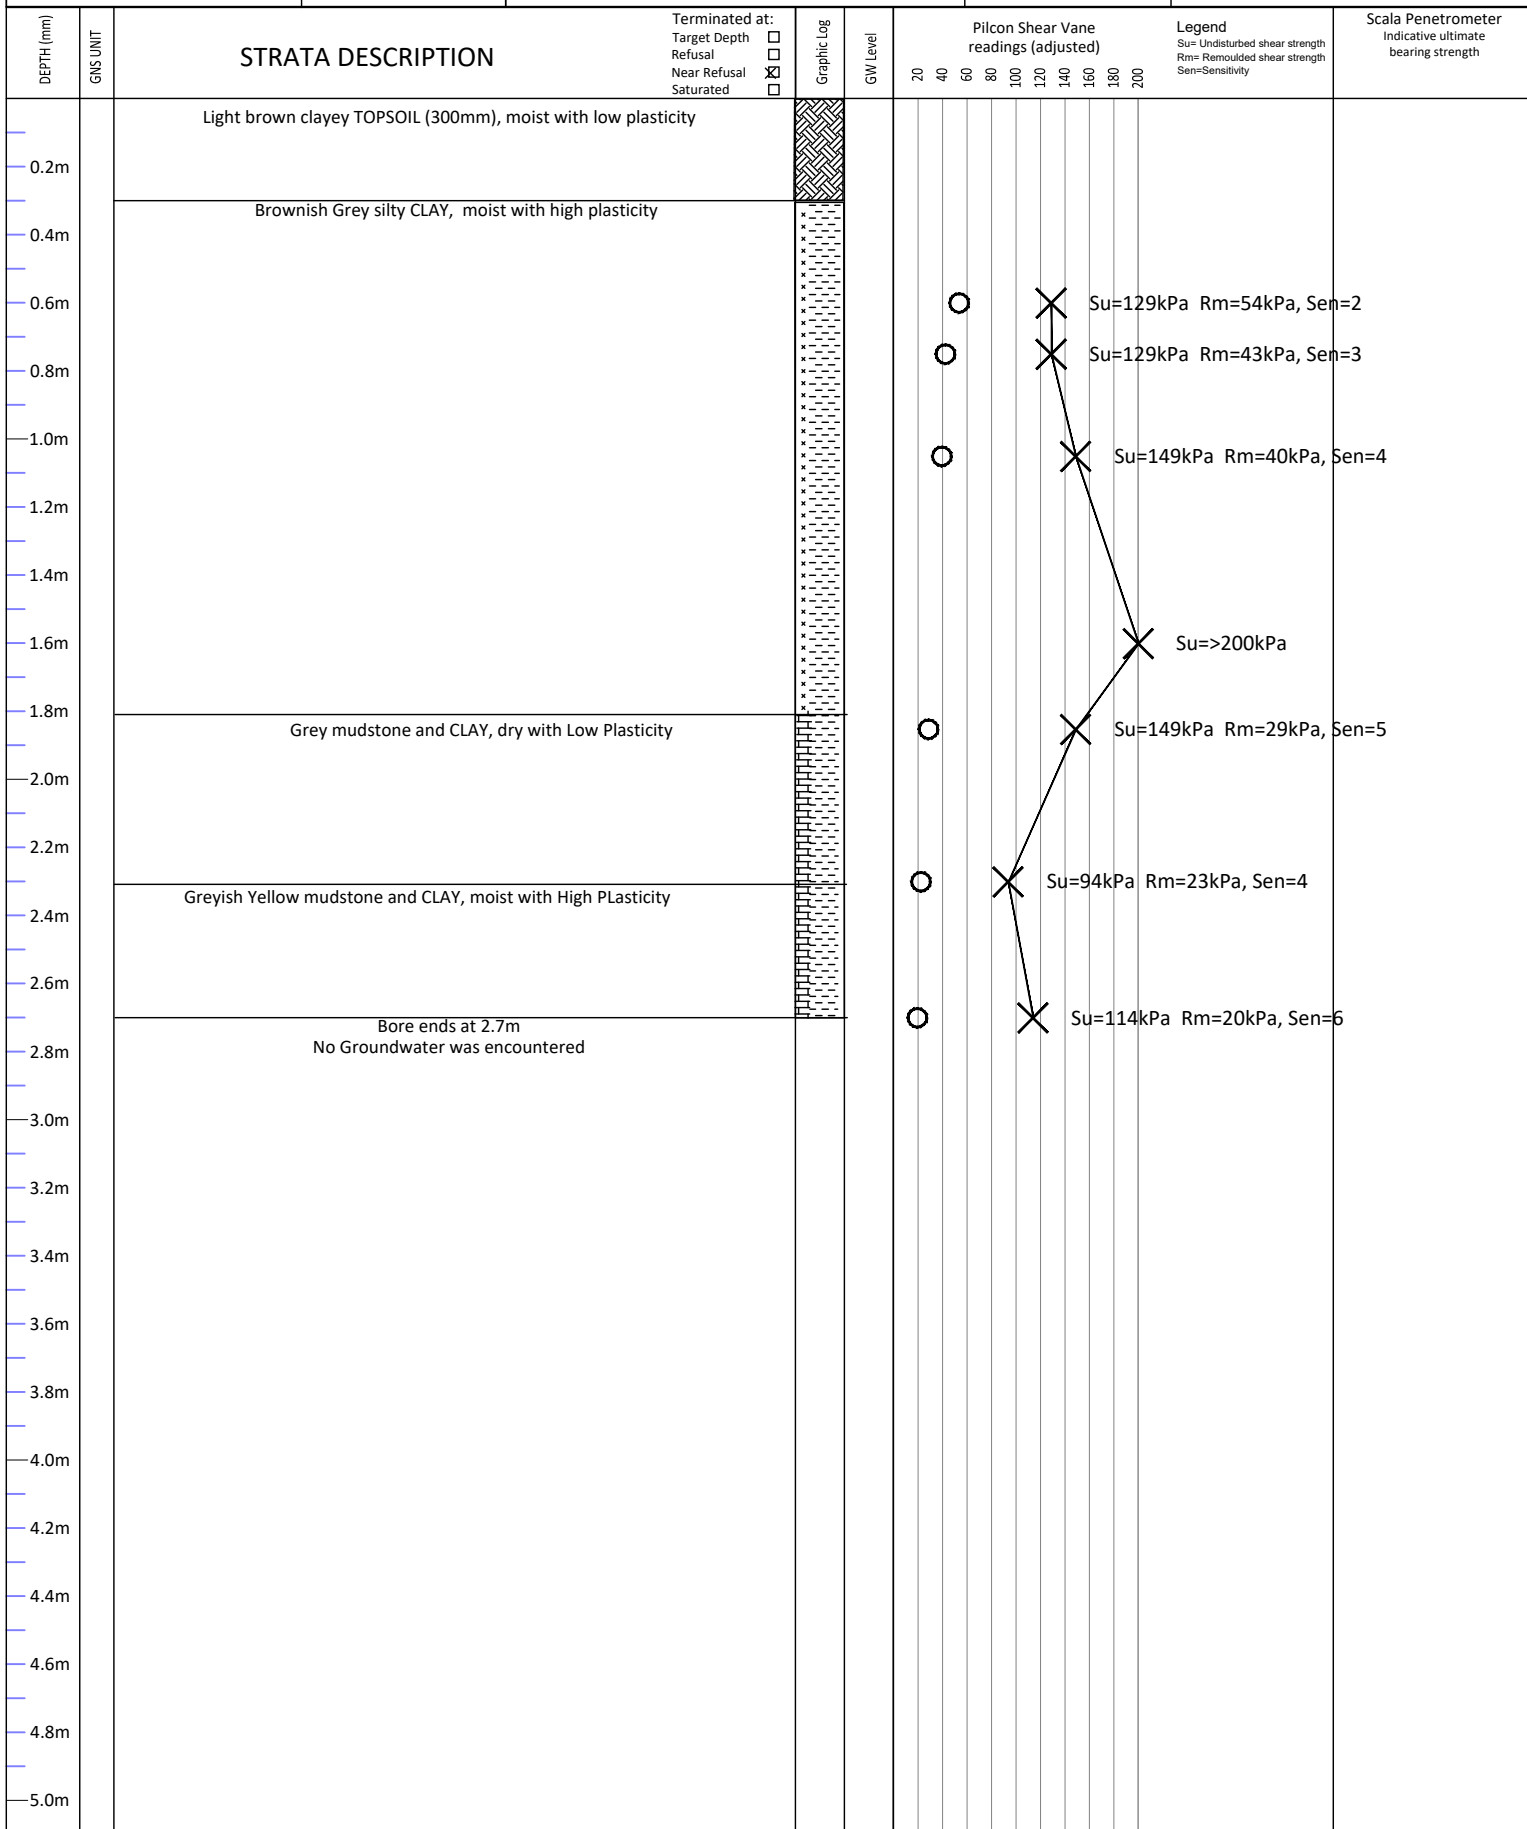
Appendix 1 – Borehole Test Results

A machine augered borehole was undertaken at the centre of the site to confirm the consistency of the underlying material. In-situ Pilcon Shear Vane readings indicated adjusted shear strength readings of generally greater than 100kPa down to 2.7m. The underlying weathered mudstone (Northland Allochthon) initially decreased in strength to 94kPa at 2.3m then began to increase in strength as depth increased and eventually resulting in near refusal from the machine auger. From the recovered material, the near refusal suggested that moderately weathered mudstone is present at a depth of 2.7m below existing ground level. This is consistent with the subsoil investigation encountered downslope of the property on the neighbouring property. No groundwater was encountered during the subsoil investigations.

- Natural Ground Conditions (no fill encountered during subsoil testing)
- No Groundwater encountered
- Residual or completely weathered Melange of Northland Allocthon materials, comprised of stiff plastic silty CLAY to a depth of ~1.8m bgl overlying moderately weathered MUDSTONE with some to minor clay.

- Upper layers unsuitable for shallow footings, requiring loads to be transferred to underlying (mudstone) layers.
- Conditions, including both soil and slope conditions, suggest a foundation of either bored piles embedding a minimum of 350mm into the mudstone and/or soldier piles and appropriate retaining to suit the proposed construction to confirmed once conceptual plans are available.
