# Inspection Report

## Profile building and pest inspections

**20 Carstens Ct Currumbin , Gold Coast , QLD**

Report/Agreement # 281025104441807  
 Inspection Date: 28 Oct 2025  
 Inspection Time: 11:00 am

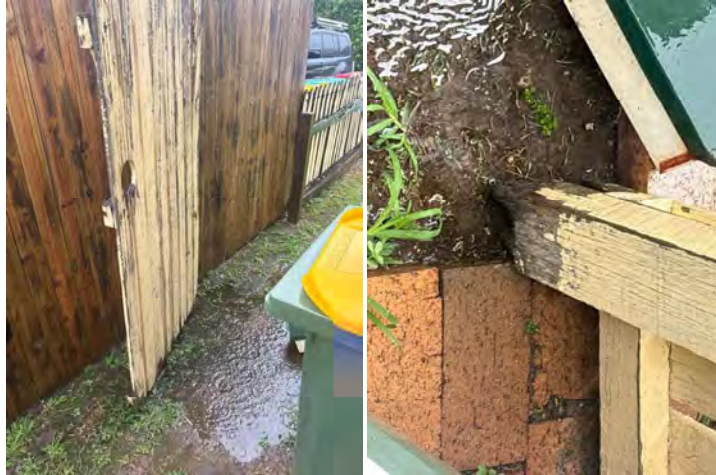
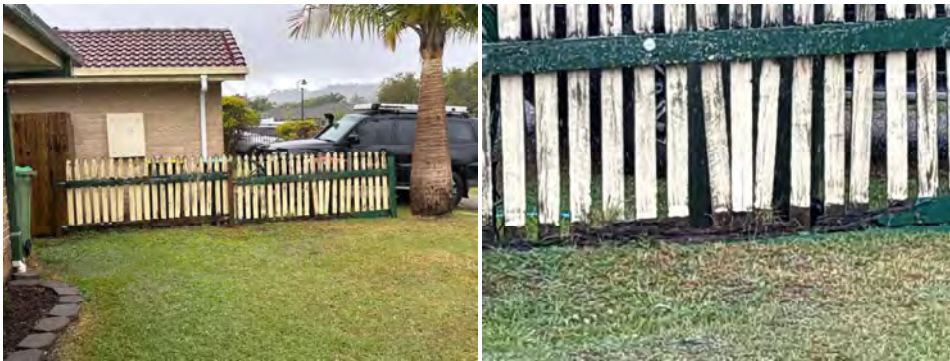
- #1. weathering and deterioration to front fence components in sections - Recommendations: Repair and replace affected areas. A qualified fencing contractor should be engaged for repairs
- #2. Gates are binding and/or not latching. Repairs recommended by licensed contractor

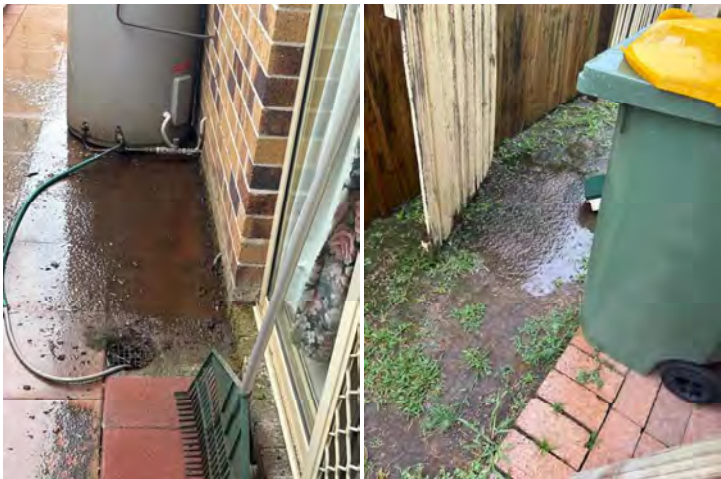
- #3. Some ponding water around hot water system and side gate, improvement to site drainage to these areas recommended

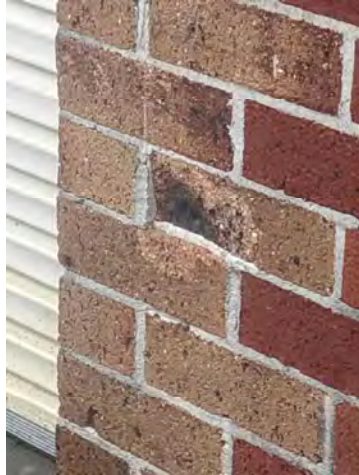
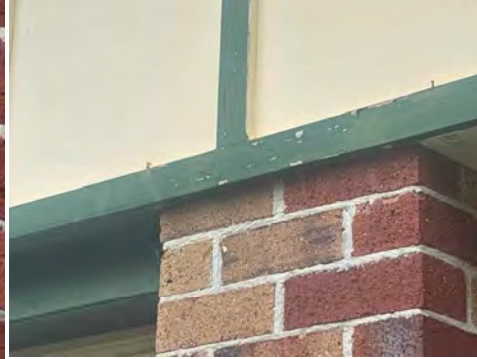
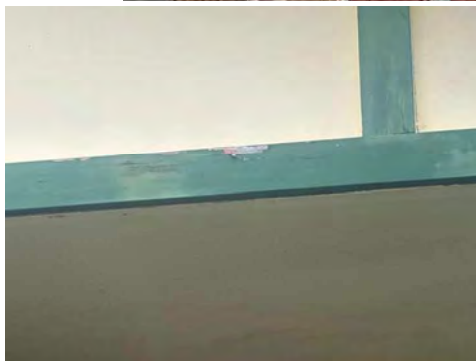
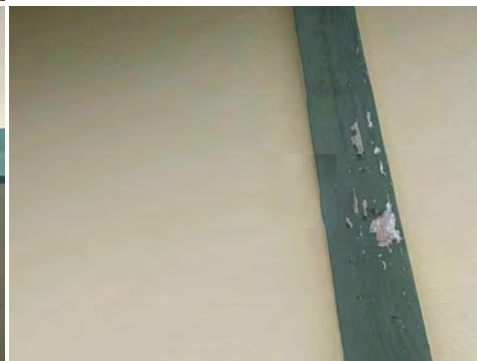
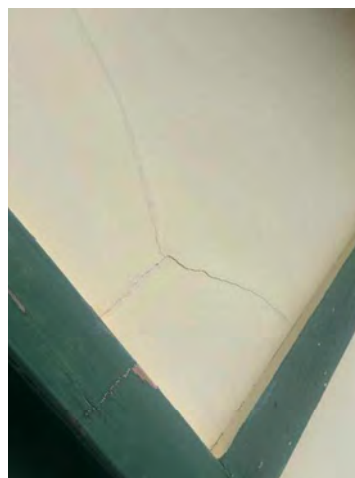
#4. Minor cracking has occurred to areas of external wall cladding above garage door . Recommend contacting a licensed contractor for further advise and repair

#5. The external paint has deteriorated in isolated areas.

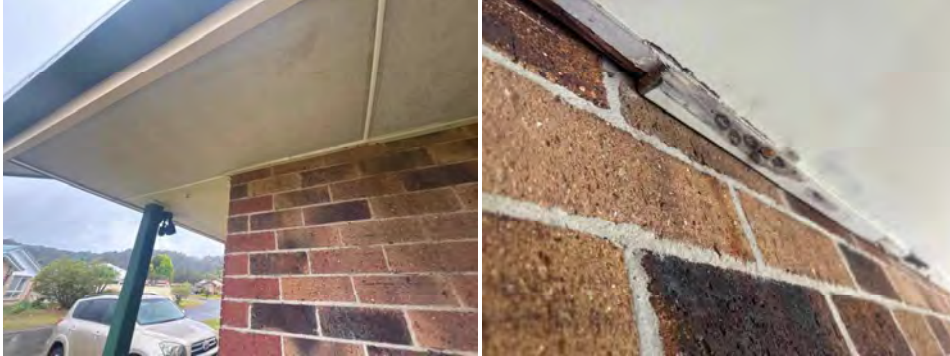
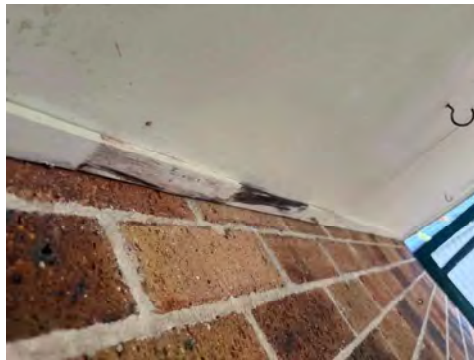
#6. Staining to eave lining in alfresco area suggests previous leaks from roof. No moisture detected on day of inspection. Recommend to monitor the area for any changes and proceed with repairs as necessary

#7. Some entry eave sheets are not painted

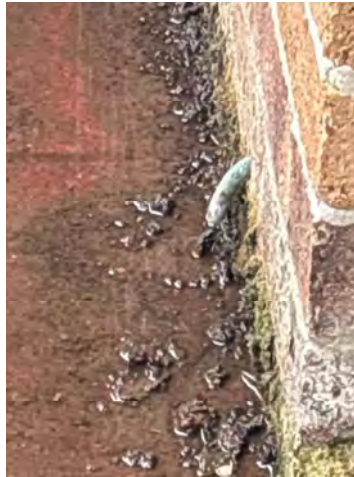
#8. The hot water overflow requires diverting to a drain or further from the dwellings wall or footings. Excess water ponding alongside walls and into perimeter footings has the potential to cause rising damp, differential settlement and wall cracks over time. It is also conducive to termite infestation. Recommendations: Engage a plumber to rectify.

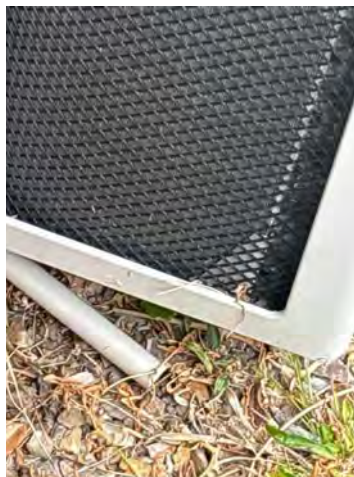
#9. The Air-Conditioning overflow requires diverting to a drain or further from the dwellings wall or footings. Excess water ponding alongside walls and into perimeter footings has the potential to cause rising damp, differential settlement and wall cracks over time. It is also conducive to termite infestation. Recommendations: Engage a plumber to rectify.

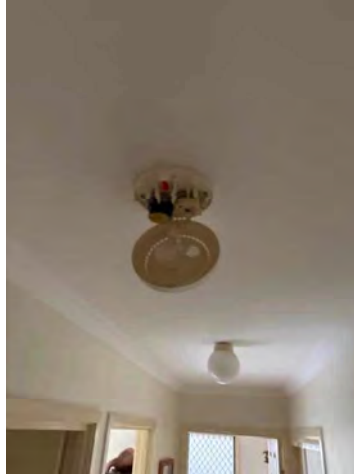
#10. Some smoke alarms are missing.

Legislation requires smoke Alarms to be installed. Check with your local council regarding type, locations and other related requirements.

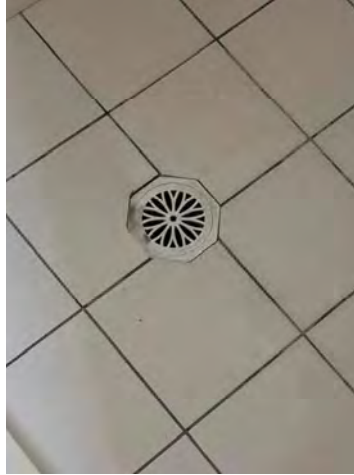
#11. Floor waste defective. Damaged/loose ect. This may lead to water penetration into surrounding areas. Contact a licenced plumber or tiler for repairs

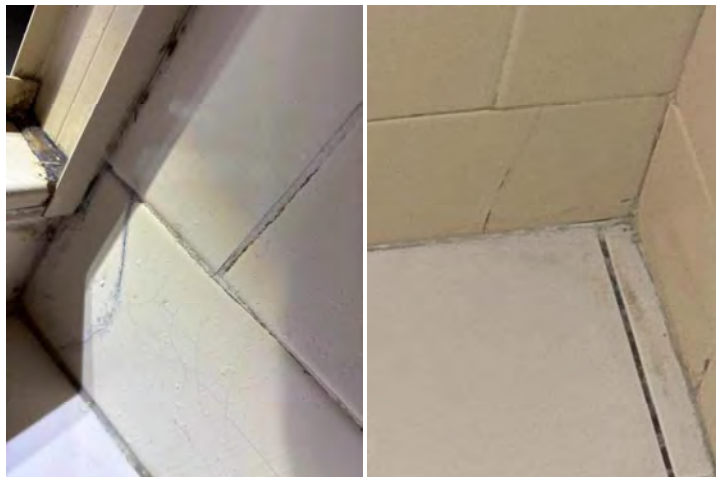
#12. Isolated Cracked tile/s noted. Any cracked tile has the potential to cause issues with leaks from the shower if left unattended. A qualified tiler should be engaged for advice and recommendations.

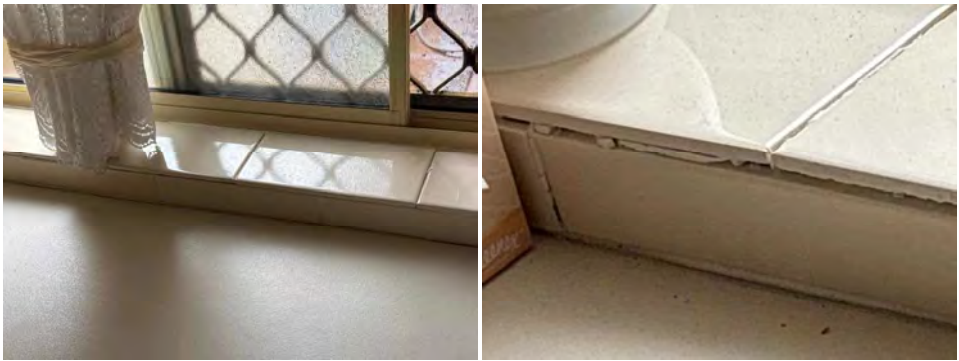
#13. Glue has failed to windowsill tiles causing them to come loose. Repair recommended

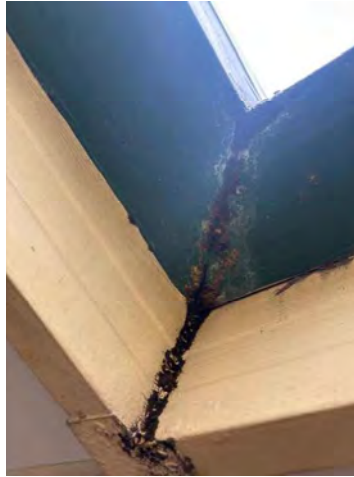
#14. There is evidence of leaking gutter joins. Silicone requires repairs. Contact a roof plumber for advice and repairs.

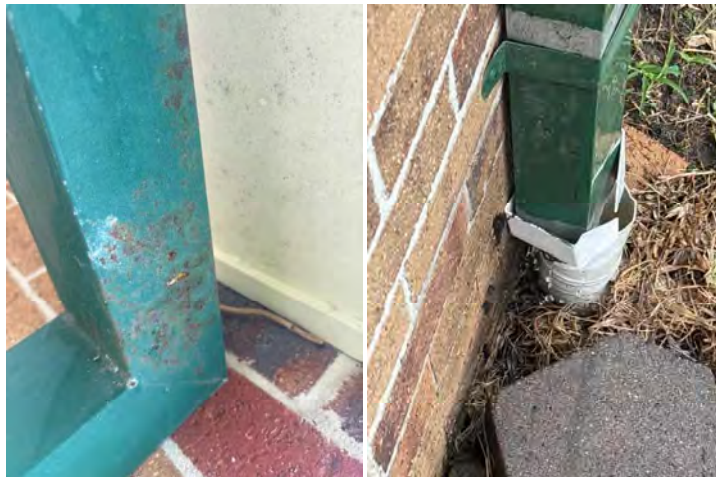
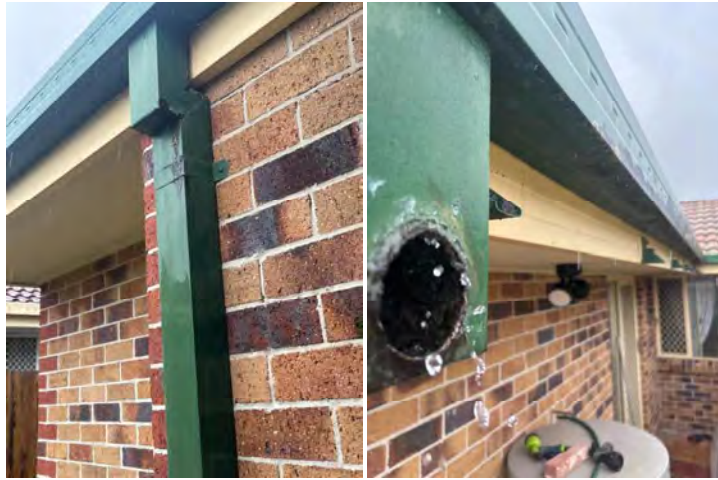
#15. Leaking down pipe joins visible. Recommendations: A qualified roof plumber should be engaged to repair.

#16. Minor down pipe rust visible. Recommendations: A qualified plumber should be engaged for advice and recommendations -

#17. Cracking/ or damage to down pipe base. This has the potential to cause leaking next to house. Recommendations: A qualified plumber should be engaged for repairs.

#18. Hole in back downpipe is allowing water to overflow next to the house. Repairs recommended

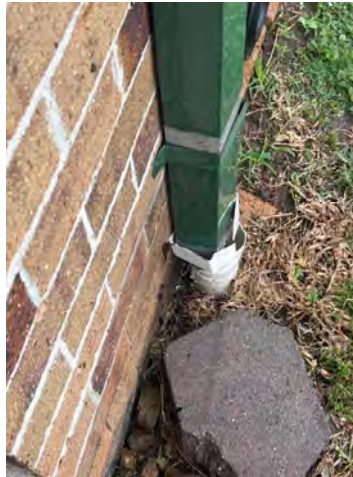
Downpipes

Water leaks, especially in or into the sub-floor or against the external walls ie: Leaking taps, water tanks or down pipes and or guttering, increases the likelihood of termite attack. Leaking showers or leaks from roofs or other areas" also increase the likelihood of concealed termite attack. These conditions are also conducive to borer activity and wood decay. If any leaks were reported then you must have a plumber or other building expert to determine the full extent of damage and the estimated cost of repairs

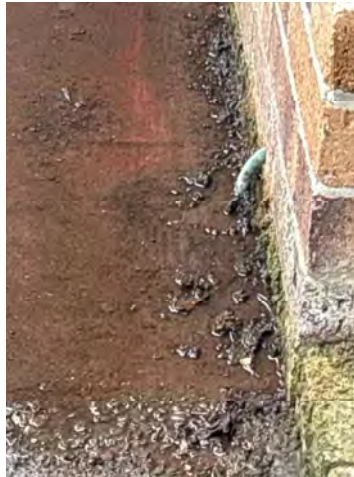
No - Hot water services which release water alongside or near to building walls need to be connected to a drain (if this is not possible then their water outlet needs to be piped several meters away from the building) as the resulting wet area is highly conducive to termite activity

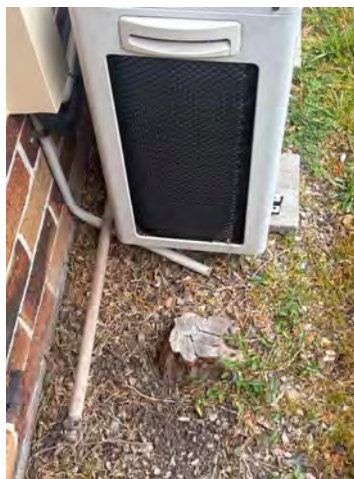
No - Air conditioning units which release water alongside or near to building walls need to be connected to a drain (if this is not possible then their water outlet needs to be piped several meters away from the building) as the resulting wet area is highly conducive to termites.

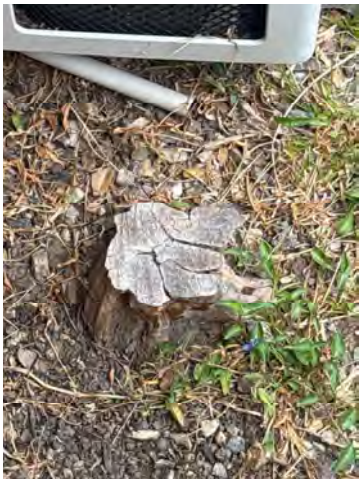
Old Tree stumps located on the site are conducive to termite activity and should be removed
