## Building Inspection Report

Inspection Date: Wed, 24 Sep 2025

Property Address: 35/1 Grenada Way, Parrearra QLD 4575,  
Australia

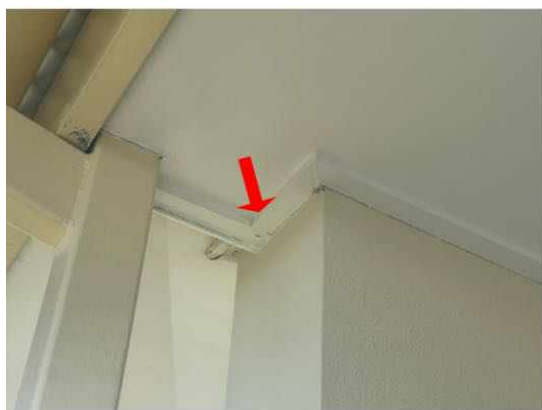
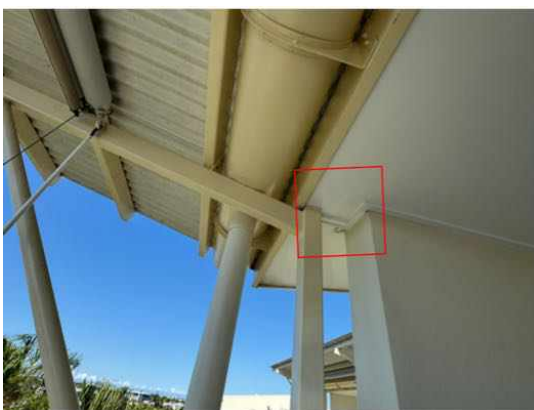
#### Defects 3.01

| Building: | Main Building |
| Location: | Eaves > Level 4 |
| Finding: | Timbers- Wood rot/ Fungal decay |
| Information: | The following photographs are an example of the timber building elements showing evidence of wood rot throughout the property. |

Wood rot, also known as fungal decay, occurs when timbers and other cellulose building materials are exposed to damp conditions on an ongoing basis. This could be the result of age, exposure to weathering over a prolonged period of time, roof plumbing leaks or the attraction of excessive moisture from other abutting building materials.

Prior to any works being performed, the cause of the moisture that has created the visible wood rot should be identified and addressed in a suitable manner.

Repair or replacement of all affected timbers will then be a necessary step in protecting surrounding building elements from such deterioration.

Recommend the appointment of a licensed builder or carpenter to assess the cause of excessive moisture, provide advice and perform all the remedial works necessary. Further information by the seller is that the body corporate is most aware of this deterioration and contractors are onsite at the moment rectifying external building works.

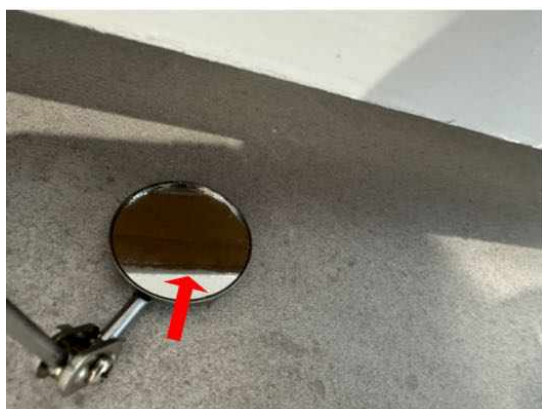
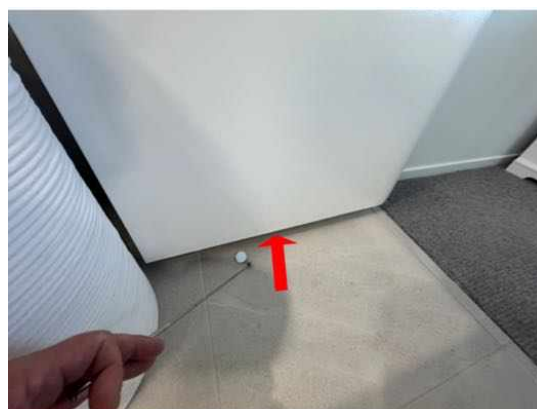
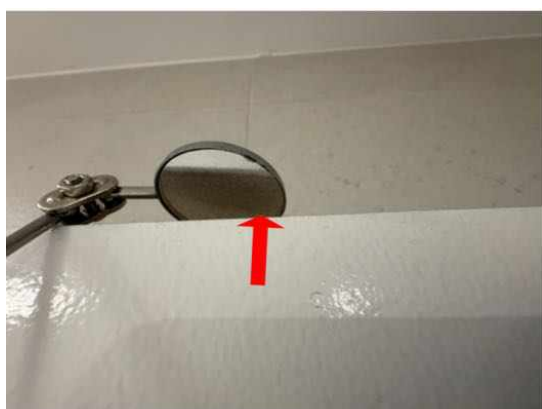
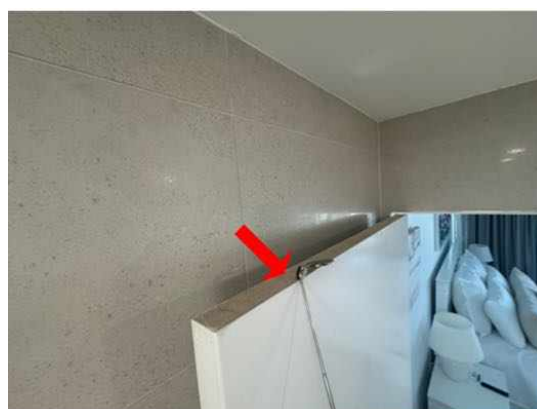
Building: Main Building  
 Location: Doors- especially wet areas > Level 4  
 Finding: Bottom and tops of wet area doors- Not sealed  
 Information: Tops and bottom of doors should have adequate paint sealer applied to prevent absorption of moisture, especially within wet area rooms.

Over time and excessive exposure to moisture, these door will most likely absorb moisture and may deteriorate/ become swollen.

Being internal doors, secondary defect are not likely to form apart from the potential of the door to lose its functionality.

Recommend engagement of a licensed painting or general handyman to apply appropriate paint protection/ sealer to the tops and bottoms of these wet area doors are client's discretion.

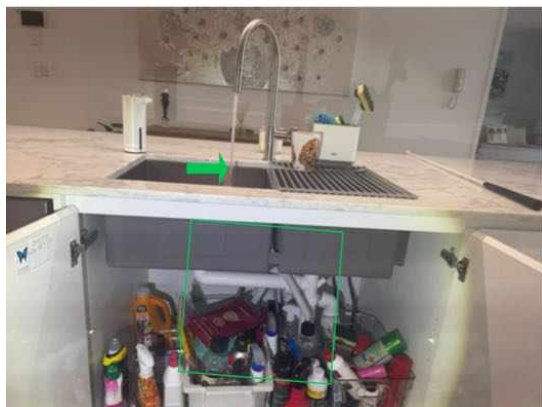
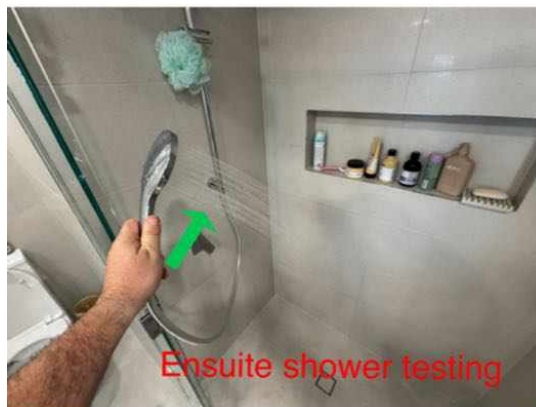
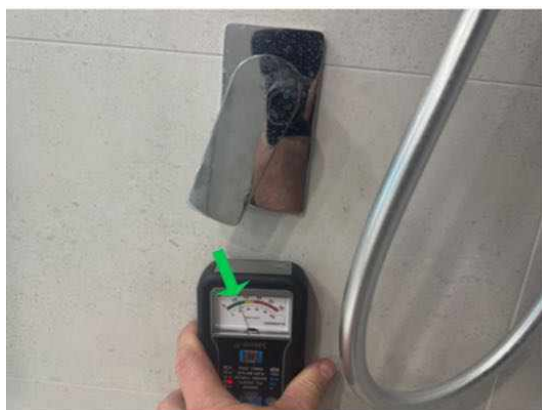
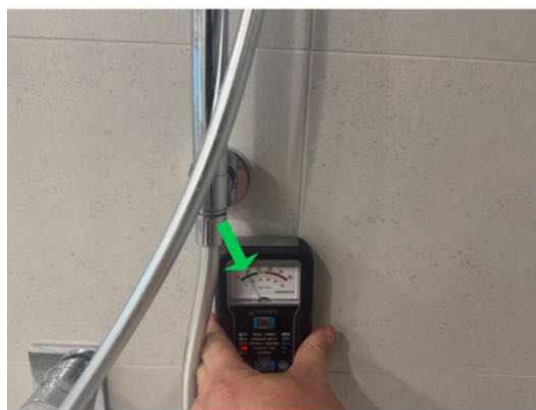
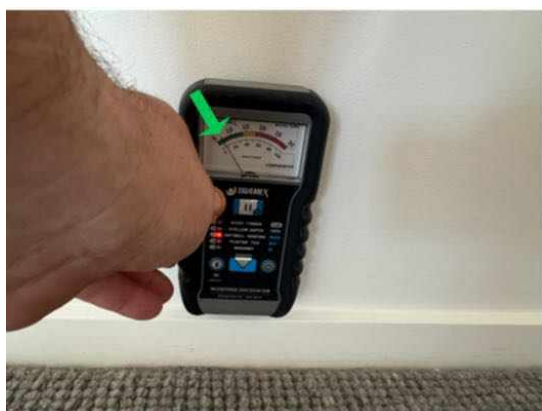
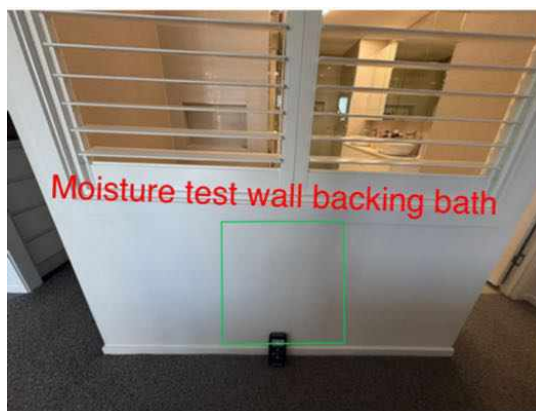
Building: Main Building  
 Location: All Internal Plumbing Areas > All Areas  
 Finding: Shower/ plumbing testing  
 Information: No evidence of any water leaks to the showers, vanities or sinks when water was run for minimum 5 mins over all walls of showers and 30 secs in vessels (sinks and vanities)

Moisture meter testing completed on all opposition sides of shower wet areas flooded and all findings were found to be within the normal range.

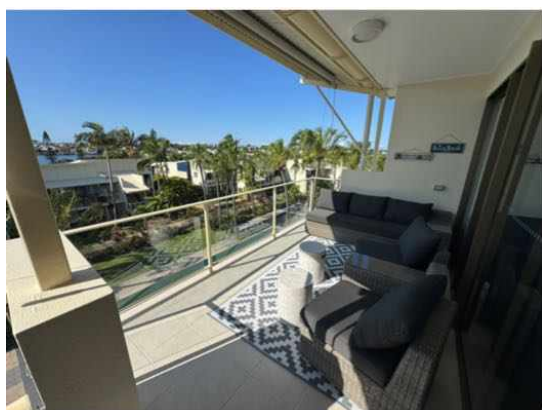
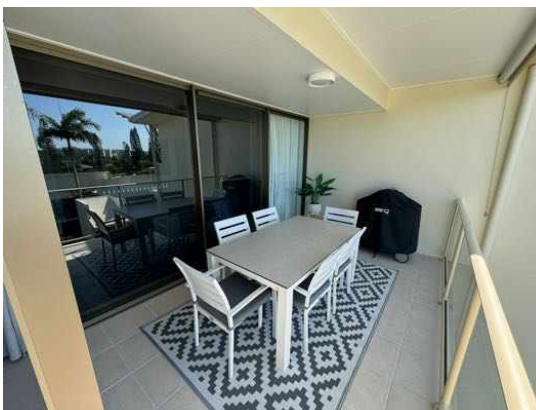
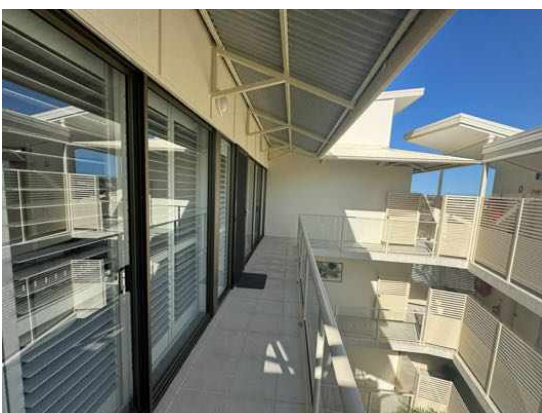
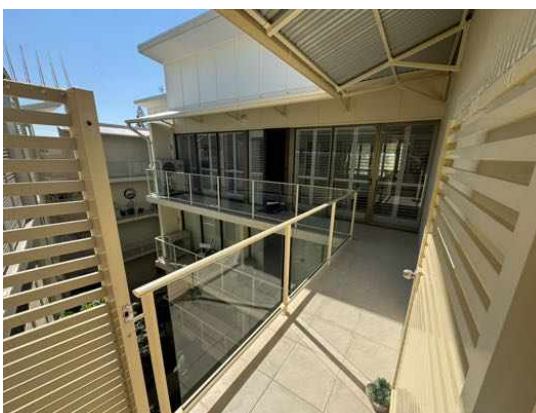
Building: Not Applicable

Location: All External Areas > All Areas

Finding: Additional Photos - Obstructions and Limitations (externally)

Information: These photographs are an indication of the obstructions and limitations which impeded full inspection of the property at the time of inspection. These obstructions can hide an array of defects and should be removed to allow full inspection to be carried out. A re-inspection is recommended once the areas are made accessible.

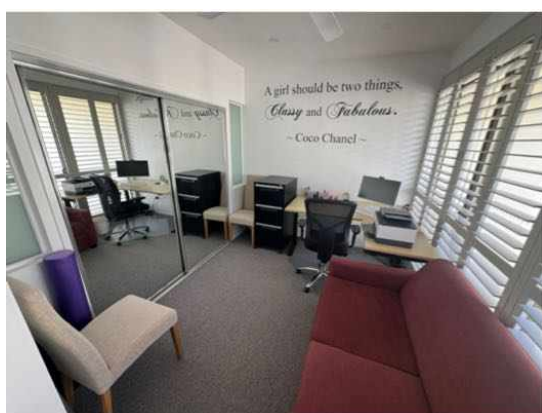
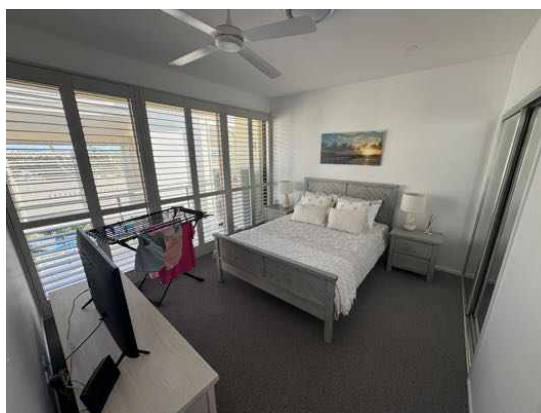
Building: Main Building  
 Location: All Internal Areas > All Areas  
 Finding: Additional Photos - Obstructions and Limitations (Internally)  
 Information: These photographs are an indication of the obstructions and limitations which impeded full inspection of the property at the time of inspection. These obstructions can hide an array of defects and should be removed to allow full inspection to be carried out. A re-inspection is recommended once the areas are made accessible.
