STANDARD PROPERTY & TIMBER PEST REPORT

Report number: 3050
Inspection date: Saturday 4th October 2025
Property address: 67 Oceanic Drive
Warana
QLD 4575

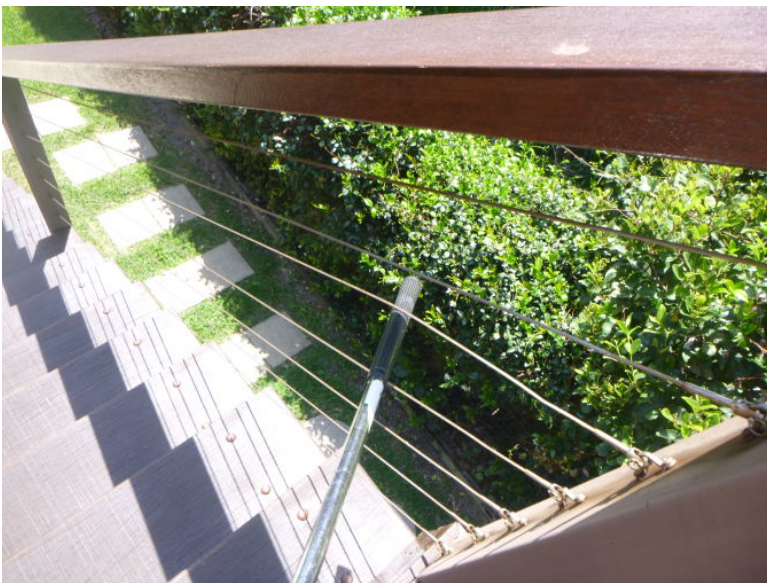
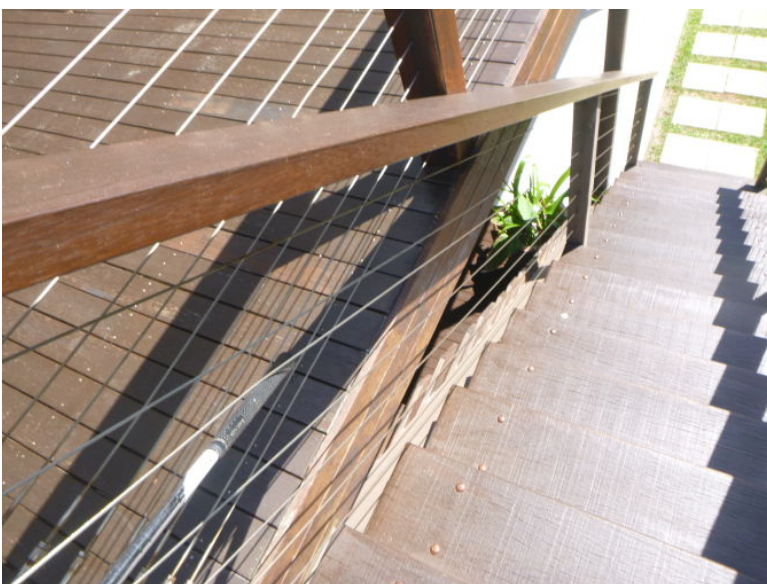
Area	Building exterior
Location:	The verandah steps (first floor and at the rear of the building).
Affected element:	Wire balustrades.
Defect or Sign:	Loose.
Visible extent:	Localised.
Recommendation:	Normal maintenance required (Tighten up)
Implementation:	The above recommendation should be implemented immediately.

Image comments: Loose wire balustrades.

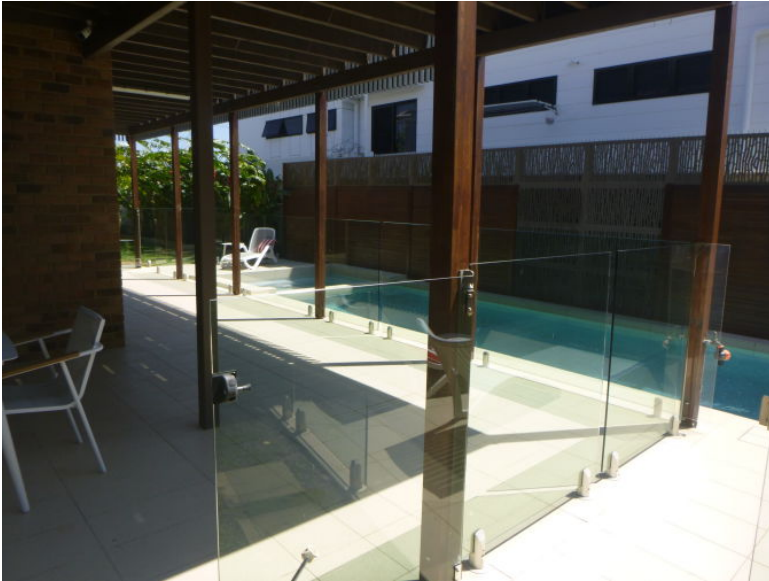
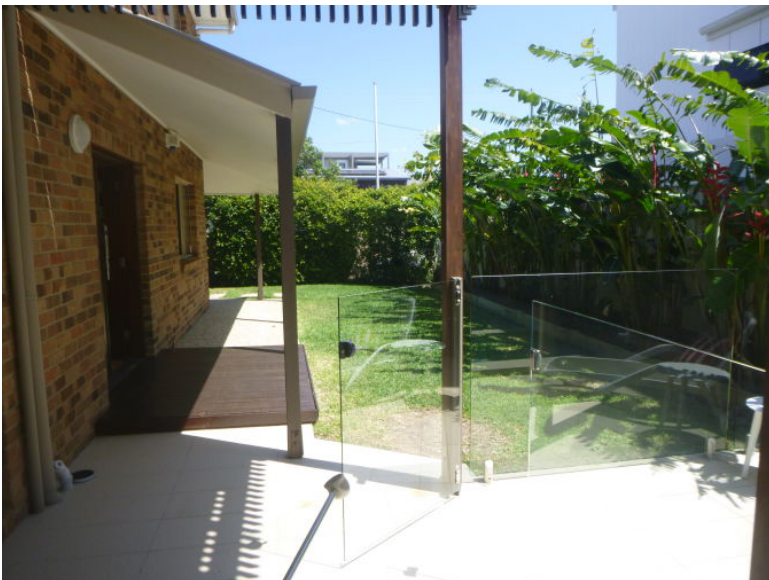
Area	The site
Location:	At the side of the property.
Affected element:	Swimming pool fence gates.
Defect or Sign:	Not closing to latch, immediate danger to small children.
Visible extent:	Localised.
Recommendation:	Competent advice (e.g. from a licensed or registered building contractor) should be obtained to determine the method of rectification or repair work, without delay, immediate effect.
Implementation:	The above recommendation should be implemented immediately.

Image comments: Gate remains open, immediate remedial action required.

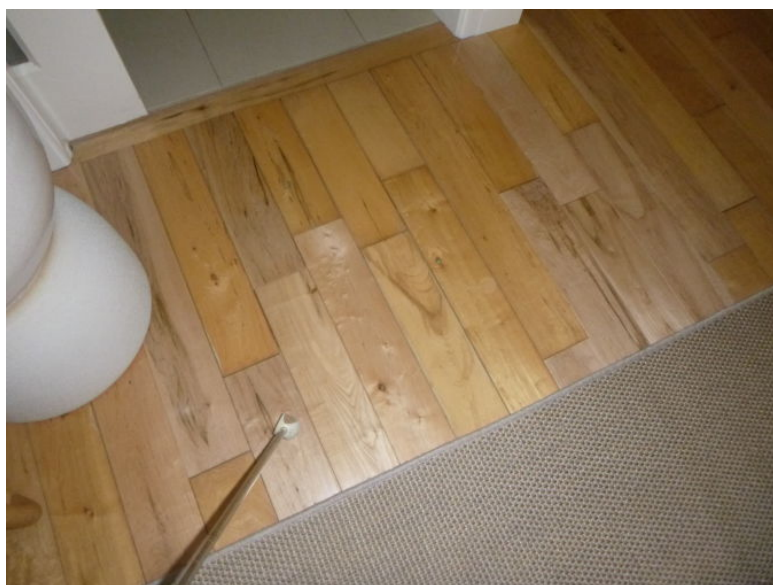
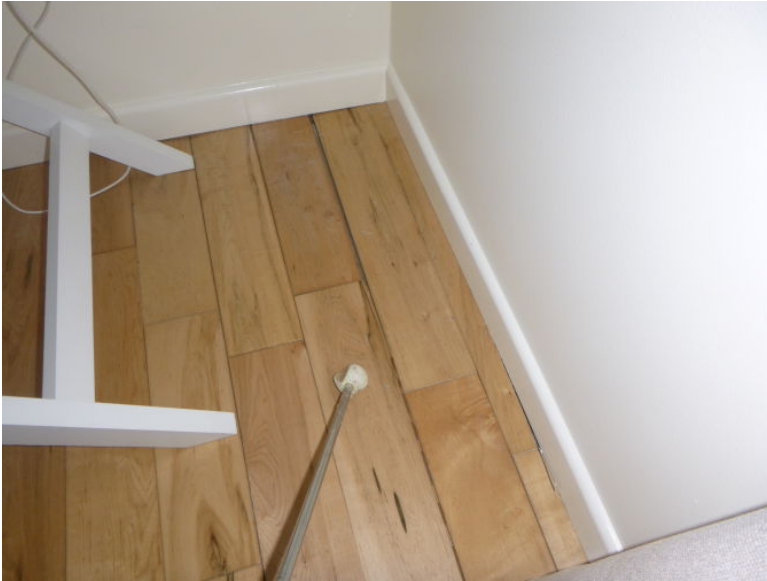
Area	Building interior
Location:	In the bedroom (first floor).
Affected element:	Hardwood floorboards.
Defect or Sign:	Creeping, opening up on the tongues.
Visible extent:	Localised.
Recommendation:	Monitoring and normal maintenance must be carried out.
Implementation:	The above recommendation should be implemented as soon as possible.

Image comments: Boards creeping.

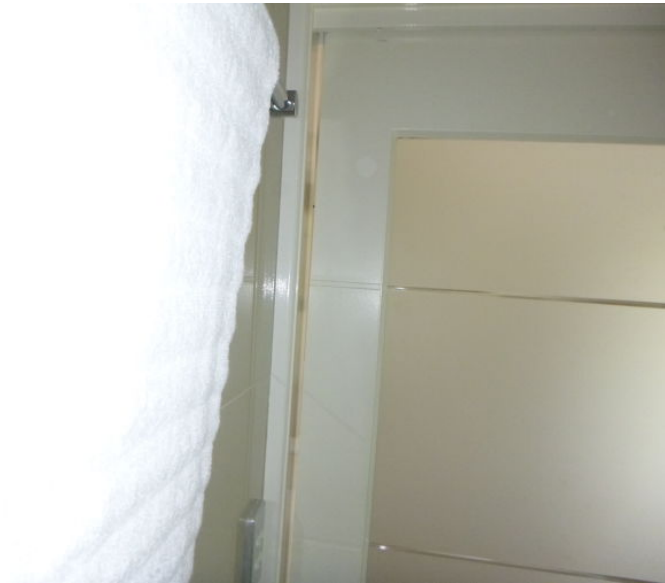
Area	Building interior
Location:	In the ensuite.
Affected element:	Sliding door.
Defect or Sign:	Out of alignment with the frame.
Visible extent:	Localised.
Recommendation:	Normal maintenance/adjustment must be carried out.
Implementation:	The above recommendation should be implemented as soon as possible.

Image comments: Space between the door and frame when closed, adjustment on the runners required.

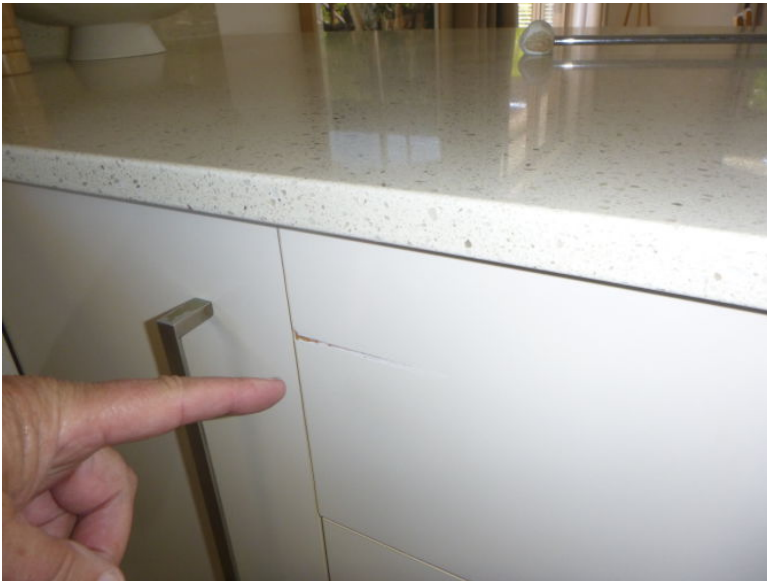
Area	Building interior
Location:	In the kitchen.
Affected element:	Cabinetry drawer front.
Defect or Sign:	Damaged.
Visible extent:	Localised.
Recommendation:	Normal maintenance/repair must be carried out.
Implementation:	The above recommendation should be implemented as soon as possible.

Image comments: Drawer front scratched, adjacent door causing this damage.

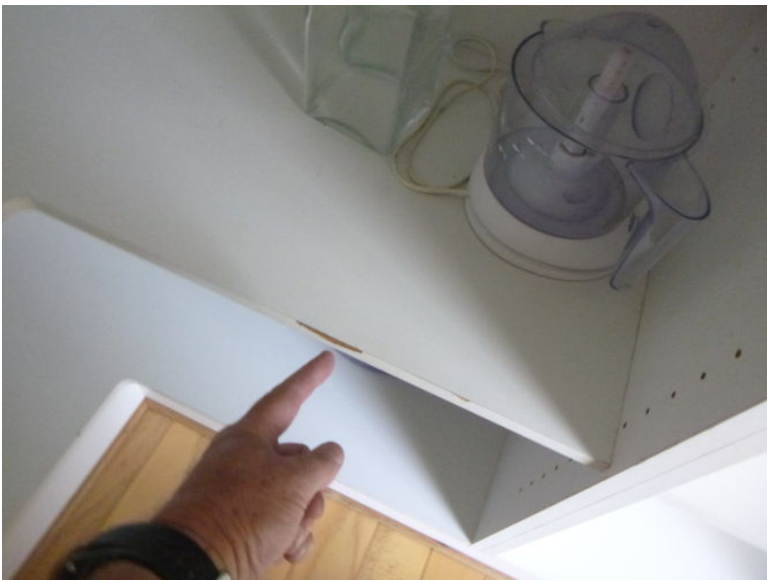
Area	Building interior
Location:	In the pantry.
Affected element:	Cabinetry shelf edge.
Defect or Sign:	Damaged.
Visible extent:	Localised.
Recommendation:	Normal maintenance/repair must be carried out.
Implementation:	The above recommendation should be implemented as soon as possible.

Image comments: Pantry shelf edge damaged.

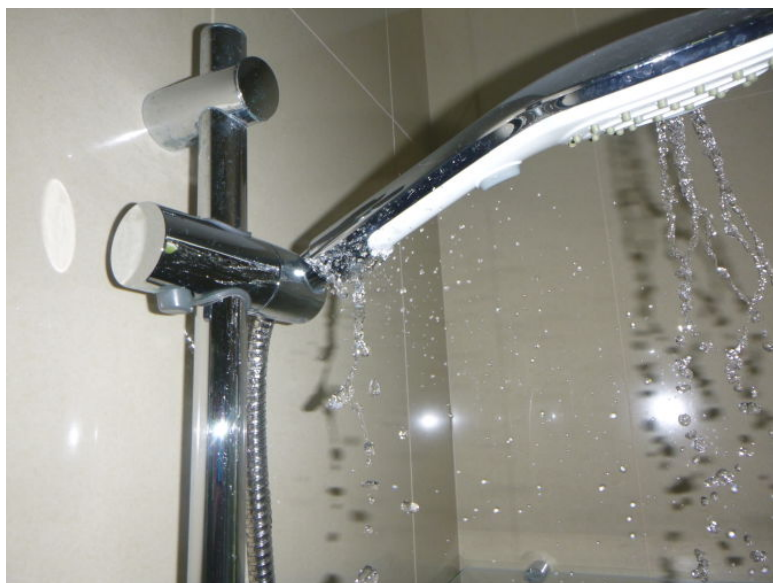
Area	Building interior
Location:	In the ensuite.
Affected element:	Shower head.
Defect or Sign:	Leaking when the tap is running.
Visible extent:	Localised.
Recommendation:	Normal maintenance/adjustment/reseal must be carried out.

Image comments: Leaking from the connection thread.

Implementation: The above recommendation should be implemented as soon as possible.

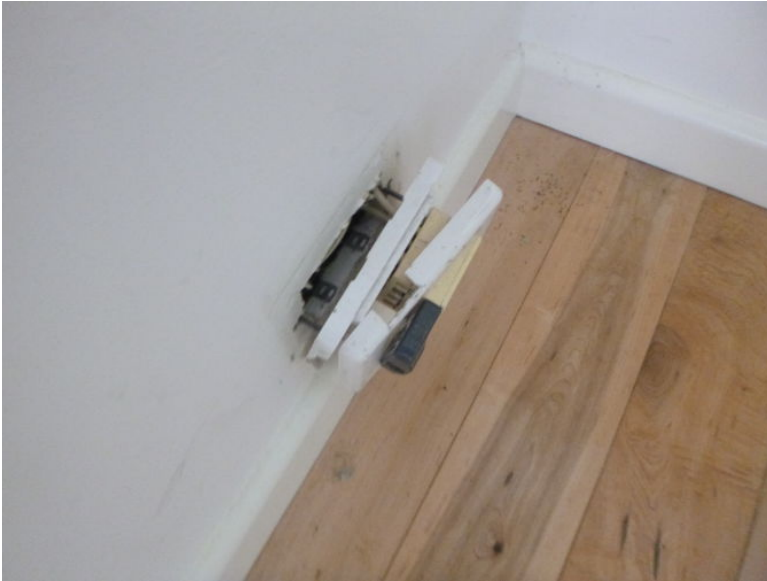
Area	Building interior
Location:	In the bedroom (first floor).
Affected element:	Electrical power point, in the wardrobe.
Defect or Sign:	Loose.
Visible extent:	Localised.
Recommendation:	Competent advice (e.g. from a licensed electrical contractor) should be obtained, without delay, to determine the need or otherwise for rectification or repair work.
Implementation:	The above recommendation should be implemented as soon as possible.

Image comments: Loose service outlet.

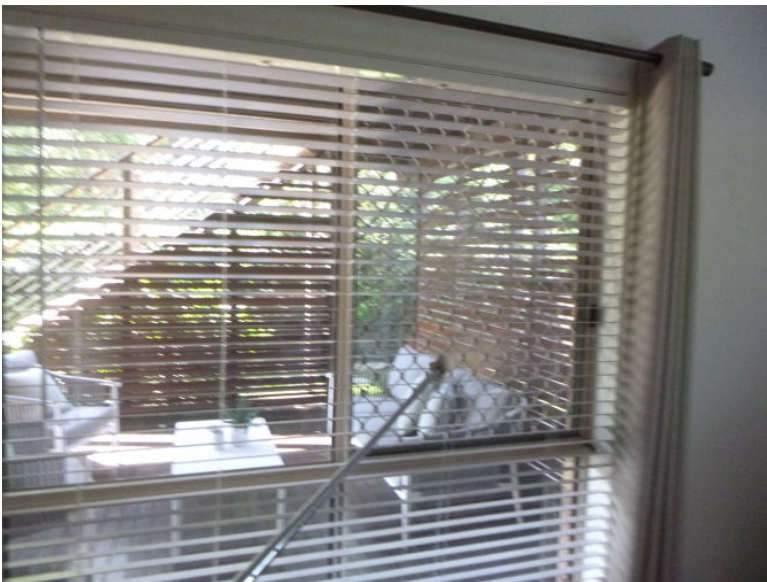
Area Building exterior
Location: Outside the living area.
Affected element: Window.
Visible extent: Localised.
Recommendation: Monitoring and normal maintenance must be carried out.
Implementation: The above recommendation should be implemented as soon as possible.

Image comments: Living room window, worn wheels, difficult to open and close, age wear and tear.

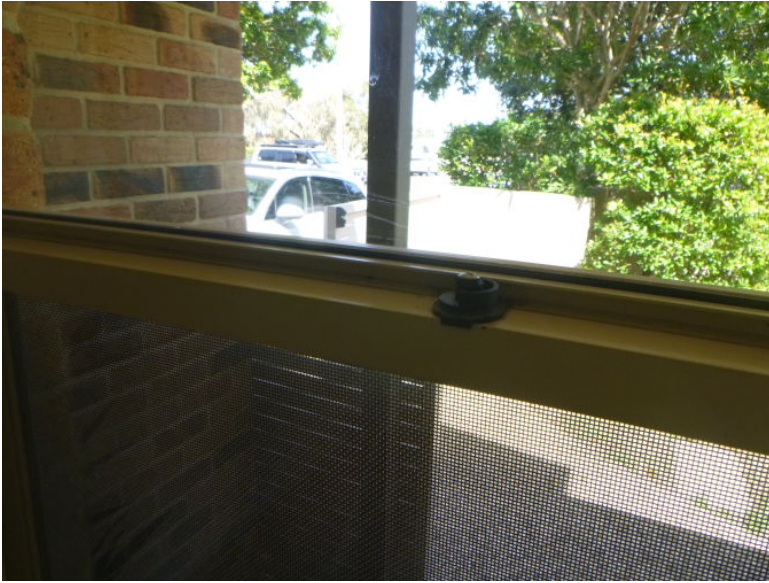
Image comments: Broken window lock.

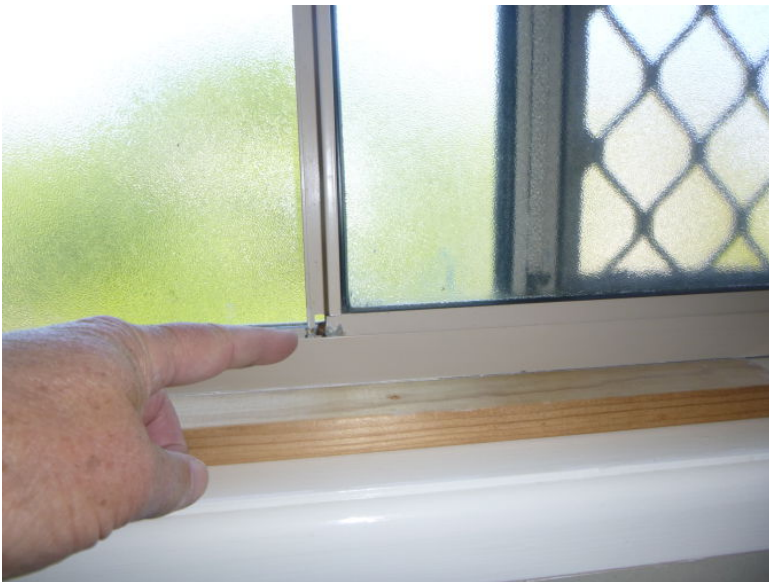
Area Building exterior
Location: Outside the ensuite.
Affected element: Window.
Visible extent: Localised.
Recommendation: Monitoring and normal maintenance must be carried out.
Implementation: The above recommendation should be implemented as soon as possible.

Image comments: Bathroom, sliding sash window, broken joint, bottom left of the frame.

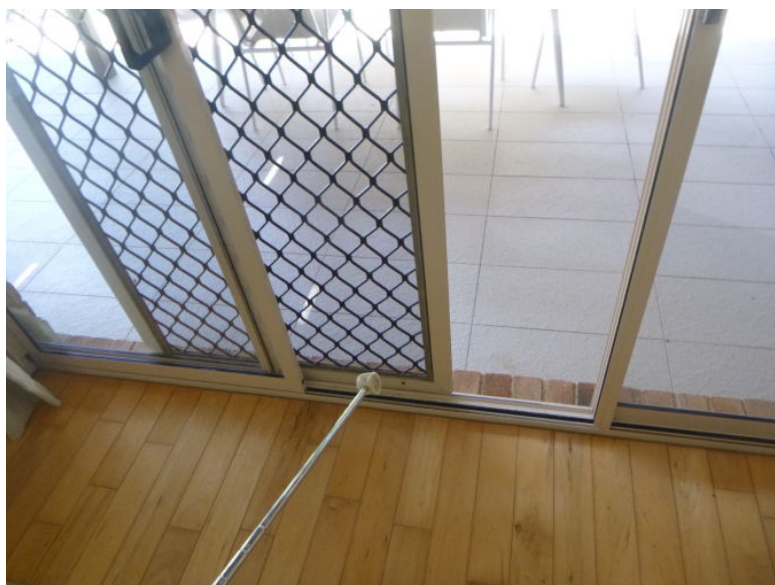
Area	Building exterior
Location:	Outside the building (at the rear of the building).
Affected element:	Doors.
Defect or Sign:	Difficult to open and close worn wheels. Surface corrosion of the door handles, close proximity to the sea (salt air) not uncommon.
Visible extent:	Localised.

Image comments: Worn wheels.

Recommendation: Normal maintenance/replacement must be carried out.

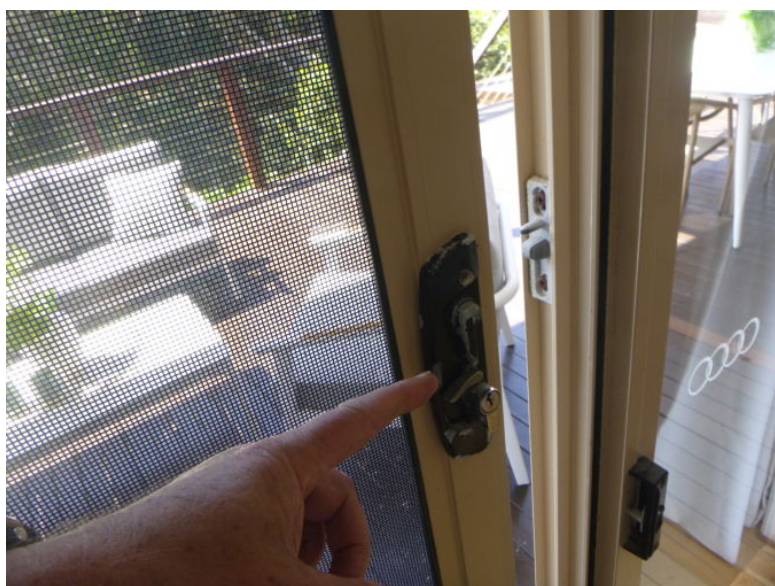
Image comments: Example of surface corrosion to the external door handles ,inside and out.

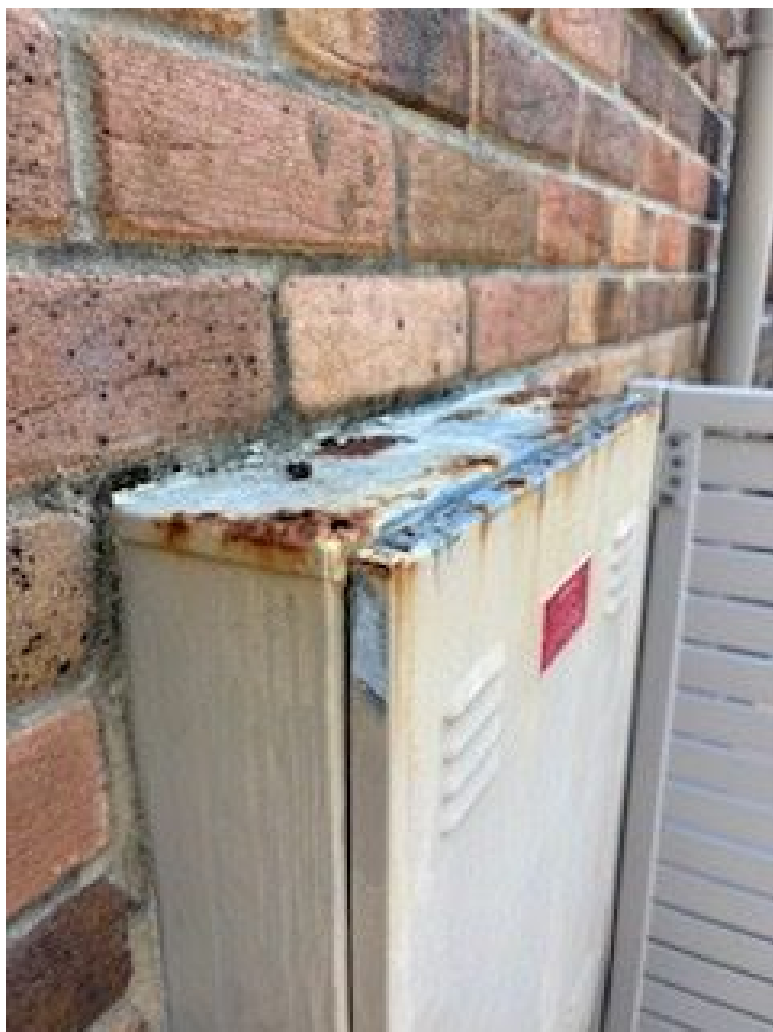
Area	Building exterior
Location:	Outside the building.
Affected element:	Electrical meter box. Hot water heater tank. Barge board fixings.
Defect or Sign:	Surface corrosion.
Visible extent:	Localised.
Recommendation:	Monitoring and normal maintenance must be carried out.
Implementation:	The above recommendation should be implemented as soon as possible.

Image comments: Surface corrosion.

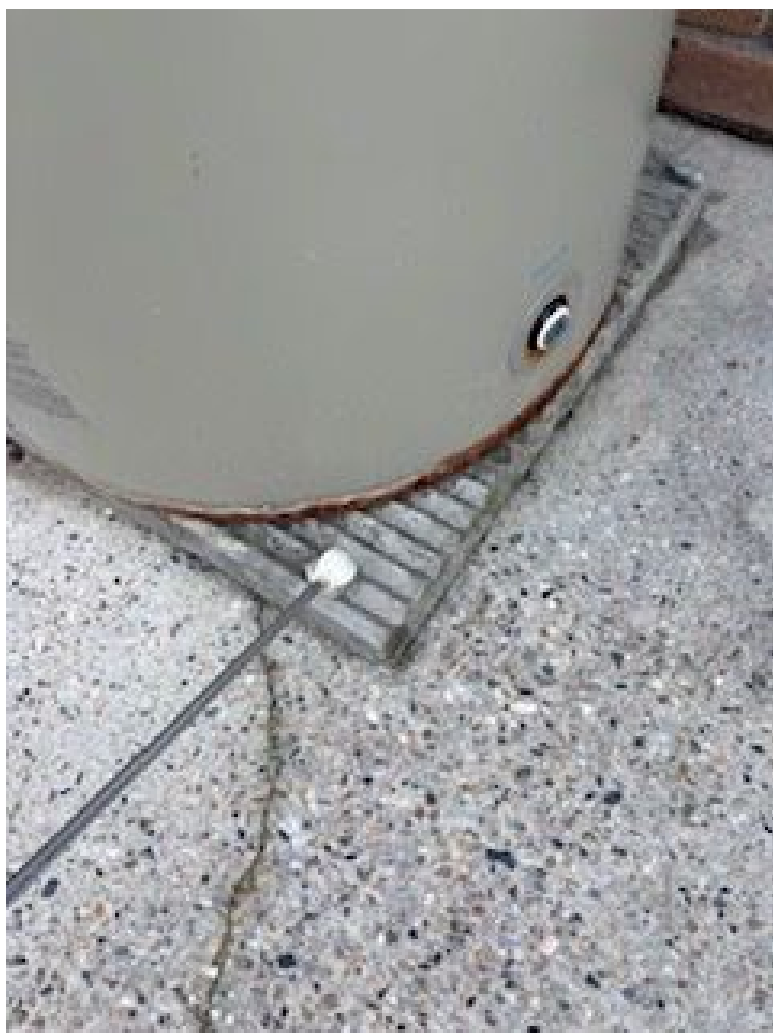
Image comments: External surface corrosion of the outer shell bottom.

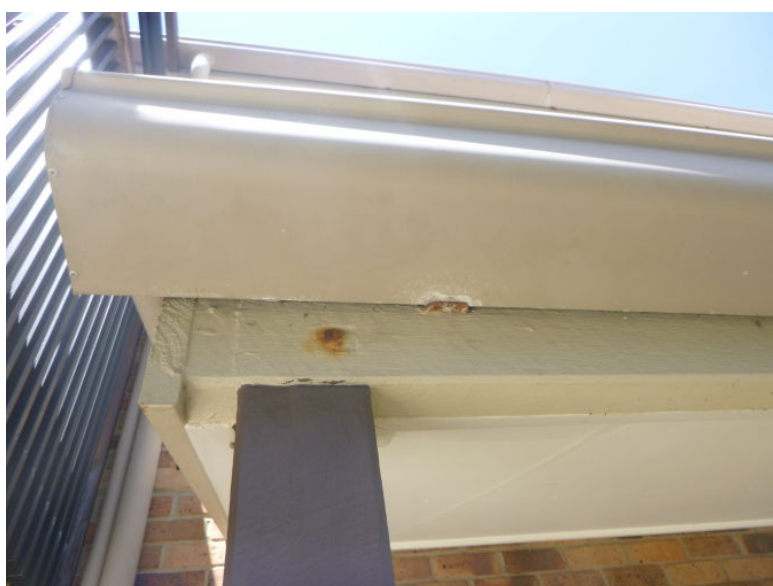
Image comments: Example of corroding heads to fascia and barge board fixings.

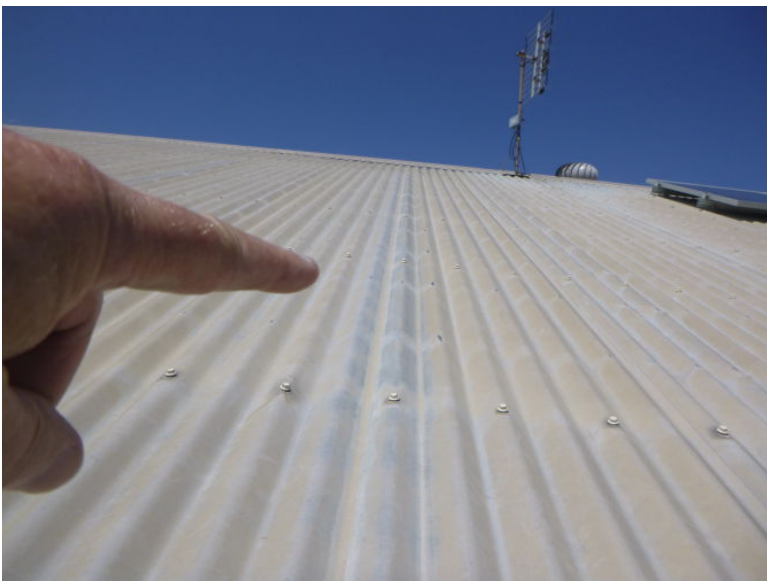
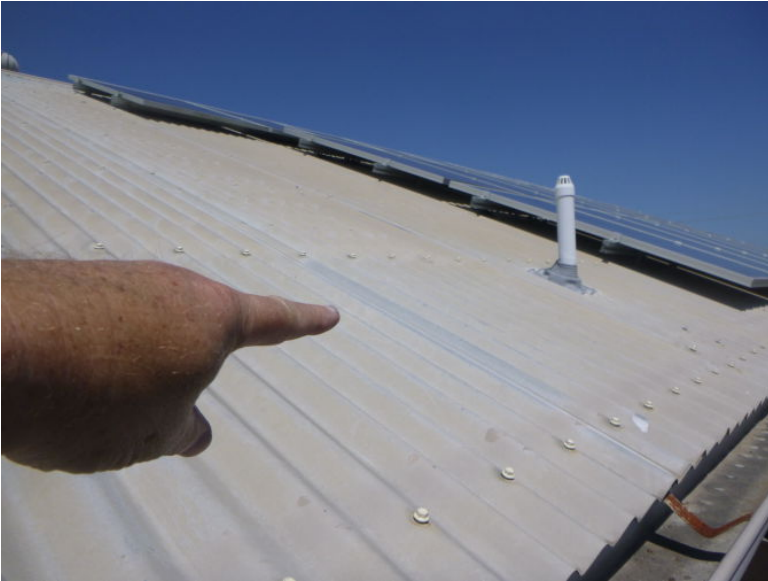
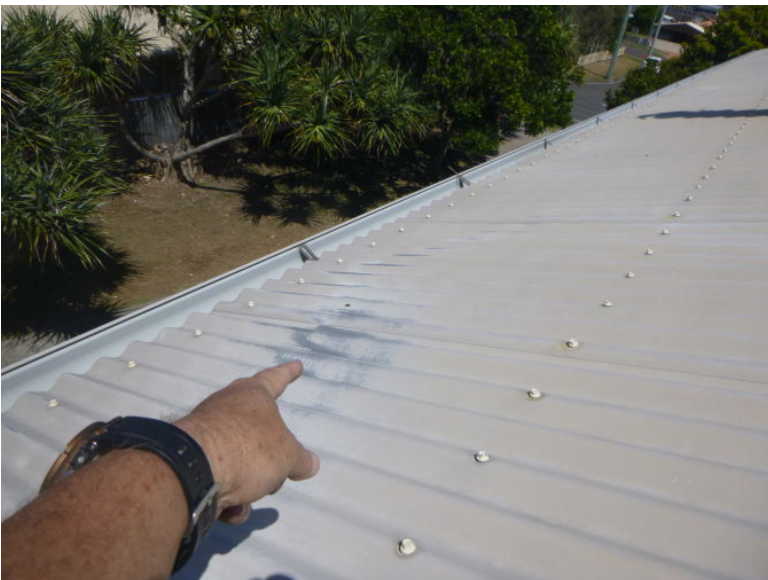
Area	Roof exterior
Location:	Above the building in general.
Affected element:	Roof sheeting paint finish.
Defect or Sign:	Discolouration./UV degradation of the paint finish, age and exposure to UV and weather.
Visible extent:	Widespread.
Recommendation:	Monitoring and normal maintenance must be carried out until redecoration takes place.
Implementation:	The above recommendation should be implemented as soon as possible.
Additional comments:	Budget accordingly.

Image comments: UV degradation of the paint covering.

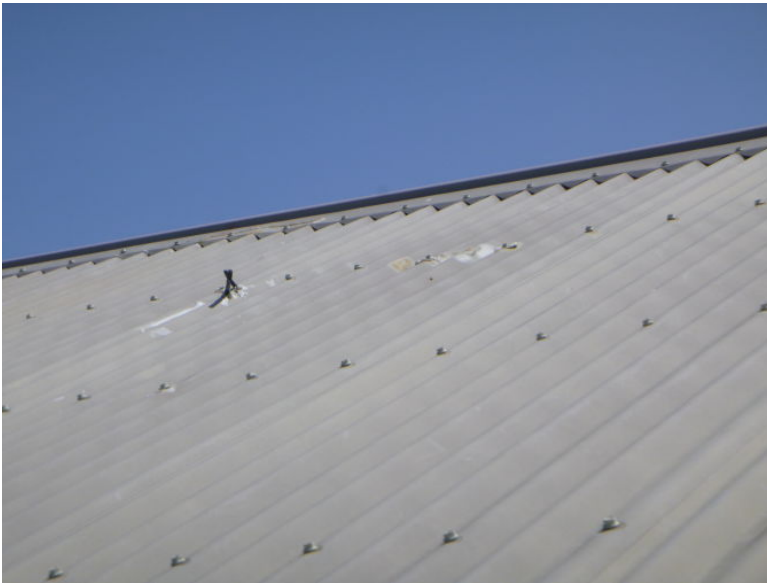
Image comments: Old fixing holes, sealed with filler/silicone.

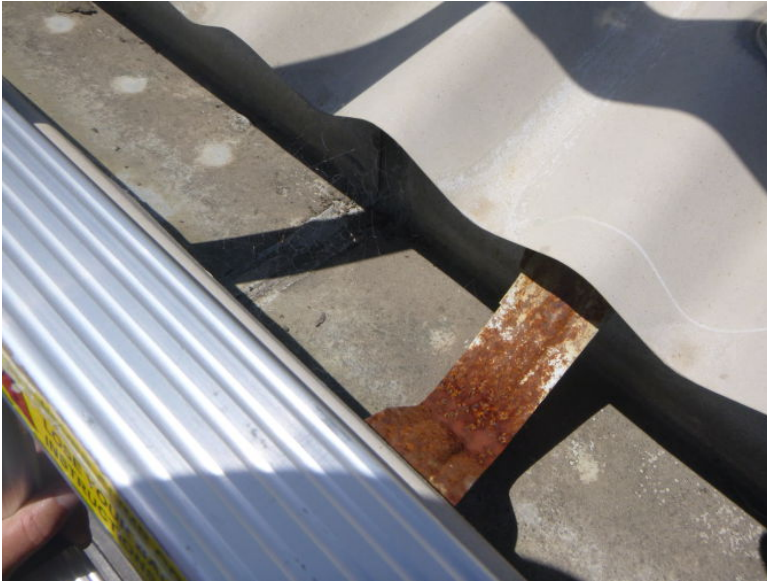
Area	Building exterior
Location:	Outside of the building in general.
Affected element:	Brackets to the gutter.
Defect or Sign:	Surface corrosion.
Visible extent:	Widespread.
Recommendation:	Monitoring and normal maintenance must be carried out.
Implementation:	The above recommendation should be implemented as soon as possible.
Additional comments:	Budget accordingly.

Image comments: Example of surface corrosion of the gutter brackets.

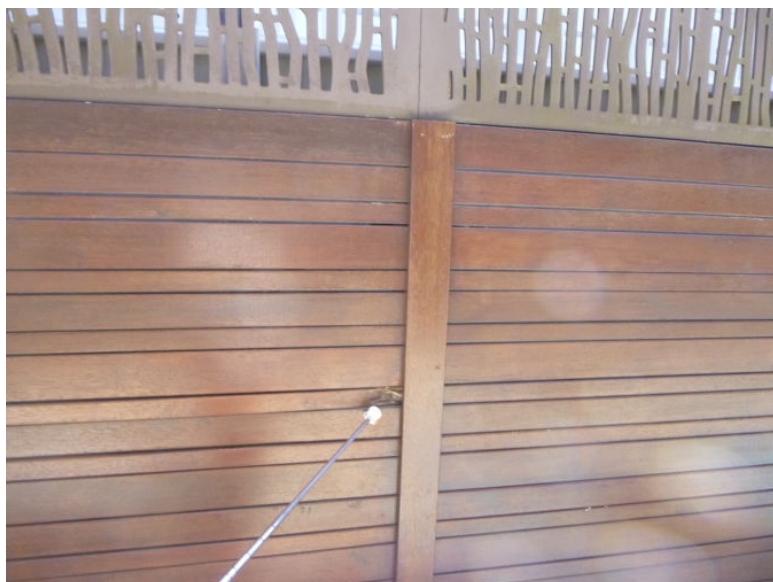
Area	The Site
Location:	On the left-hand side of the property.
Affected element:	Fence.
Signs of attack:	Isolated area of soft of timber surfaces.
Visible condition:	The condition of the timber appears to be decaying.
Visible extent:	Localised.
Recommendation:	Normal maintenance must be carried out.
Implementation:	The above recommendation should be implemented as soon as possible.

Image comments: Isolated area of timber decay, within the boundary fence, adjacent the pool.

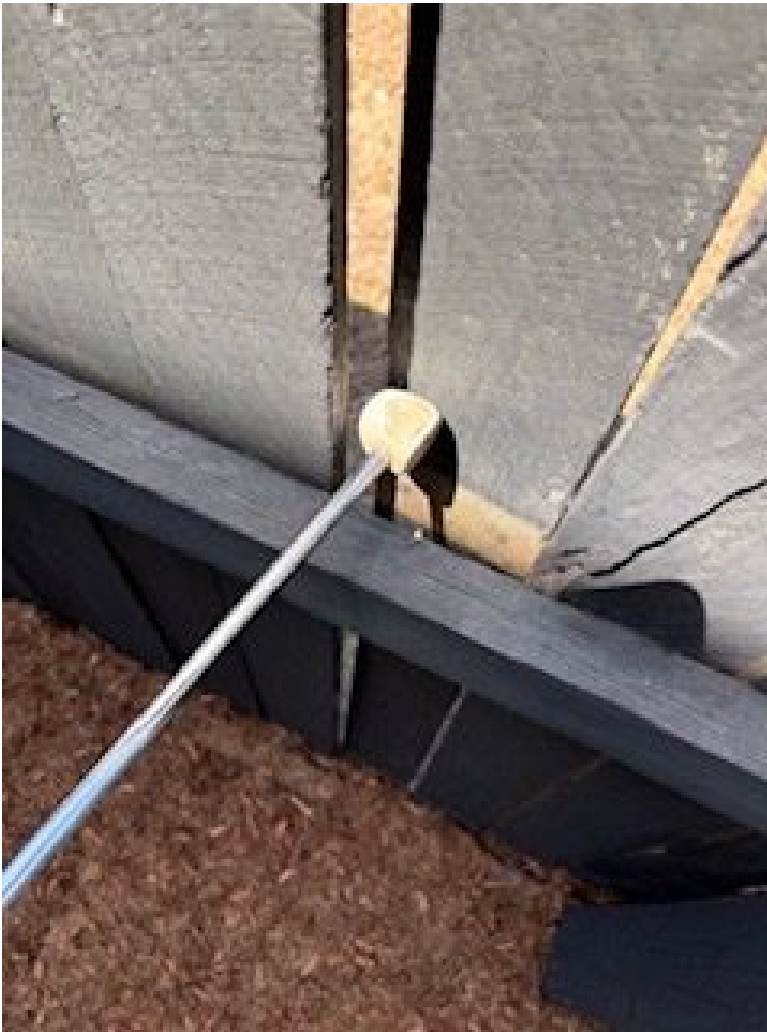
Image comments: Example of a loose piling.

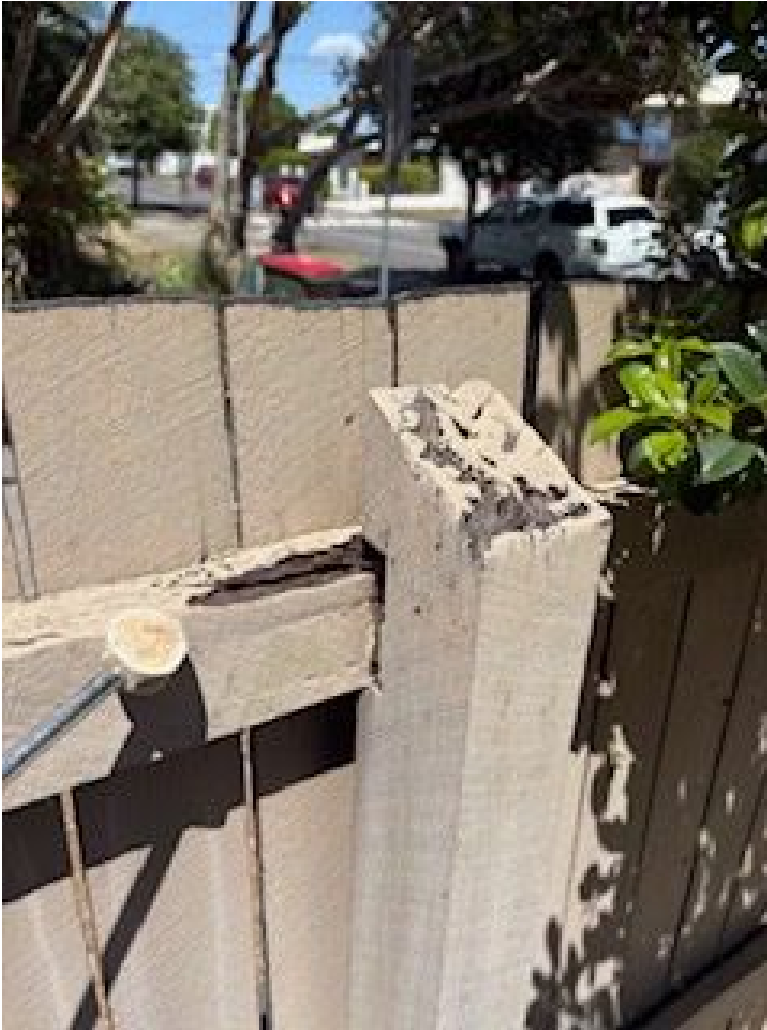
Image comments: Example of fungal decay along the boundary fence.

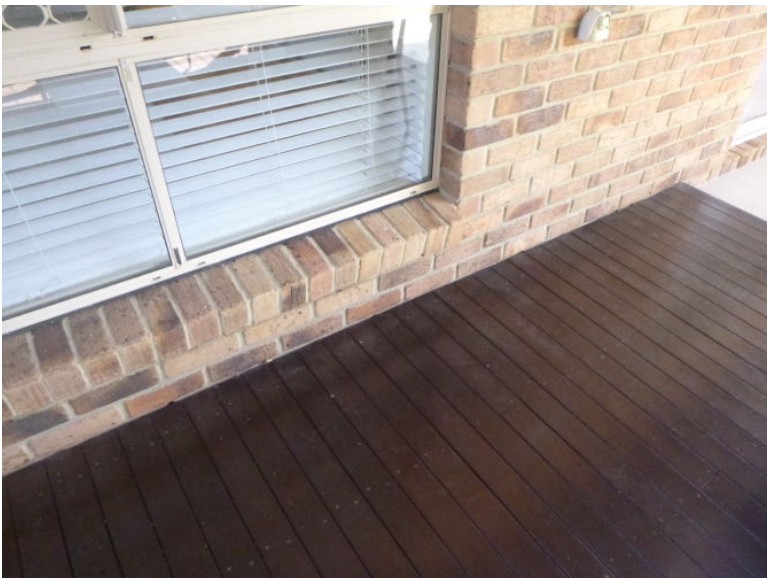
Area	Building exterior
Location:	Perimeter of the building.
Affected element:	Weep holes.
Defect or Sign:	Concealed by the verandah.
Visible extent:	Localised.
Recommendation:	Weepholes at the base of external walls must not be concealed by pavements, gardens, lawns, landscaping or the like as it is possible for termites to gain undetected entry. provision should be made for weep holes to be clearly visible (building contractor).
Implementation:	The above recommendation should be implemented as soon as possible.

Image comments: Decking covering the weep holes.
