## RED LBP PRE-PURCHASE REPORT

# PRE-PURCHASE BUILDING REPORT

Property Address	44 Strathmore Street, Matua, Tauranga 3110		
Client	Amy Mann		
Date of Inspection	28th April 2025	Time	8:30 am
Inspector	Brennan Rapira National Certificate in Carpentry, Licensed Building Practitioner		
LBP Number	138160		
Additional Information	Asbestos		
People Present	Inspector, Owner		
House Occupied	Yes

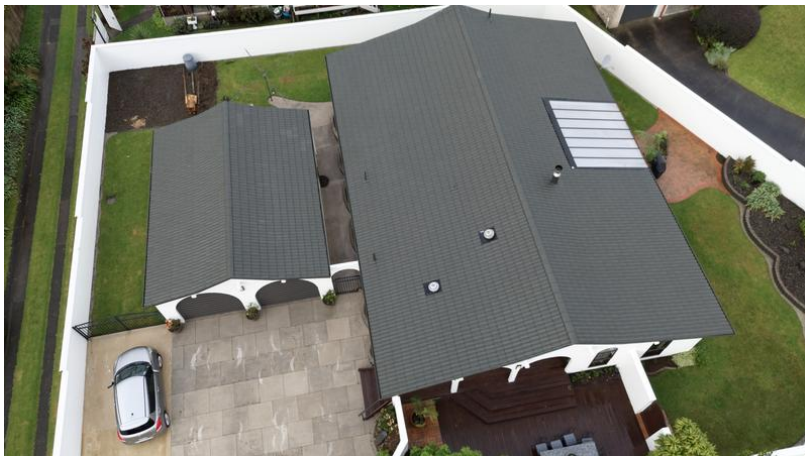
Photo 3

Masonry tile gable roof construction.

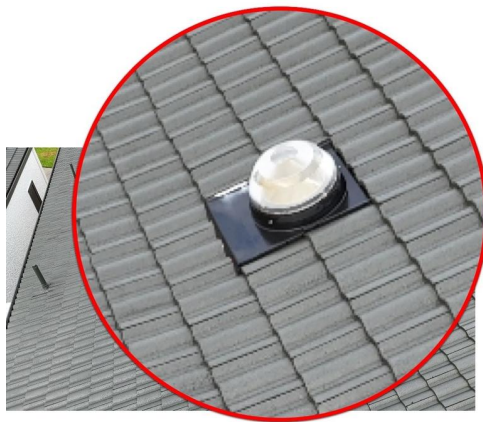
Photo 4

Skylight penetration.

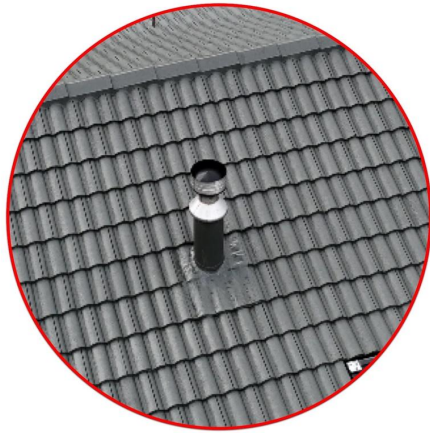
Photo 5

Flue penetration.

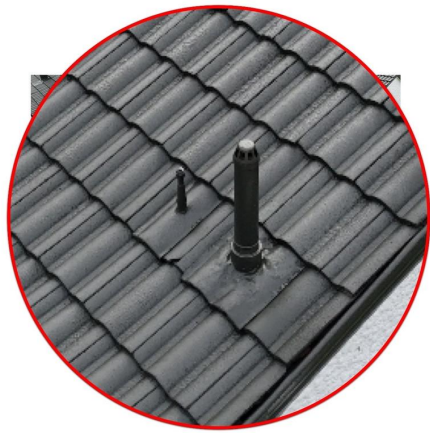
Photo 6

Vent pipe and overflow penetrations.

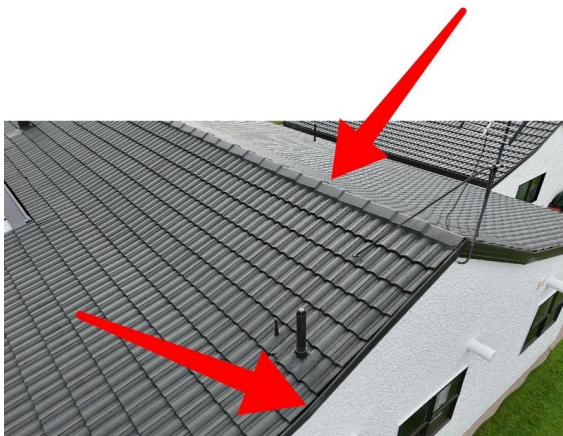
Photo 7

Ridge and barge flashings.

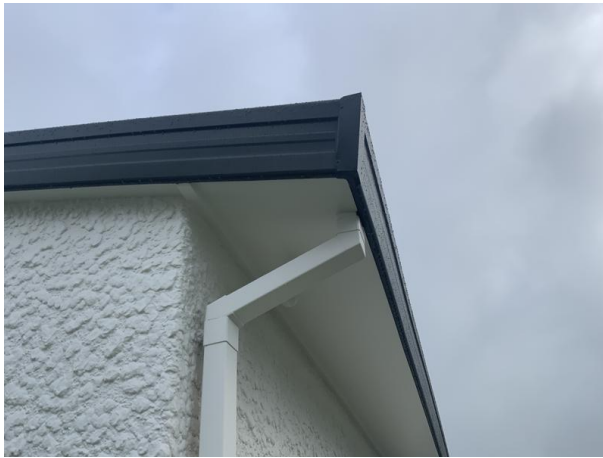
Photo 8

Gutter system, south east side. Note: this concealed gutter system, is the older type and has no overflows.

In addition to keeping the gutters clear, it is important to monitor the concealed gutter and fascia systems for any signs of leaks or failures. Mould or water stains on the soffits can be early

indicators of a problem. If you notice such signs, it is recommended to promptly investigate and address the issue to prevent further damage.

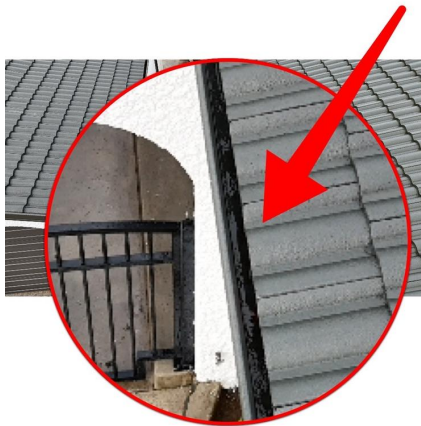
Photo 9

Gutter system, east side. Note: gutters clear at the time of inspection.

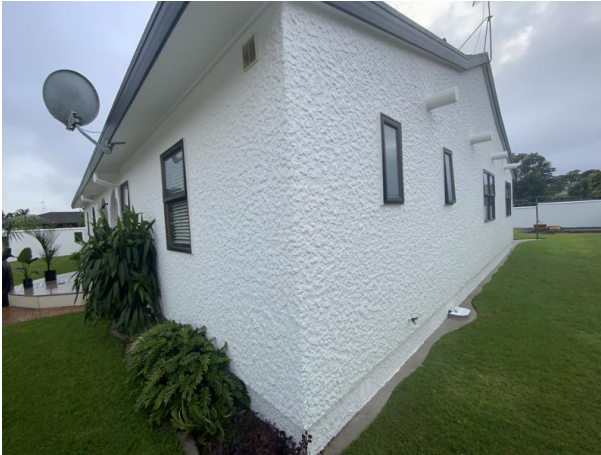
Photo 10

Fibrous cement sheet substrate direct fixed with stucco plaster finish and paint coating.

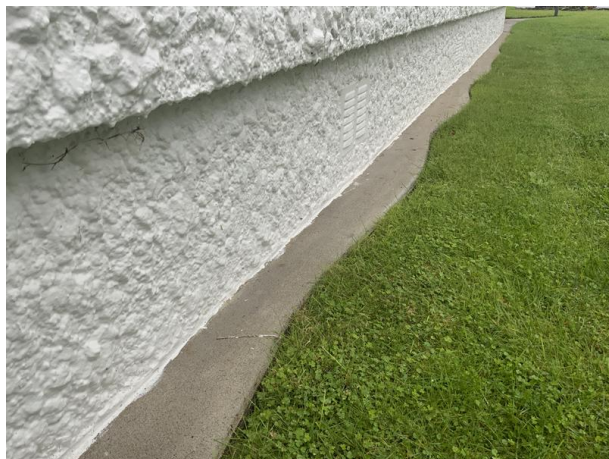
Photo 13

Fibrous cement sheet base cladding with vents, stucco plaster finish and paint coating.

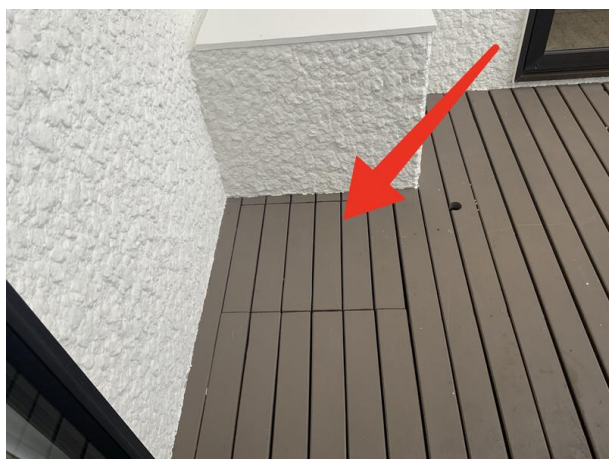
Photo 14

400 x 500mm access hatch to subfloor space, located on timber deck west side.

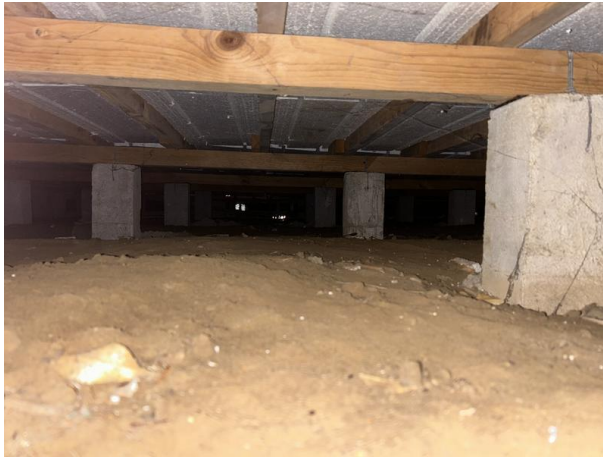
Photo 15

Sub-floor timbers, type and condition - Suspended timber floor. Untreated subfloor framing.

Suspended timber framed subfloor construction, precast concrete piles and polystyrene insulation.

It is recommended to install a ground moisture barrier over any exposed soil in the subfloor area. This barrier helps to reduce moisture levels, minimizing the risk of dampness, mold growth, and timber decay. Proper installation in accordance with best practices and building standards will improve overall subfloor ventilation.

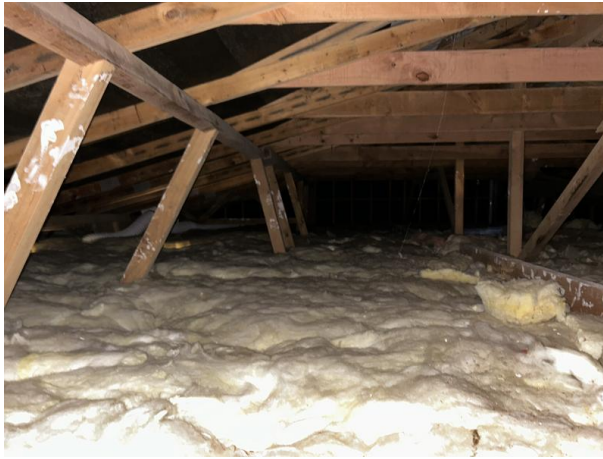
Photo 17

Pitched timber framed roof construction, bituminous paper and glass wool insulation.

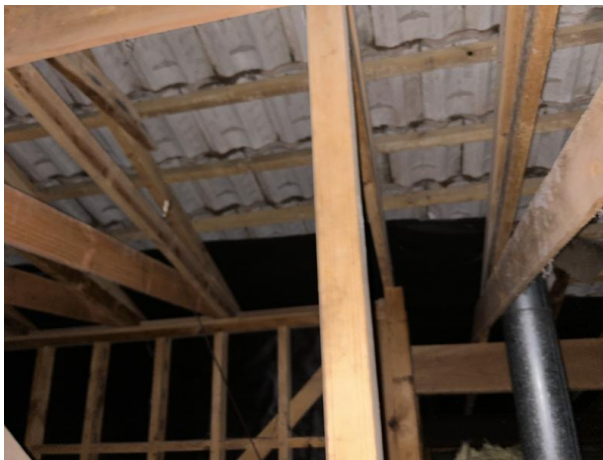
Photo 18

Roofing underlay - Bituminous self-supporting paper. Condition - Some roofing underlay missing.

Some areas missing bituminous paper roof underlay.

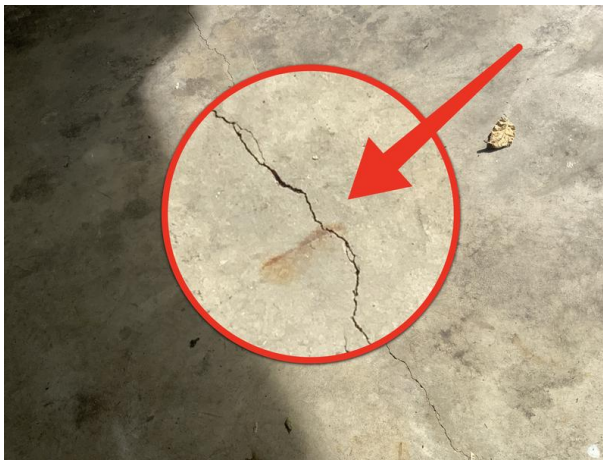
Photo 37

Cracking - Shrinkage cracking in concrete floors is common. Plastic shrinkage cracks are due to the too rapid loss of moisture from the surface of the concrete, e.g. during hot, dry and windy conditions. Thus, they are a form of drying shrinkage crack. Usually, they form without any regular pattern and may range from as little as 25mm to as much as 2m in length.

Shrinkage crack to concrete floor.

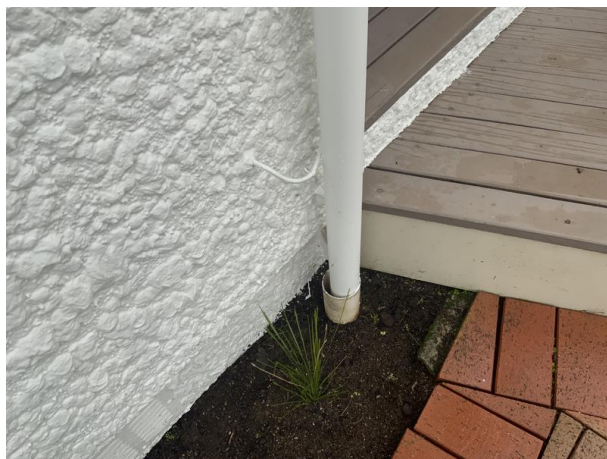
Photo 88

Downpipe and riser connection, west side.

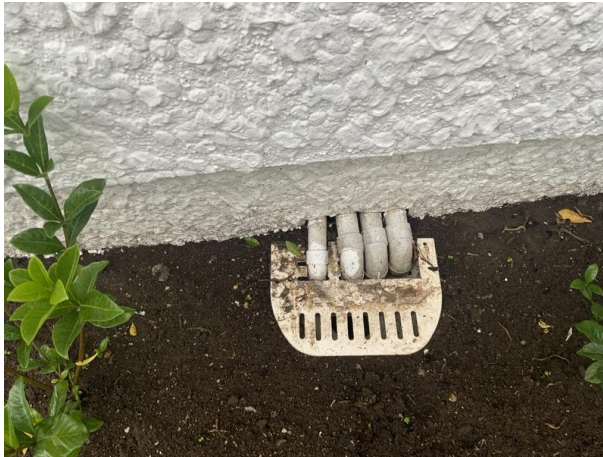
Photo 89

Gully trap drain, east side.

A deck may be built over a gully trap, but at least 600 mm of clear access space above the trap must be provided. This is for access to the gully trap for drainage inspections and maintenance in the event of blockages.

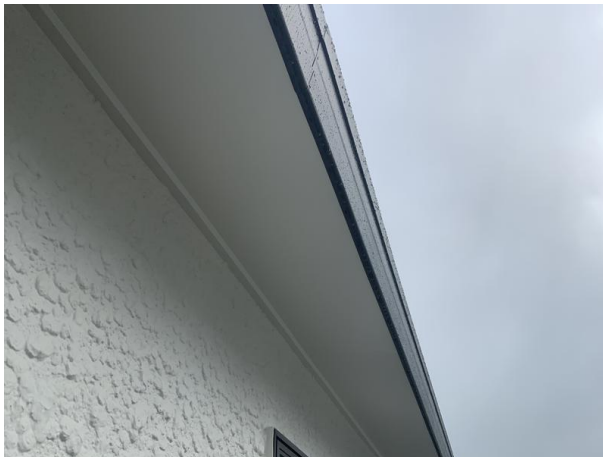
Photo 100

This product is non-friable, meaning when dry may not be crumbled, pulverised or reduced to powder by hand pressure (for example materials containing asbestos that have been mixed with cement or other hard bonding materials).

Fibrous cement sheet soffit.

Have this tested for asbestos before undertaking any invasive works, such as drilling, cutting or sanding.
