## RED LBP PRE-PURCHASE REPORT

# PRE-PURCHASE BUILDING REPORT

<b>Property Address</b>	6/674 Ranginui Road, Welcome Bay, Tauranga 3175
<b>Client</b>	Robbie & Rose Shaw
<b>Date of Inspection</b>	28th July 2025
<b>Time</b>	8:00 am
<b>Inspector</b>	Brennan Rapira National Certificate in Carpentry, Licensed Building Practitioner
<b>LBP Number</b>	138160
<b>People Present</b>	Inspector, Owner
<b>House Occupied</b>	Yes

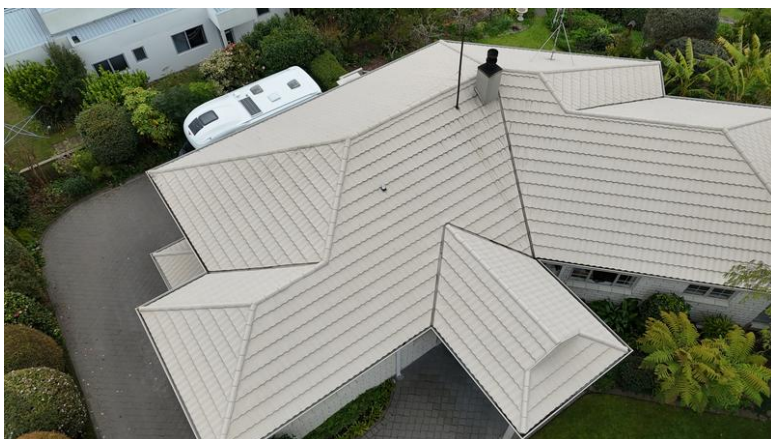
**Photo 3**

Pressed metal tile hip roof construction with nail fixings.

Considering the age of the roof, it appears to be in a maintainable condition. To preserve its condition and extend its lifespan, it is recommended to prioritise the maintenance of the paint coating. This should be undertaken in the near future.

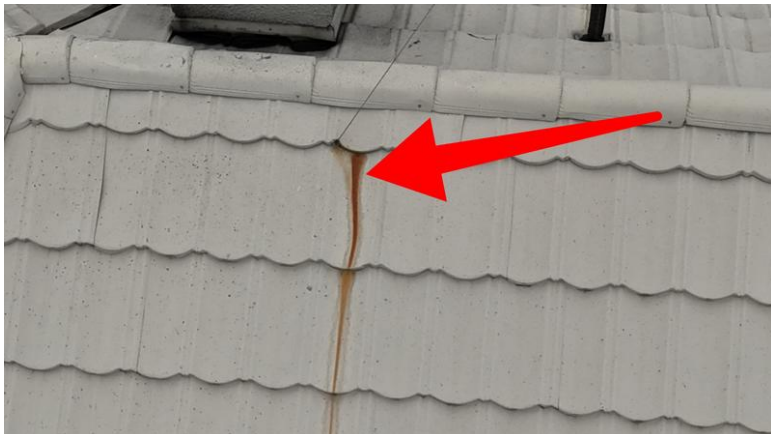
**Photo 4**

Rust stain visible, north side.

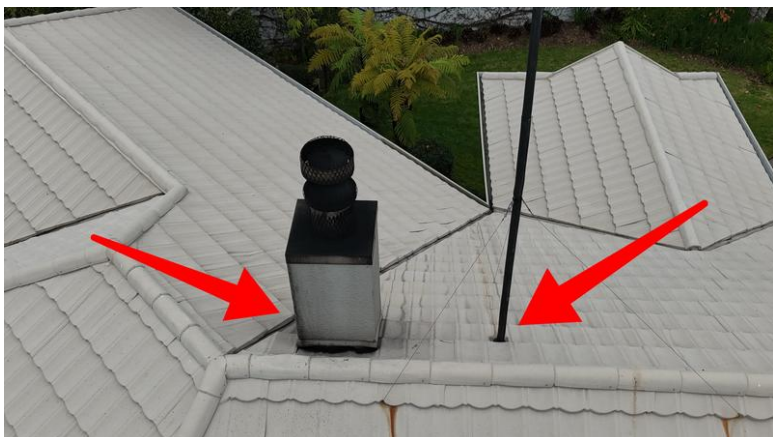
**Photo 5**  
Overflow and chimney/ flue penetrations.

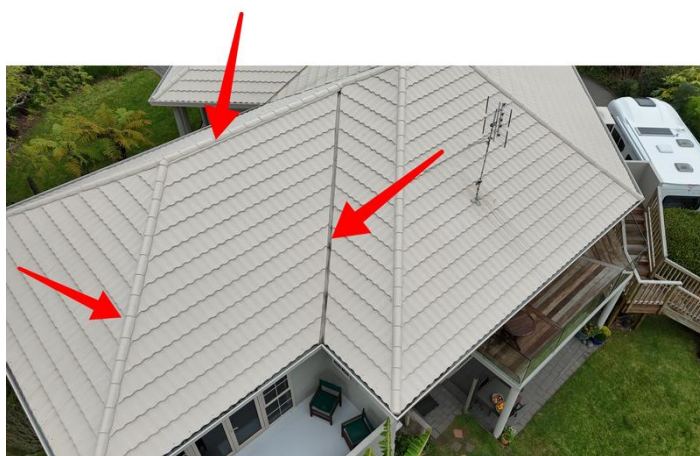
**Photo 6**  
Ridge, hip and valley flashings.

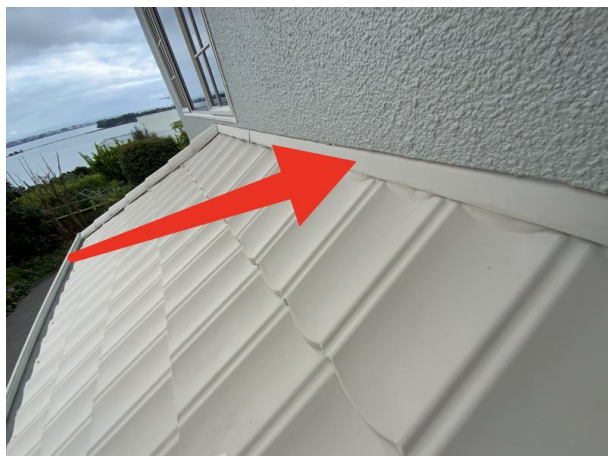
**Photo 7**  
Apron flashing.

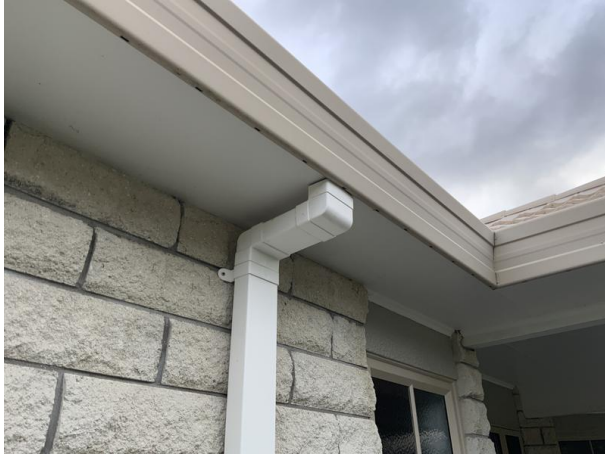
**Photo 8**

Profiled metal concealed gutter system, fibrous cement sheet soffit and PVC downpipe, south side.

In addition to keeping the gutters clear, it is important to monitor the concealed gutter and fascia systems for any signs of leaks or failures. Mould or water stains on the soffits can be early indicators of a problem. If you notice such signs, it is recommended to promptly investigate and address the issue to prevent further damage.

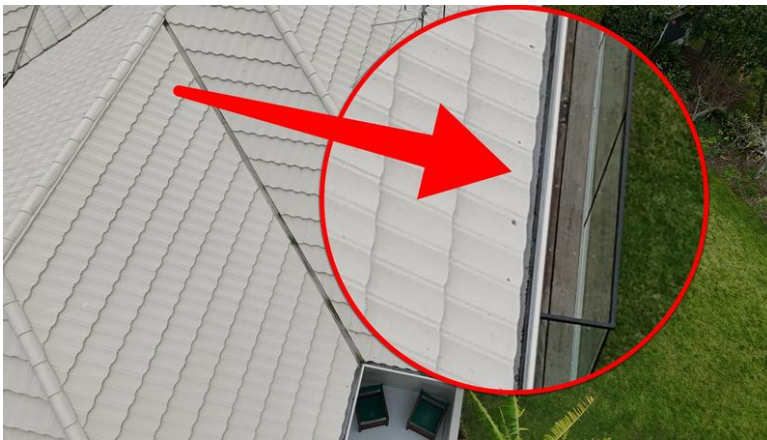
**Photo 9**

Gutter system south side, clear at the time of inspection.

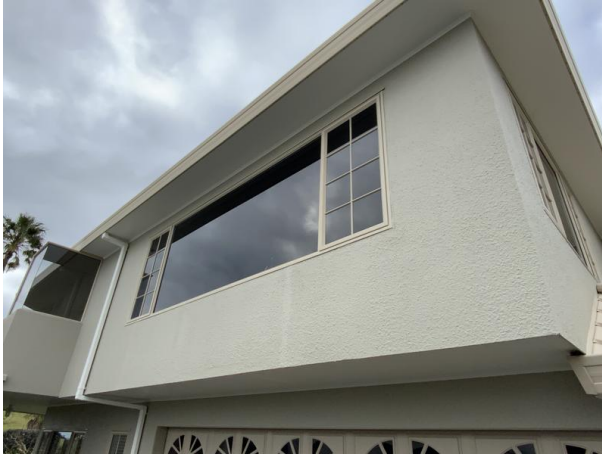
**Photo 11**  
Plaster cladding system with paint coating, north side.

It is recommended to regularly maintain the painted surfaces, in accordance with the manufacturer's recommendations for the specific cladding type, is essential to preserving weathertightness. Proper upkeep helps protect the cladding from environmental exposure, prevents deterioration, and ensures the building's exterior remains effective at repelling moisture.

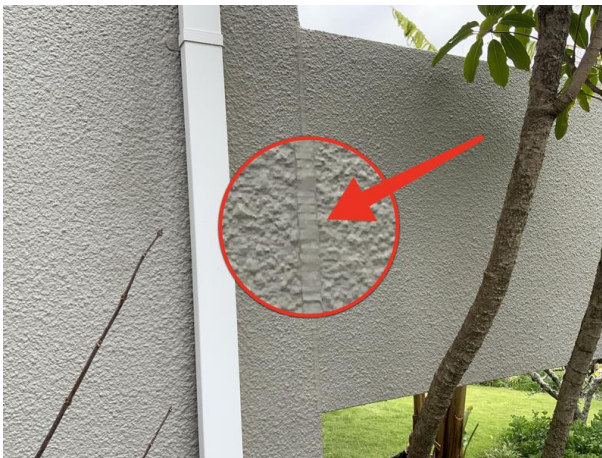
**Photo 12**  
Control joint for membrane deck handrail connection, east side.

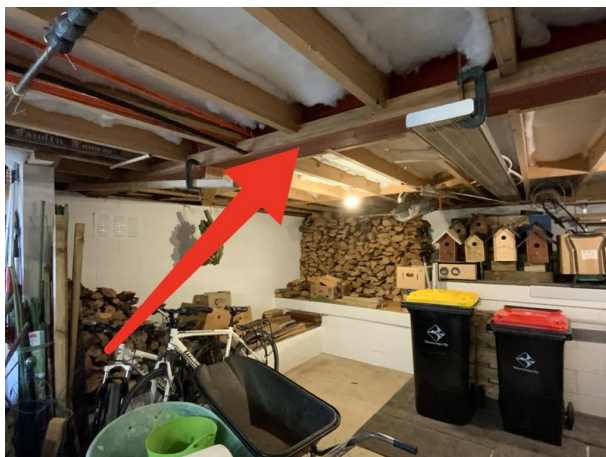
**Photo 13**

Masonry block perimeter foundation, suspended timber subfloor construction and polyester insulation. Note: engineered steel beam support visible.

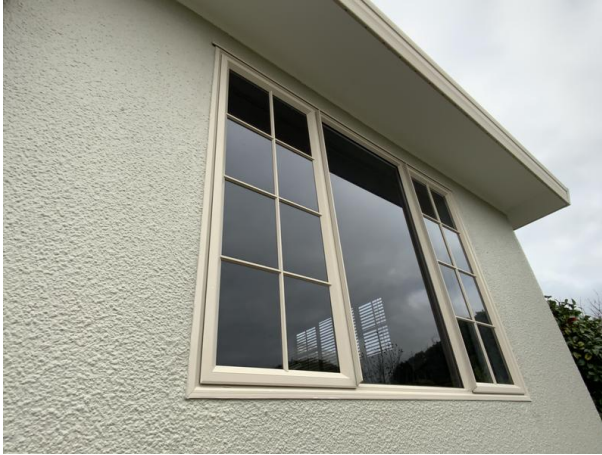
**Photo 16**

Single glazed powder coated aluminium joinery, located west side. Note: joinery is completely sealed to the cladding system.

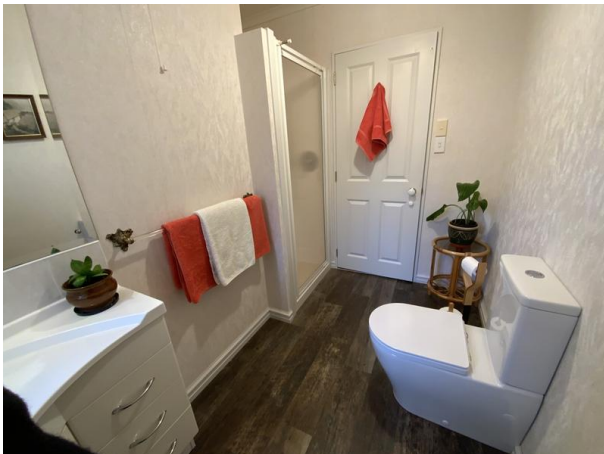
**Photo 26**  
Bathroom.

There is no externally vented mechanical ventilation system installed in the bathroom. It is recommended to install a suitable system for the rooms requirements.

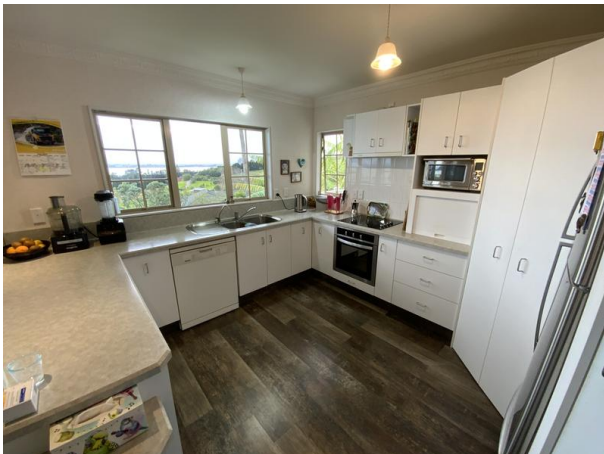
**Photo 31**  
Kitchen.

There is no externally vented system installed in the kitchen. It is recommended to install a suitable system for the rooms requirements.

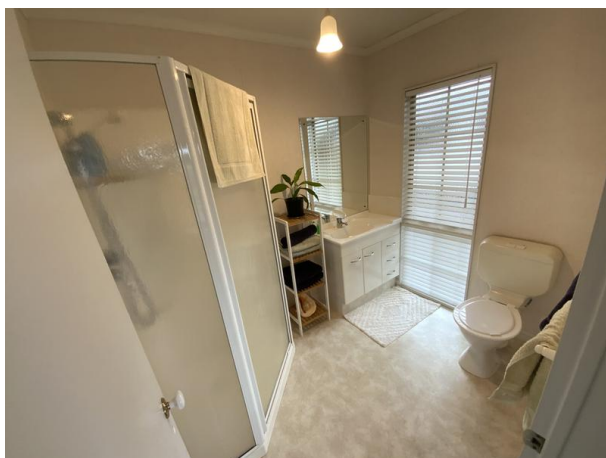
**Photo 41**  
Ensuite, bedroom 3.

There is no externally vented mechanical ventilation system installed in the ensuite. It is recommended to install a suitable system for the rooms requirements.

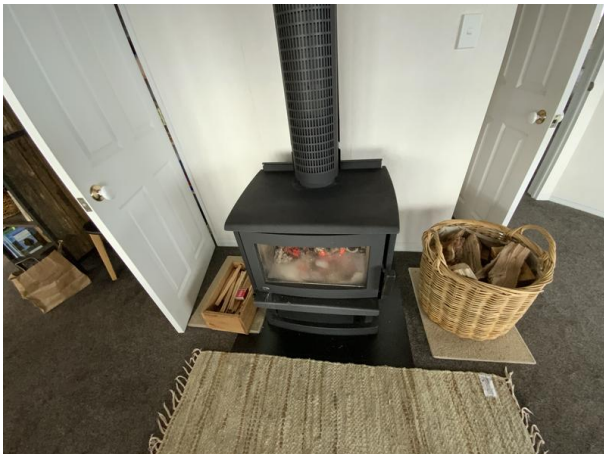
**Photo 60**

Solid fuel burner, located in living room.  
Note: this has wet back connection.

It is recommended to have the wood burner flue professionally cleaned and inspected annually to ensure safe and efficient operation. Regular maintenance helps to prevent the buildup of creosote, which can pose a fire hazard, and ensures that the flue remains clear of obstructions that could affect ventilation. An annual inspection also allows for the early detection of any damage or wear that may require repairs, prolonging the lifespan of the system and maintaining compliance with safety regulations.
