## **BUILDING CONDITION ASSESSMENT REPORT**

Date of Assessment: 20 October 2025

Subject property: 40 Margaret Drive, Omokoroa

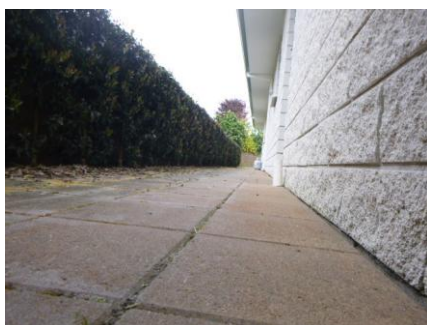
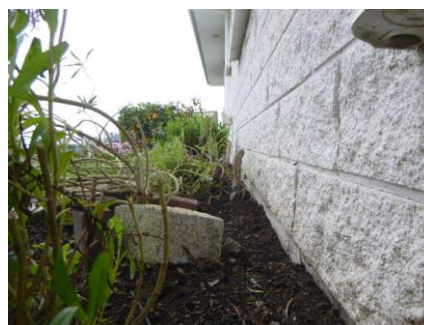
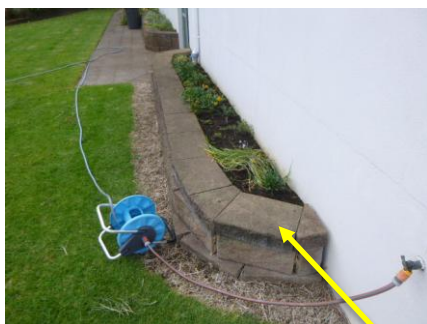
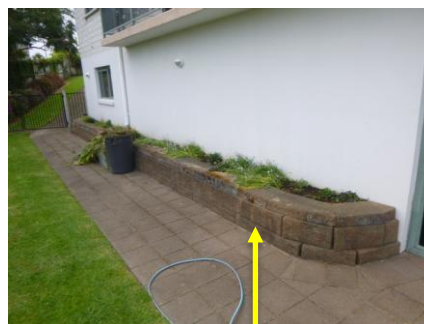
| FOUNDATION AND FLOOR | |
|---|---|
| <b>Comments:</b><br><br><i>The current Acceptable Solution requirement of the Building Code requires that a concrete floor to ground dimension with brick veneer be 150 mm to unpaved and 100 mm to paved surfaces and cladding other than brick veneer be 225 mm to unpaved and 150 mm to paved surfaces. This dwelling generally satisfies this requirement, see photos below. However, we recommend that the raised gardens adjacent to the basement garage and rumpus room be lowered or moved away from the cladding, see photos below.</i> | |

*The clearance between the interior floor level and ground is generally good however we recommend that the raised gardens be lowered or moved off the cladding*

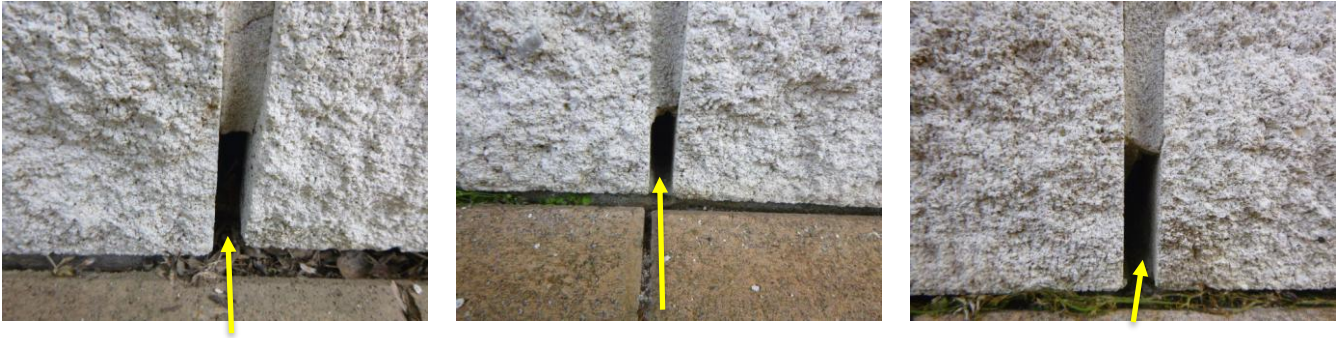
*Note the open vertical perpendicular joints to the bricks that assist the cavity system to drain and ventilate as required*

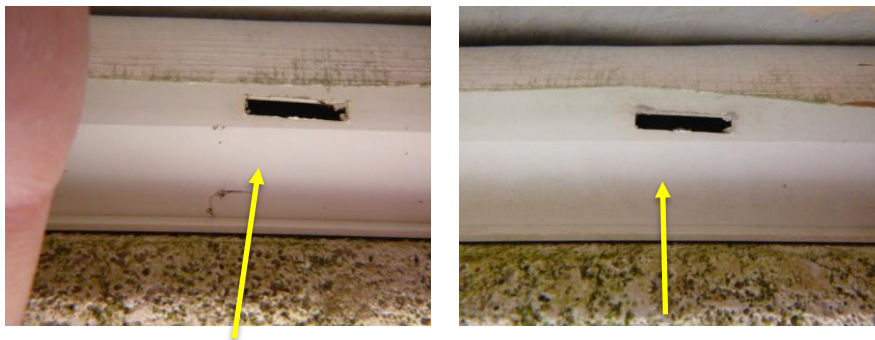
*Note the cavity closure strips to the plaster over lightweight aerated concrete panels that allow the cavity to drain and ventilate as required*

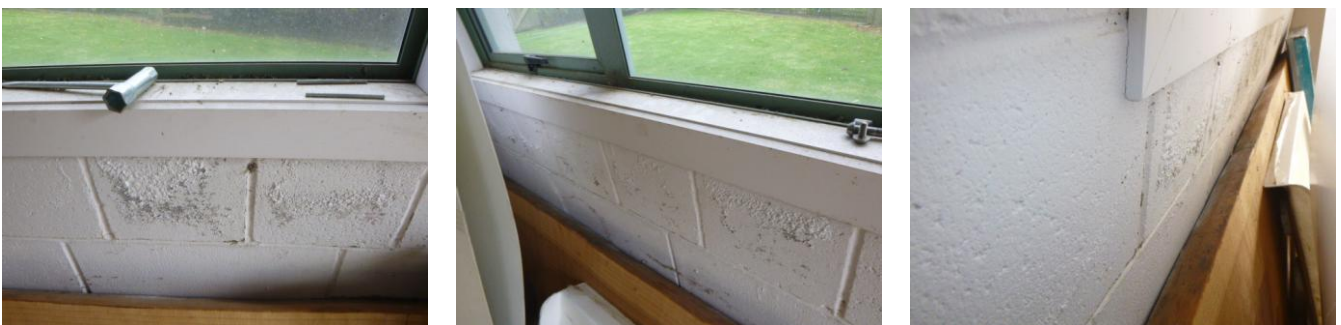
*Efflorescence was evident below the basement garage window as seen in these examples*

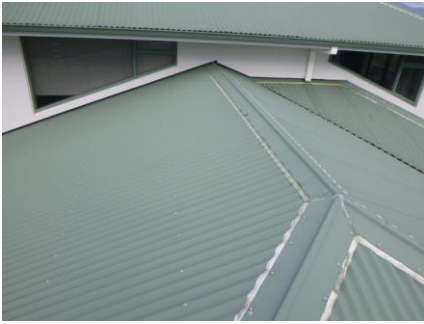
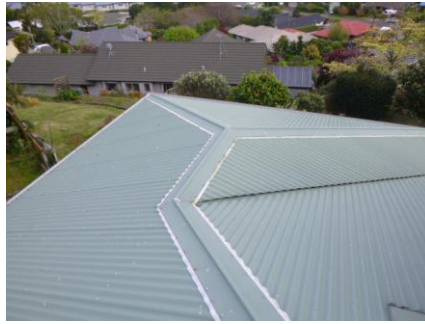
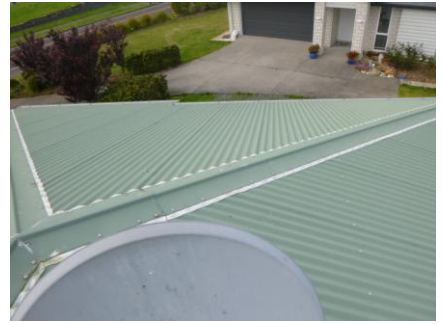
*The roof installed to this dwelling is generally in good visual condition for its age*

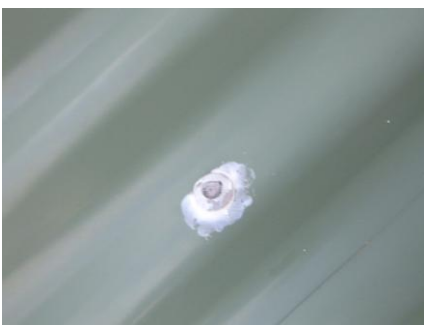
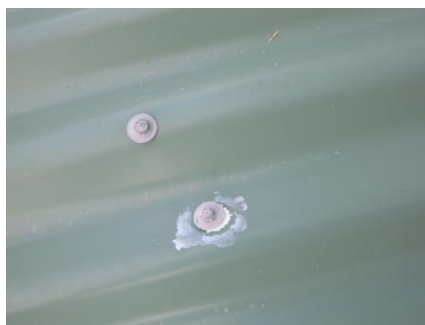
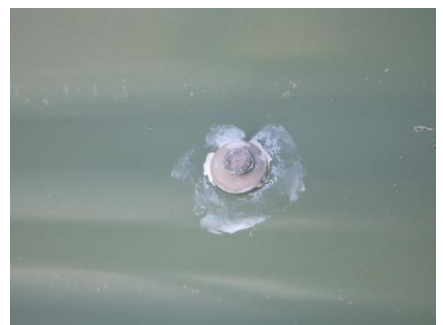
| ROOF | |
|---|---|
| <p><b>Comments:</b></p> <p><i>On the day of our inspection silicone was evident around some roof fixings, see photos below. Silicone is not regarded as being a long-term repair solution therefore future leaks cannot be ruled out.</i></p> <p><i>The roof to this dwelling appears to be in good condition for its age however it would be beneficial for the roof if the lichen were removed as lichen can hold moisture that can lead to premature deterioration of the roof.</i></p> <p><i>Regular inspections of the roof should be made by the owner of the property (or a suitably qualified person using approved safety equipment) to inspect the overall condition of the roof fixings and any flashings that have been used on the roof as the sun can deteriorate flashings (especially rubber flashings) that are used around roof penetrations at a fast rate.</i></p> | |

*Note these photo examples of the silicone use to some roof fixings*

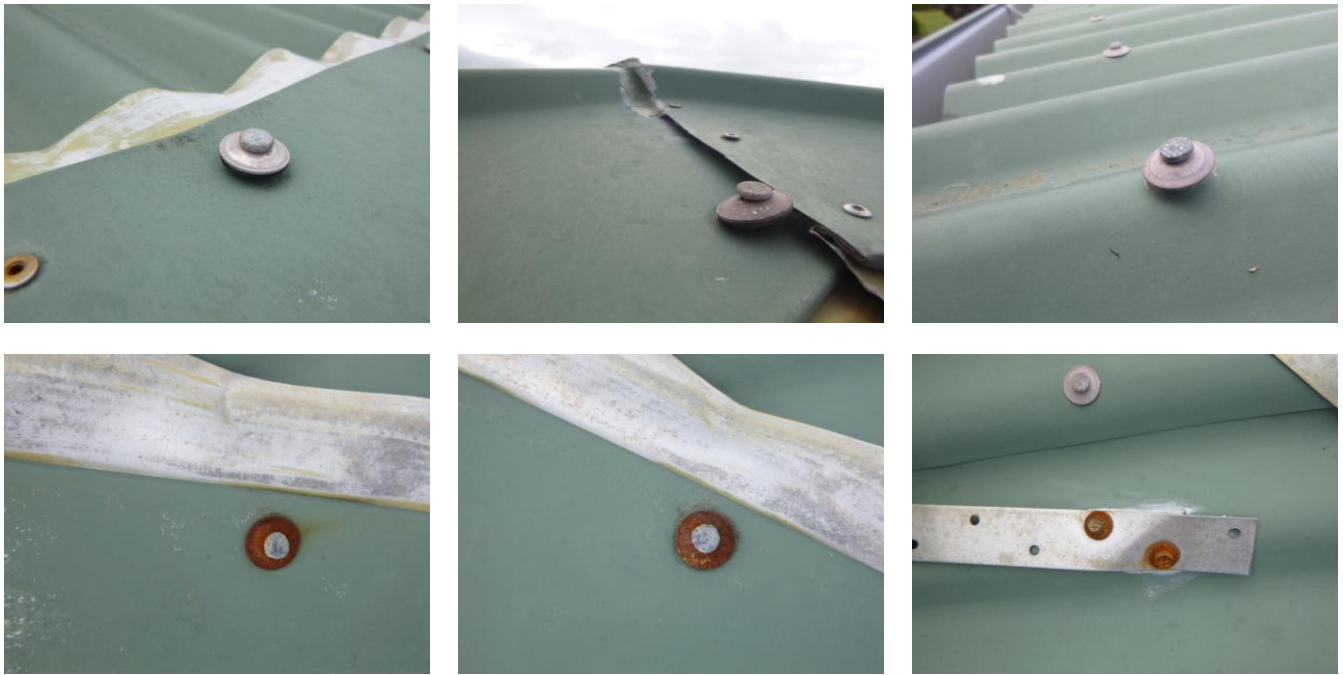
| ROOF | |
|---|---|
| <b>Original or replacement</b> | It appears to be the original roof. It is advisable with old roofs to replace any current loose, corroded or damaged roof fixings and monitor them over time as they may allow exterior water entry into the roof space below, which in turn can cause damage to the roof framing or ceiling below. Some loose and corroded fixings (and missing flashings rivets) were evident on the day of our inspection, see photos below. |

*Some loose and corroded fixing were noted on the day of our inspection as seen in these examples*

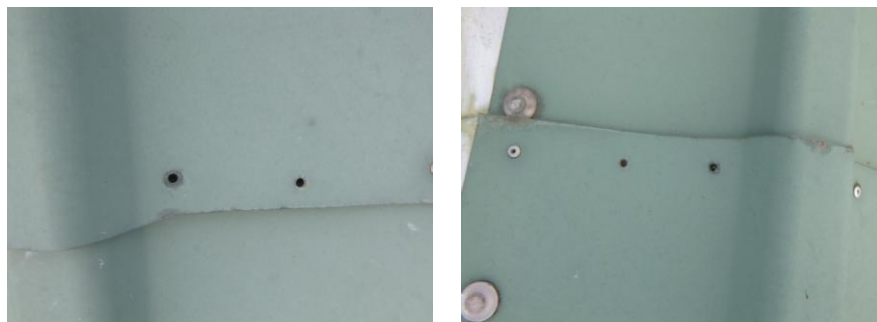
*Note the missing rivets from some of the roof flashings*

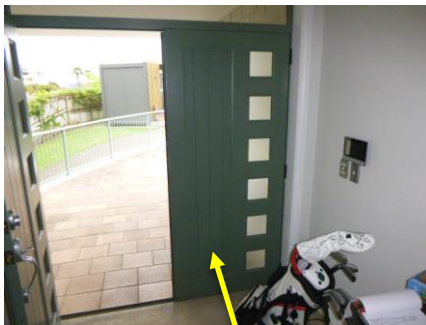
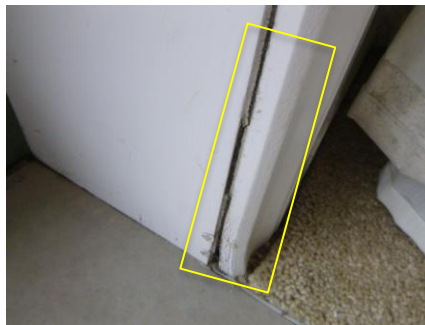
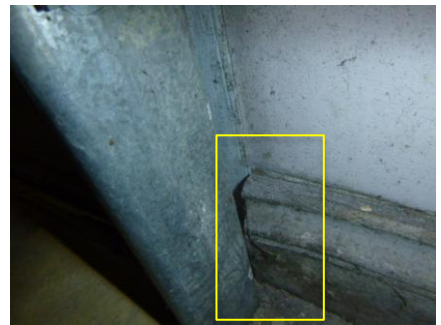
| <b>Comments:</b><br><br><i>Regular inspections and maintenance should be performed to all joinery units so that they continue to operate as intended. We did note swelling to areas of the timber trim around some joinery units and the double garage door therefore we recommend that these be monitored, see photos below.</i> | |

*This entry door seen in the left-hand photo would benefit from some adjustment. In the middle and right-hand photos are examples of the swelling to areas of the timber trim.*

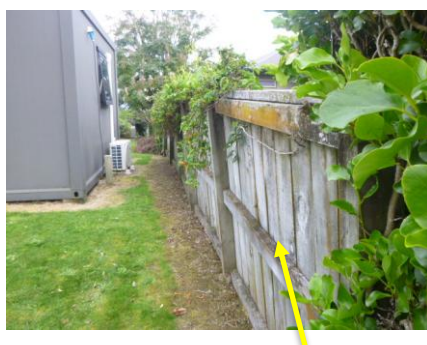
*On the day of our inspection some movement was evident to the timber boundary fence to the right-hand side of the driveway therefore monitoring this fence is recommended, see photo below.*

*On the day of our inspection there were signs of movement to this fence*

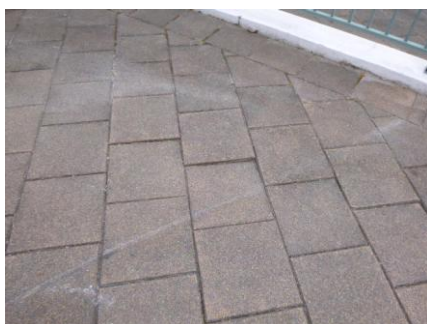
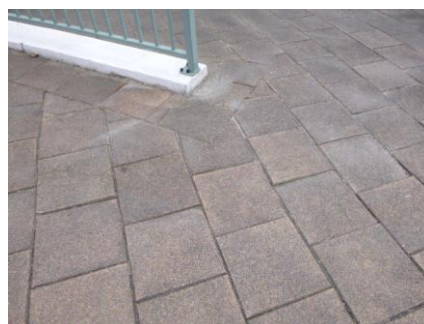
| PATHS AND DRIVEWAY | |
|---|---|
| <b>Comments:</b><br><br><i>On the day of our inspection, some unevenness was noted areas of the driveway paving, see photos below. These may be potential tripping hazards therefore caution should be taken when using these areas.</i> | |

*Note the unevenness to these pavers*

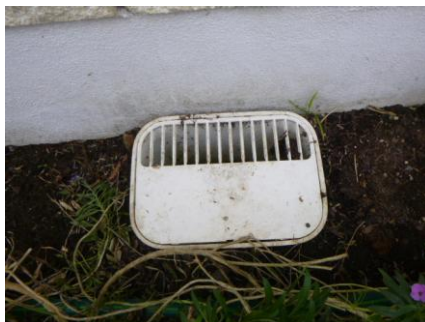
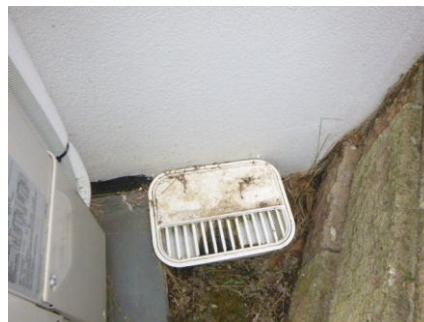
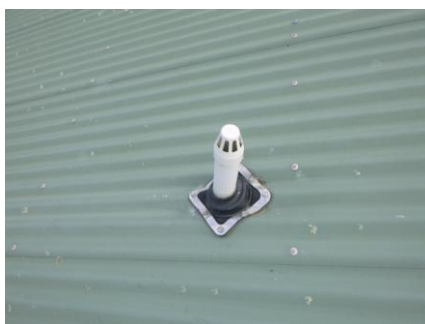
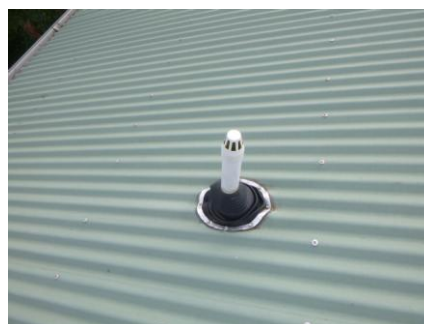
*These gulley traps have been installed at the correct height above the ground to prevent surface water entry and the terminal vent pipes are bird proofed as required*

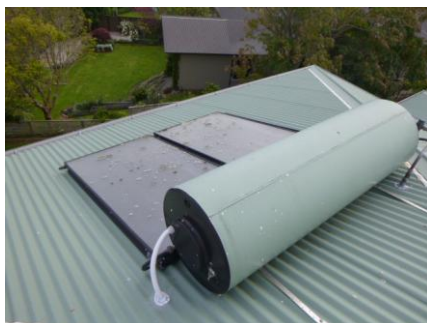
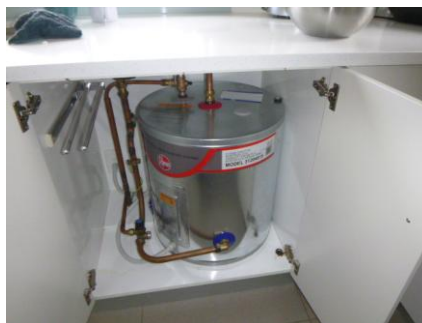
And an under-bench kitchen October 2023 43 litre electric indoor hot water mains pressure cylinder visually in good condition at the time of our inspection however it is **not** seismically restrained as required. Installing two seismic restraints to the hot water cylinder is advisable for earthquake reasons and this was a Building Code requirement at the time that the cylinder was installed. Both seismic restraints must be installed **within 100 mm from the top and bottom** of the cylinder to be effective and comply. (BRANZ Bulletin 529)

*On the day of our inspection there were no leaks evident to the hot water cylinders and note that the under-bench cylinder is not seismically restrained as required*

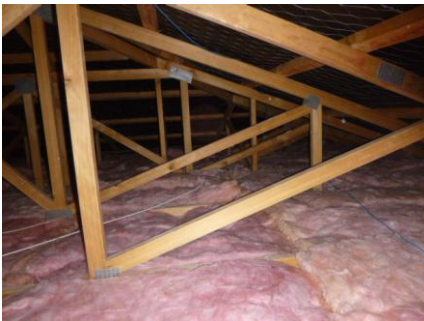
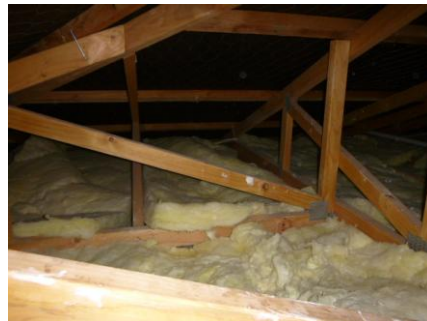
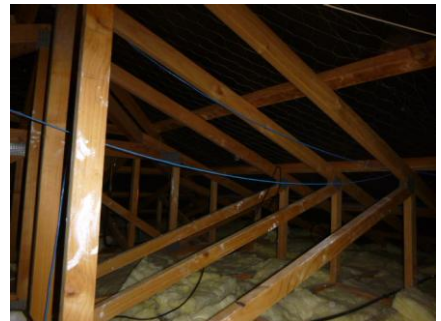
*Where visible the roof cavity was dry and insulated on the day of our inspection*

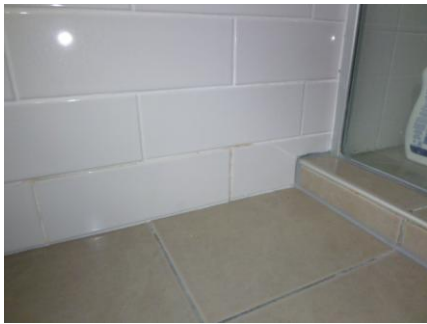
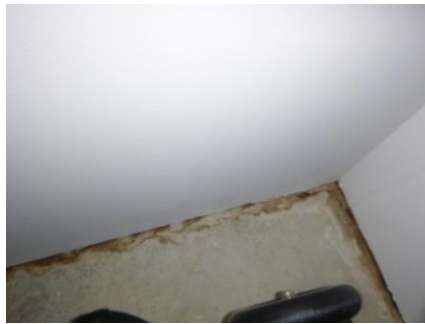
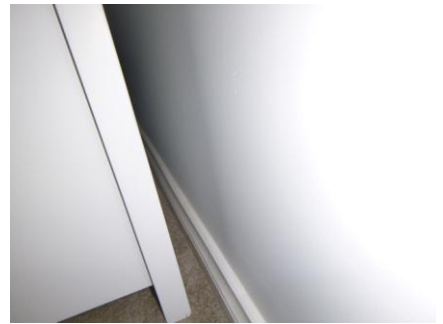
| Page No. | Brief description |
|---|---|
| 22/24 | High moisture content readings (and visual signs) to the walls around the bathroom shower |

*On the day of our inspection high hand held non-invasive moisture meter readings (and visual signs) were evident to the interior of this dwelling to the walls around the bathroom shower. All other hand held non-invasive moisture meter readings taken to the interior of this dwelling were regarded as being 'within normal tolerances'.*

*High moisture content readings (and visual signs) were evident to the walls around the bathroom shower*

*Further investigation will be required to the above areas to determine if there is any damage to the framing timber and also to try and determine the cause of the higher than usual moisture readings. This will most likely involve the removal of some of the interior wall linings so that a visual inspection can occur. We are suitably qualified to perform this investigation if required.*

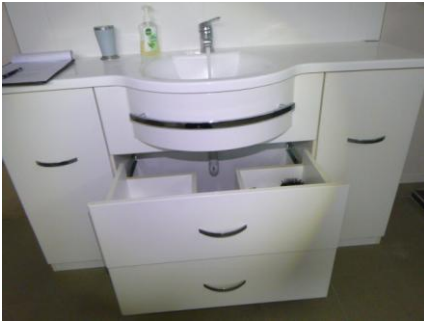
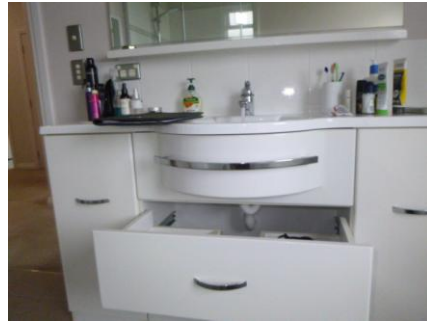
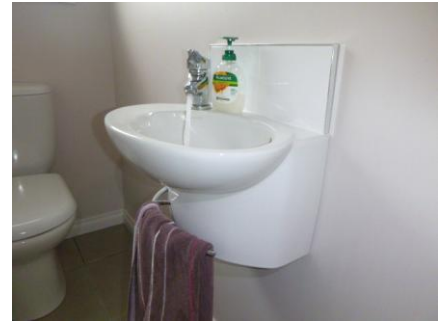
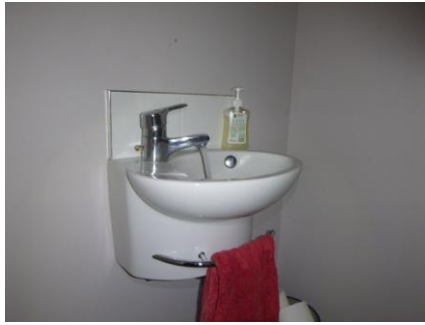
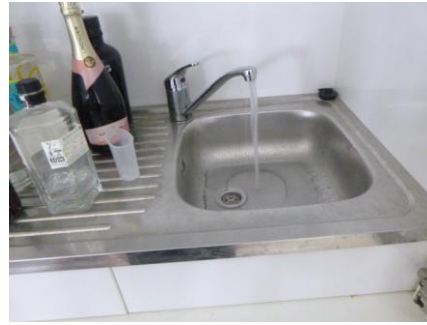
*On the day of our inspection there were no current leaks evident to these vanity units*

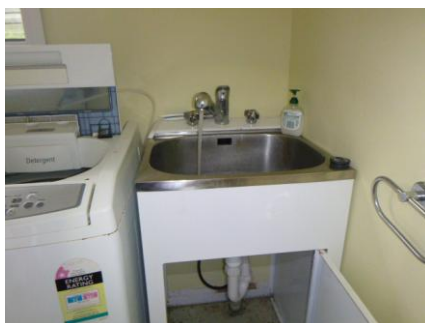
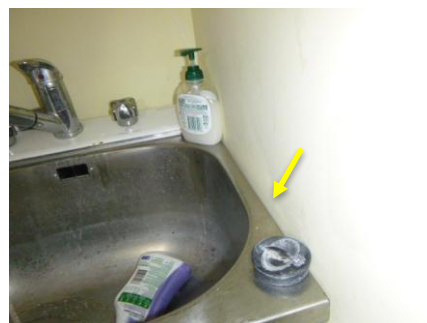
*On the day of our inspection there were no current leaks evident to the laundry tub. Sealing the tub to the wall as indicated in the right-hand photo is advisable.*

| LAUNDRY | |
|---|---|
| <b>Comments:</b><br><i>Sealing the right-hand side of the laundry tub to the wall is recommended for waterproofing reasons</i> | |

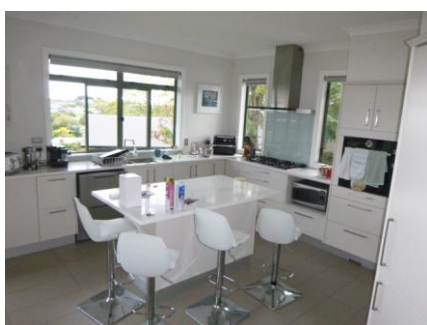
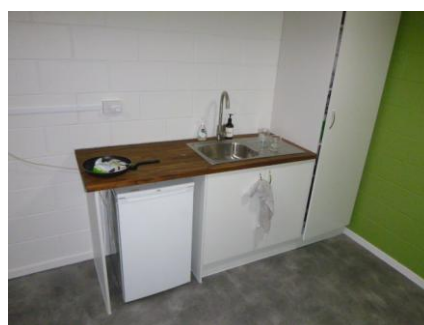
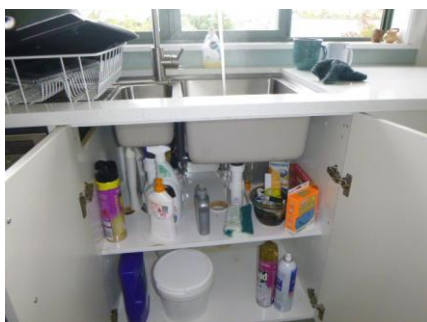
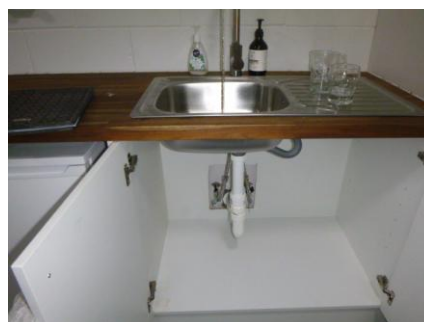
*On the day of our inspection there were no current leaks evident to the kitchen sink inserts*
