62 Links View Drive  
Omokoroa

# Property Inspection Report

**INSPECTION OF** 62 Links View Drive, Omokoroa

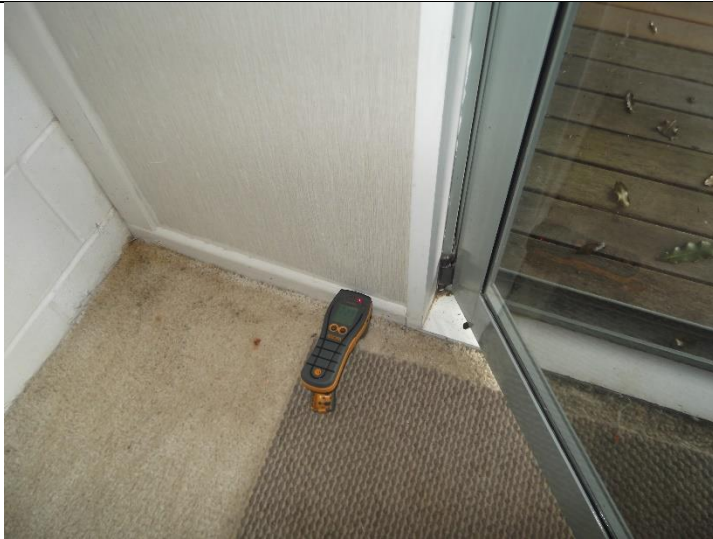
| AREA | ITEM | A | B | C | D | R | UR | COMMENTS |
|---|---|---|---|---|---|---|---|---|
| | Moisture | | | | ✓ | | | High reading to the left of door just above skirting |

A high moisture reading was found beside the door in the workshop downstairs. The decking is close to the cladding and this could cause a build up of moisture over time.

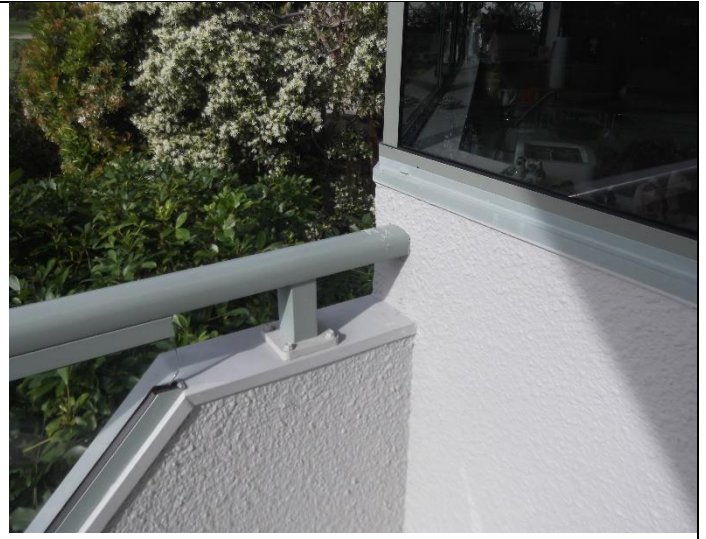
Not a good building practice to run a balustrading directly into the cladding. The ballustrade is well capped with a powder coated flashing

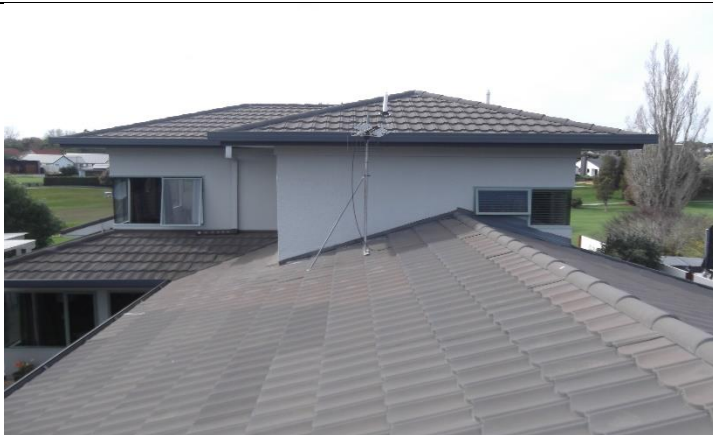
The pressed metal tiles are generally in good condition

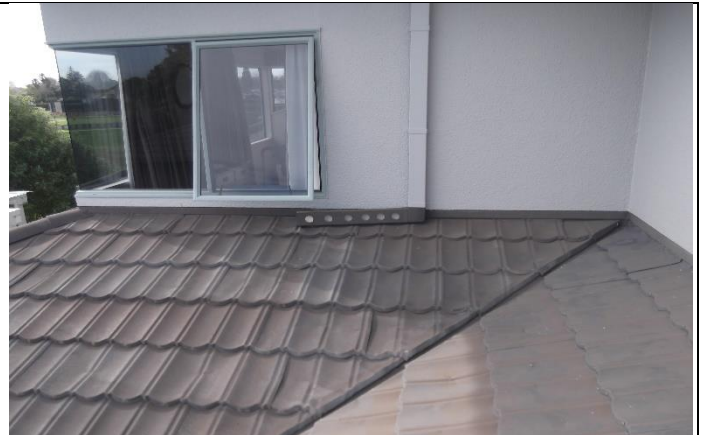
| AREA | ITEM | A | B | C | D | R | UR | COMMENTS |
|---|---|---|---|---|---|---|---|---|
| ROOF | Material | | | ✓ | | | | Pressed metal colour steel tiles. Some minor damage |
| Comments: Most of the roof is in good condition with some dents and colour loss. | | | | | | | | |

Some of the roof tiles are losing their colour and there are several dents from careless tradesmen.

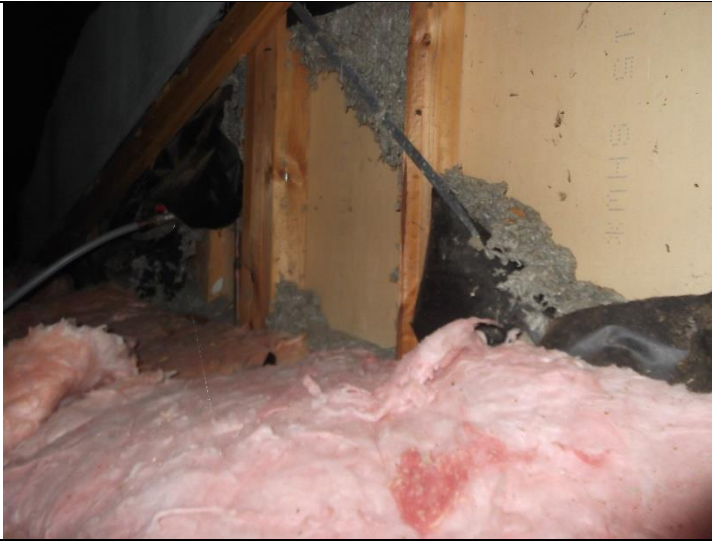
| AREA | ITEM | A | B | C | D | R | UR | COMMENTS |
|---|---|---|---|---|---|---|---|---|
| Comments: Missing insulation above laundry on upstairs shower wall. | | | | | | | | |

Insulation dropped out of wall above the laundry. This is the upstairs shower wall.

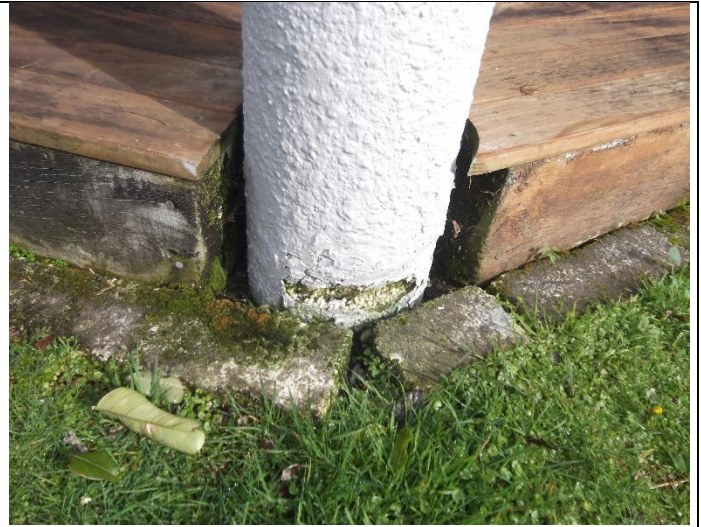
Damage to base of poles possibly by weed eater. Plaster repair required

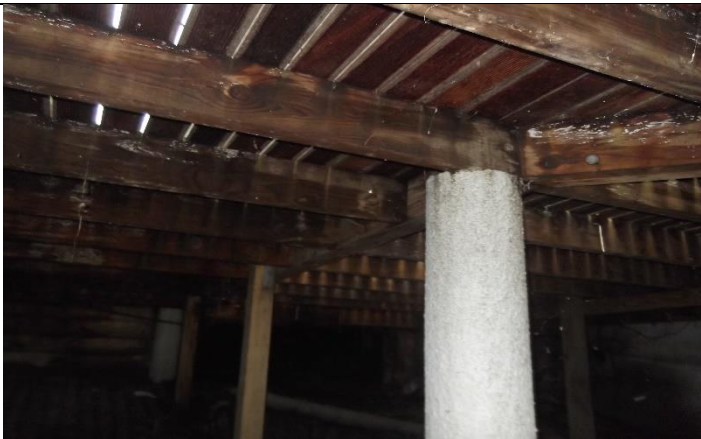
Underside of deck showing sub floor framing

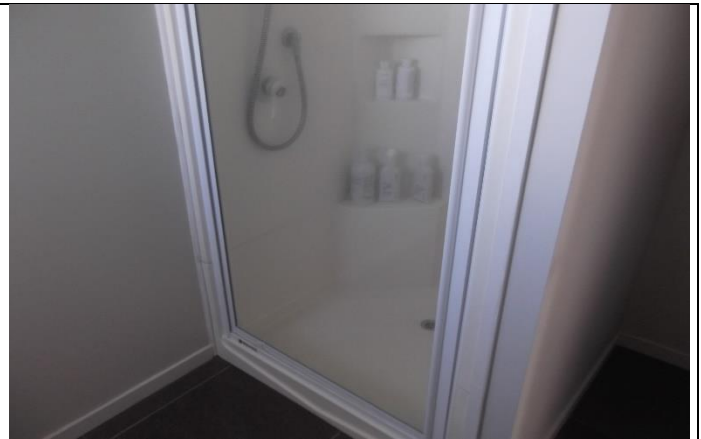
| AREA | ITEM | A | B | C | D | R | UR | COMMENTS |
|---|---|---|---|---|---|---|---|---|
| Comments: Omokoroa has a problem with high amounts of silica in the water. This damages fittings and fittings and leaves a white film on tiles | | | | | | | | |

The high silica content in Omokoroa water leaves a residue on shower fittings and fixtures.

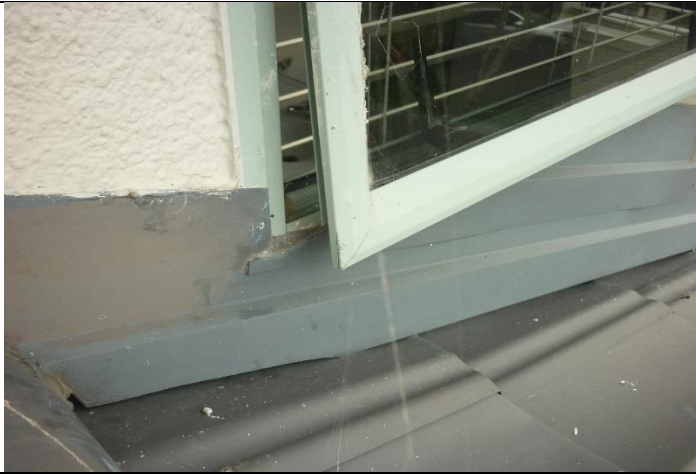
Unusual flashing on upstairs bathroom window

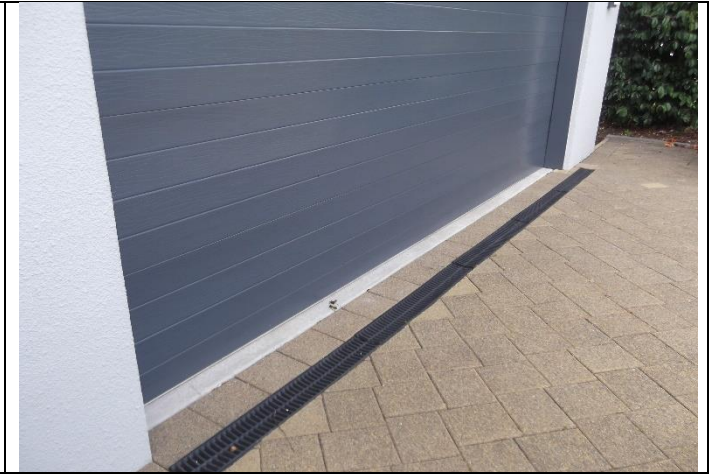
Good collection drain on garage door entrance

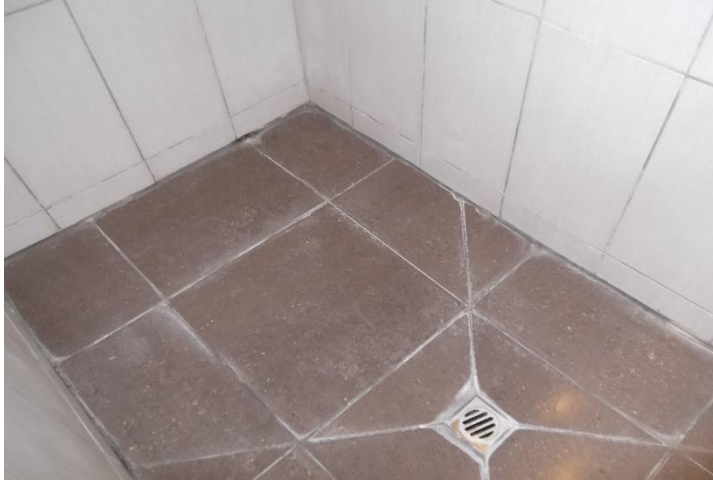
| AREA | ITEM | A | B | C | D | R | UR | COMMENTS |
|---|---|---|---|---|---|---|---|---|
| | Shower | | | ✓ | | | | Crout needs cleaning / replacing around bottom of tiles and there are signs of silica residue. |

Grout needing repair and silica residue on tiles and grout

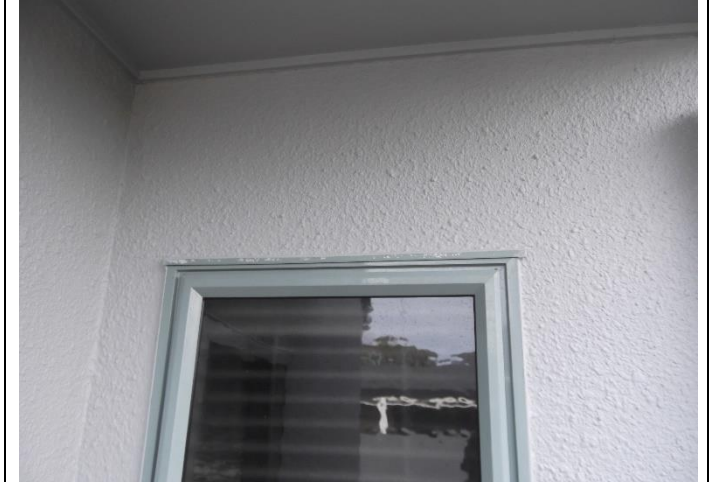
Correct flashings in place. Well maintained cladding

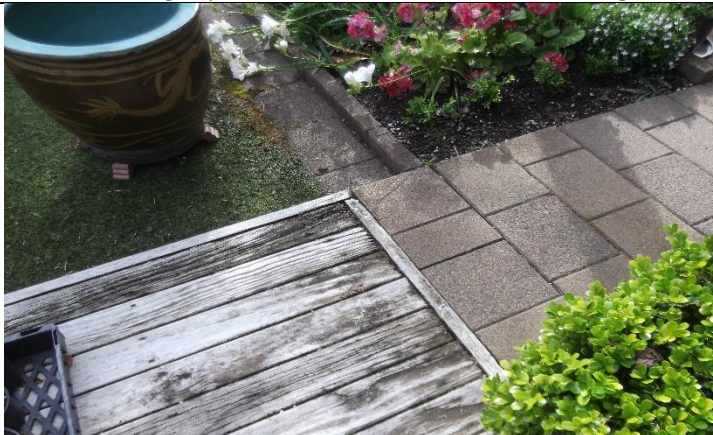
| AREA | ITEM | A | B | C | D | F | UR | COMMENTS |
|---|---|---|---|---|---|---|---|---|
| Comments: There is some repair or replacing needed to deck areas. Low to ground in places so couldn't see timber. | | | | | | | | |

Some decking boards worn and will need repair

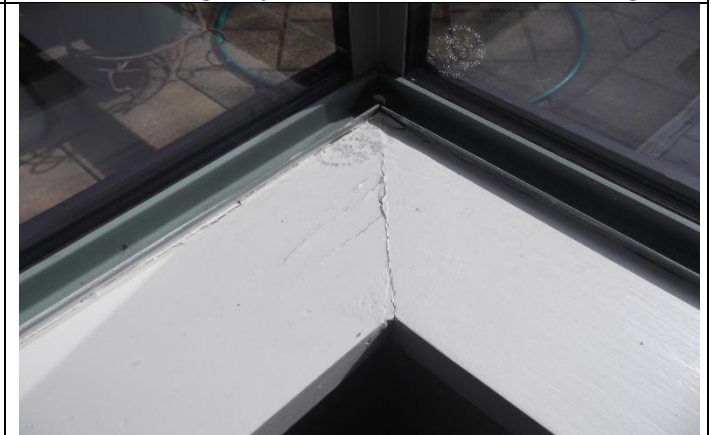
Minor painting required on some window sills
