**Inspector Homes Limited**

## **Building Inspection Report on...**

**19 Bramley Drive, Omokoroa**

## CERTIFICATE OF INSPECTION IN ACCORDANCE WITH NZS 4306:2005 Standard Residential Property Inspection

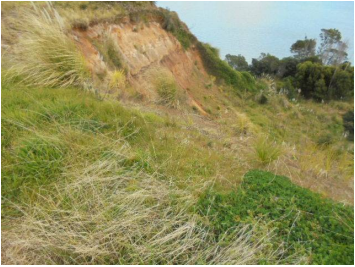
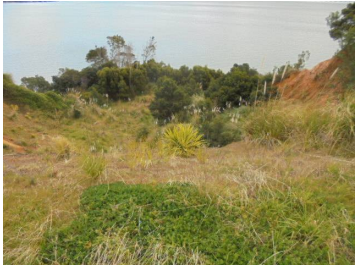
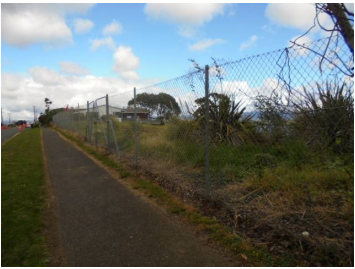
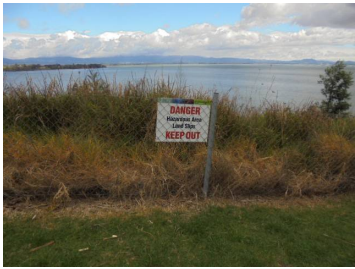
We do note some historical (but serious) landslips on adjacent properties and strongly recommend investigating the history, existing Geotech Reports and any proposed predictions and/or remedies associated with the slips.

Photos of neighbouring property slip damage for  
your info.

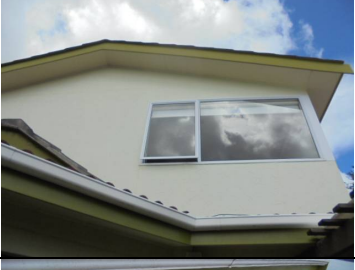
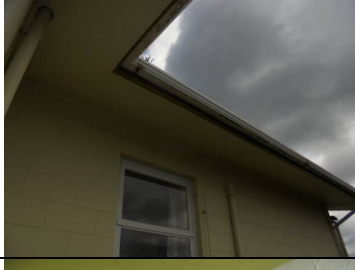
The exterior of the blockwork and the plastered upper floor cladding and are in generally functional condition but coming due for repainting; the plastered fibre cement sheet upper floor cladding has some cracking to the sheet joins and these should be ground out, sealed and re-plastered prior to repainting. The window joinery is in good and functional condition for its age; easing to some window sashes is recommended.

| | Sheet joins to upper floor plaster cladding need repairs and maintenance prior to repainting | |

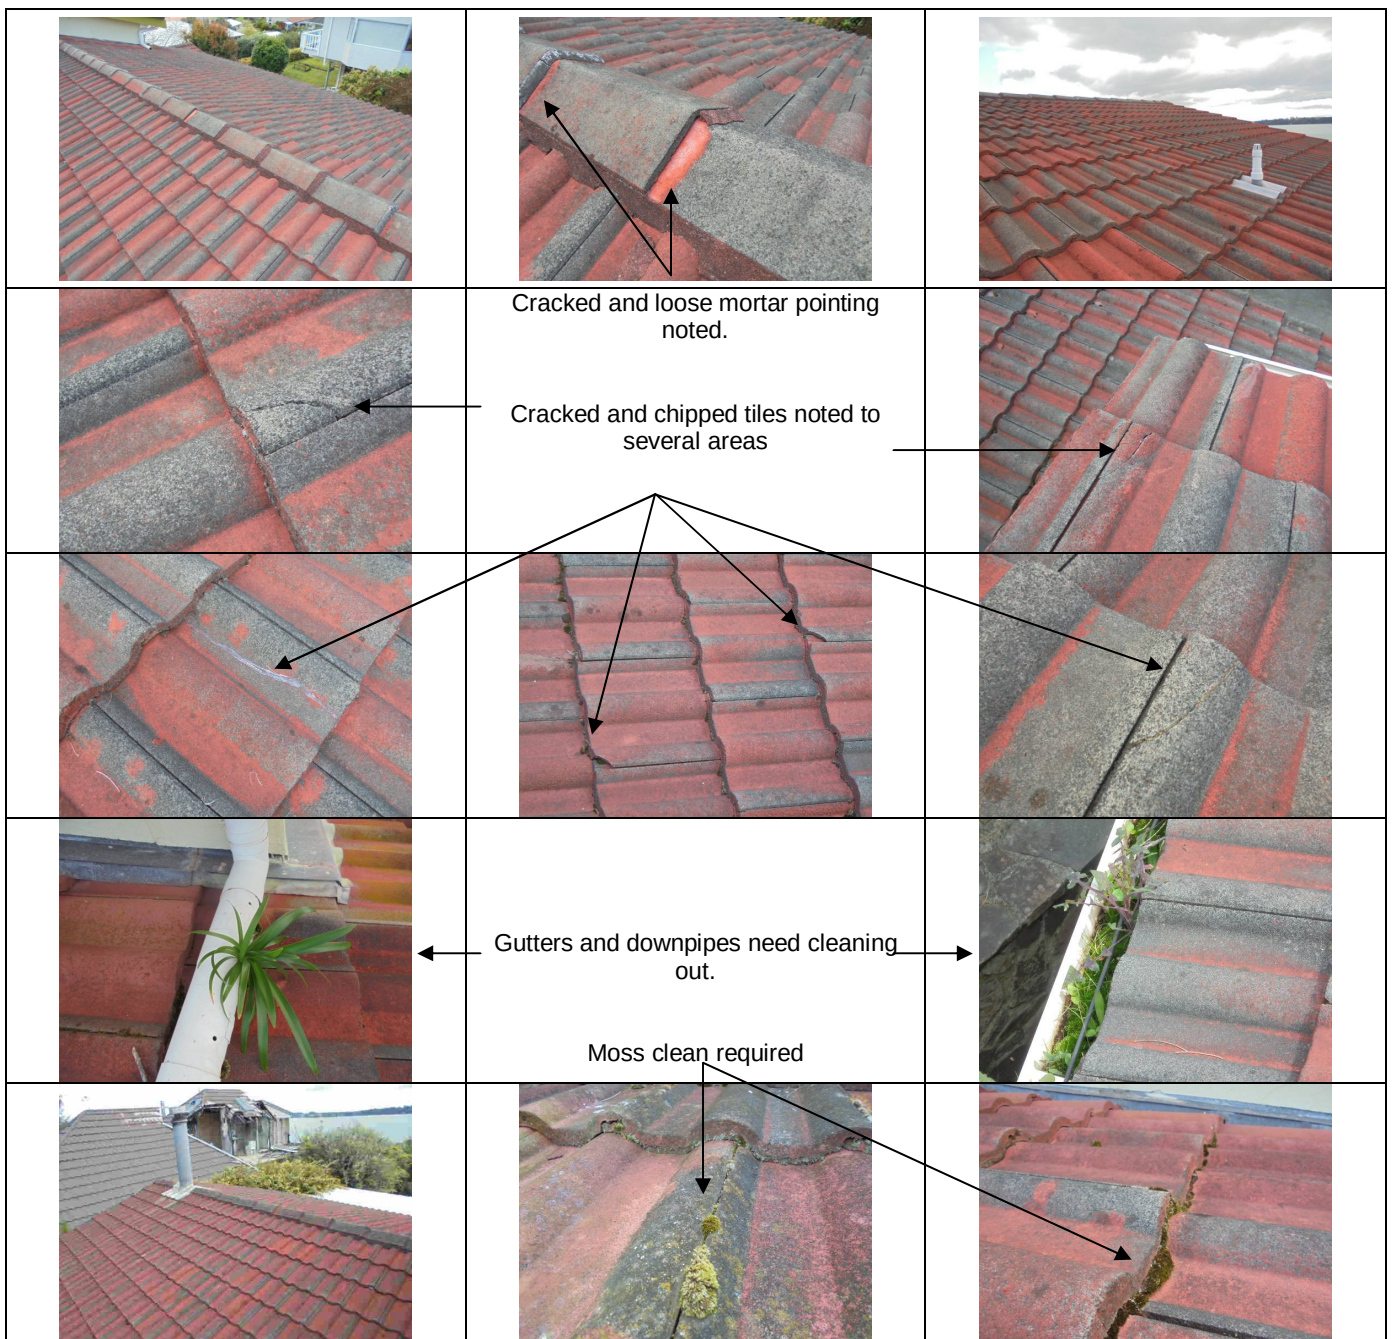
| <b>ROOFING:</b> | Concrete roofing tiles - re-coating is coming due<br>- several cracked and chipped tiles noted |

The Monier Centurion concrete tile roofing is in functional condition showing normal weathering to the surface; recoating is recommended within the next 5 years. Several cracked and chipped tiles and loose and cracked mortar pointing were sighted – replacement tiles and re-pointing are required prior to recoating. An immediate moss clean is recommended. No leaks or other serious defects were detected to the dwelling in relation to the roofing.

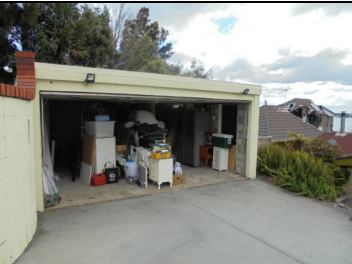
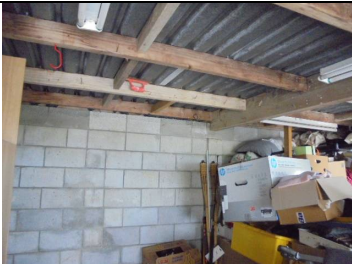
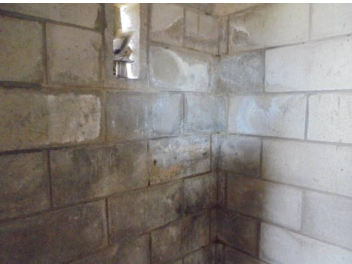
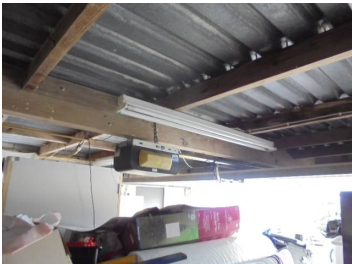
The garage appears to be structurally sound with no cracking sighted to the concrete block structure. Efflorescence noted to the interior of the blockwork indicates some dampness/seepage. Repainting the exterior with an elastomeric high-build acrylic paint should help to seal the exterior and reduce seepage. The roof appears to be functional and structurally sound.

| Efflorescence indicates damp seepage to the blockwork. | | |

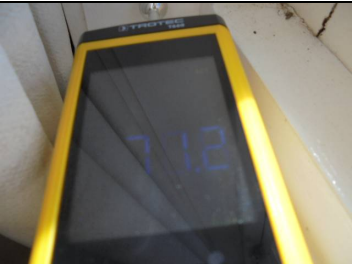
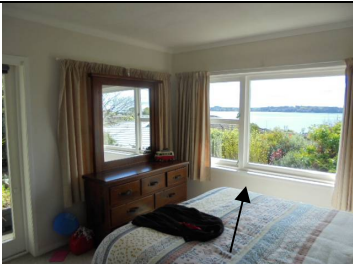
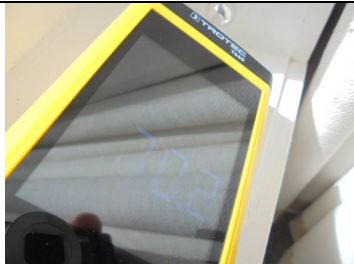
| <p>The readings to this window were slightly higher due its more exposed nature – keeping it well maintained is important</p> | | |

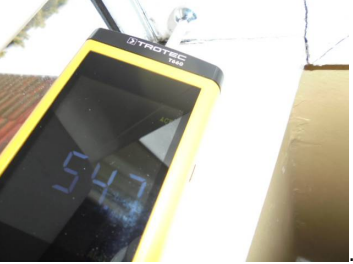
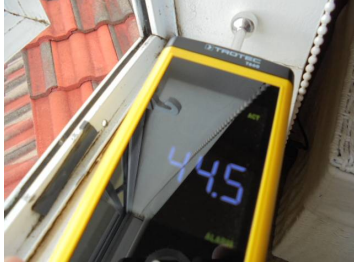
| | | <p>Visible signs of moisture affected timber to sill (minor) - internal condensation can also be a factor, so good ventilation is important.</p> |

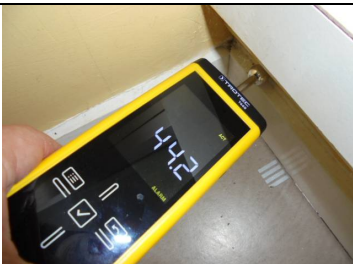
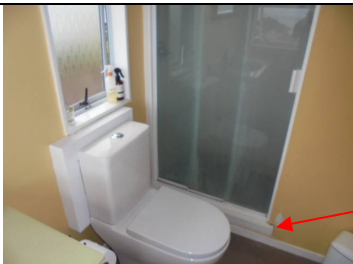
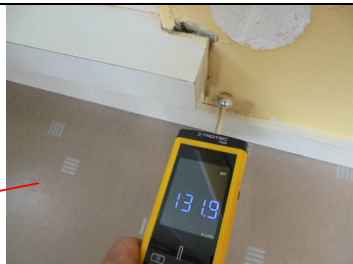
The main bathroom appears to have been refurbished in recent years and is in good order with no defects or moisture issues detected to the windows. Excessive moisture was detected to the base of the ensuite shower which is coming due for refurbishment.

| <p>This shower mixer is due for replacement.</p> | | <p>Even though these aqua panel shower wall linings are in reasonably good order for their age, they do have a limited lifespan and refurbishment is coming due.</p> |

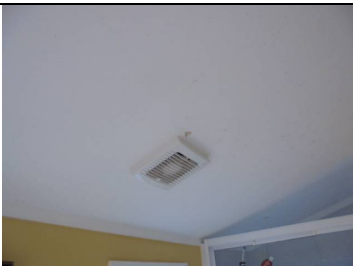
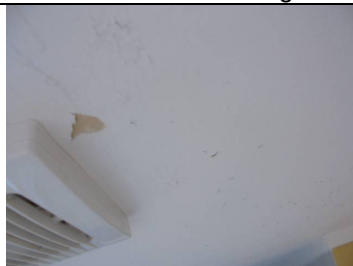
| | <p>The ceiling is due for repainting</p> | |

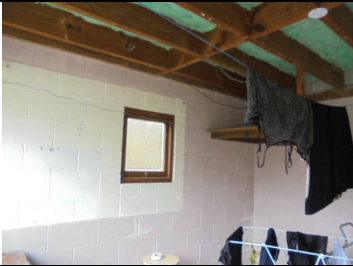
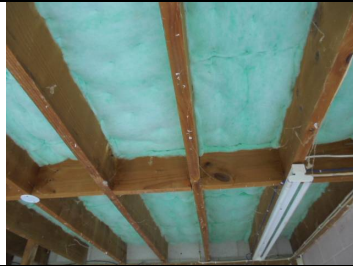
| The window needs repairs and maintenance | | |
