Pre Purchase Building Report

VENDOR REPORT

37 Bulada Street Bungaribee

25505

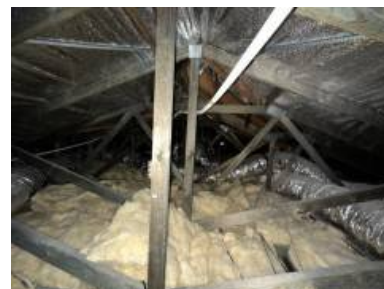
Roof Supports - Type and Condition: The timber truss roof system is adequate for the roof covering.

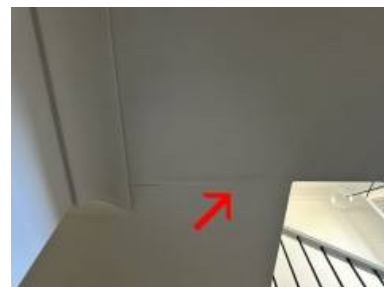
Ceiling Condition: Minor settlement cracks were noted and these are typical of this type of material. Periodic maintenance may be required - Lounge room.

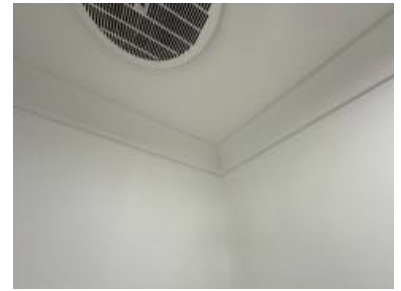
Minor cracking is present to cornices.
This will require maintenance - Various areas.

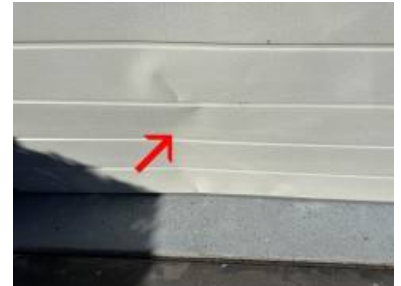
The main garage door is a panel lift style door, there is moderate impact damage to the door.

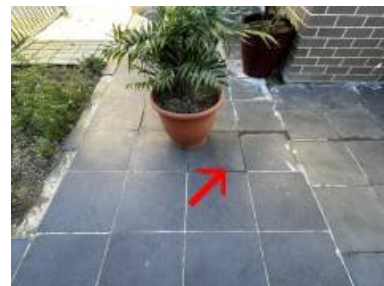
Some drummy, cracked and loose tiles were noted. These will require relaying.

A tiler should be called to make a further evaluation and repairs or rectification as needed.

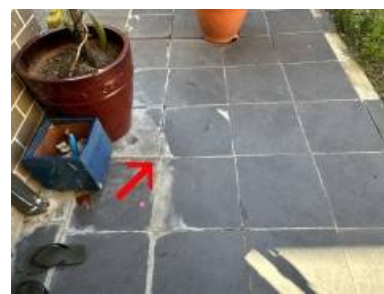
Efflorescence is noted to the grout. It is due to soluble salts rising to the surface of a cement based product. When they dry out on the surface, the remaining salts appear white and powdery. Recommend the area be cleaned to remove efflorescence.

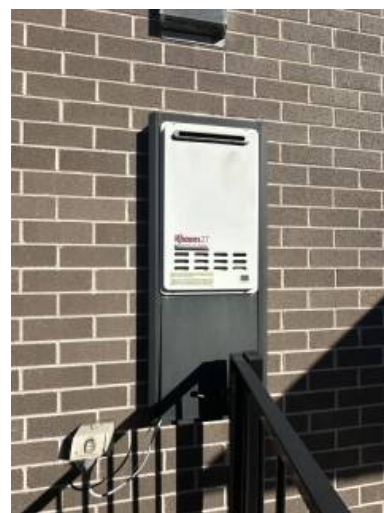
Gas hot water system: Instantaneous:
Located externally: The hot water system appears to be in working condition. No specific tests other than running the hot water from a tap was carried out. No determination has been made as to the suitability or adequacy of the hot water system in relation to capacity or otherwise.
