Pre Purchase Timber Pest Report

37 Bulada Street Bungaribee

25505-P

VISUAL TIMBER PEST INSPECTION REPORT as per AS4349.3-2010

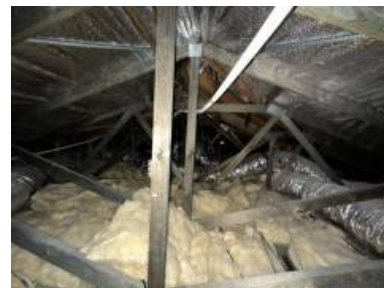
Various areas of the roof void:

No Timber Pest activity was detected to visible and accessible timbers at the time of the inspection.

It should be noted that inspection within this area was limited as noted. This comment regarding the absence of evidence of Timber Pest activity refers to the accessible inspected areas and timbers only.

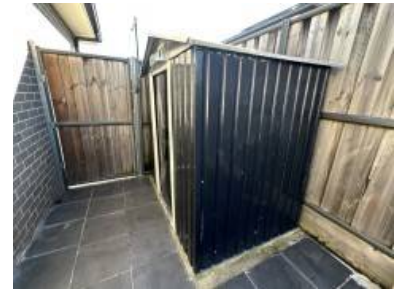
To the left hand side of the property.

A metal garden shed:

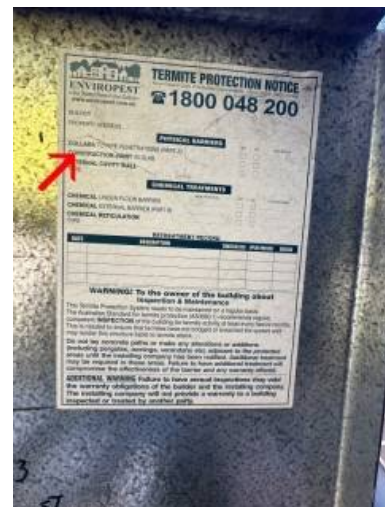
A notice indicates that the property may have been treated during construction in respect to protection against subterranean termite attack. We strongly recommend any prospective purchaser attempt to verify this information and obtain copies of all relevant documentation.
