# FIRE SAFETY & BUILDING CODE OF AUSTRALIA ASSESSMENT REPORT (BCA 2013 Edition)

**18 THROSBY STREET, WICKHAM**

# Peer review of fire engineering report

18 Throsby Street, Wickham

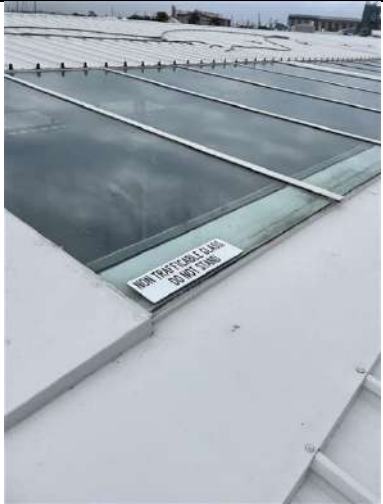
| Item No. | Item | Agreed Rectification Method Between the Parties | PSBR Comment |
|---|---|---|---|
| 5.2 | <b>Main Roof</b> | | |
| 5.2.1 | <b>Glass Roof Panels</b><br>Flashing and sealing due to water entry. | Install additional flashing to perimeter and seal. | Not carried out, no additional flashings evident<br> |

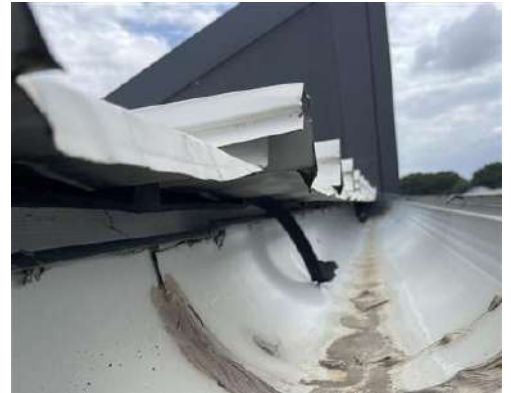
| 5.4.2 | Foam Fill. | | RPF to provide and install foam inserts. | <p>Have been installed, but are loose and falling out into the gutter as they have not been secured in place, and only installed at low end of sheets</p> |

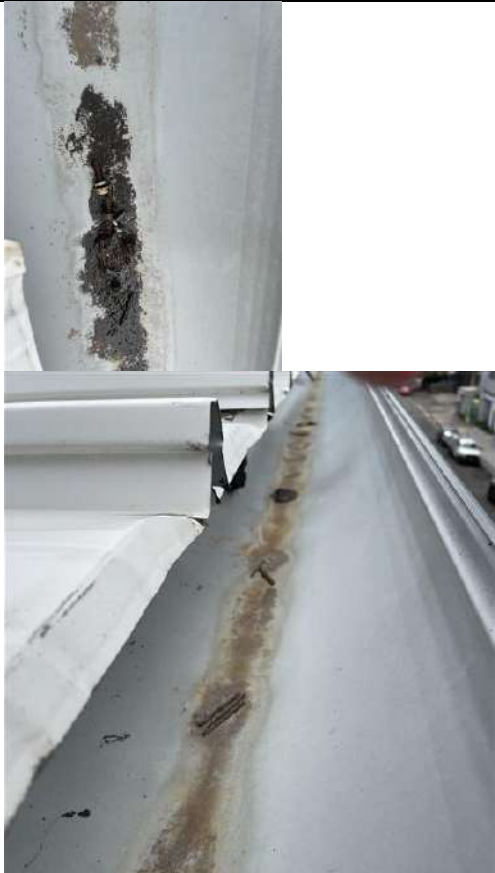
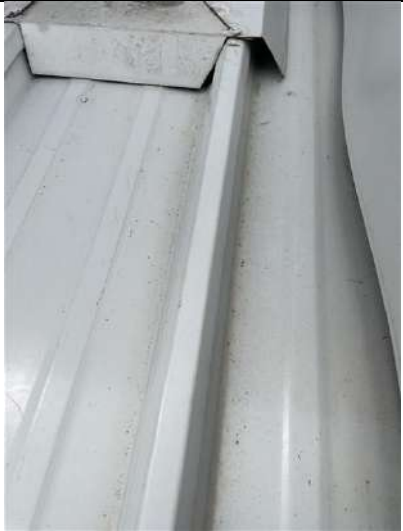
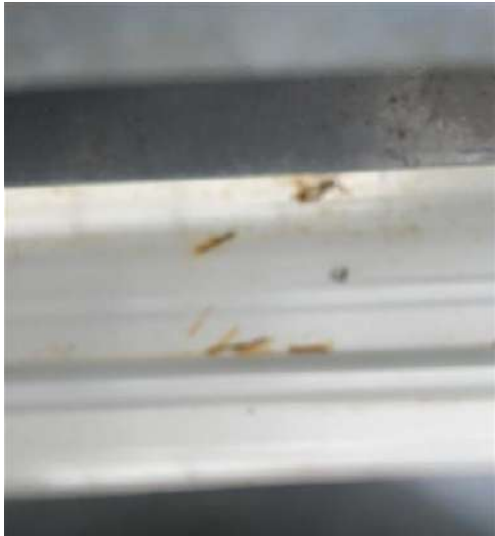
| 5.5 | Swarf and Metal Debris. | | As per 5.5C of PSBR<br>Agreed to remove debris, clean swarf and RPF to replace sheets where required. | <p>Not completed<br/>Screws and rivets in gutters and swarf on sheets and in gutters</p> |

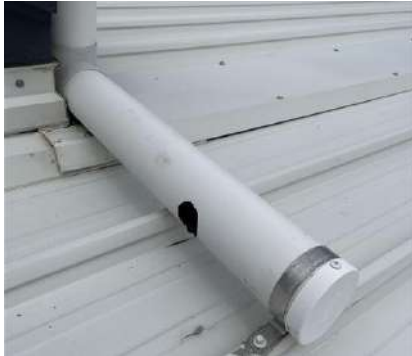
| 5.6 | Downpipes spreaders. | Add end caps to spreader and change rusted screws.<br>Agreed to extend so they did not discharge with 450mm of flashing. | The size of the outlets in the spreaders now that the ends have been closed are undersized, and should be equal to the size of the outlet in the gutter<br> |

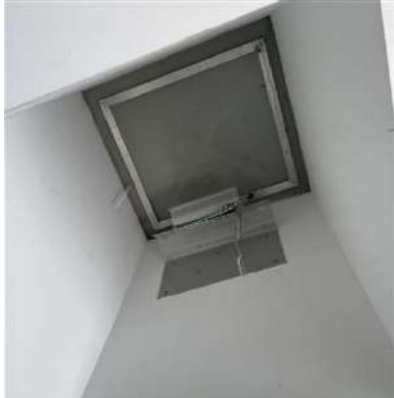
| 5.7.1 | Access from stairwell to roof not compliant. | RPF to remove existing and make good the ceiling and roof as part of the stairwell works.<br>RPF to construct new roof access. Position, location and construction details to be approved by the owners then Halstead and the original PCA.<br>Provide access from lower to upper roofs. | Not completed as hatch still remains and hatch opening is within 3m of side boundary.<br> |

| | | | | Details and approval of these works by the OC and Halstead has not been provided prior to any works being carried out, as is required by the Deed of agreement |

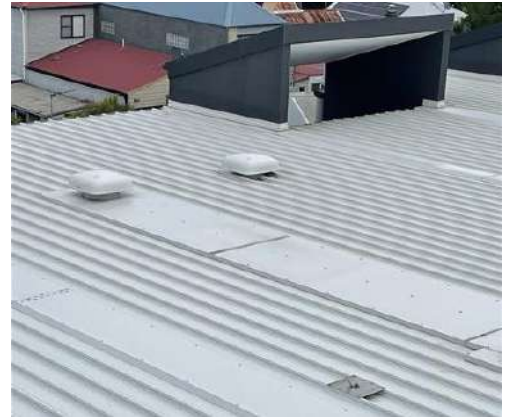
| 5.7.2 | Roof safety system not as per Spec. | | RFP to provide current and additional plan showing booting.<br>RFP to supply and fit additional anchor points and provide certification that the entire system complies with the Australian Standard AS/NZS1891.4 along with plan showing the layout. | <p>Some works have been carried out but appears not to all areas.</p> <p>No walkways provided<br/>No harness point to roof areas.</p> |

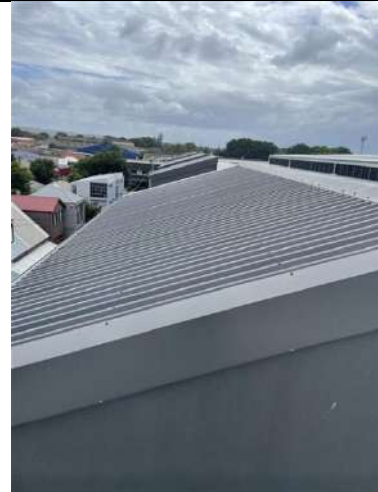
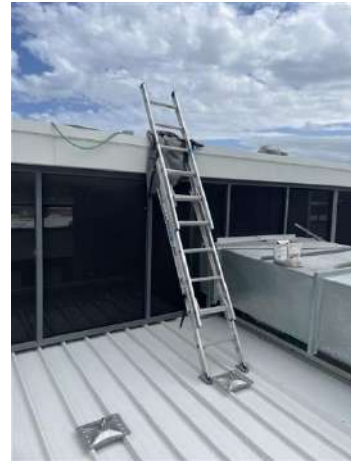
| | | | <p>No permanent access from northern roof to upper roof</p> <p>Certification as not been supplied</p> |

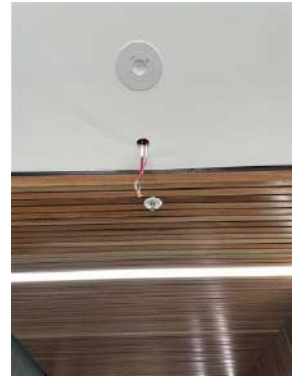
| 6.5 | <p>Separation of Classifications in the Same Storey</p> <p>Door between lobby and carpark not capable of achieving an FRL of not less than -/120/30.</p> <p>Lobby separated from carpark by glazed door not capable of -/120/120. Drencher system requires a separate valve-set monitored to detect unauthorized closure. No wall wetting drenchers and smoke seals are fitted to Residential Entry Lobby. Heat strengthened, tempered glass and smoke seals required between Commercial 02 lot and the internal and external portions of the adjoining Residential Entry Lobby.</p> | <p>Rectification or Solution as per Halstead Report dated 18/04/18 and report dated 07/11/2018.</p> | <p>Not completed</p> <p>Non fire rated hatch in ceiling</p> |

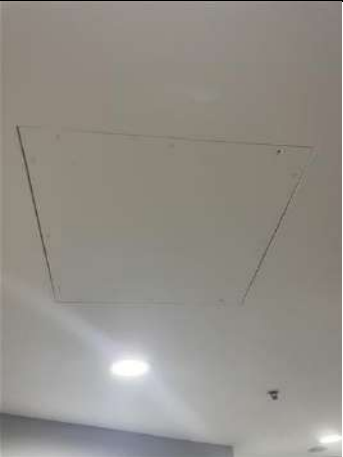
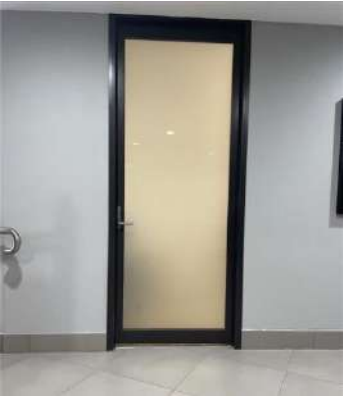
| | | | <div></div> <div>Non fire rated door between commercial and residential</div> <div></div> |

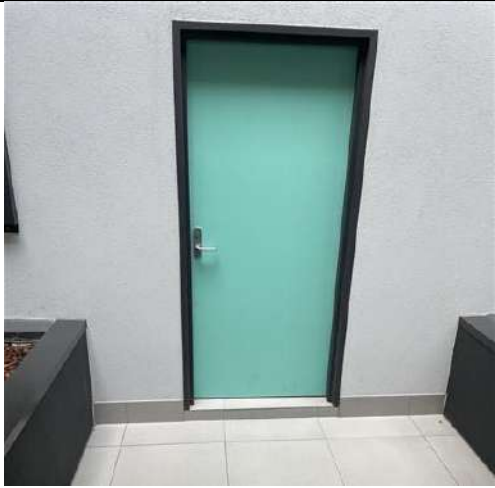
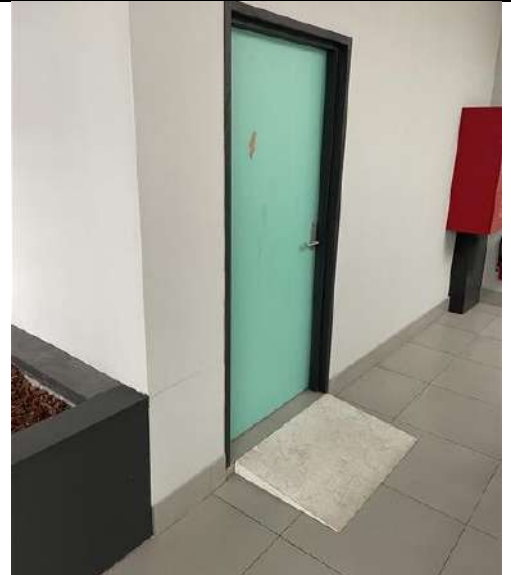
| | | | <p>Works to doors incomplete<br/>Door above has non compliant access<br/>Door below has non compliant ramp and<br/>ramp extends into pathway to fire stairs</p> |

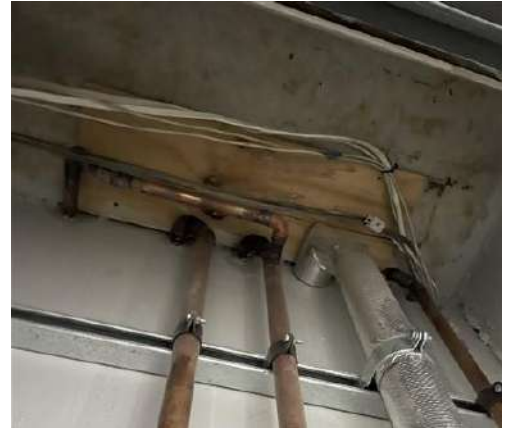
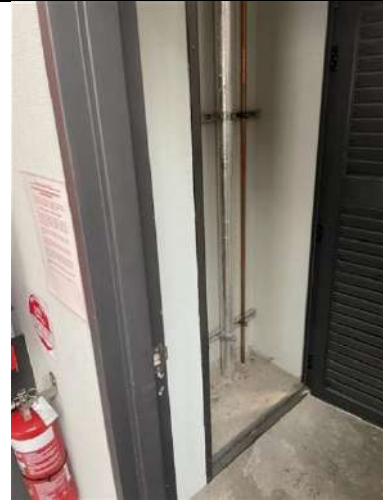
| 7.1 | Fire Stairs Two and Three and Passageways Ceiling linings under the roof are not fire rated.<br>PVC pipes have been concealed in the passageways by lightweight plasterboard construction. Top of Fire Stairs is not enclosed by construction achieving a FRL of not less than --/90/90. Opening in fire isolated stairs to gain access to roof compromises the fire separation. | Rectification or Solution as per Halstead Reports of 18/4/18 and 7/11/18. | Works appear to be not completed<br>Services located in fire stair<br> <p>Door to services cupboards not fit with a latch to keep door closed and in stairwell and paths of travel doors swing open</p> |

| | | | Details and approval of these works by the OC and Halstead has not been provided prior to any works being carried out, as is required by the Deed of agreement |

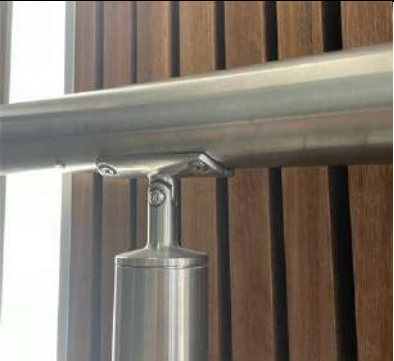
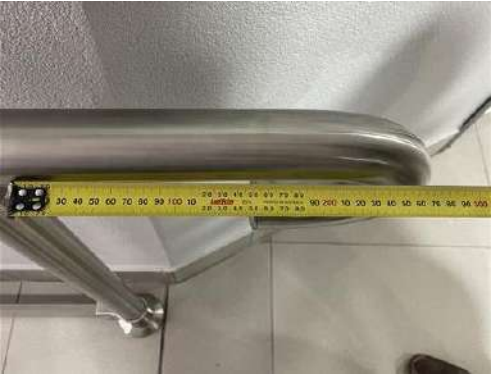
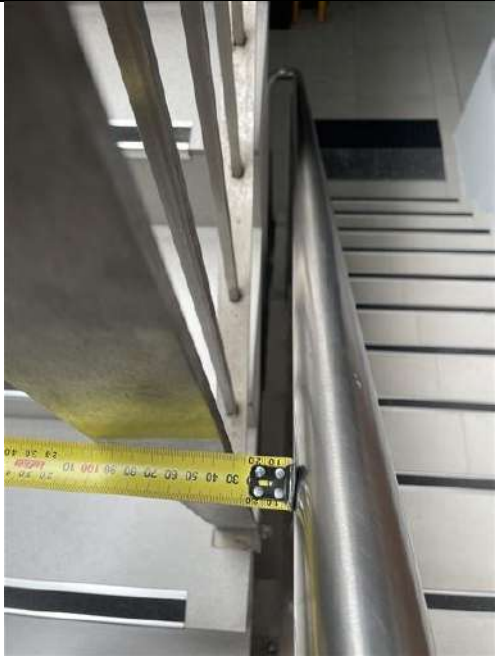
| | <b>8. Access and Egress</b> | | |
|---|---|---|---|
| 8.5 | Disabled Access<br>Handrail servicing Fire Stair 01 has a clear opening width of 40mm which is insufficient. Access to the first-floor commercial tenancies is only via the internal stairs or by the use of the residential lift which does not form part of the commercial strata. Rails do not comply. Designated parking/shared space does not comply. | RPF to rectify handrail spacing to 50 mm. Access issues resolved in Lindsay Perry report.<br>Lindsay Perry Report to be supplied.<br>Halstead to confirm LP report.<br>Halstead report of November 2018 requires works.<br>AED or access consultant to provide certification that completed works comply with BCA and DA requirements for disabled access. | RPF to provide copy of the LP Report as well as Certification by Halstead that the LP report effects compliance.<br><br>Fittings to rails can break hand grip |

| | | | <div data-bbox="1574 193 1966 555"></div> <div data-bbox="1574 595 2054 699"><p>Horizontal section not 300mm long over level floor, that is after the transition from graded to level</p></div> <div data-bbox="1574 735 2063 1110"></div> |

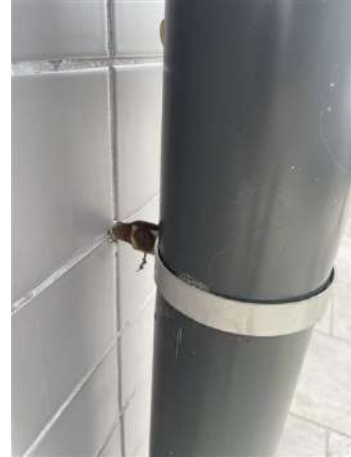
| 9.1.3 | Studs securing downpipes | As per 9.1C of the PSBR.<br>Remove and replace screws. | These have not been replaced<br> |

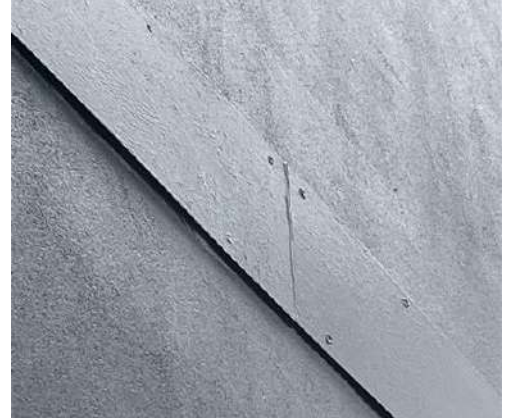
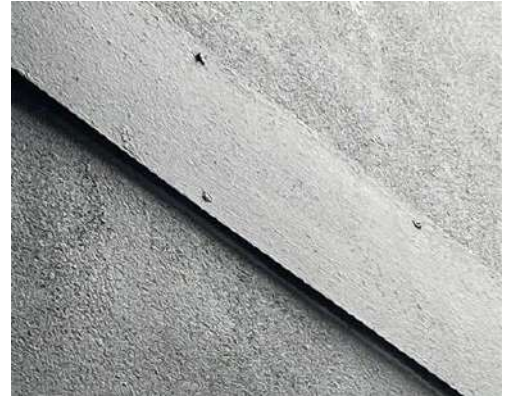
| 9.2.1 | <b>Wall Floor Junction and Finish</b><br>Not as per AFS Details and water enters the units. | Water-proof bandage to be installed and cover with CFC cladding.<br>Rectification to extend into the balcony areas by removing the skirting tiles to ensure continuity of the waterproof membrane from the rear wall.<br>Then reinstate skirting tile and make good walls and make good consequential damage. | Works have been carried out however in places are poorly finished (western wall)<br>The entire wall has not been painted as per the PSBR report SOW<br><br>Owners have reported ongoing water entry. |

| | | | <p>Further investigation required to confirm whether works extended into the balconies as required, this involved the removal of some tiles.</p> <p>Screws not well or neatly fitted<br/>No evidence of bevelled sealant on top edge<br/>Paintwork is patchy and does not appear to be for the entire wall</p> |

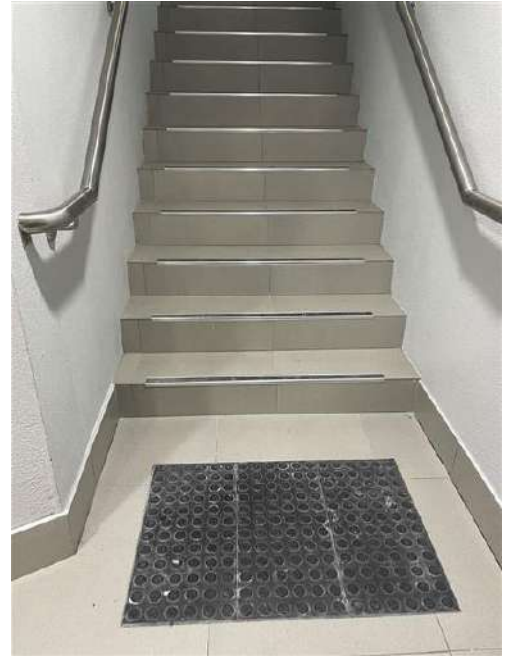
| 10.1 | <p>Non-Compliant Stair Construction</p> <p>Rise is not consistent throughout. Tactile indicators have not been provided on the landing in each fire stairwell as shown on approved plans.</p> | <p>As per Halstead Report dated 18/04/18.</p> <p>Agree to remove treads and riser and reinstate to meet the min requirement. Top up or grind back fire stair to achieve the same. Add Tactile Indicators. RPF to ensure that works are certified by Halstead.</p> <p>On completion works will need to be certified by Halstead and that he has considered and accepted the LP report.</p> | <p>Tiling works have been carried out. The stairs are extremely dirty and stained and there are paint marks on the fittings and tiles.</p> | <p>No tactile indicators or kerb rail</p> |

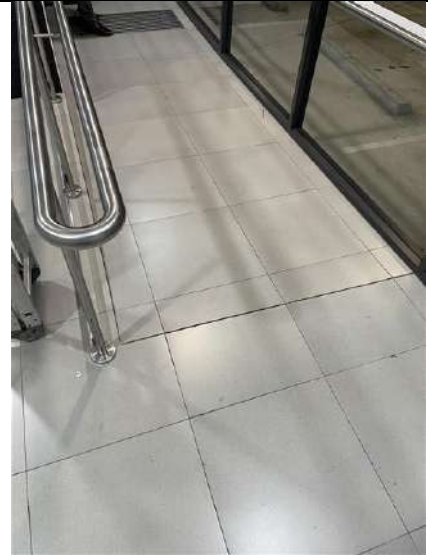
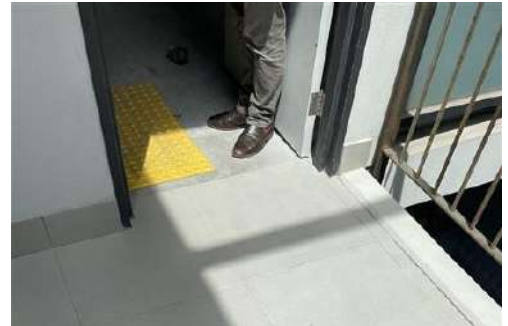
| | | | <p>Tactile may not be compliant but this will be confirmed in the Halstead certification</p> <p>RPF to supply certification from Halstead</p> |
