## Timber Pest Inspection Report

40 Arthur Way, Ormeau, QLD, 4208

Inspection prepared for: Han Na Cho

Date of Inspection: 1/10/2025 Time: 9:00 AM

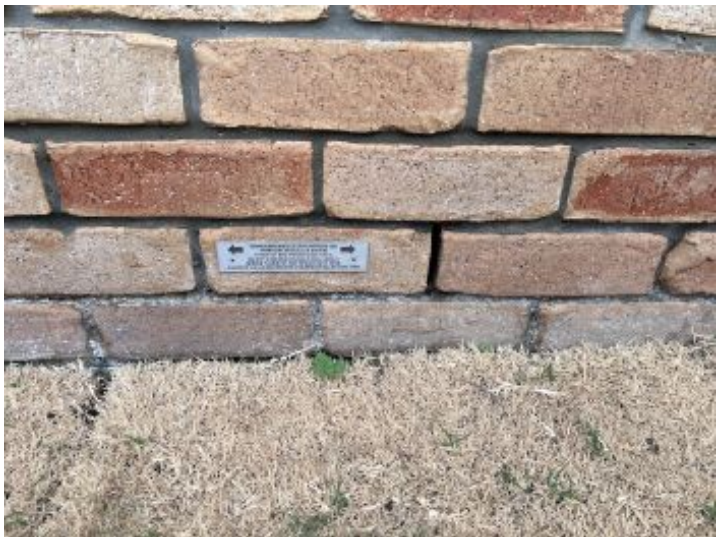
- The reticulation system found and is evidence of a possible previous termite treatment.

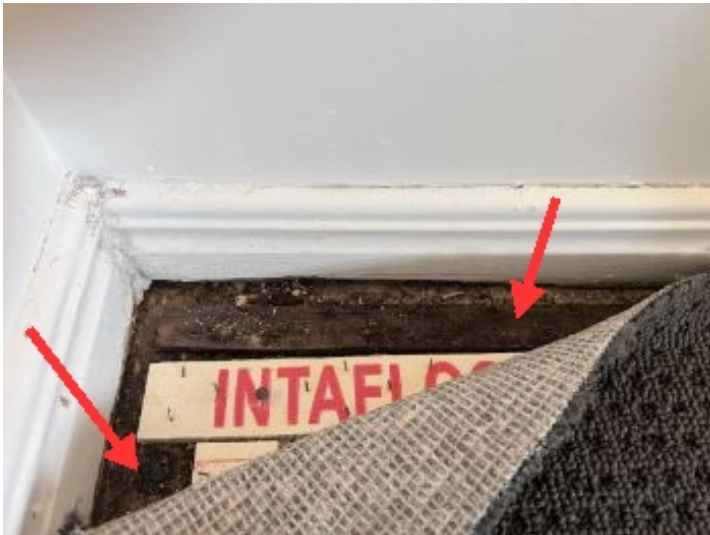
WIR

- Evidence of wood decay fungi (wood rot) found during the inspection: Location - Boundary fence, carpet nail strip (WIR), door jamb & architraves (main bathroom).

We claim no expertise in building and if any evidence of fungal decay or damage is reported you should consult a building expert to determine the full extent of damage and the estimated cost of repairs or timber replacement (See Terms & Limitations).

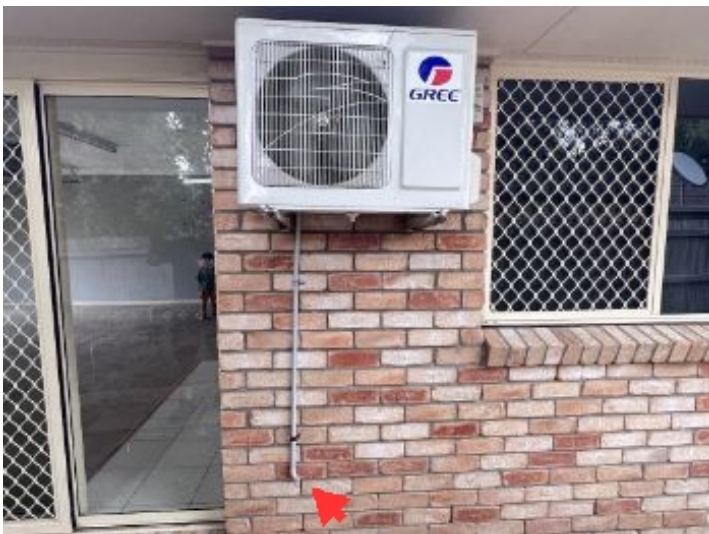
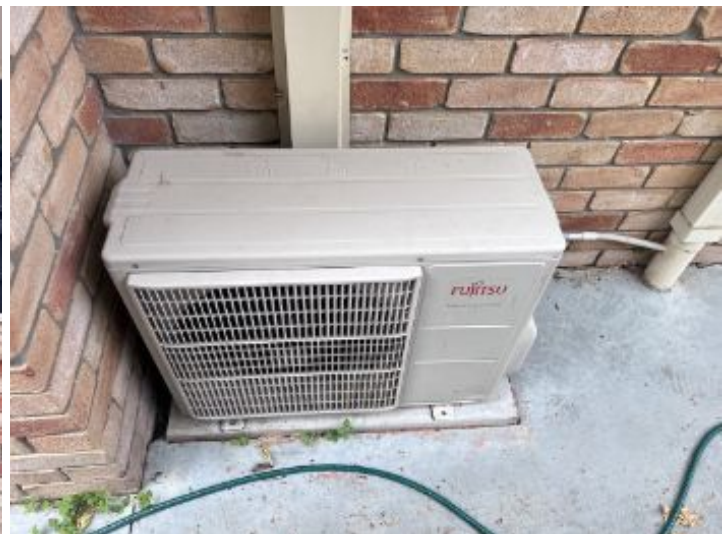
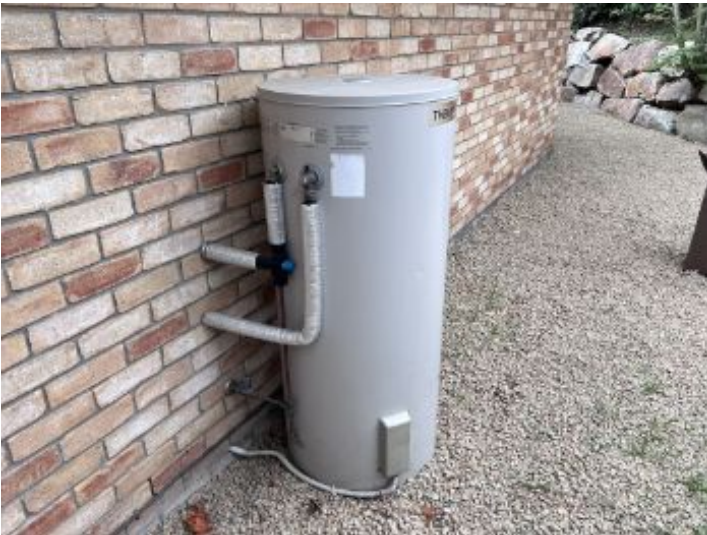
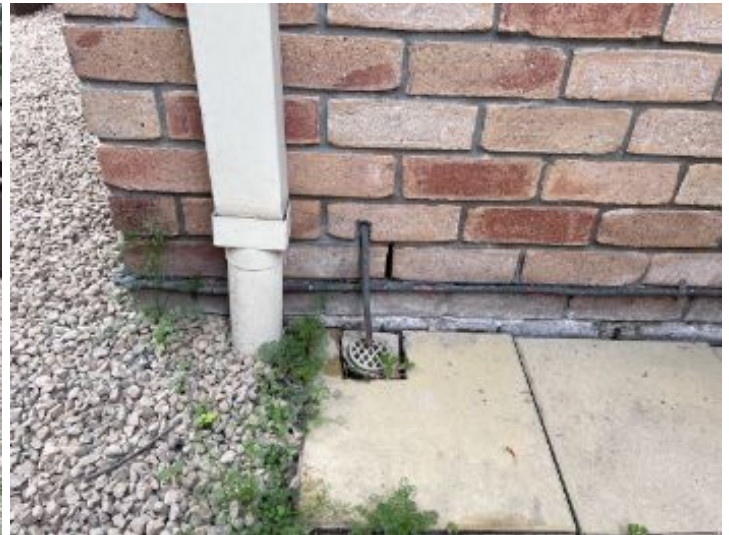
- The air conditioner discharge pipe discharges on the ground. Repair as required.

- The hot water heater and air conditioner discharge pipe discharges to the stormwater drainage.

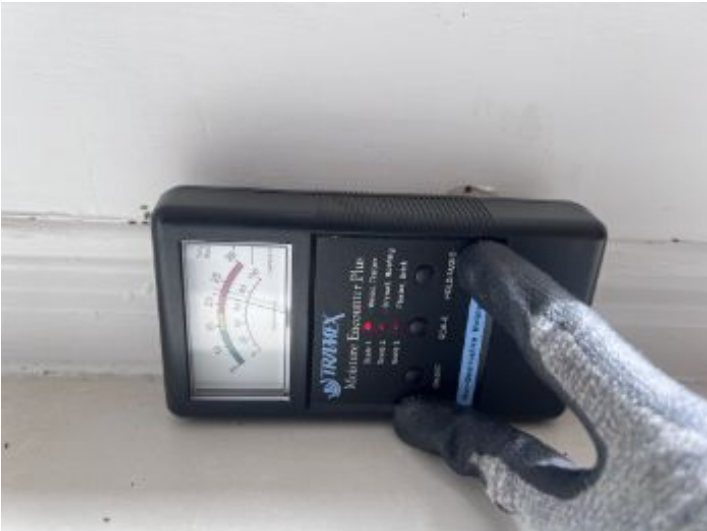
Dining

- At the time of the inspection and at the discretion of the inspector where moisture was tested for by means of a Tramex Encounter moisture meter the high moisture readings were found in the interior wall (dining) & interior ceiling (bedroom).

If high moisture was reported then you must have a building expert investigate the moisture and its cause and determine the full extent of damage and the estimated cost of repairs.

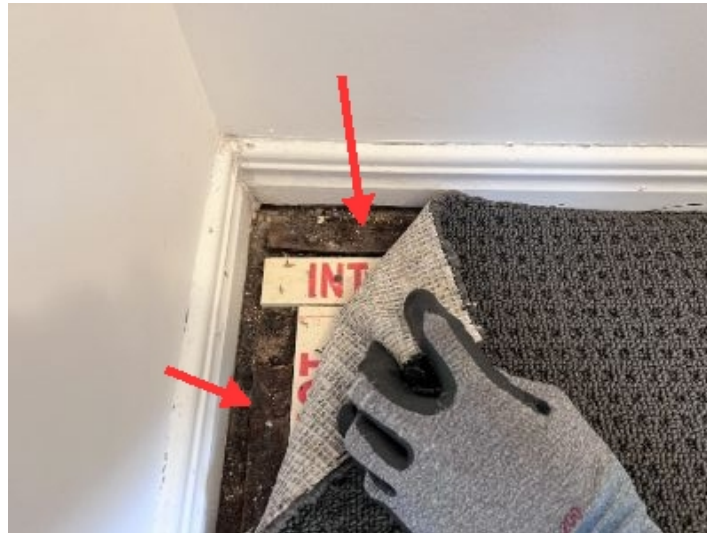
- Mould was found in the WIR (old carpet nail strip). Repair is required.

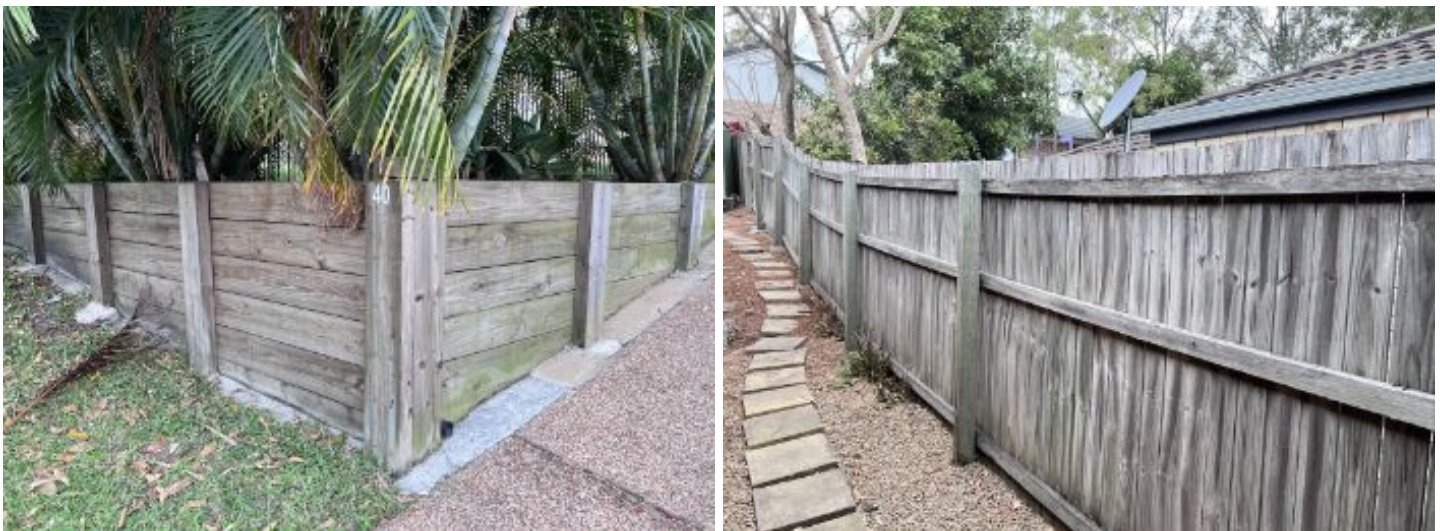
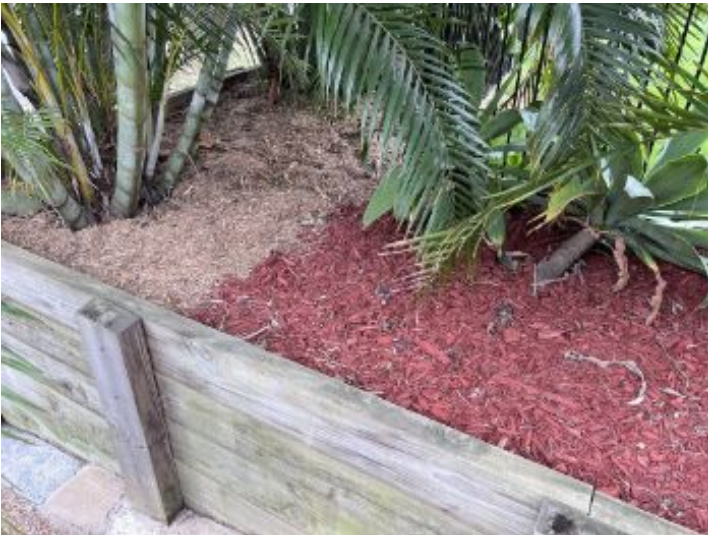
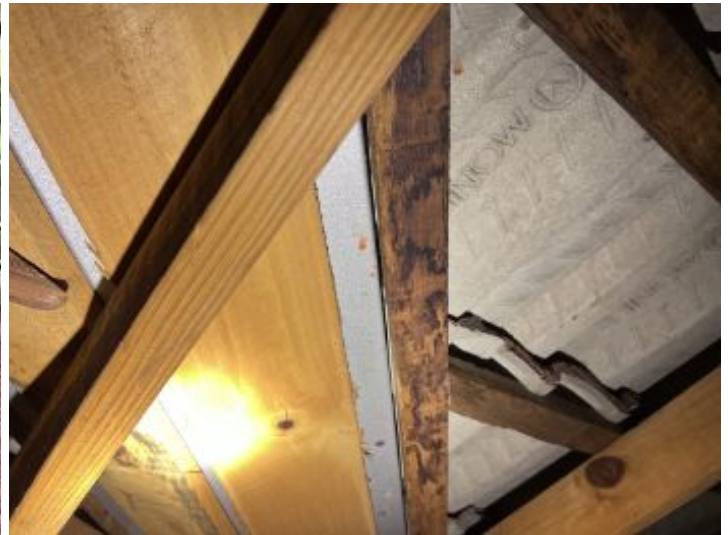
- Timber materials in contact with the ground that provides possible breeding grounds for subterranean termites. This should be removed and/or isolated from the ground. Suggest monitoring this area in order to reduce termite risk.
- Past water stain noted to the roof structure. Recommend monitoring this area to reduce termite risk.

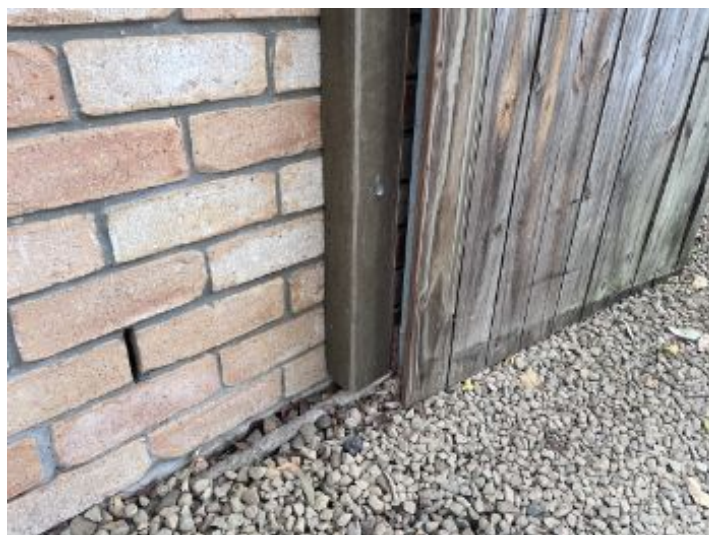
- Gate is attached to the side of the home and in direct ground contact can provide a concealed TERMITE entry point. A clearance of 75mm from finished ground level is required. Where this is not practical then a chemical barrier would be considered essential.
