Visual Timber Pest Inspection and Report in Accordance with AS 4349.3-2010

30 Leanne Street, Marsden

| Type of inspection: | Pre-Purchase Timber Pest Inspection AS 4349.3-2010 |

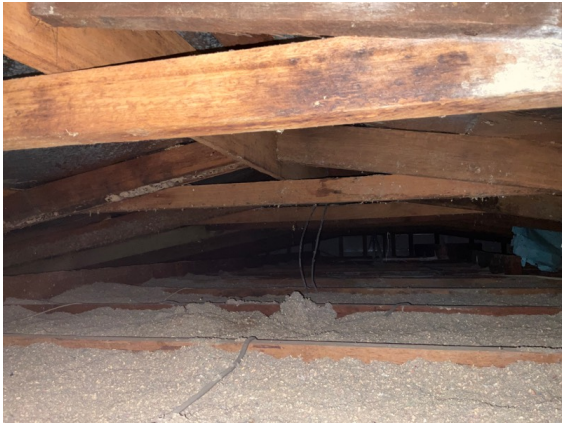
Insulation & sarking in roof void which restricts the inspection process in this area.

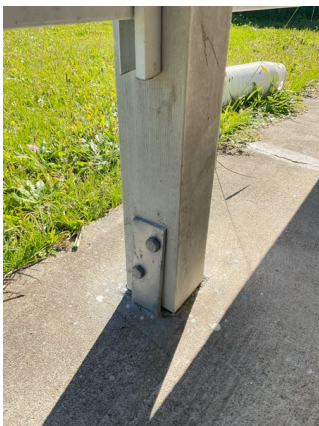
3 x Timber posts on front patio are in contact with the ground, recommend having a minimum 75mm clearance between timber and ground

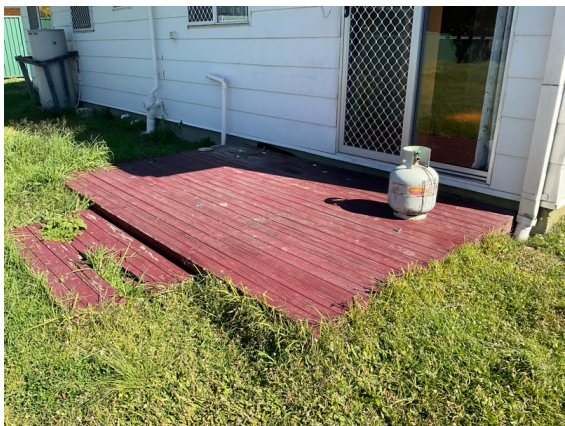
Timber decking is in contact with the ground, recommend having a minimum 75mm clearance between timber and ground

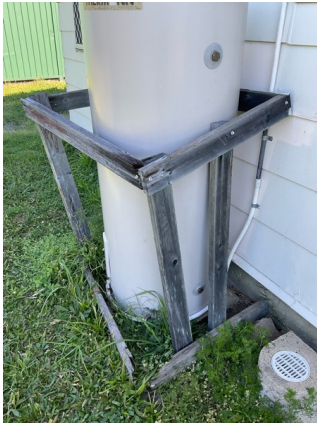
Recommend removing the timber around the hot water system as it's in contact with the ground and house

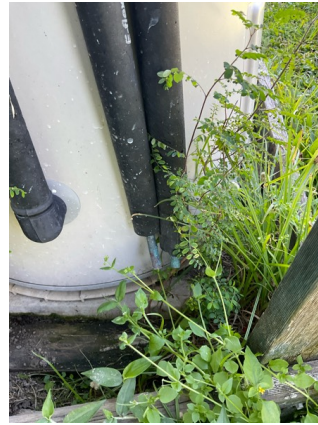
Hot water system overflow isn't to a drain, recommend repairs.

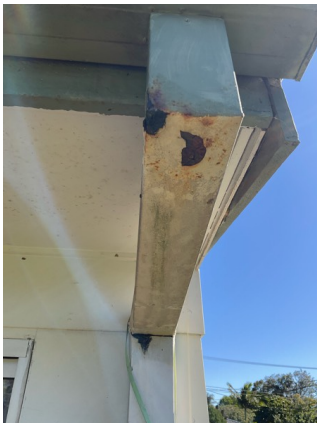
Rusted downpipe on the back left hand corner of the home, recommend repairs.

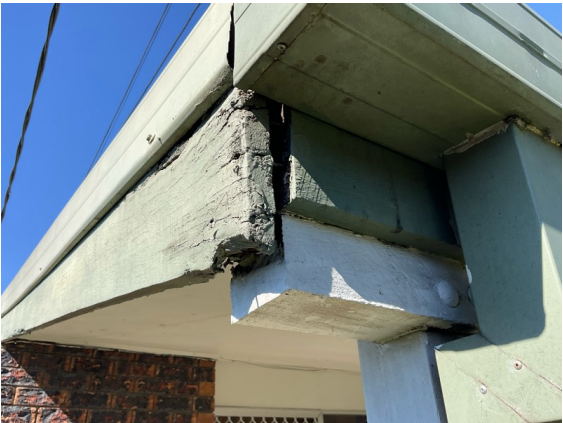
| | Fungal Decay Damage Extent: Moderate |

Wood decay (fungal decay) found along the fasciaboards around the home, recommend repairs.

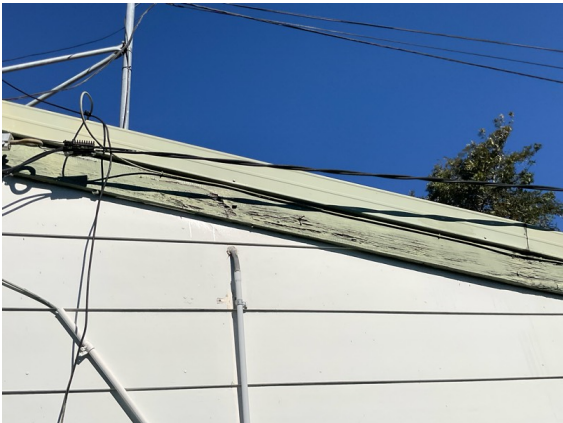
Wood decay (fungal decay) found along the fasciaboards around the home, recommend repairs.

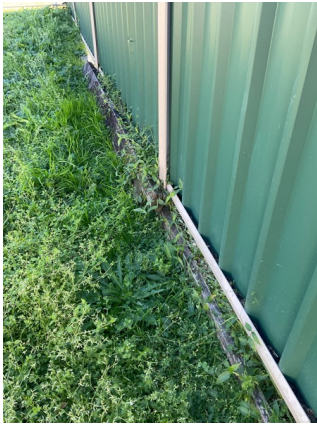
| Conductive Conditions Present: | Yes. Tree and or Stumps on site, Garden Edging |

Recommend replacing all timber edging with non susceptible termite material

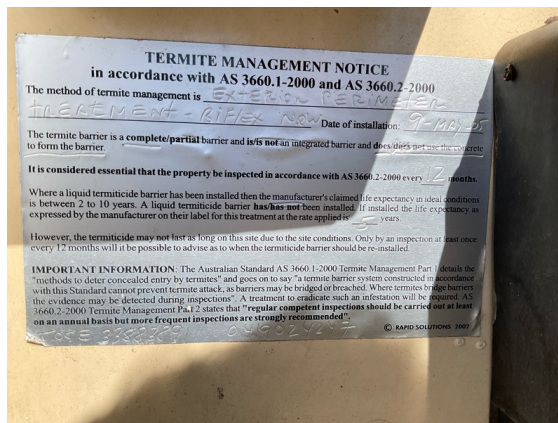
Image of Termite Management Sticker

Recommended as the installed termite management system is not current
