Pre-Purchase Standard Property Inspection Report

**30 LEANNE STREET
MARSDEN 4132**

Report number:	23471
Date of inspection:	03 Jul 2025
Address of property inspected:	30 LEANNE STREET MARSDEN 4132
Pre-engagement inspection agreement number (if applicable):

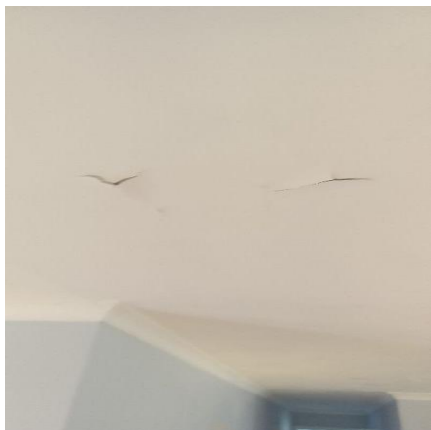
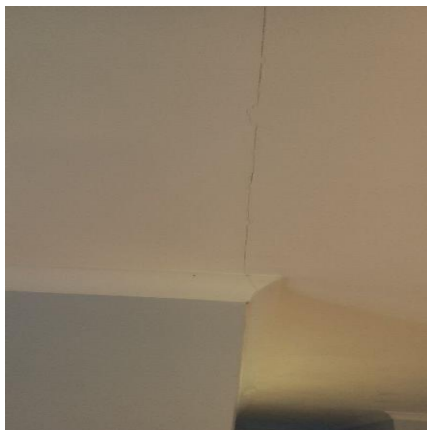
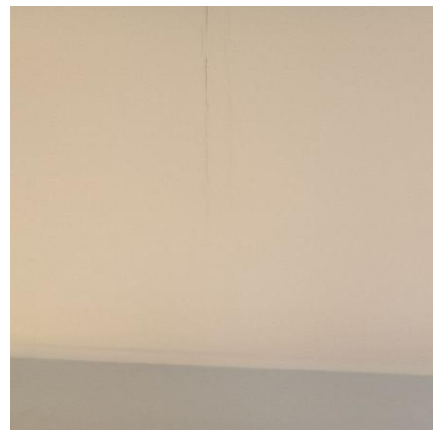
D2 Ceilings:	<p>No evidence of Major Defects was found.</p> <p>I noted cracking in the living room ceiling. This is not a structural crack it is only a plasterboard sheet movement crack</p> <p>I recommend that it be patched and the ceiling painted.</p>
--------------	--

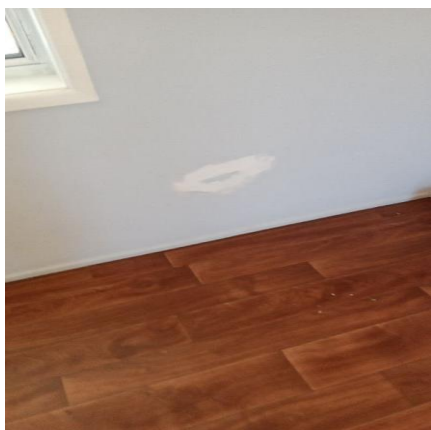
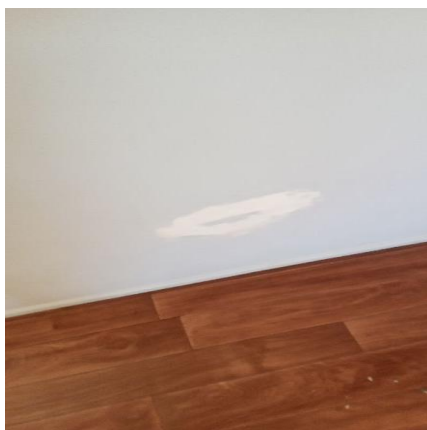
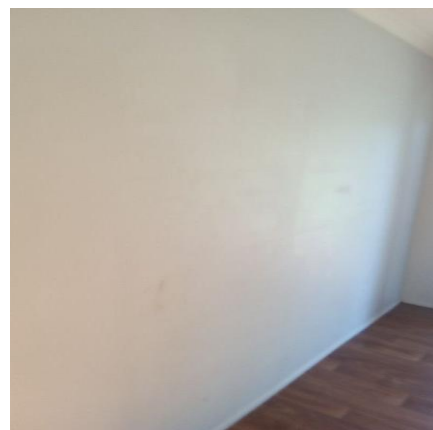
D3 Internal walls:	<p>No evidence of Major Defects was found.</p> <p>I noted general wear and por patches.</p> <p>I recommend some remedial patching and painting.</p>
--------------------	--

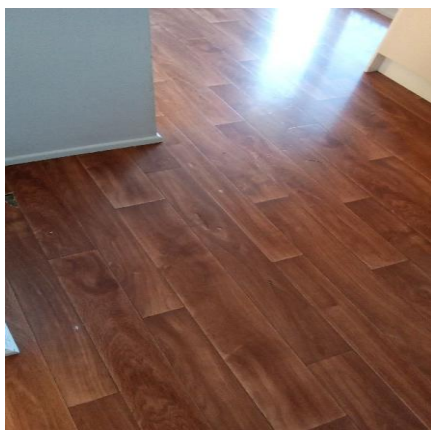
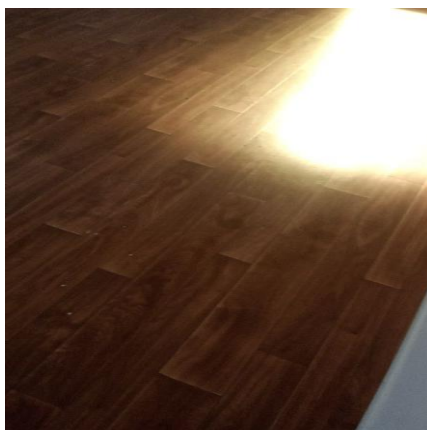
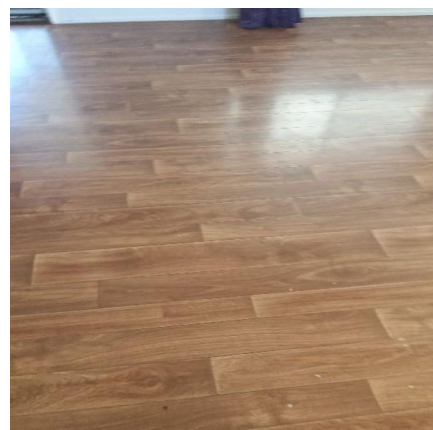
D4 Floors:	<p>No evidence of Major Defects was found.</p> <p>I noted general wear and moisture damage to the floating timber floor.</p> <p>This is quite common with this particular type of flooring</p>
------------	---

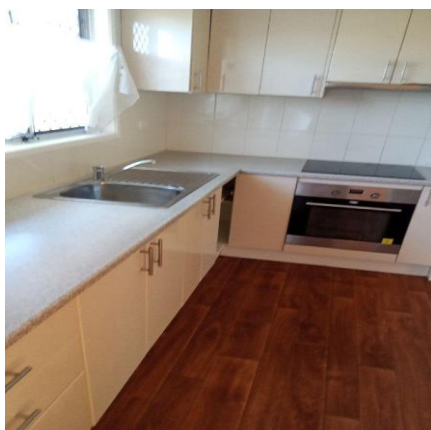
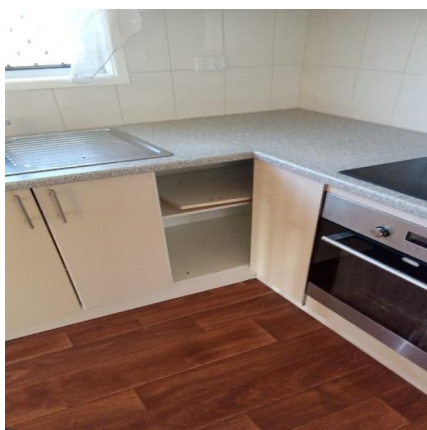
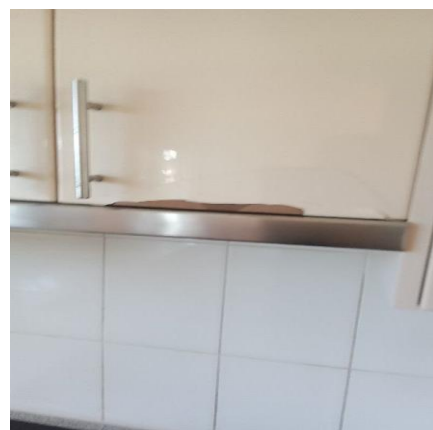
D6 Built in fittings: (built in kitchen and other fittings, not including the appliances)	<p>No evidence of Major Defects was found.</p> <p>I noted general wear.</p> <p>I noted that the corner cabinet door is missing.</p> <p>I recommended this door be reinstated.</p> <p>I noted that the vinyl wrapping has peeled away from some doors.</p> <p>I recommend remedial replacement.</p>
---	--

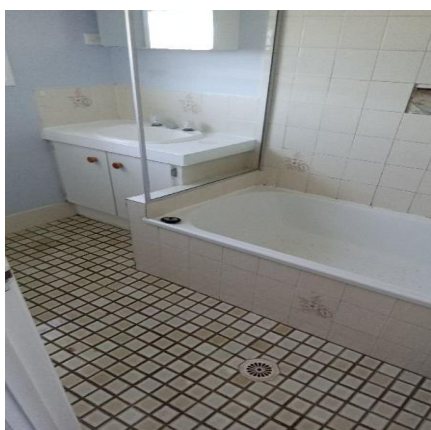
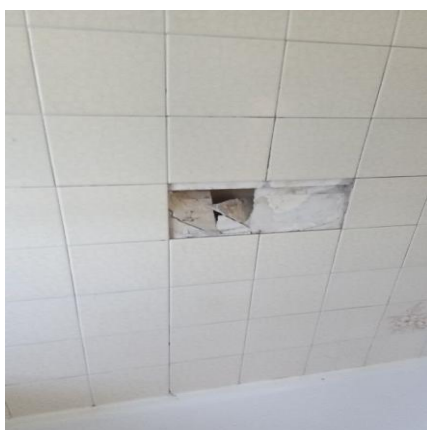
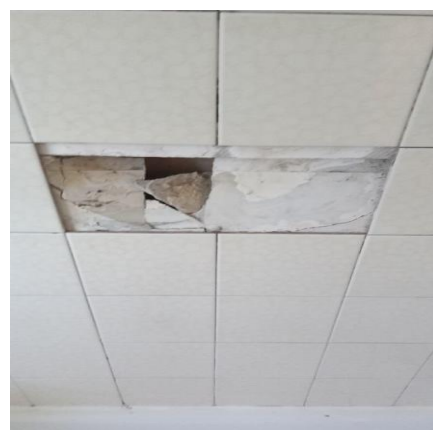
D7 Bathroom fittings:	<p>No evidence of Major Defects was found.</p> <p>I noted general wear.</p> <p>I noted a hole in the tiled wall above the bathtub.</p> <p>I recommended that this hole be patched up.</p>
-----------------------	--

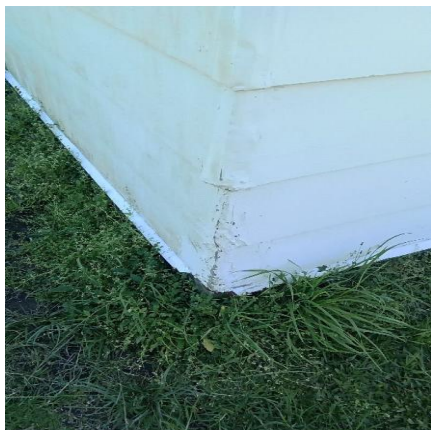
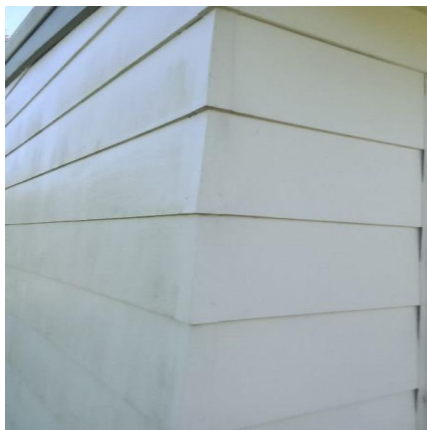
D11 External walls:	<p>No evidence of Major Defects was found.</p> <p>I noted general weathering and patching of the cladding in the rear-right corner.</p> <p>I recommend some general maintenance.</p>
---------------------	---

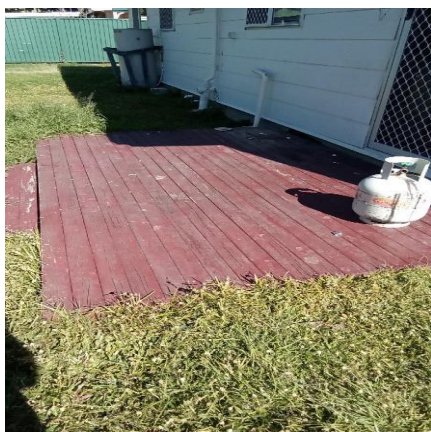
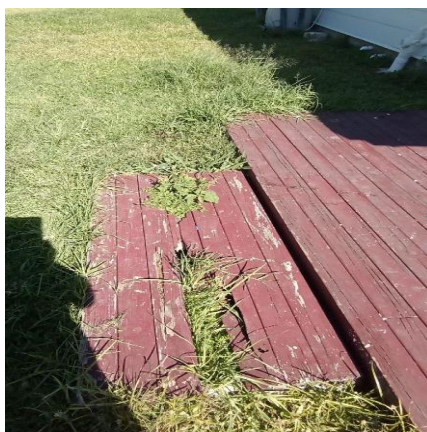
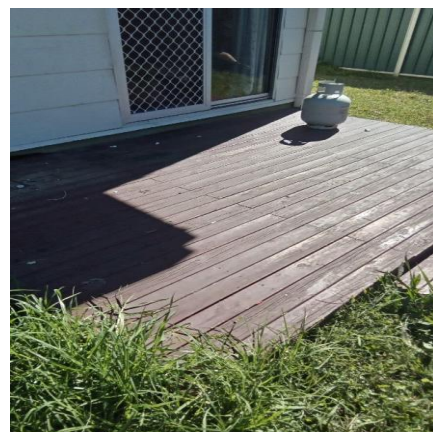
D14 Platforms: (including verandas, patios, decks and the like)	<p>No evidence of Major Defects was found.</p> <p>I excessive weathering and decay in the rear deck.</p> <p>I recommend that it be replaced. I suggest a concrete slab.</p>
--	--

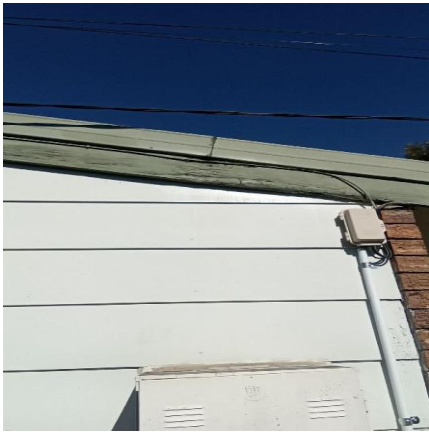
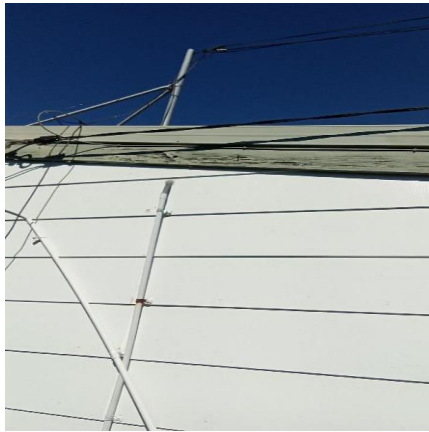
D15 Other external primary elements	<p>No evidence of Major Defects was found.</p> <p>I noted fungal decay in the left side timber fascia.</p> <p>I recommended this fascia be replaced.</p>
-------------------------------------	---

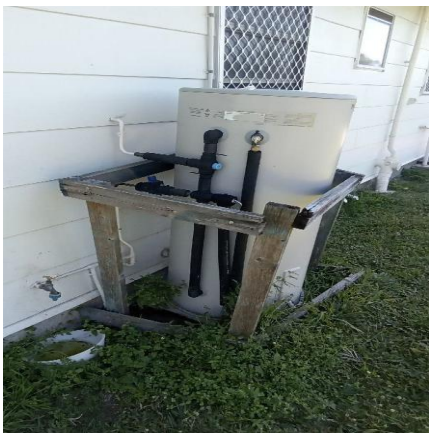
<p>D16 Other external secondary & finishing elements:</p>	<p>No evidence of Major Defects was found.</p> <p>The timber framework around the hot water system is falling apart</p> <p>I recommended be removed.</p>
---	--

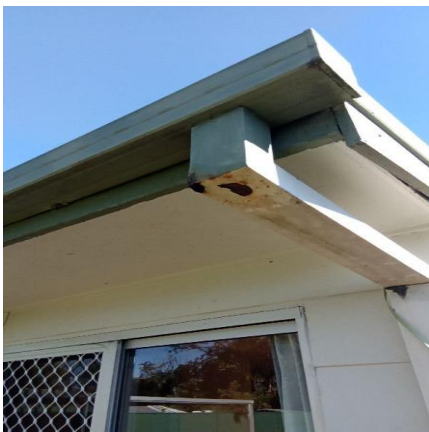
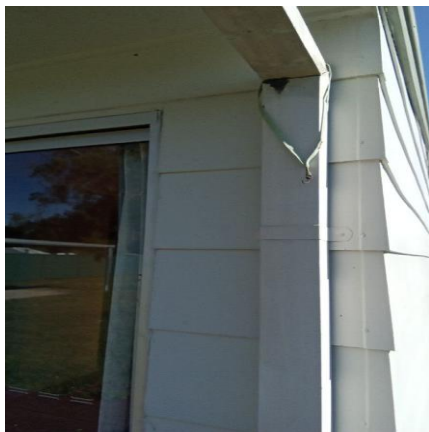
<p>D18 Rainwater goods:</p>	<p>No evidence of Major Defects was found.</p> <p>I noted corrossion in the rear left downpipe adjacent to the gutter.</p> <p>I recommended that this downpipe be replaced.</p>
-----------------------------	---

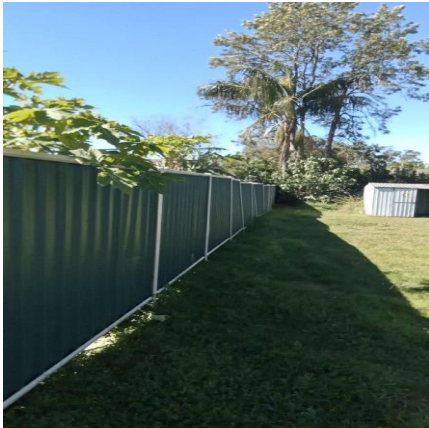
D20 Walls & fences:	<p>No evidence of Major Defects was found.</p> <p>I noted movement in the left boundary fence</p> <p>I recommended that this fence be straighten..</p>
---------------------	---

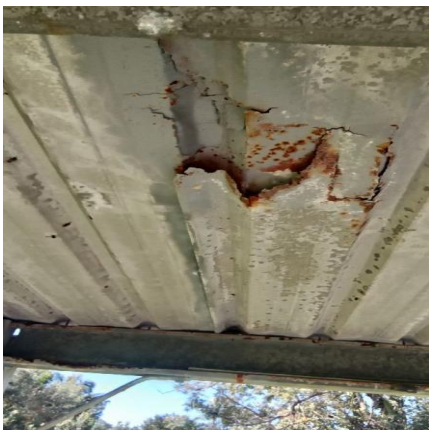
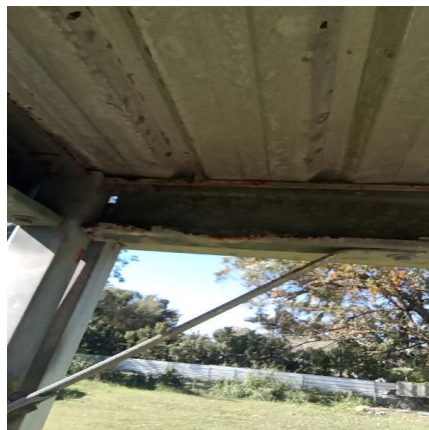
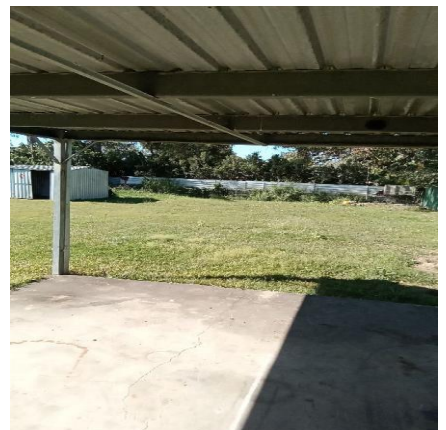
D21 Outbuildings:	<p>No evidence of Major Defects was found.</p> <p>I noted corrosion in this roof sheeting.</p> <p>I recommend that the corroded sheet be replaced.</p>
-------------------	---
