## **Pre-Purchase Standard Property Inspection Report**

**147 POHON DRIVE  
TANAH MERAH 4128**

## PRE-PURCHASE STANDARD PROPERTY REPORT

| Report number: | 23781 |

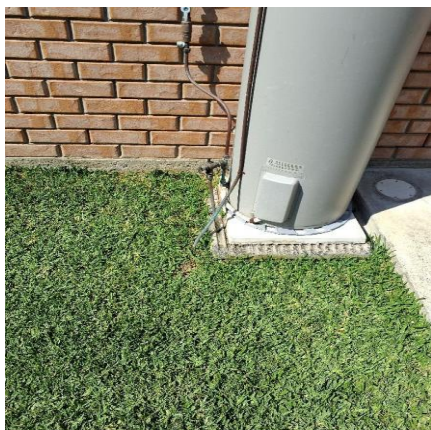
| D15 Other external primary elements | <p>No evidence of Major Defects was found.</p> <p>The hot water systems overflow pipe discharges onto the ground.</p> <p>It is important to note that wet areas May attract to termites.</p> <p><b>I therefore recommend that these pipes be diverted to the nearest drain.</b></p> |

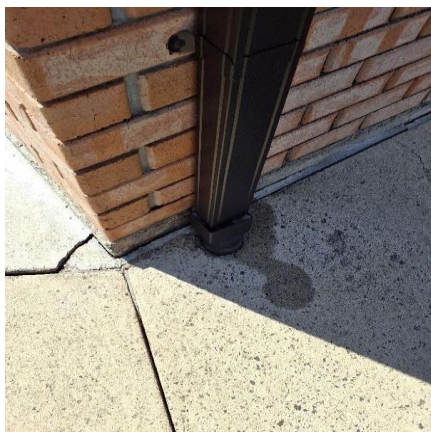
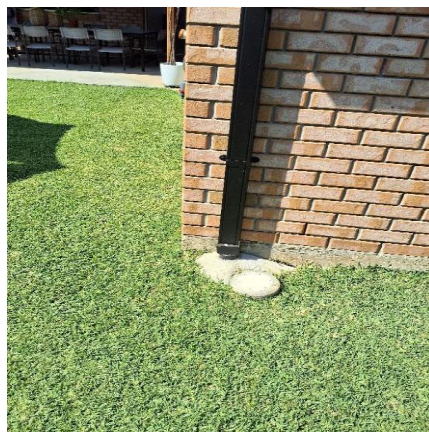
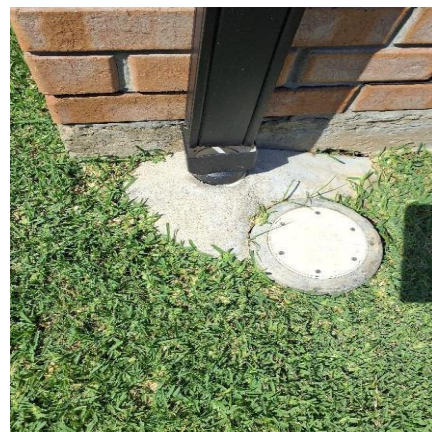
| D18 Rainwater goods: | <p>No evidence of Major Defects was found.</p> <p>The rear downpipes are short in connection to the stormwater drain.</p> <p><b>I recommend that the stormwater pipe be extended further up to the downpipe.</b></p> |

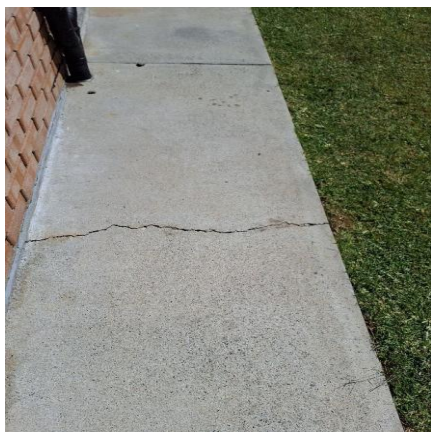
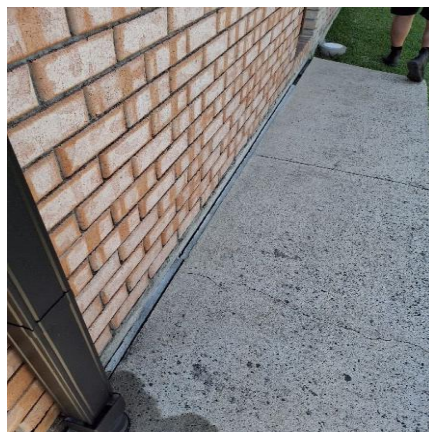
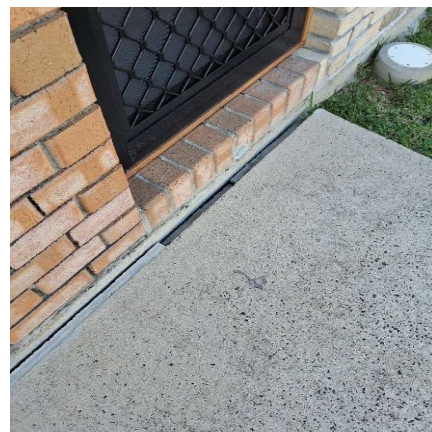
| D19 The grounds: | <p>No evidence of Major Defects was found.</p> <p>I noted some subsidence and cracking of the external concrete pavement.</p> <p>This is quite common in pavements of this type and age</p> <p><b>Remedial work is not warranted.</b></p> |
