TD BUILDING & INSPECTIONS
Offering Real Values

Vendor Pre-Sale Building & Timber Pest Inspection Report

114 North Rd, Woodridge QLD, Australia

Vendor Pre-Sale Building and Timber Pest Inspection - Vendor Pre-Sale Building & Timber Pest Inspection Report w/ Photos**10 Sep 2025**

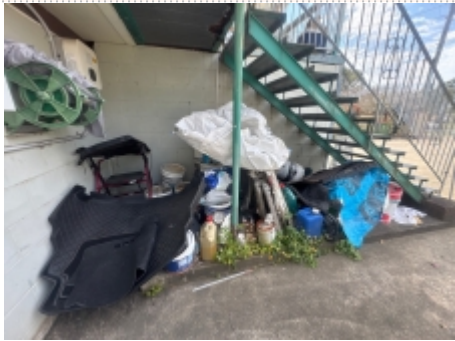
Photo Comments:	Showing examples of obstructions
-----------------	----------------------------------

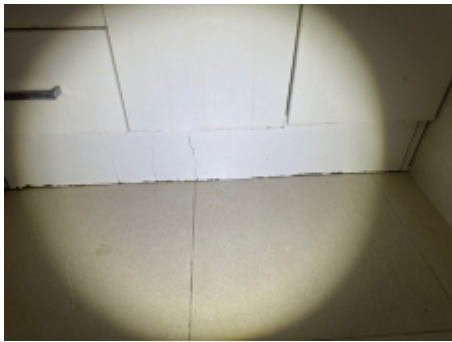
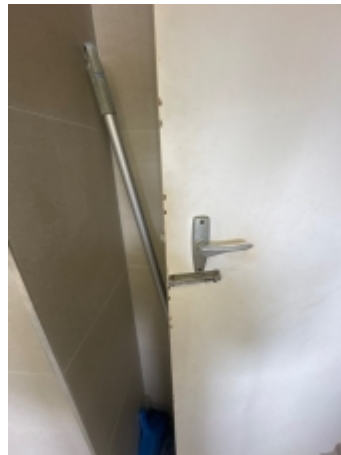
Defect Severity	Minor Defect
Comment	Showing examples of minor damage to parts

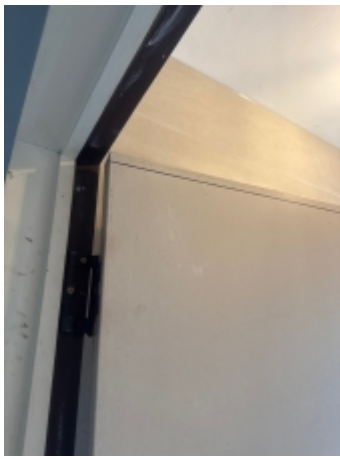
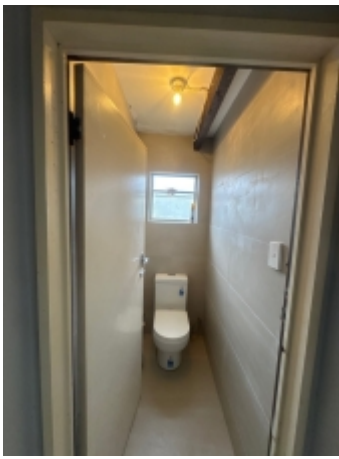
Defect Severity	Safety Hazard
Defective Item	Doors and Frames
Defect	No lift off hinges
Comment	Toilet area is restrictive and the door swings inwards. No lift off hinges to toilet door or insufficient clearance above the door was observed. Recommend engaging a carpenter to rectify to reduce the risk of people being unable to be accessed in an emergency.

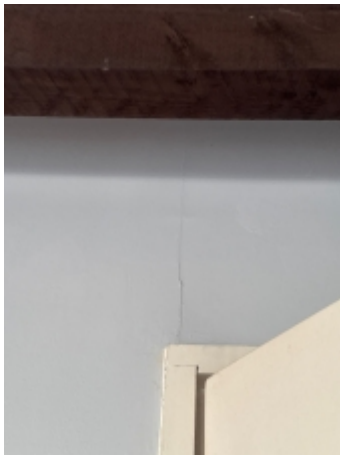
Defect Severity	Minor Defect
Defective Item	Walls
Defect	Cracks
Comment	Minor visible cracks present, but these do not affect structural integrity. Potentially caused by settlement or temperature change

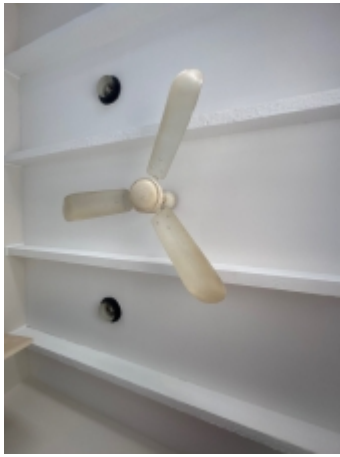
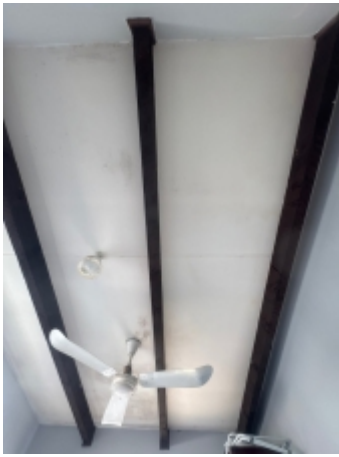
Defect Severity	Safety Hazard
Defective Item	Ceilings
Defect	No smoke alarms
Comment	The property may not have compliant smoke alarms installed. It is recommended to engage a licensed professional to carry out a smoke alarm inspection to reduce the risk of injury or fatality in the event of a fire. Please note: smoke alarm compliance is not assessed as part of this report.

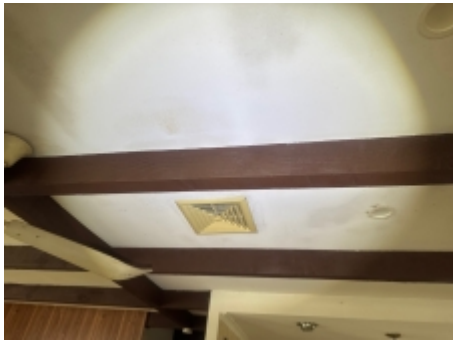
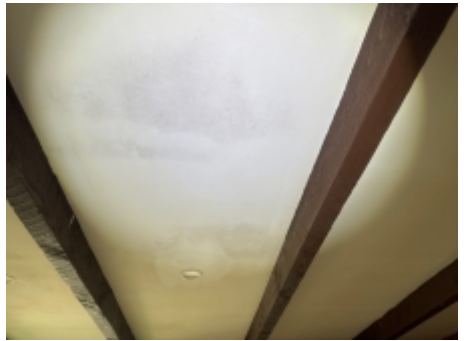
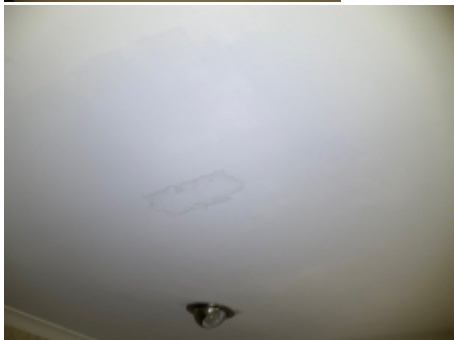
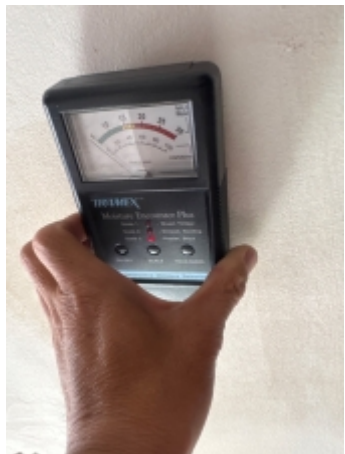
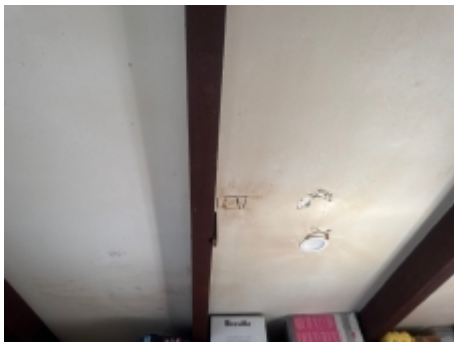
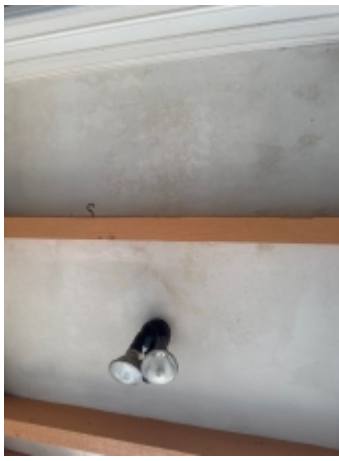
Defect Severity	Major Defect
Defective Item	Ceilings
Defect	Moisture
Comment	Signs of water staining were observed on the ceiling at multiple areas. However, no elevated moisture levels were detected at the time of inspection. It is recommended to engage a licensed builder for further investigation and necessary repairs to reduce the risk of water penetration and further deterioration.

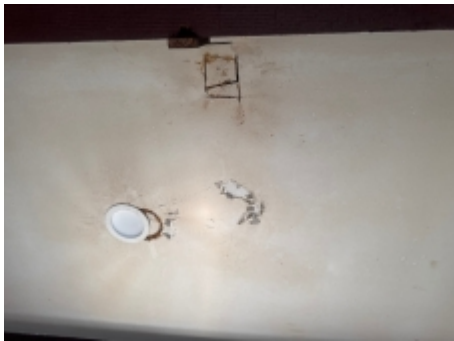
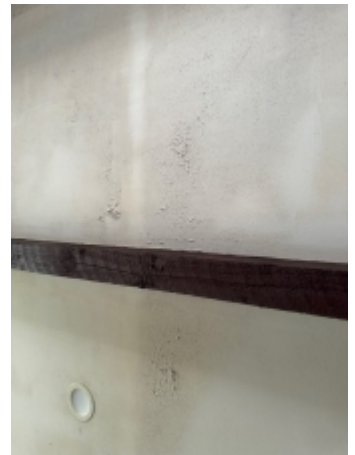
Defect Severity	Major Defect
Defective Item	Ceilings
Defect	Paint deterioration
Comment	Paint deterioration was noted on the ceilings. It is recommended to engage a painter to rectify the issue and reduce the risk of further deterioration.

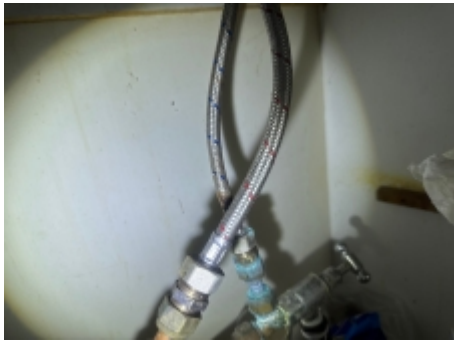
Defect Severity	Major Defect
Defective Item	Kitchen Sink/Taps
Defect	Rust hose

Comment	Rust and/or damage to braided inlet hose to taps. Recommend engaging a plumber to replace to reduce the risk of further deterioration and property damage.
---------	--

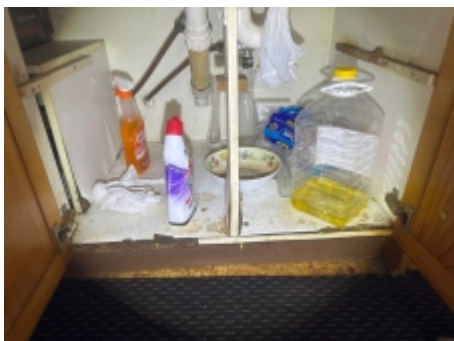
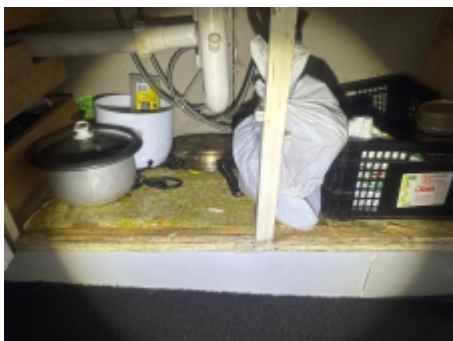
Defect Severity	Major Defect
Defective Item	Kitchen Sink/Taps
Defect	Moisture damage
Comment	Moisture damage was observed to the kitchen cabinet. It is recommended to engage a licensed plumber to inspect for potential leaks and a qualified carpenter or cabinet maker to repair or replace the damaged cabinetry to ensure safe and functional use of the kitchen.

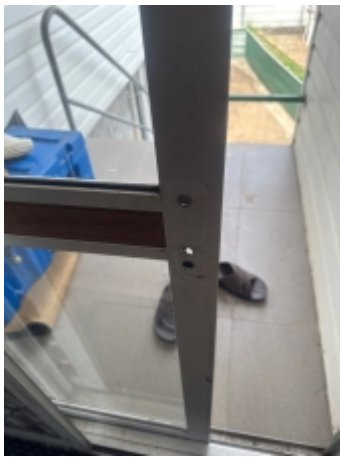
Defect Severity	Minor Defect
Comment	Missing a door handle was observed

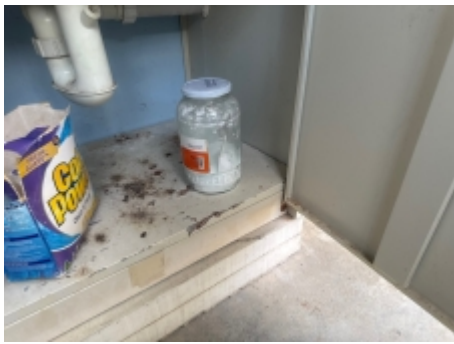
Defect Severity	Major Defect
Defective Item	Laundry Tubs/Cabinets
Defect	Rust
Comment	Rust is present on parts of the metal tub. It is recommended to engage a suitable tradesperson to rectify the issue and reduce the risk of further deterioration

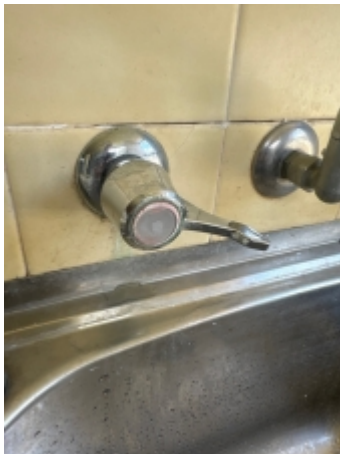
Defect Severity	Major Defect
Defective Item	Laundry Taps
Defect	Leaks
Comment	Water leakage observed from the taps, potentially resulting in water wastage and possible water damage. It is recommended to engage a licensed plumber to rectify the issue to minimise the risk of water-related problems.

Visible leaks were located in the following areas: **Taps**

If leaks are detected, it is recommended that a suitably qualified plumber or builder is engaged to rectify as soon as possible.

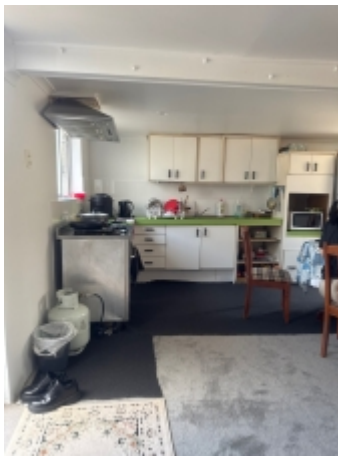
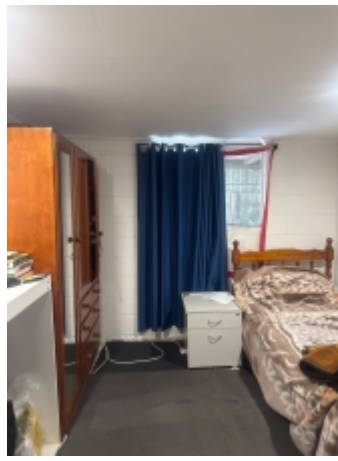
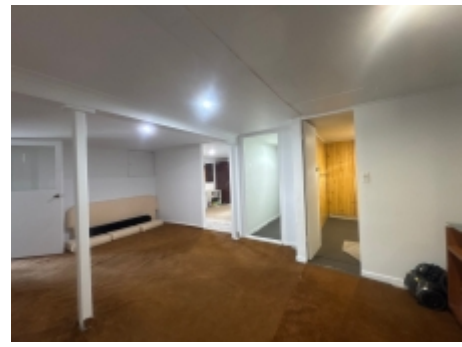
Defective Item	Ceilings
Defect	Habitable ceilings below 2.4 m
Comment	The ceiling height in downstairs areas are below the minimum standard of 2400mm, making it unsuitable for use as a habitable space. It is recommended to seek confirmation from the local council or a private certifier regarding its suitability and compliance

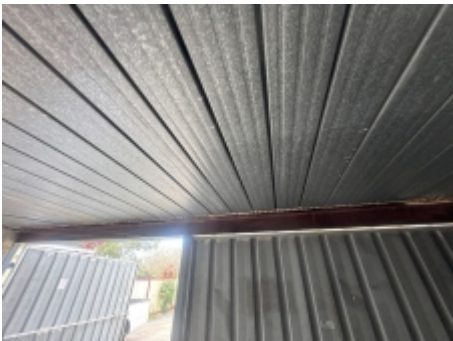
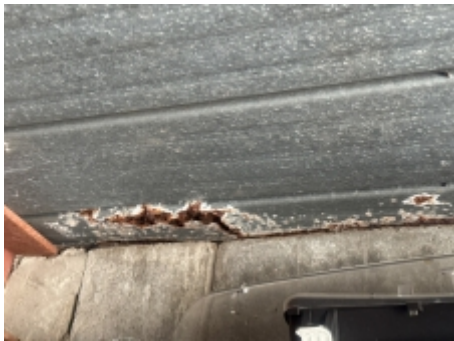
Defect Severity	Major Defect
Comment	Rust to parts of metal components. Recommend engaging a suitable trade person to rectify the issue to reduce the risk of further deterioration

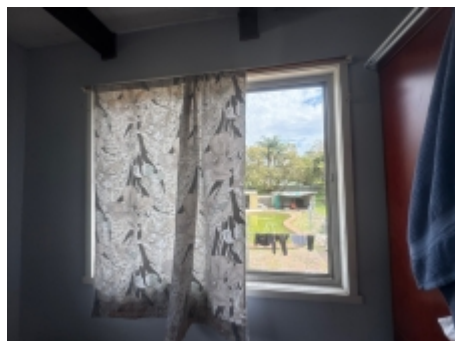
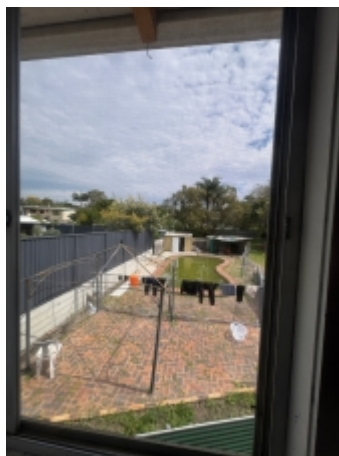
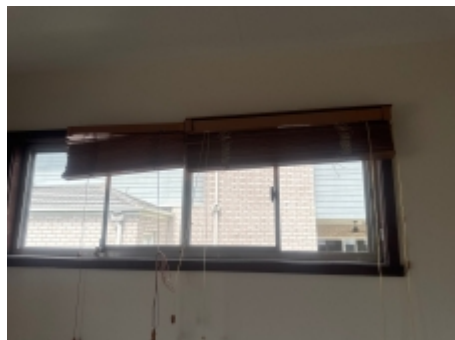
Defect Severity	Major Defect
-----------------	--------------

Defective Item	Doors and Windows
Defect	No fall prevention
Comment	Fall prevention measures were not observed on the upper-level windows. It is recommended to engage a builder to install appropriate safety measures to reduce the risk of falls.

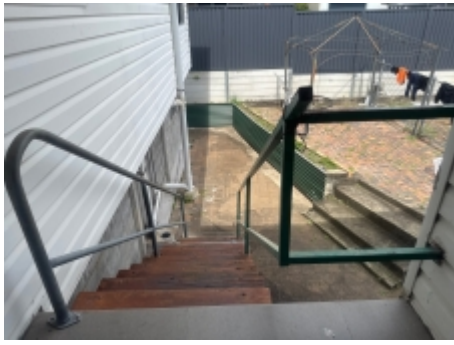
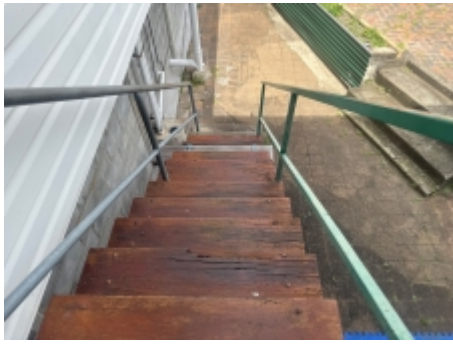
Defect Severity	Safety Hazard
Defective Item	Balustrades
Defect	Non-Compliant Balustrade Spacing
Comment	There are gaps within the balustrades that exceed the maximum allowable opening. As per NCC requirements, a 125 mm sphere must not be able to pass through any part of the balustrade. It is recommended that the balustrades be modified to comply with the spacing requirements to ensure occupant safety and regulatory compliance.

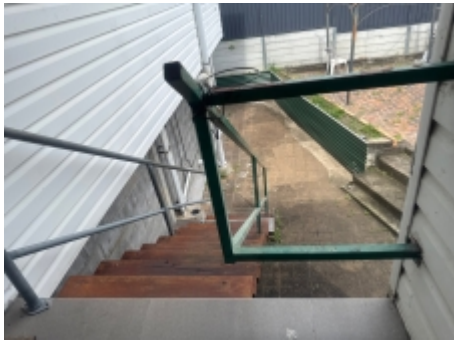
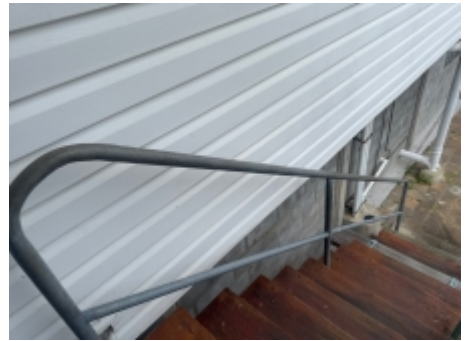
Defect Severity	Major Defect
Defective Item	Balustrades
Defect	Non-Compliant Balustrade Spacing
Comment	There are gaps within the balustrades that exceed the maximum allowable opening. As per NCC requirements, a 125 mm sphere must not be able to pass through any part of the balustrade. It is recommended that the balustrades be modified to comply with the spacing requirements to ensure occupant safety and regulatory compliance.

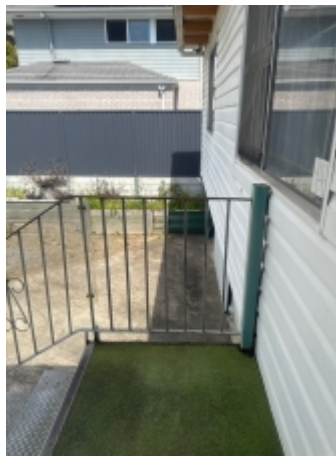
Defect Severity	Safety Hazard
Defective Item	Balustrades
Defect	Insufficient height
Comment	The height of the balustrades appears to be below the minimum required by current standards, posing a potential safety risk. Regulations stipulate a minimum height of 1000 mm. It is recommended that the balustrades be modified to comply with these requirements.

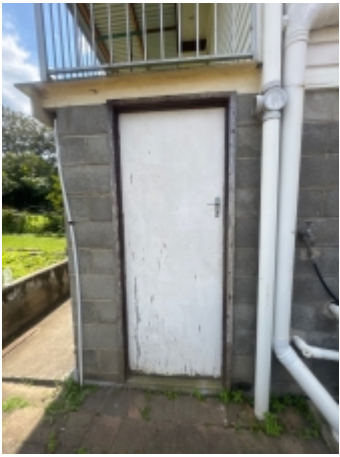
Comment	<p>The doors and/or window frames appear aged, weathered, and show signs of material deterioration, likely due to prolonged exposure to environmental elements. This may impact their functionality, appearance, and weather resistance. It is recommended to engage a licensed carpenter or suitable tradesperson to assess the condition and undertake repairs or replacements as necessary to restore proper function and prevent further deterioration.</p>
---------	---

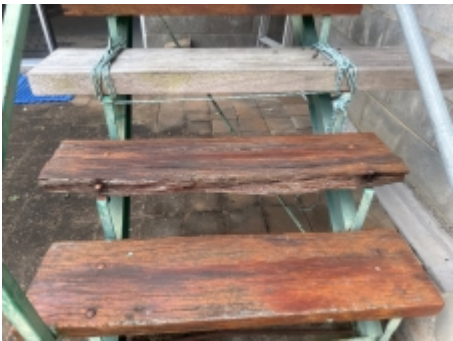
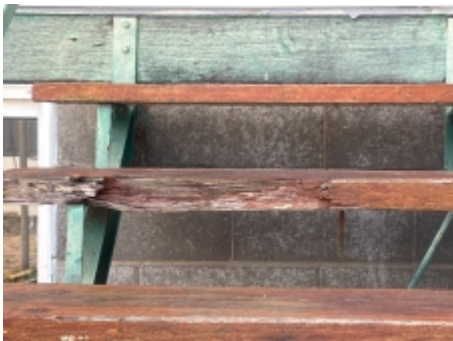
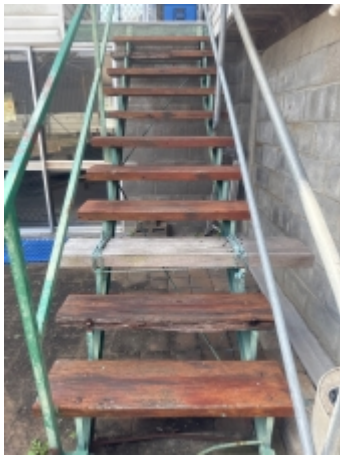
Defect Severity	Major Defect
Comment	Timber stair treads show evidence of wood rot. It is recommended to engage a licensed carpenter or builder to replace the affected stair treads.

Where fungal decay has been found, does this present a Major Safety Hazard?	Yes
---	-----

Details & Location of Safety Hazard:	Back stair
--------------------------------------	------------

Where a Major Safety Hazard is identified, it must be attended to and rectified by a Licenced Builder to avoid the possibility of personal injury or death.

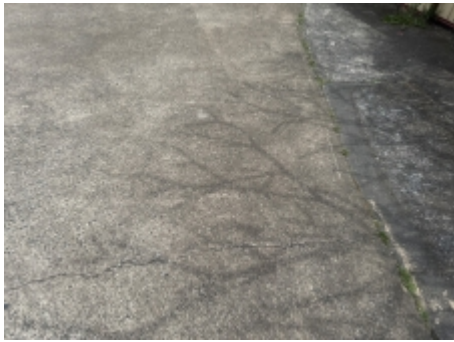
Defect Severity	Minor Defect
Defective Item	Paths and driveways
Defect	Minor cracks or damage
Comment	Signs of minor cracks or damage were observed in the driveway or paths. It is recommended that these areas be monitored for any further movement or expansion.

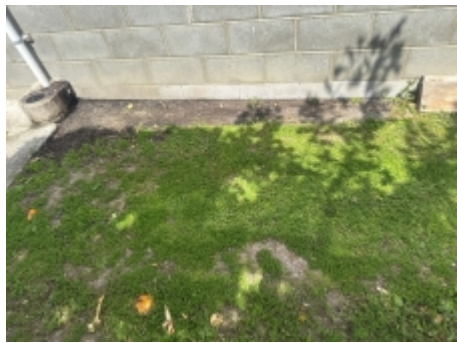
Defect Severity	Major Defect
Defective Item	Site Drainage
Defect	Poor surface drainage
Comment	Poor surface drainage was noted in this area. It is recommended to engage a plumber to rectify the issue to reduce the risk of water related problems

Where site drainage is deemed inadequate, remedial action should be undertaken by an engineer, plumber, drainer or licensed builder.

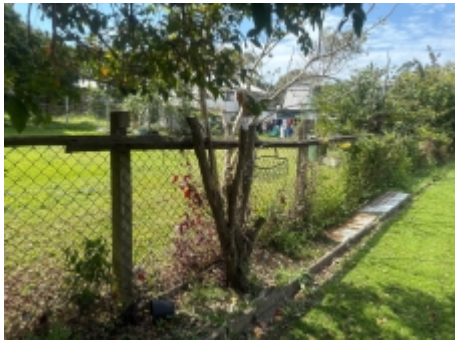
Defect Severity	Major Defect
Defective Item	Fencing
Defect	Wood Rot and damage
Comment	Wood rot, leaning and damage were observed in sections of the timber fence. It is recommended to engage a carpenter to rectify these issues to reduce the risk of damage and further deterioration.

Visible damage appears to be located in the following areas:	Timber fence External timber
--	---------------------------------
